Asset #03051(Routine)  
S.H.59 Benton 2 Co over U.S. 412-SEC 1

Location: Jct US 412 & SH 59

Team Lead: Nathan Rowland Inspection Date: 12/07/2023

12/06/2023: Routine inspection conducted this date. See element notes for documentation.

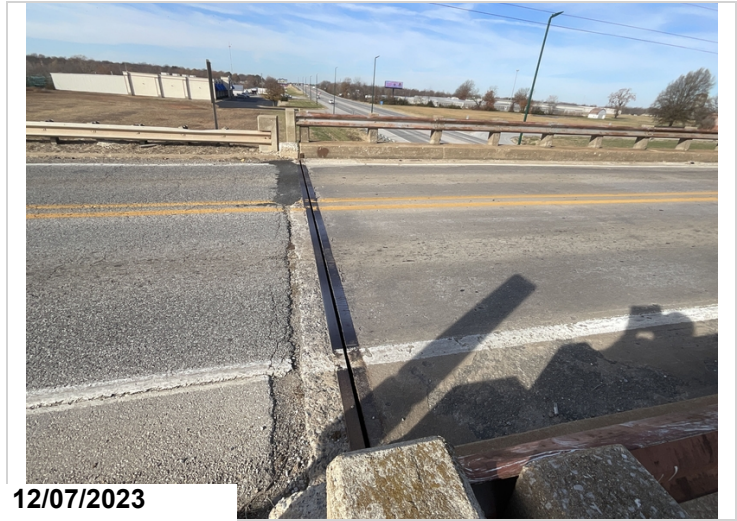
View of abutment #2 joint missing joint material

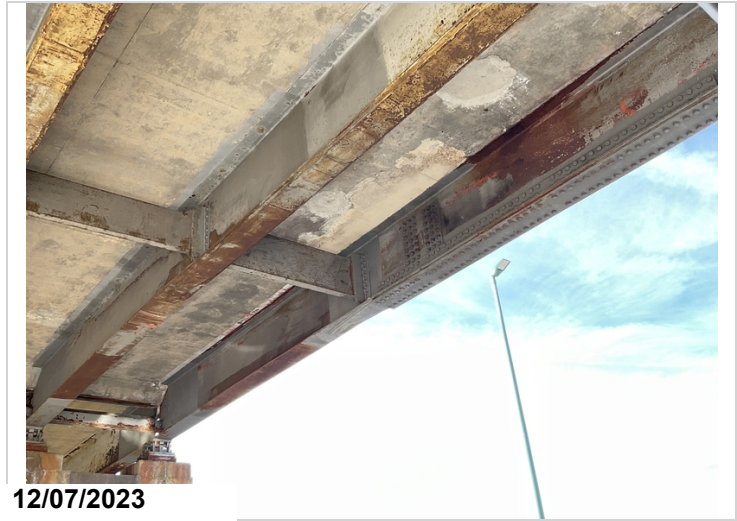
Span #2 girder #5 retrofit bolted repair

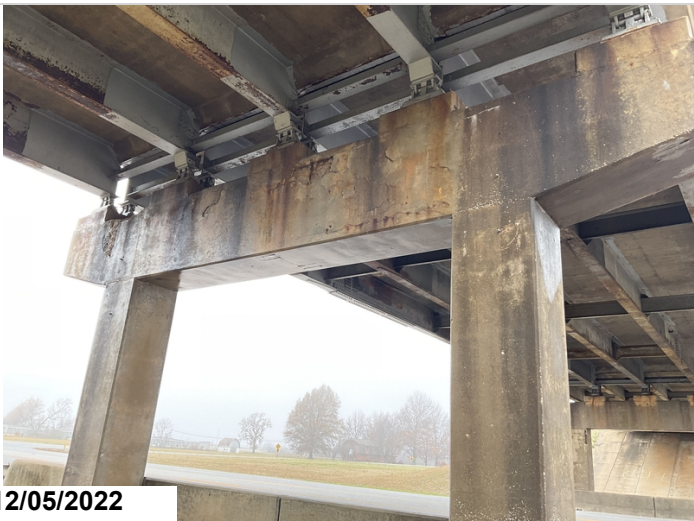
View of bent #2 cap ahead side spalling with steel exposed

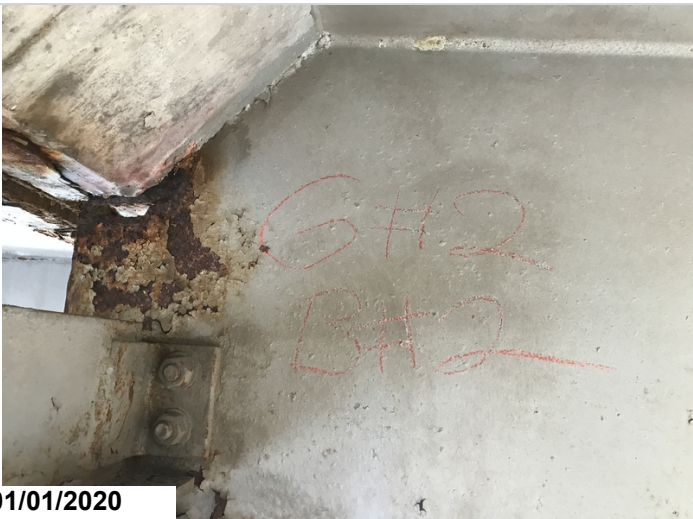
Girder #2 in span #3 over bent #2 completely section loss of web in haunch area.

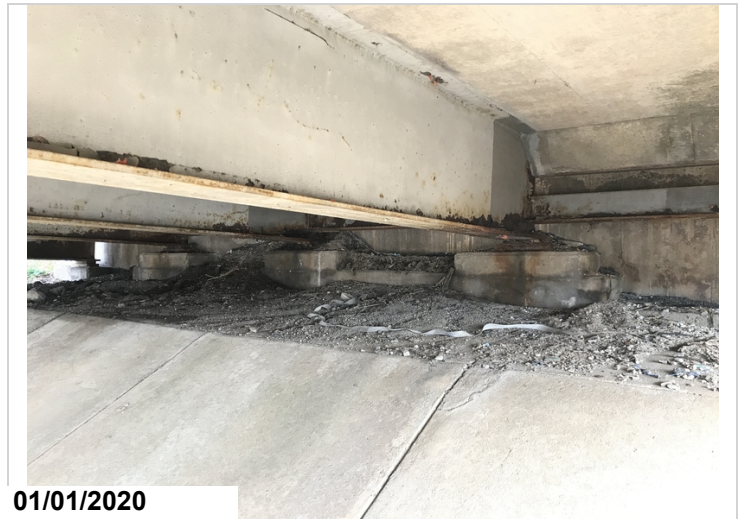
Abutment #1 dirt and debris build up.

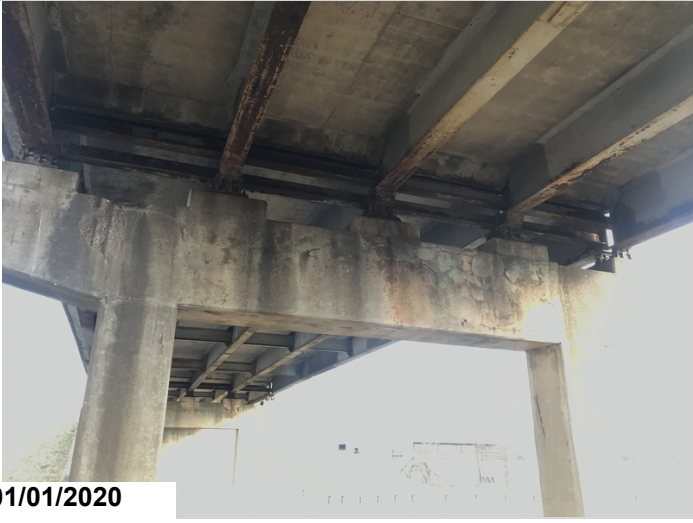
(234) 12/06/2023:							
Cap - Bent #2 cap has large spalls on the ahead face of cap with exposed reinforcing steel initial section loss to exposed reinforcing steel. Minor areas of delamination's and light/medium vertical cracks.							
302	Compression Joint Seal	LF	54	0	0	0	54
2310	Leakage	LF	54	0	0	0	54

Bent #2 cap ahead side spalling steel exposed and multiple delaminated areas.

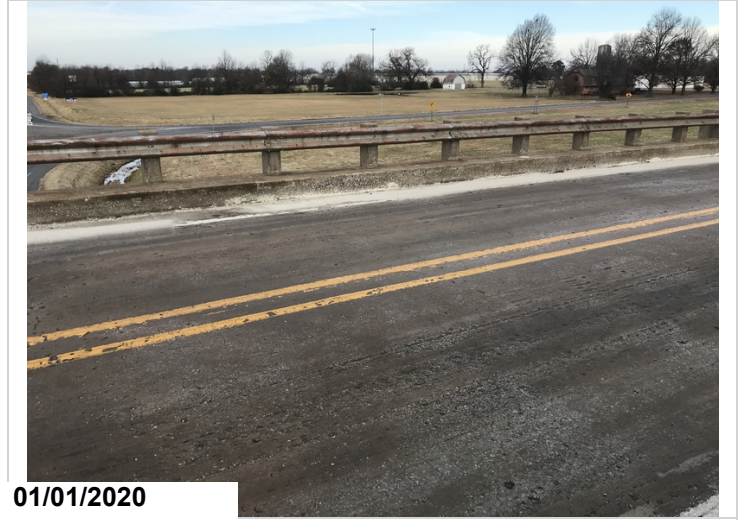
Deck Span #1 right gutterline patch repair

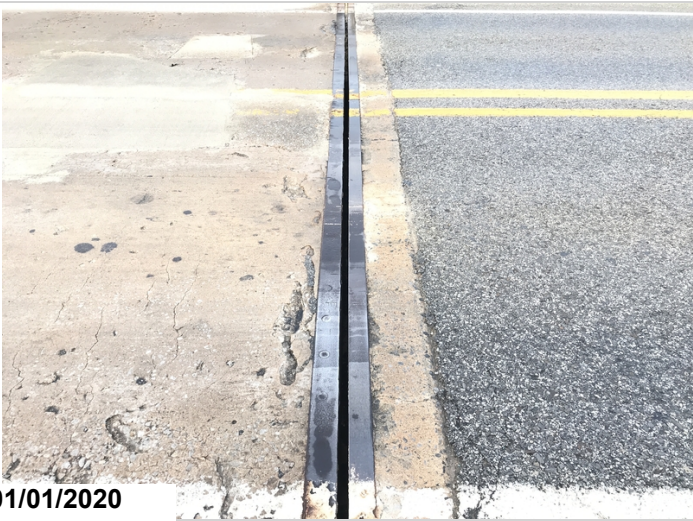
(302) 12/06/2023:							
- Compression joint seals are missing at the abutments allowing a free flow of water and debris onto the bridge seats. Spalling adjacent to the joint amour typical.							
305	Assembly Joint without Seal	LF	54	46	0	8	0
2360	Adjacent Deck or Header	LF	8	0	0	8	0

Abutment #1 expansion joint material has been displaced.

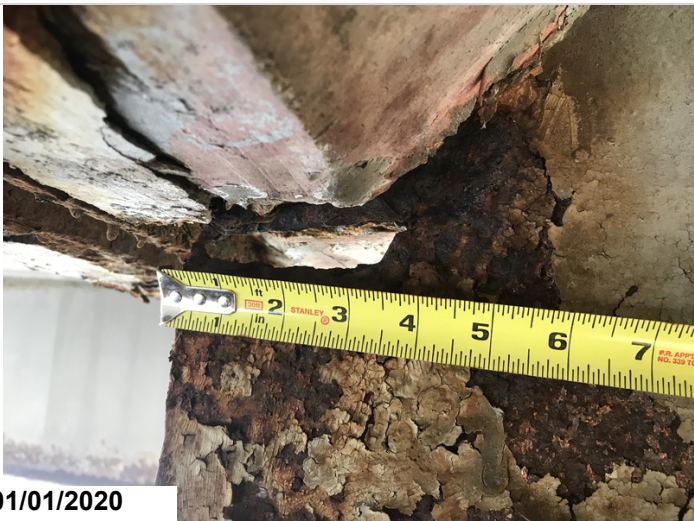
Girders #2 in span #3 over bent #2 completely section loss of web in haunch area.

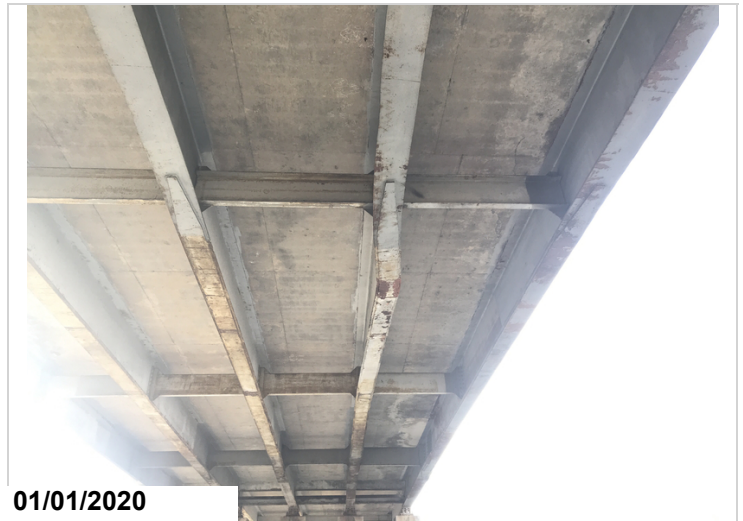
Span #2 Girder #4 out of plane bending.

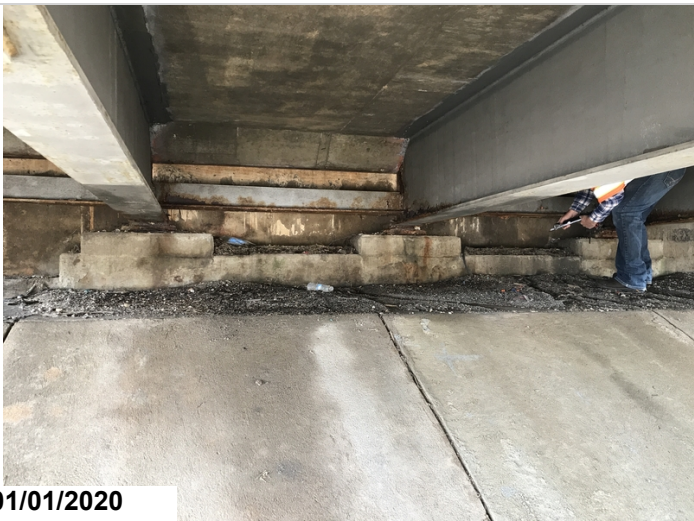
View of dirt and debris build up at abutment #2 due to open joint.

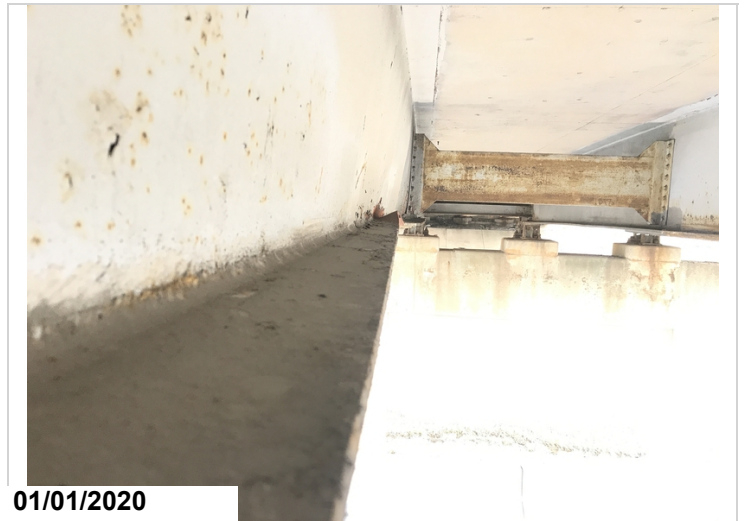
Girder #4 span #2 collision damage still exists.

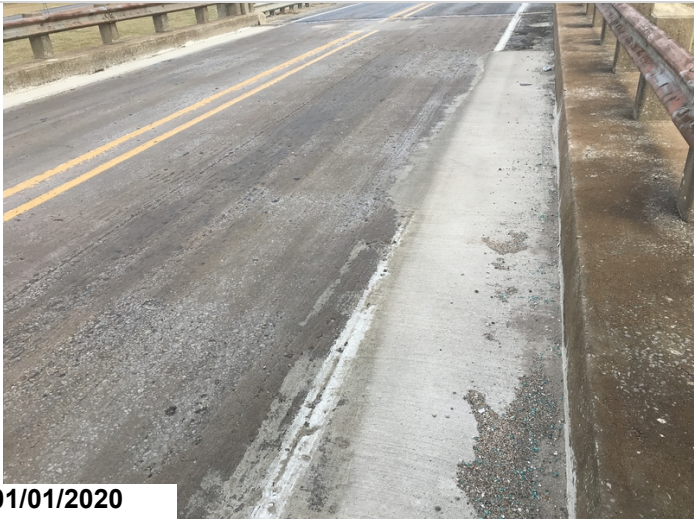
Deck Span #1 left gutterline patch repair

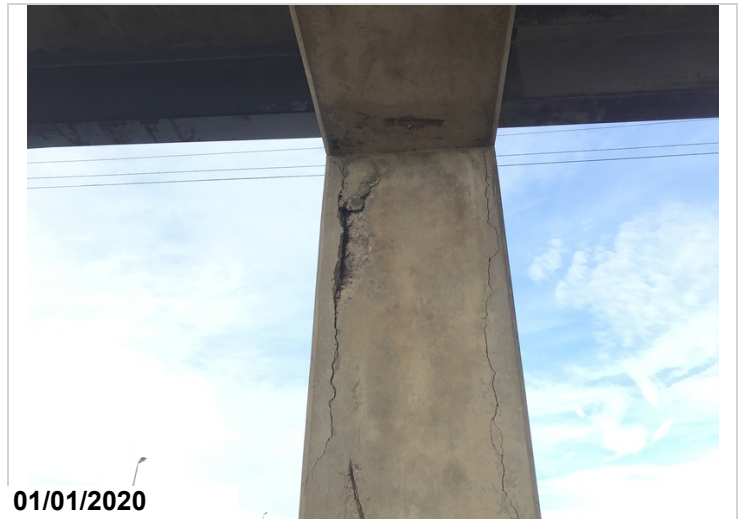
Bent #1 column #2 has spall 2' tall with steel exposed with a vertical crack that extends down to the ground.

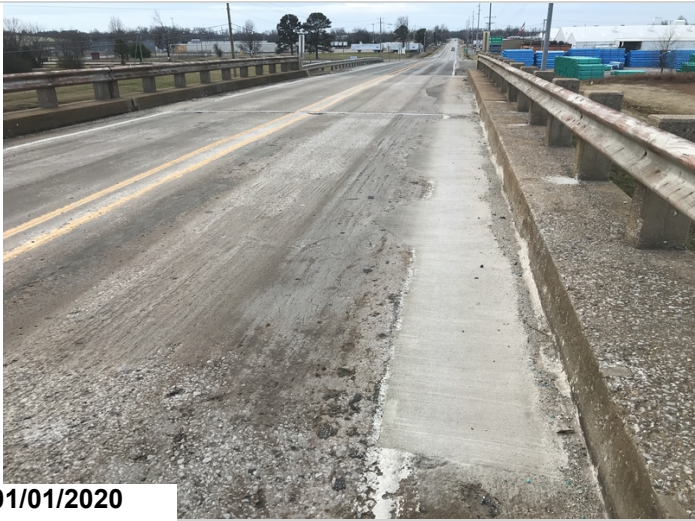
Right gutterline repairs in spans #2 and #3.

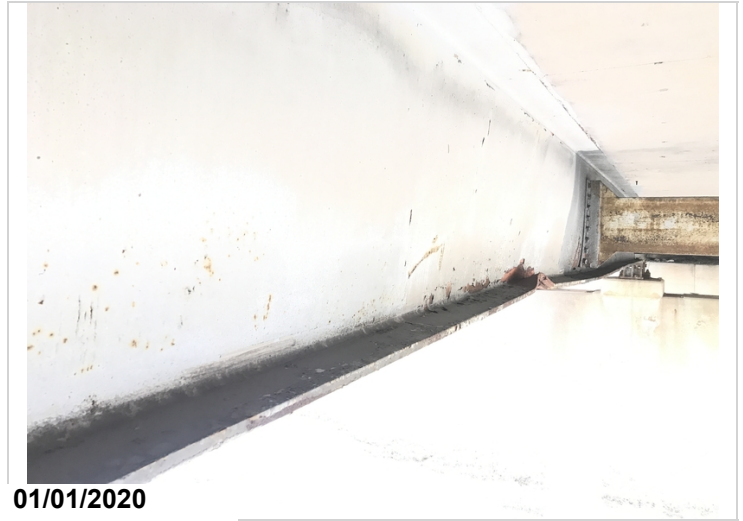
Girder #4 span #2 collision damage still exists.

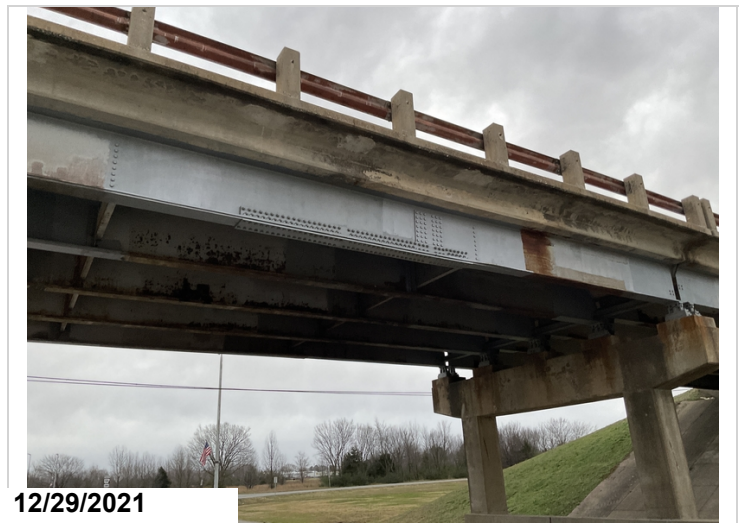
State maintenance forces have placed bolted spliced repairs

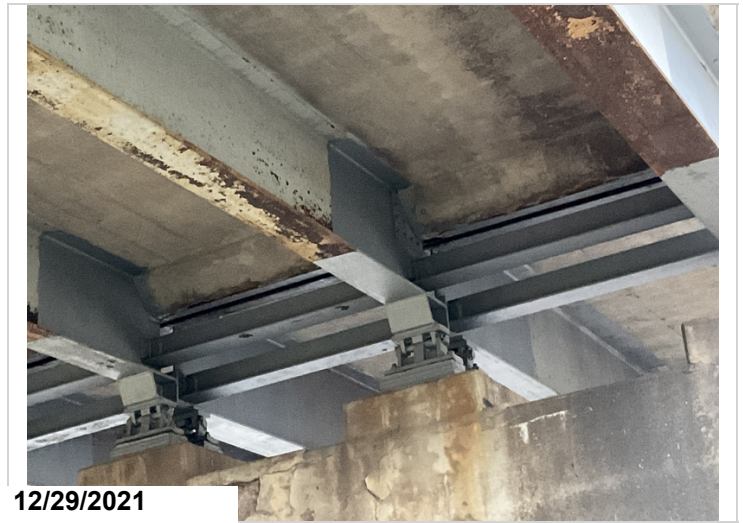
State maintenance forces have repaired haunch area with a bolted splice

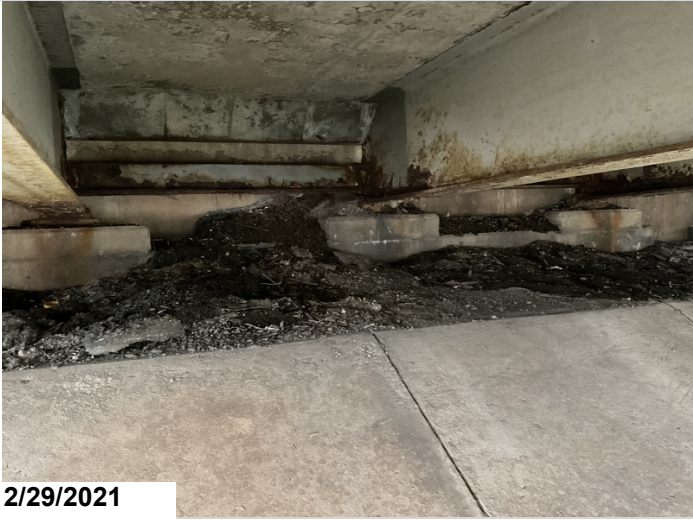
Dirt and debris accumulation at abutment #1

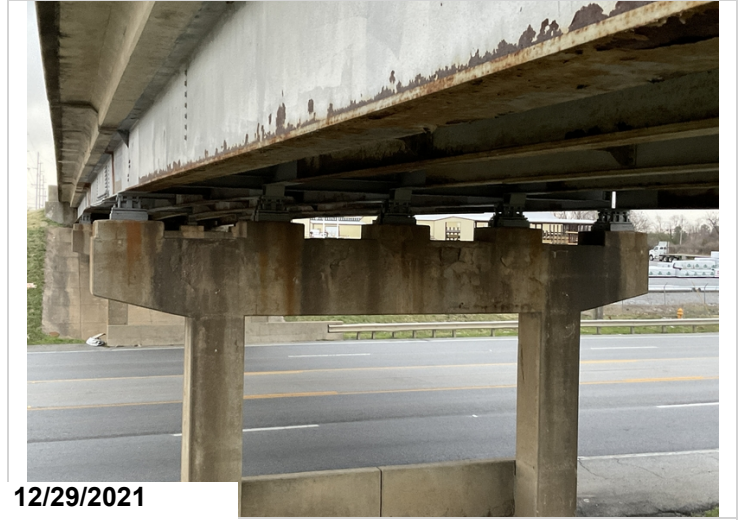
Maintenance forces have raised bridge at bearings to help combat collision to girders.

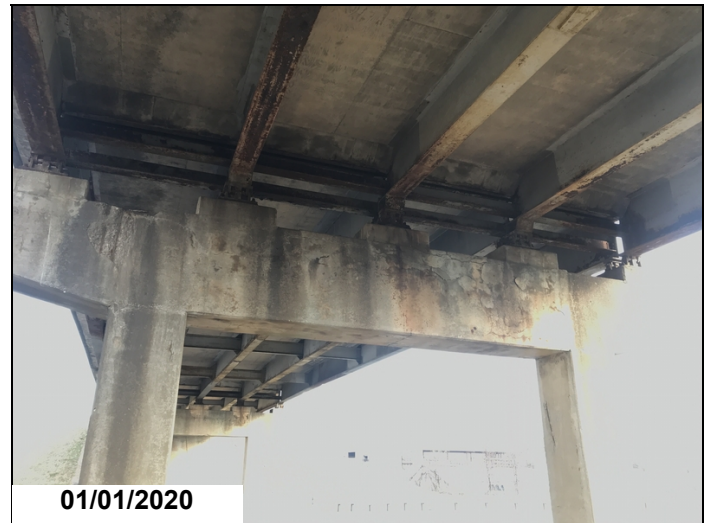
Bent #2 concrete cap ahead side ( per log ) - spalling with steel exposed and delaminations

Bent #2 cap ahead side spalling steel exposed and multiple delaminated areas.

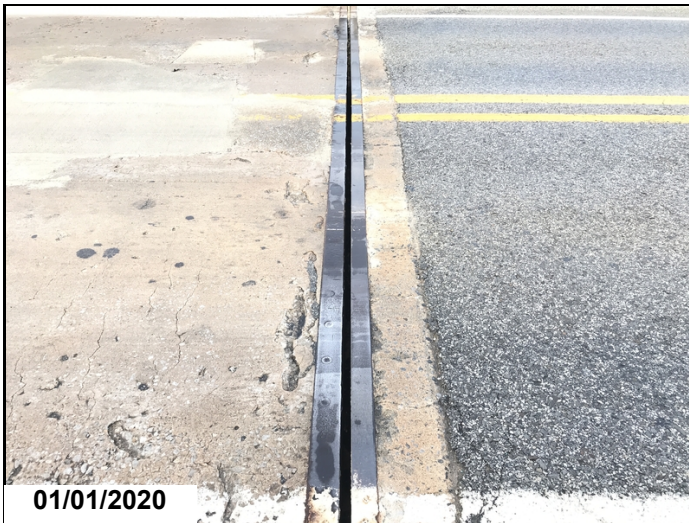
Deck joints are open at abutments #1 and #2 - Excessive leakage and large amount of debris and gravel on caps.

Abutment #1 expansion joint material has been displaced.

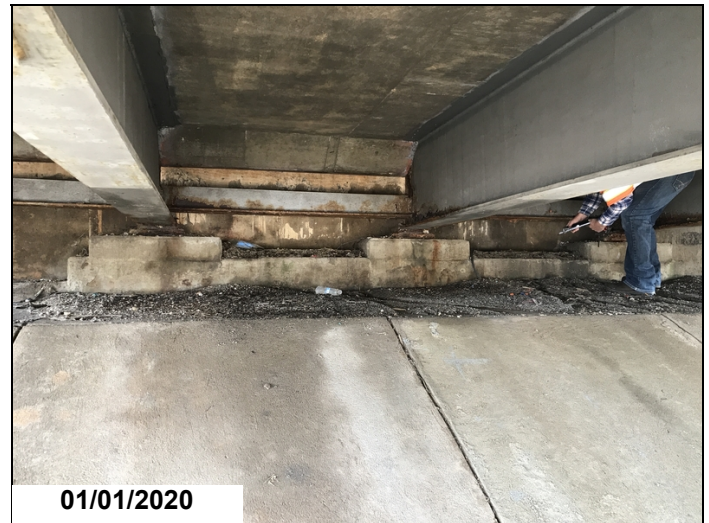
View of dirt and debris build up at abutment #2 due to open joint.

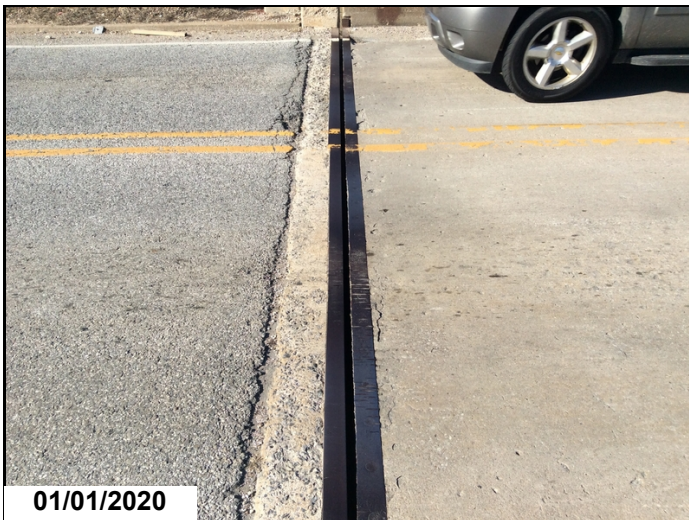
Deck bent 4 left - expansion joint missing.

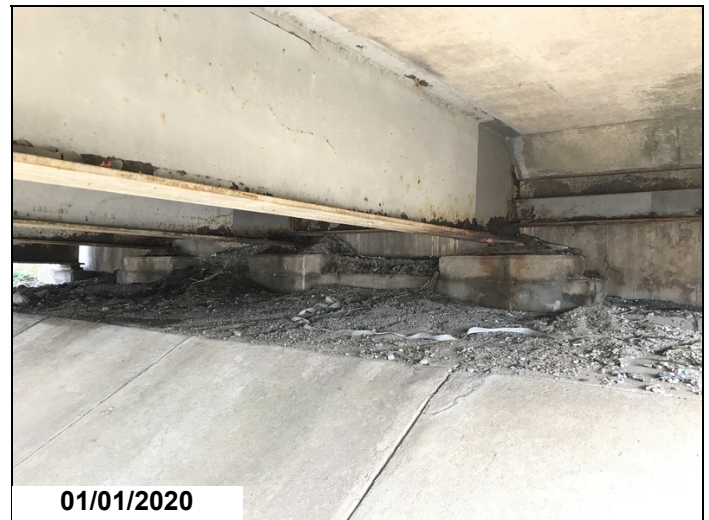
Abutment #1 dirt and debris build up.

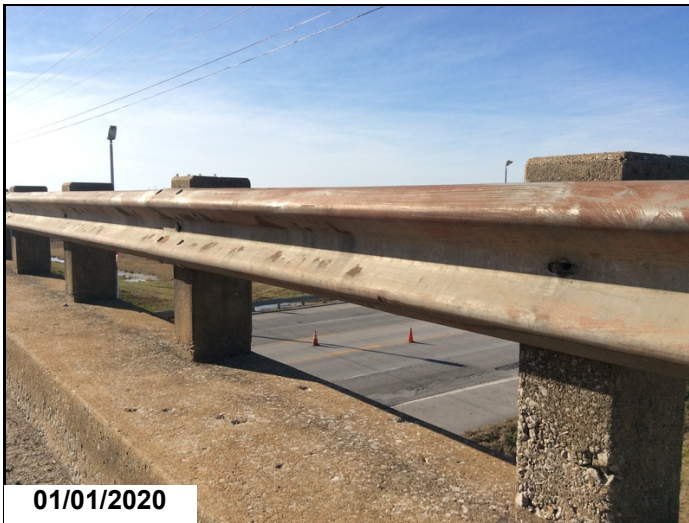
Bridge rail right side span #1 - Few posts not bolted to bridge rail.

01/01/2020  
Bridge rail right side span #1 - Few posts not bolted to bridge rail.

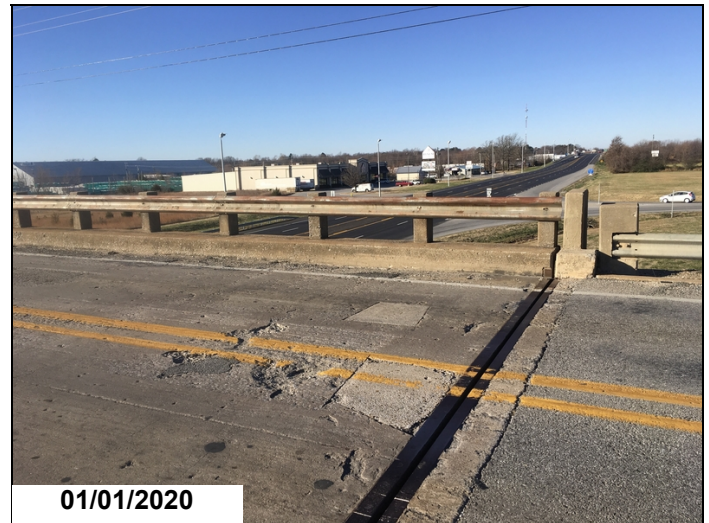
01/01/2020  
3 missing bolts in guard rail span 1 right.

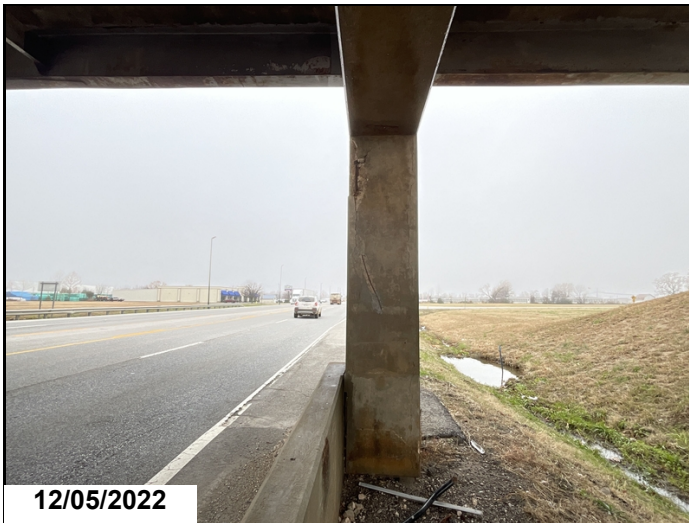
Bent #1 Column #2 Spalling with exposed reinforcing steel.

Bent #1 column #2 cracking and spalling

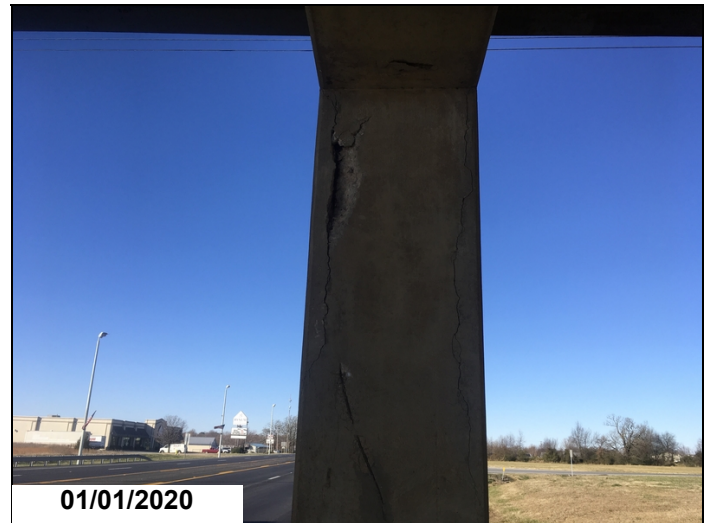
Bent 2 Column 2 spall with exposed reinforcing steel.

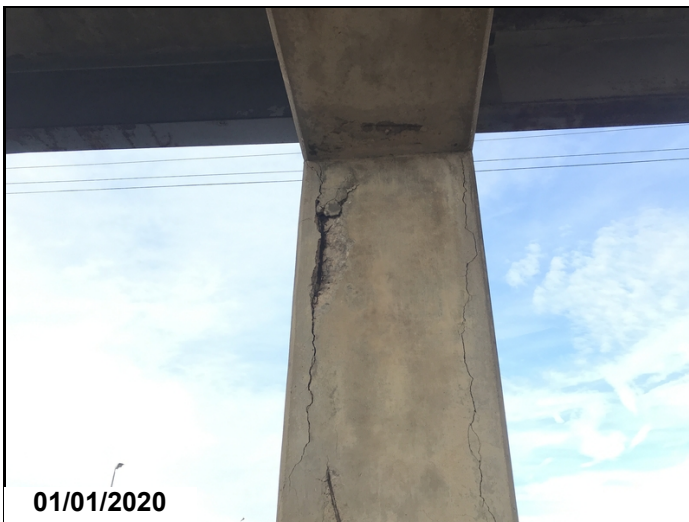
Bent #1 column #2 has spall ' with steel exposed with a vertical crack that extends down to the ground.
