Asset #03743(Routine, Underwater type 2)

SH 59 Benton 2 over ILLINOIS RIVER

Location: .64 MI N WASHINGTON CO

Team Lead: Benjamin Smith Inspection Date: 06/11/2024

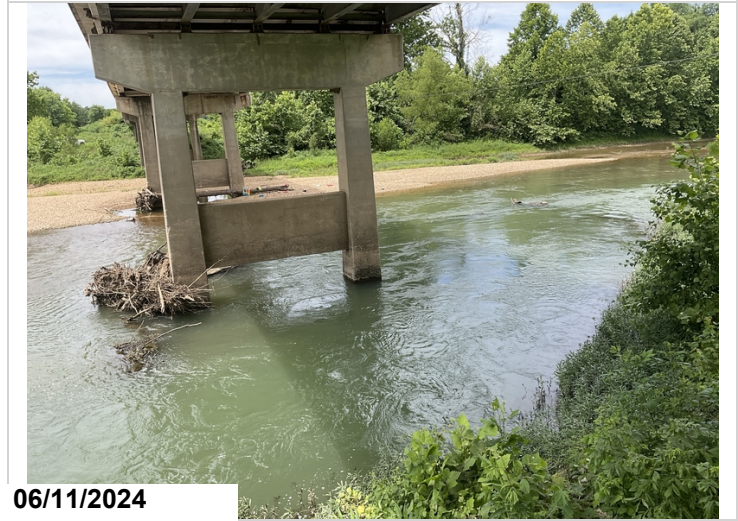
The channel beneath the structure has drift on bent #9. Bent #1 has local scour around the piles. Bent #11 has local scour around the columns. Portions of the substructure of the previous bridge are still in the channel.

Channel beneath the structure.

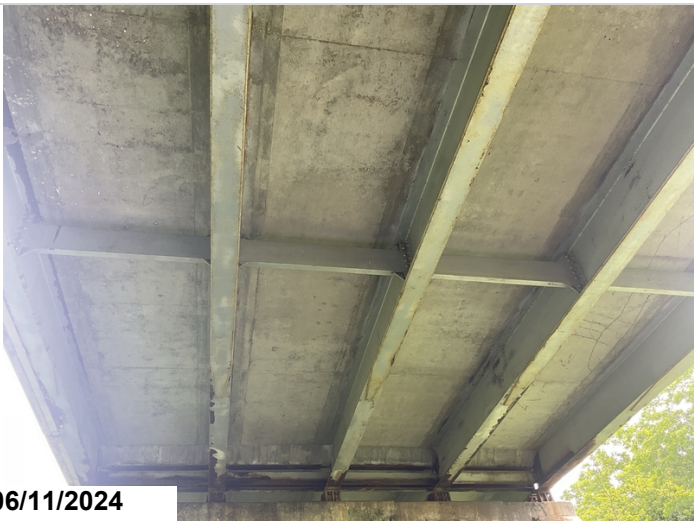
The undersurface has areas of spalling with exposed rebar in the overhangs and random drain areas.

Undersurface view.

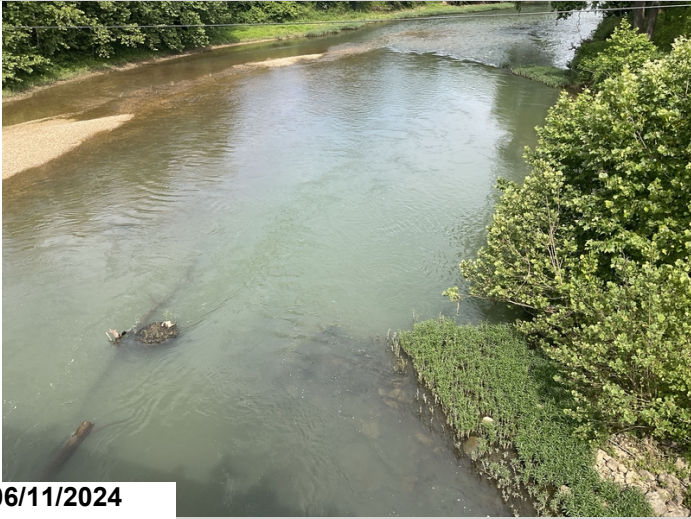
The downstream channel is well vegetated.

Downstream channel view.

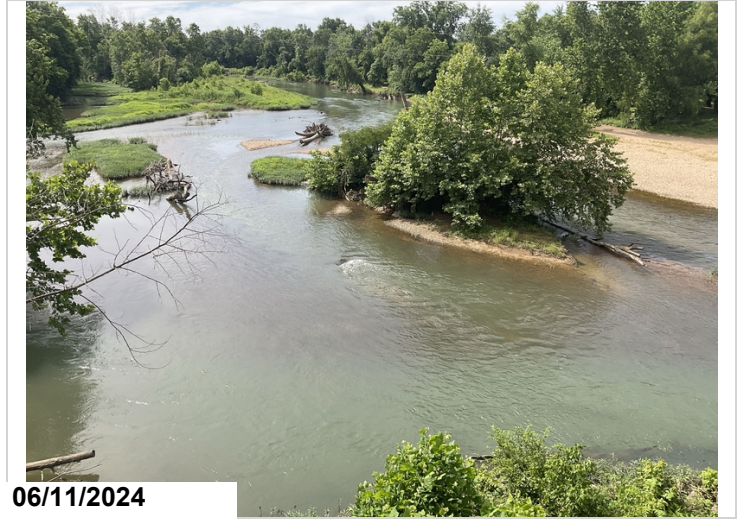
The upstream channel banks are vegetated. The upstream channel has aggradation islands.

Upstream channel view.

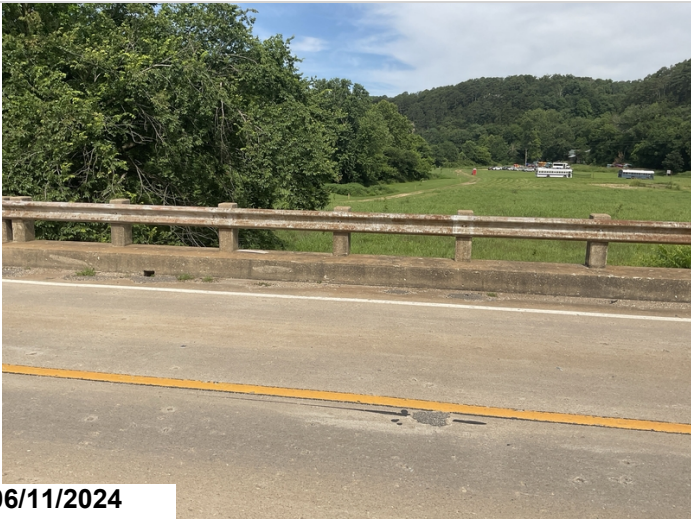
(330) The concrete posts in multiple locations have shallow cs3 rebar exposed at the base.							
Right railing- The paint system is failing for the entire length of the bridge, the railing has cs2 corrosion. Left railing- The paint system is failing for the entire length of the bridge, the railing has cs2 corrosion.							
Transitions- the approaches have thrie rail transition railing. No deficiencies noted.

Typical metal railing condition.

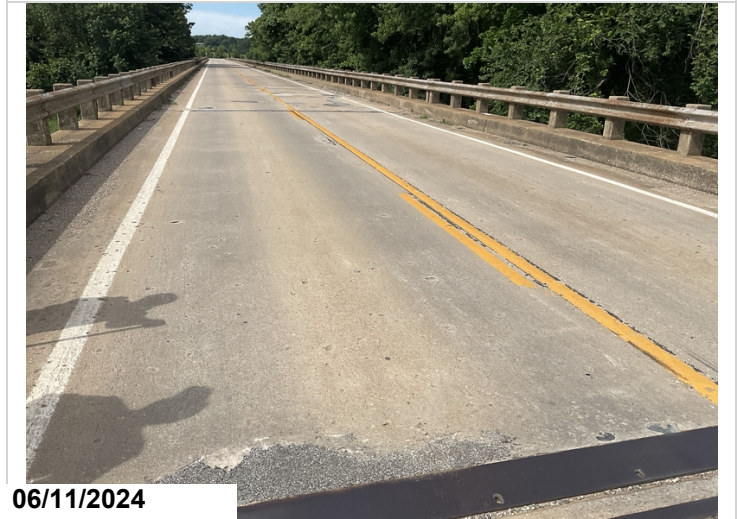
The deck driving surface has numerous areas of asphalt patches and unrepaired delaminations. The right lane has large concrete repairs.

Driving surface view.

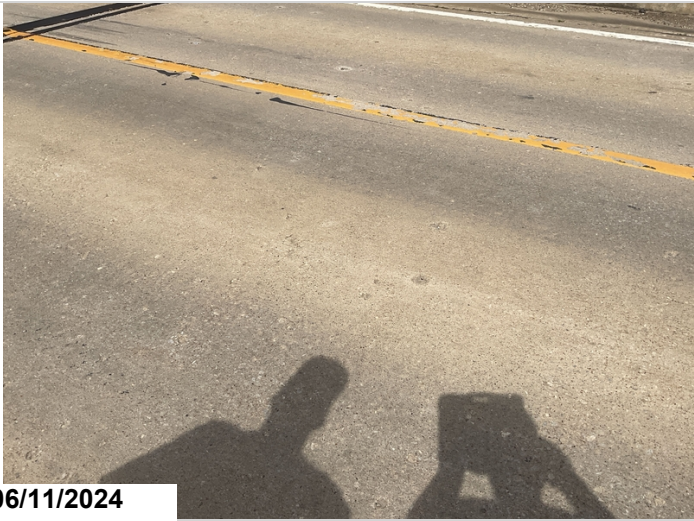
(321) Approach slab#1- has 120 square feet of wear in the wheel paths. The slab has random popouts and insignificant spalling at the edge of the slab.							
Check plans for another approach slab.							
330	Metal Bridge Railing	LF	1914	1913	0	0	1
1020	Connection	LF	1	0	0	0	1
515	Steel Protective Coating	SF	5742	3367	0	2375	0
3440	Effectiveness (Steel Protective Coatings)	LF	2375	0	0	2375	0

Approach slab #1 condition.

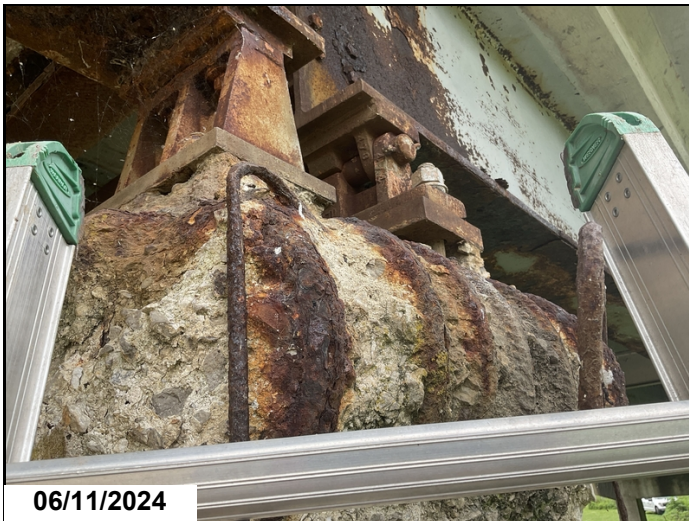
06/11/2024

Many of the pier caps have delamination. Pier caps #11,12 have deep spalling and concrete deterioration at the right cap end. Pier #11 is the worst case condition with loss of bearing area. Bent #8 has steel piling with section loss at the top of the piling.

Bent #11 the anchor bolts are exposed at the right cap end.

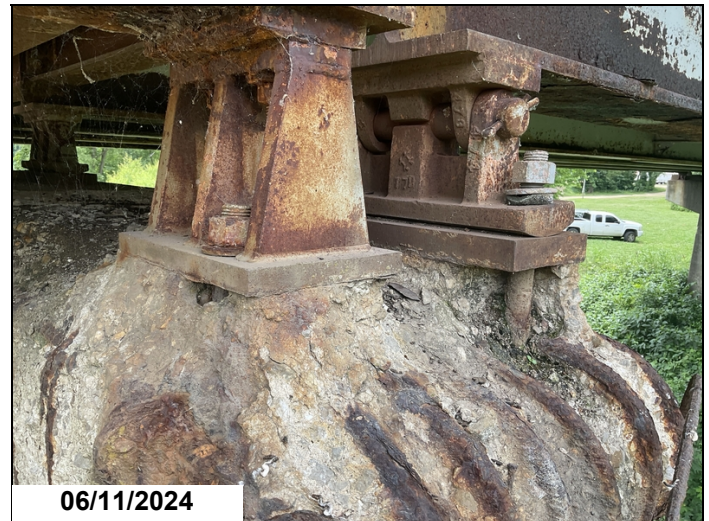
06/11/2024

Bent #11 the right cap end has concrete deterioration with severe section loss.

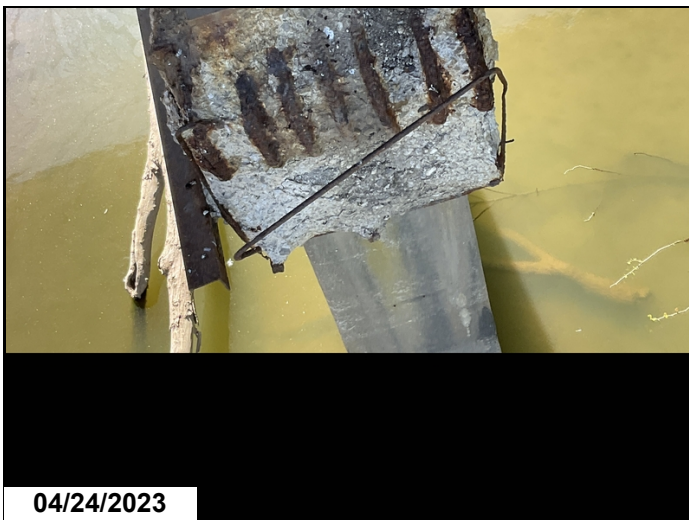
04/24/2023

-Bent #11 bearings #5 in spans #11 and #10 - have loss of bearing area and structural steel exposed due to concrete deterioration.

Still exists Bent #11 bearings #5 in spans #11 and #10 - have loss of bearing area and structural steel exposed.

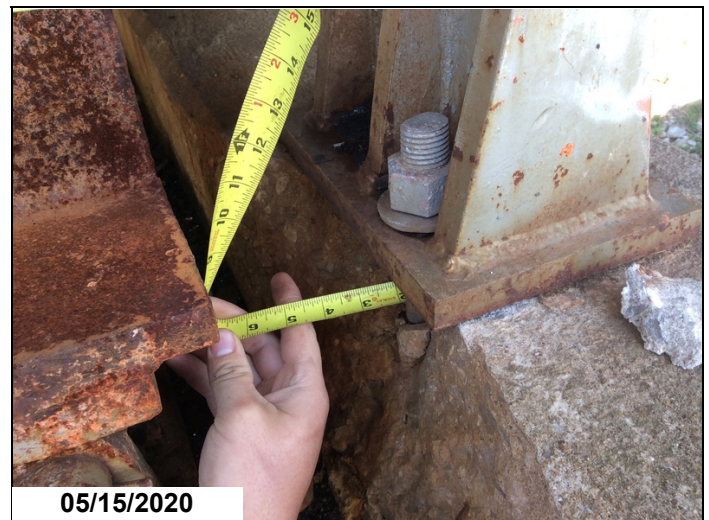
05/15/2020

-Bent #9 Span 8 bearing #1 - has loss of bearing area approximately 9"wide x2"deep.

Bent #9 Span #8 bearing #1 - has loss of bearing area.

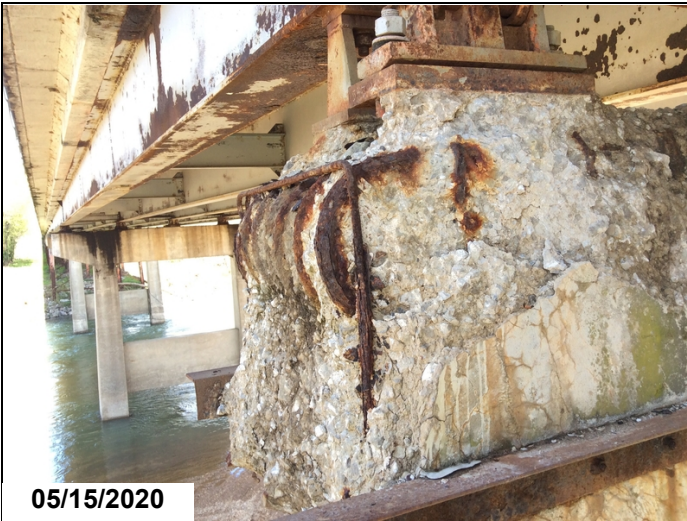
Bent #11 bearings #5 in spans #11 and #10 - have loss of bearing area and structural steel exposed.

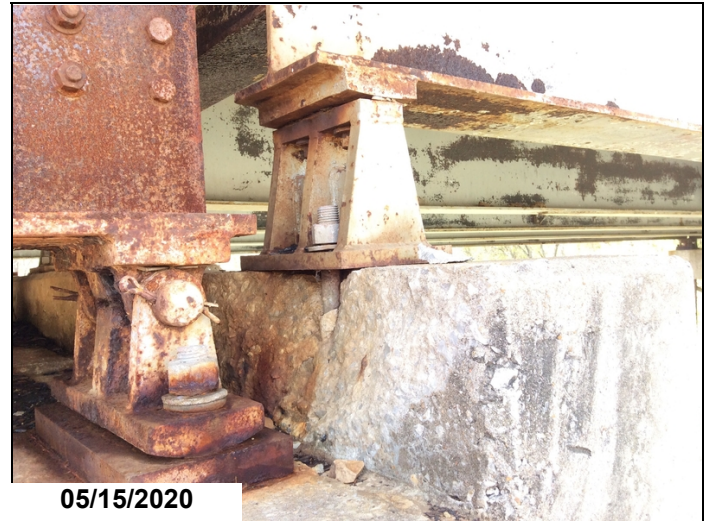
Bent #9 Span #8 bearing #1 - has loss of bearing area.

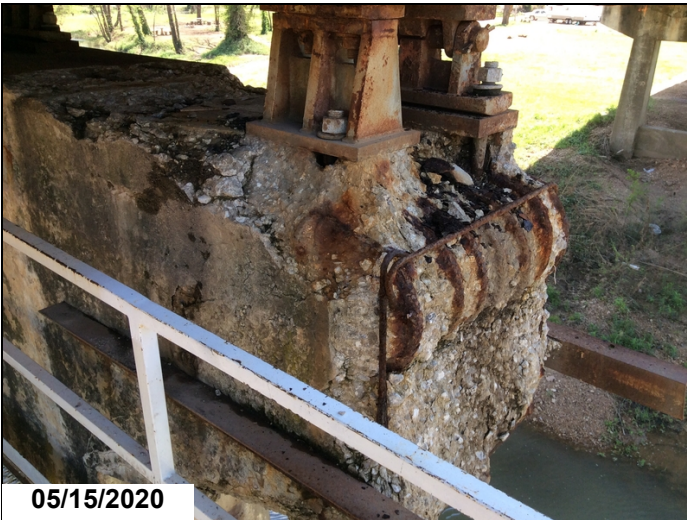
Bent #11 bearings #5 in spans #11 and #10 - have loss of bearing area and structural steel exposed.

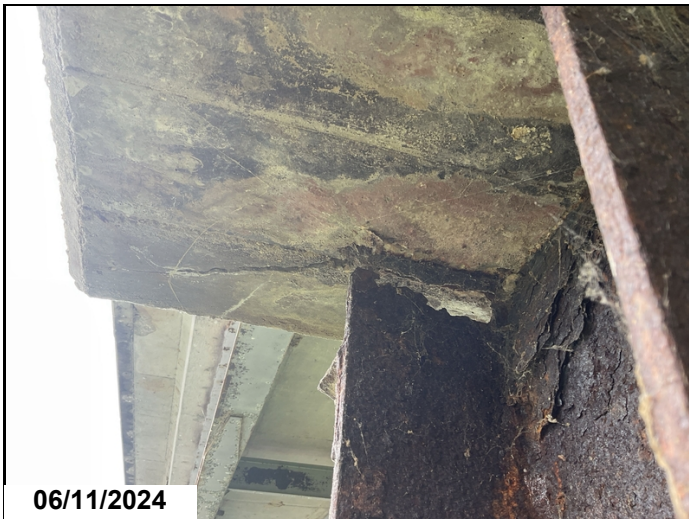
6" long by 1.5" wide rust hole on the top left flange of pile #1 at bent #8.

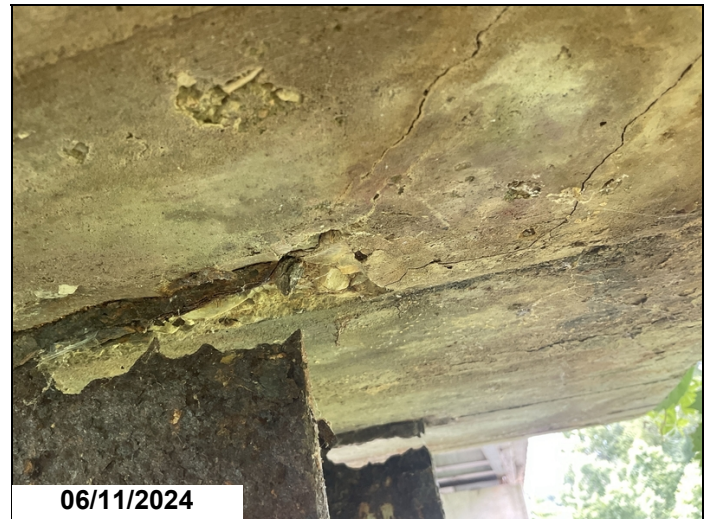
3" long by 1/2" wide rust holes at the top right side of pile #5 at bent #8 on the span #7 and span #8 sides.

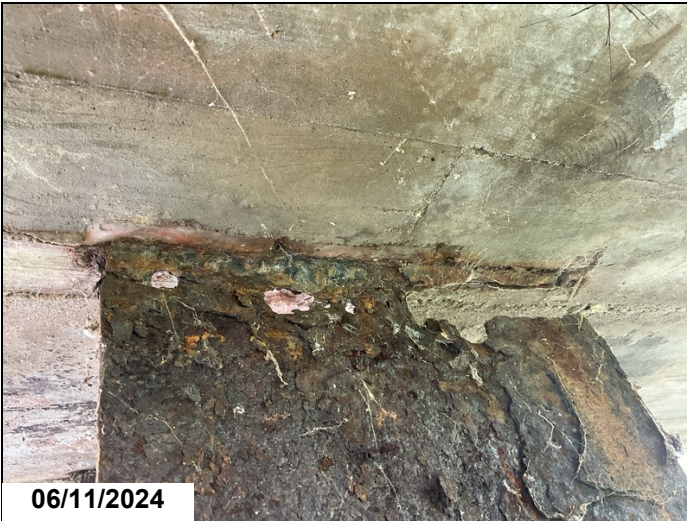
Full width flange rust hole on the span #7 side of pile #4 at bent #8.

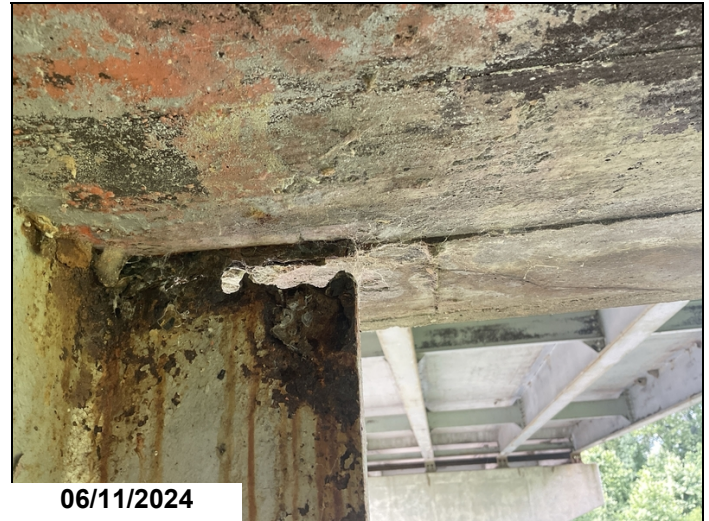
3" long by 3/4" tall rust hole at the top of pile #3 at bent #8.

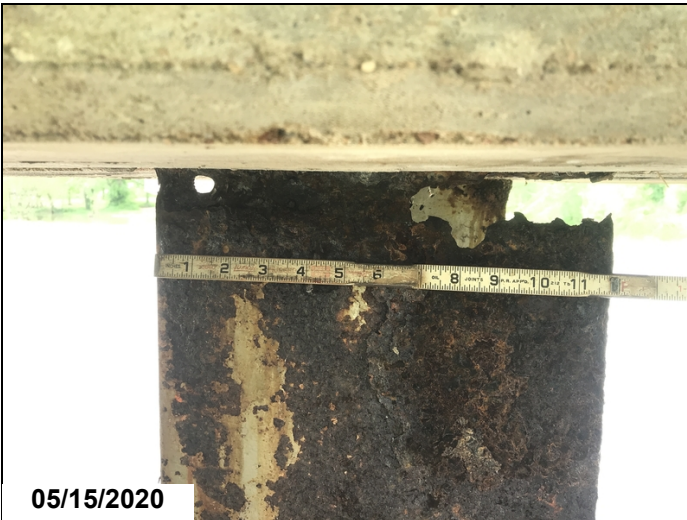
Bent #8 steel piling #4 behind flange right and left side has areas of complete section loss.

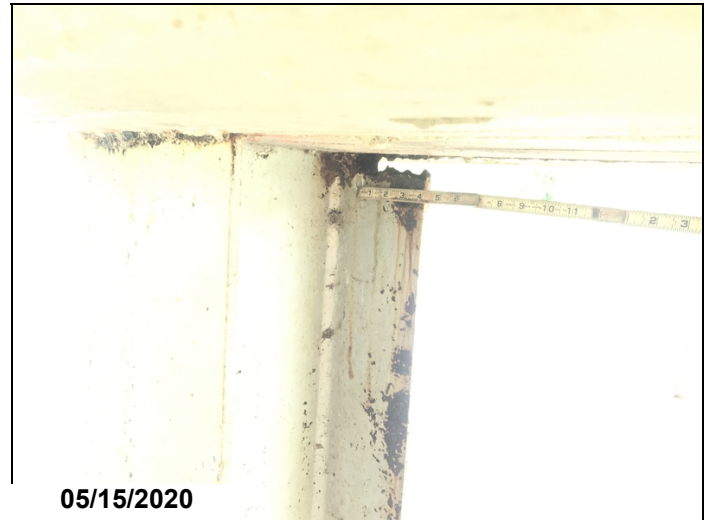
Bent #8 steel piling #3 ahead flange right side has complete section loss approximately 4" wide and 1" tall at the concrete cap juncture.

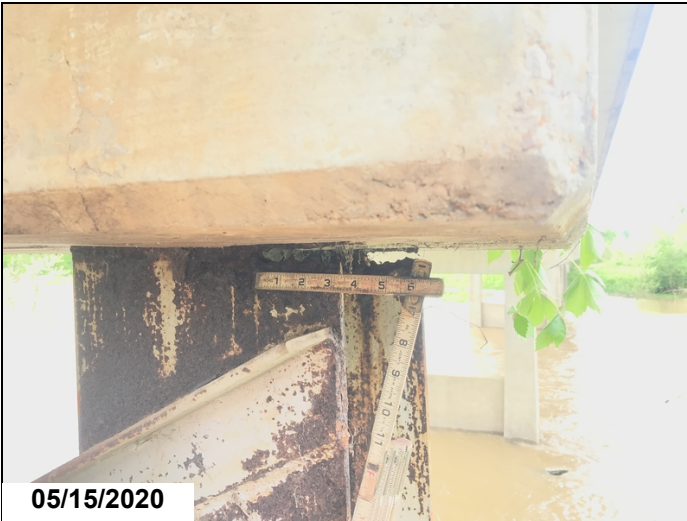
Bent #8 steel piling #5 behind flange right side complete section loss adjacent to concrete cap. Section loss area 3" x 1"

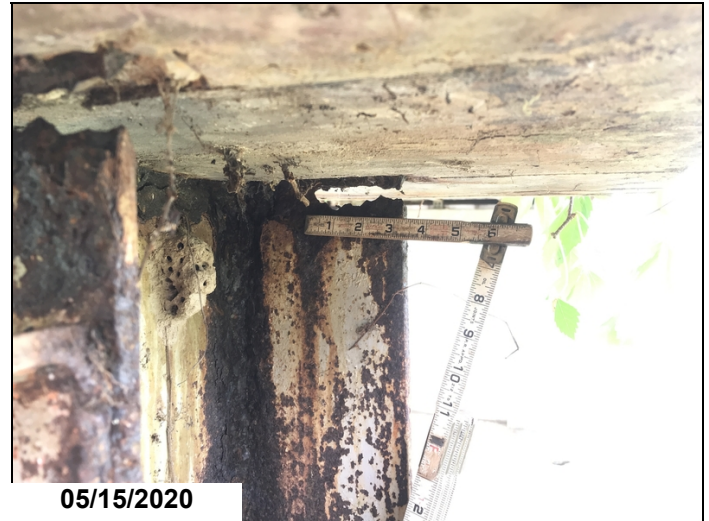
Bent #8 steel piling #5 ahead flange right side complete section loss adjacent to concrete cap. Section loss area 3" x 1"

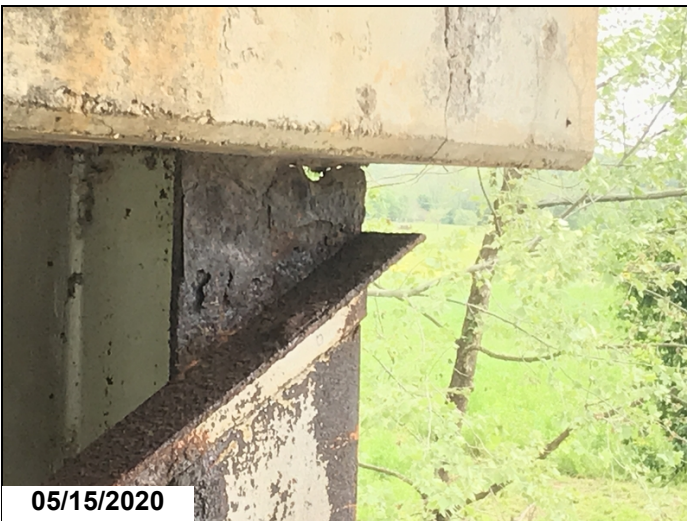
Bent #8 steel piling #1 ahead flange left side complete section loss adjacent to concrete cap. Section loss area 3" x 1"

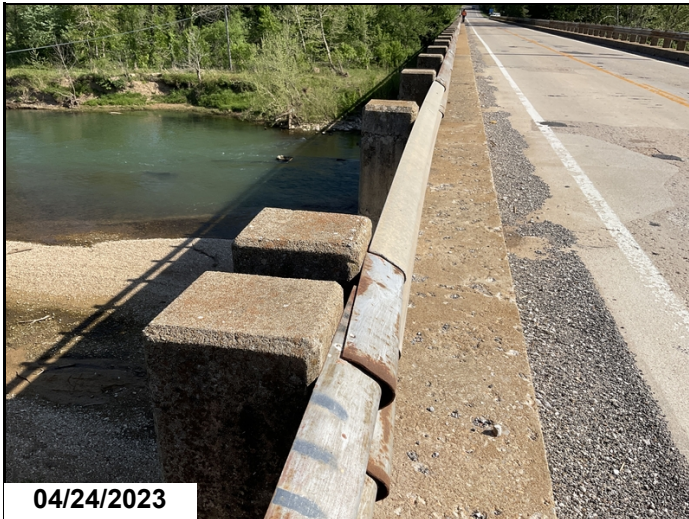
04/24/2023

Railing right in span #11 railing has lost connection

Bridge Maintenance crews have made repairs to the right railing in span #11. 4/24/2023 WNR

Maintenance forces have repaired the end of span #11 right railing loose railing and broken post.

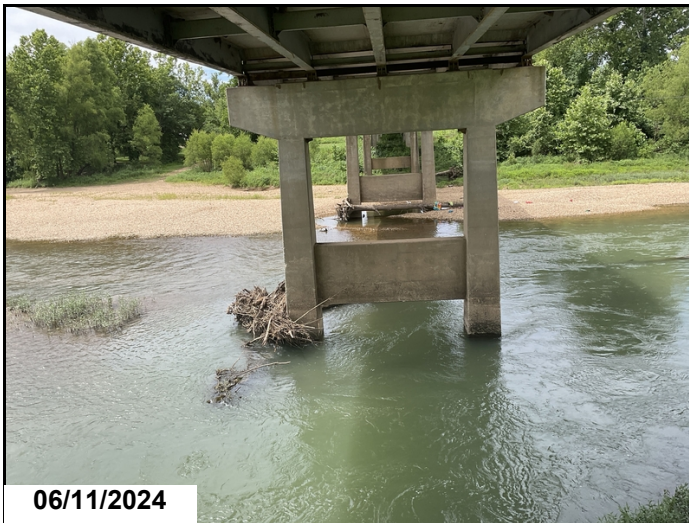
Drift accumulation causing scour at bent #9 .

Drift accumulation on bent #9.

Type of Work: Channel Work/Drift Removal

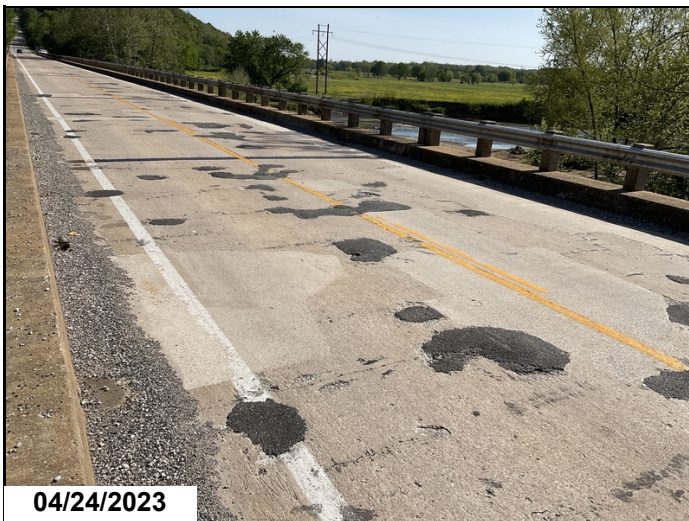
Spans #13 and #14 asphalt patches

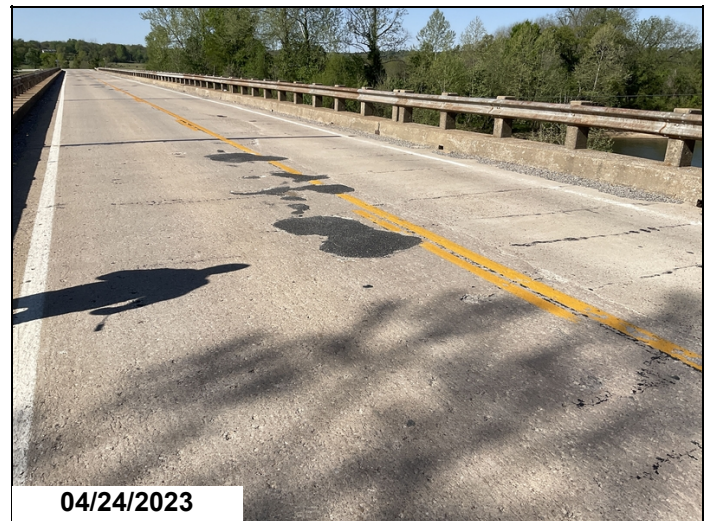
Span #8 asphalt patches

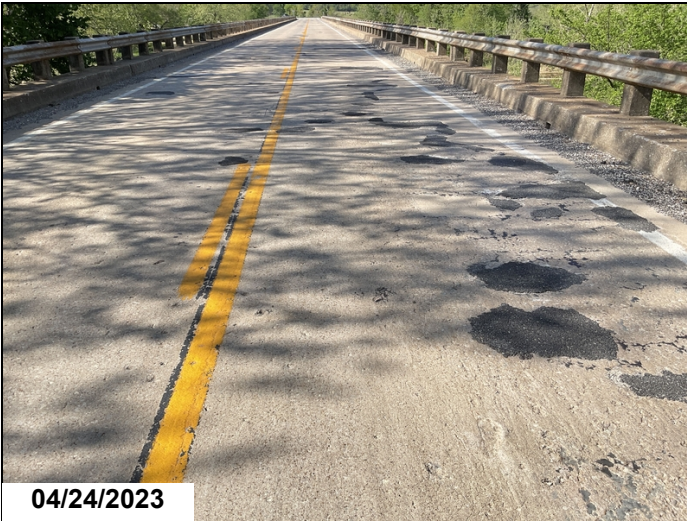
Span #6 asphalt patches

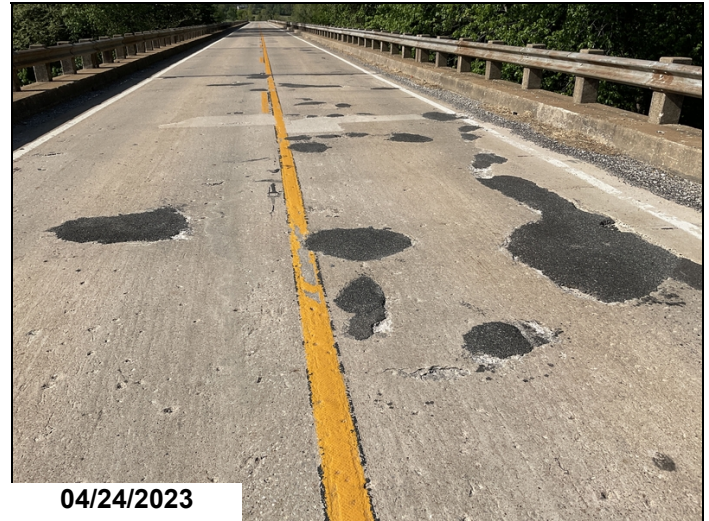
Span #2 asphalt patches

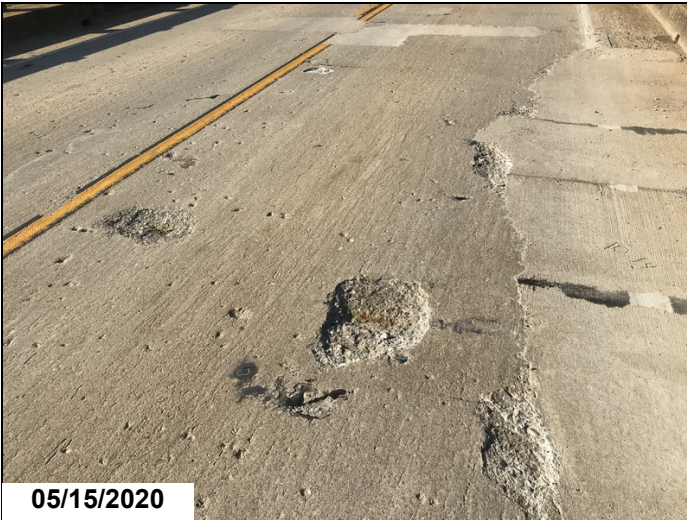
Span #2 right lane multiple spalls some with steel exposed.

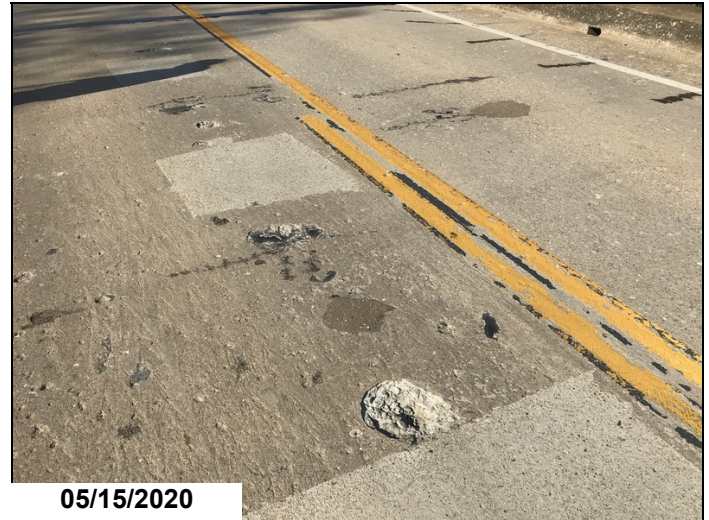
Deck span #13 left lane adjacent to centerline approximately 22' north of bent #13 basketball sized spall. Spall is approximately 2" deep at deepest point.

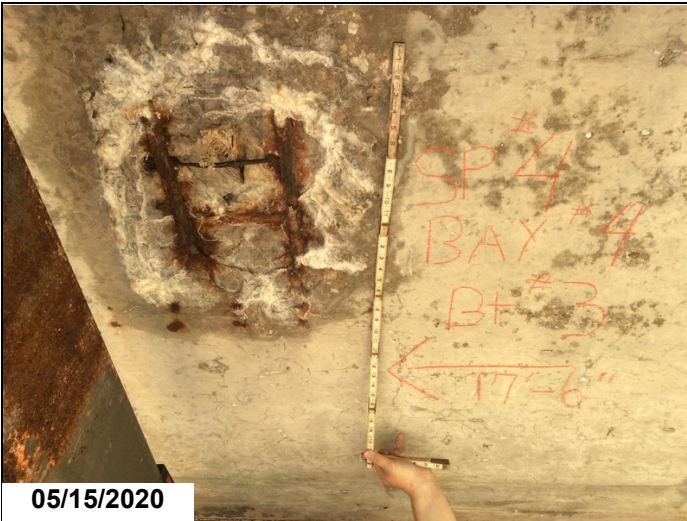
05/15/2020

Span #4, bay #4-Spall with exposed reinforcing steel in undersurface of deck.

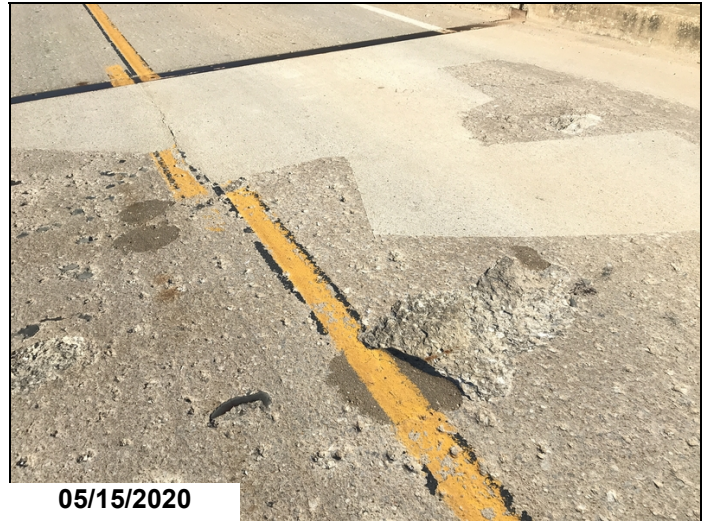
05/15/2020

Deck Span #11 right lane adjacent to centerline spalling with steel exposed approximately 10' north of bent #3.

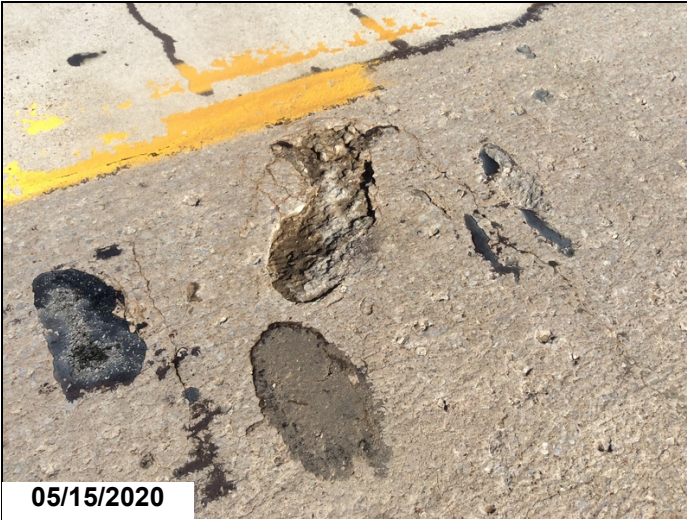
05/15/2020

Span #7-Spalling.

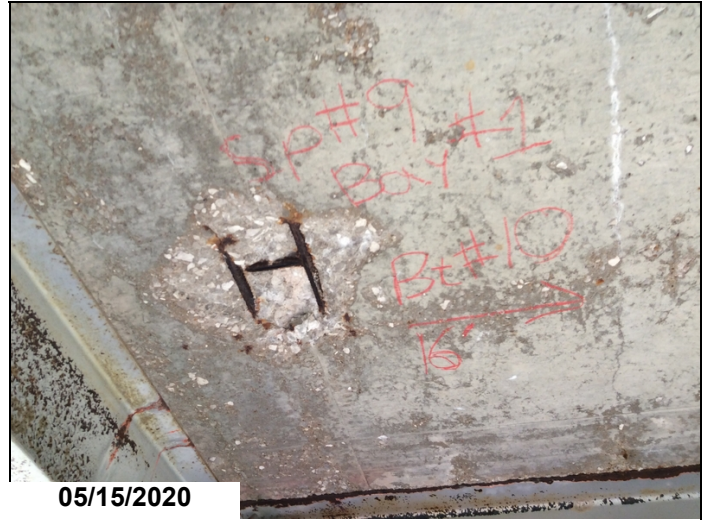
05/15/2020

Span #9, bay #1-Spalling with exposed reinforcing steel.

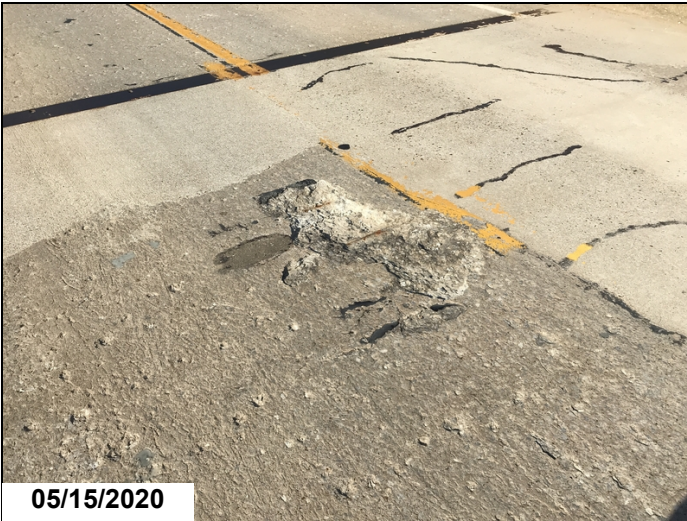
Deck span #10 left lane adjacent to centerline approximately 5' north of bent #10 large spall with steel exposed. Spall is approximately 3" deep at deepest point.

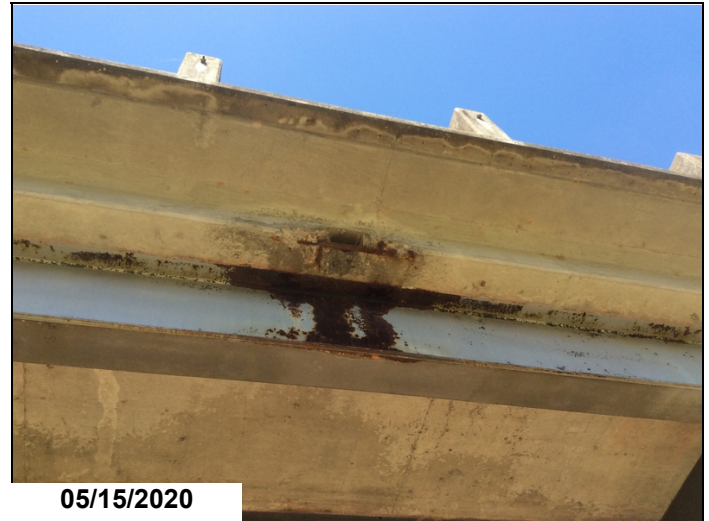
Typical spalling with steel exposed around deck drains.

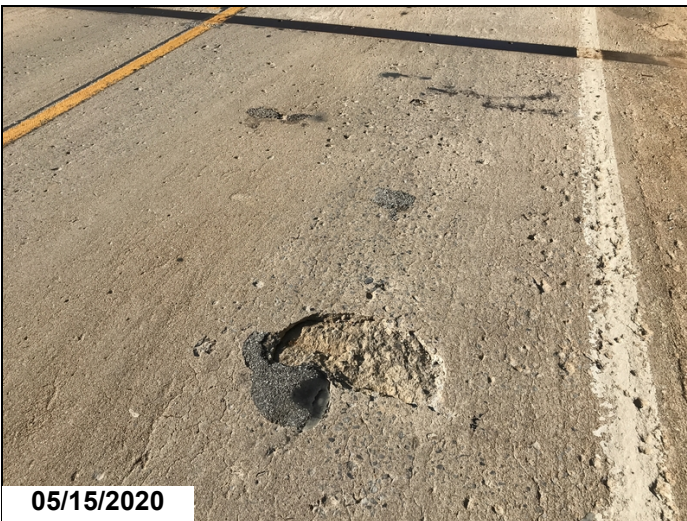
Deck Span #3 right lane spalling with steel exposed 10' north of bent #3.

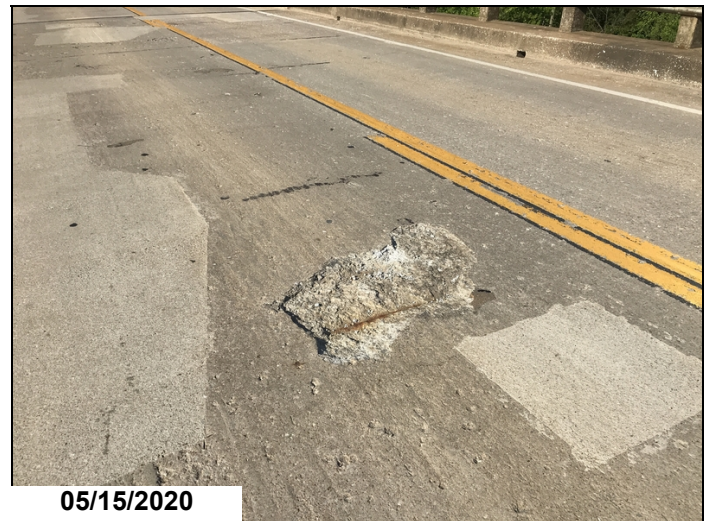
Deck span #12 left lane adjacent to centerline approximately 33' south of bent #11 large spall with steel exposed. Spall is approximately 1.5" deep at deepest point.

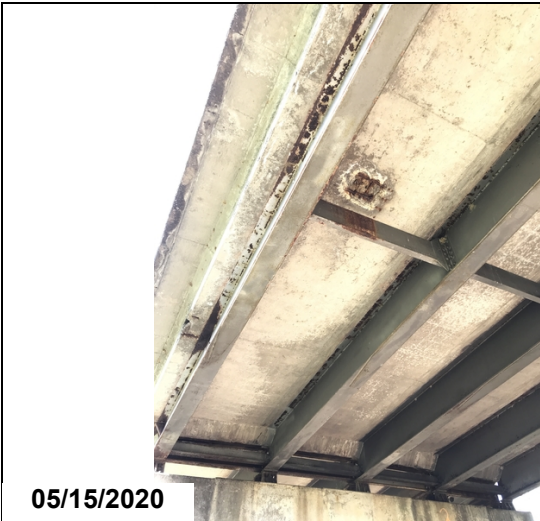
05/15/2020

Undersurface span #13 bay #1 approximately 16' behind bent #14 large deep spall with exposed steel with section loss.

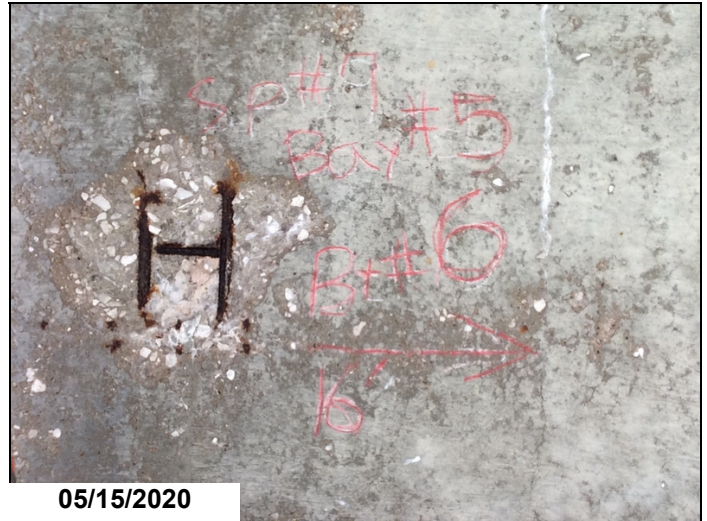
05/15/2020

Sp #7, bay #5, 16' ahead Bt #6 has a basketball sized spall with exposed reinforcing steel in undersurface of deck.

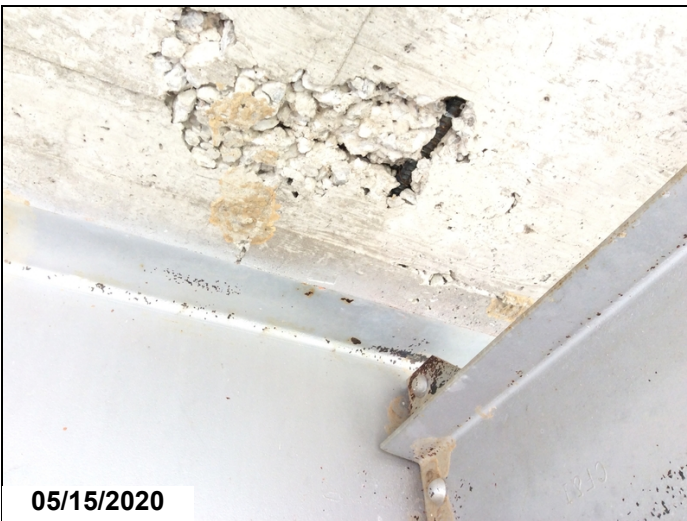
05/15/2020

Span #9 bay #3 approximately 16' from bent #9 - spalling steel exposed.

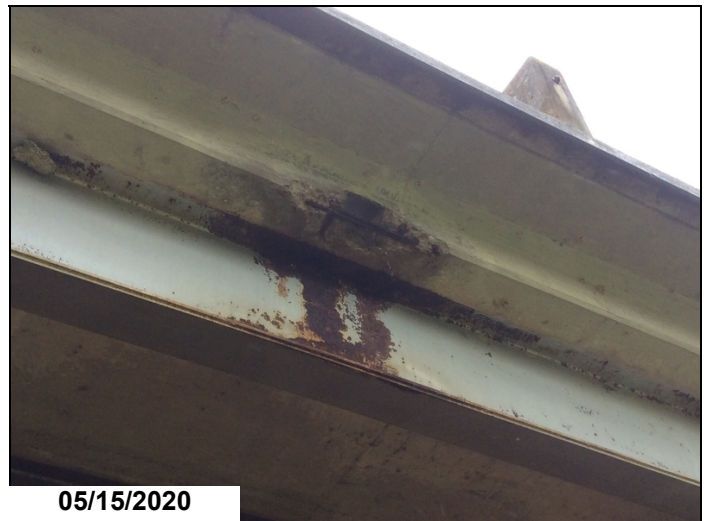
05/15/2020

Span #3, right side-Spalling with exposed reinforcing steel.
