Asset #05571(Routine, Underwater type 2)

SH 143 Carroll over KINGS RIVER

Location: 2.75 MI NW JCT HWY 62

Team Lead: Benjamin Smith Inspection Date: 04/19/2022

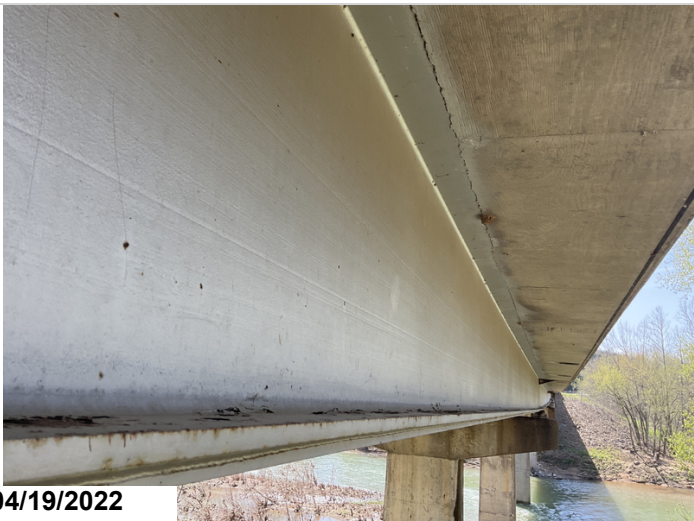
Paint condition on the exterior beams.

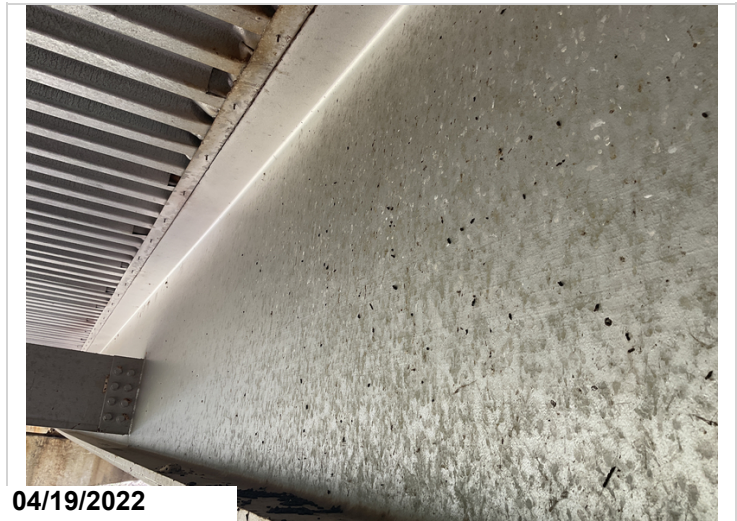
Paint condition on the interior beams.

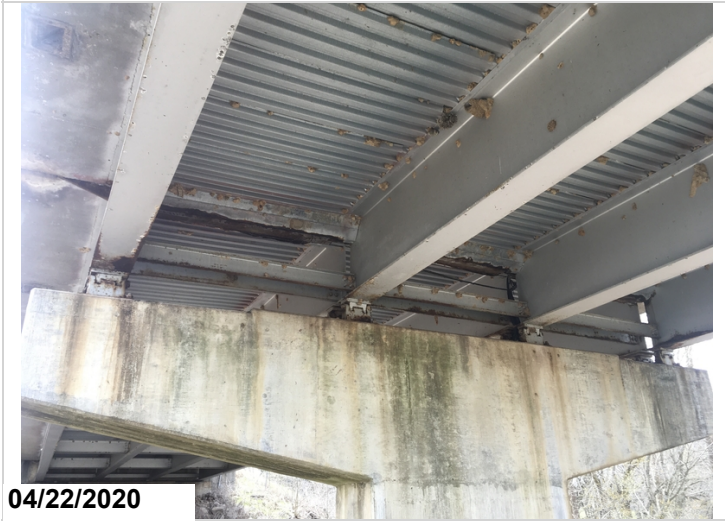
General condition of the beam ends at pier #1.

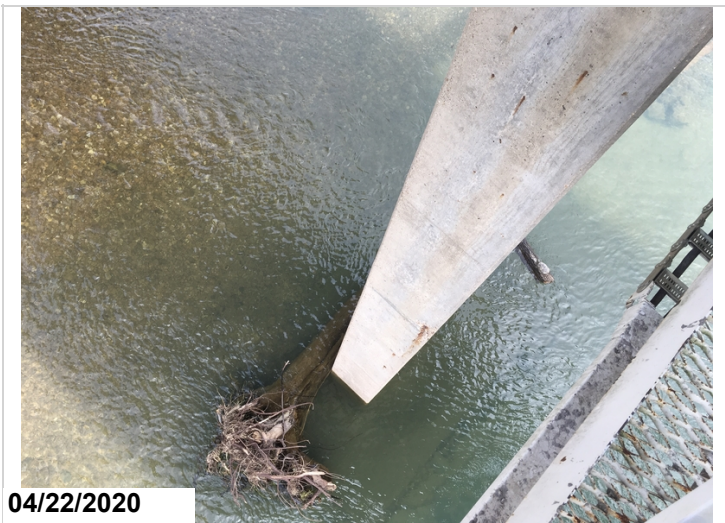
Spall with rebar exposed on the left face of pier column #2.

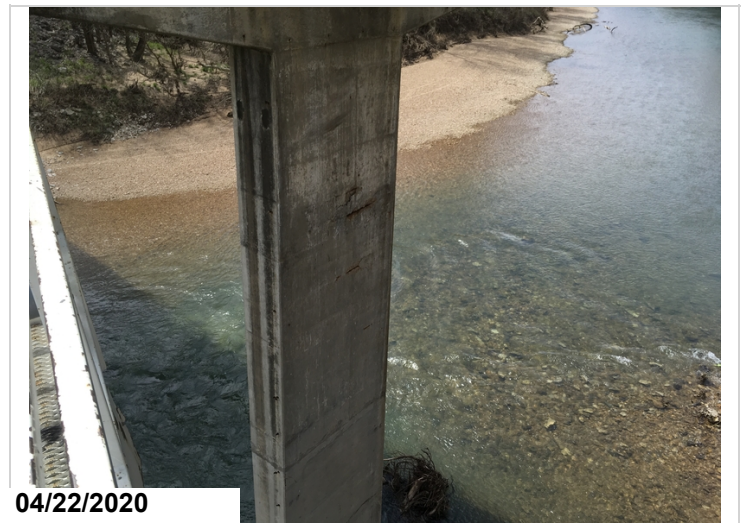
Spalling with rebar exposed on the span #3 side of pier column #2.

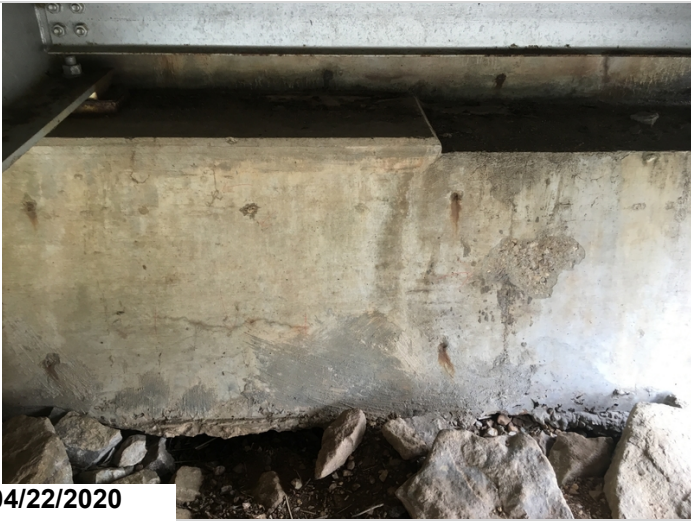
Area of map cracking with a shallow spall in bay #1 of abutment #1.

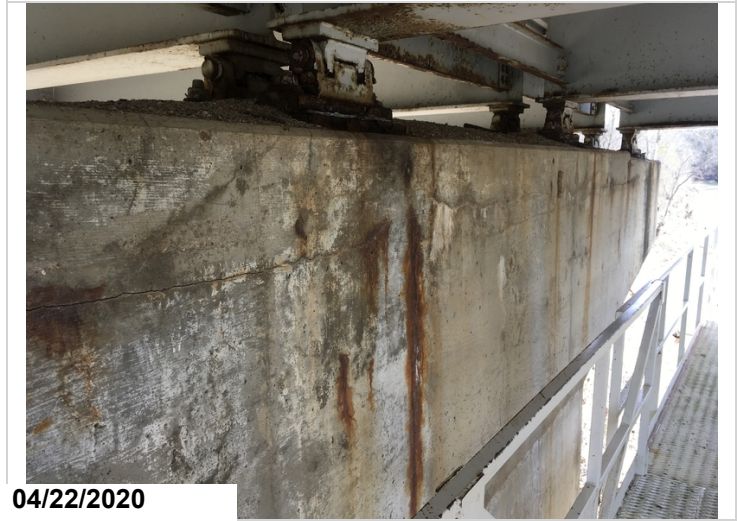
Pier cap #3 condition. Showing horizontal cracking for the full length. This area does not sound hollow under hammer blows.

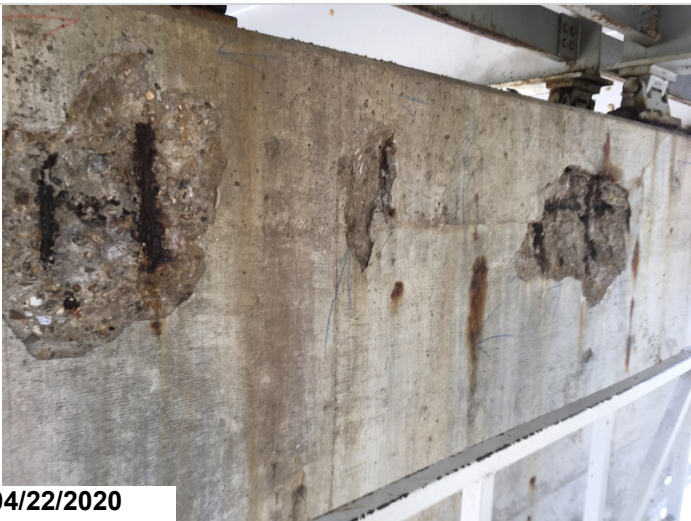
Spalling with rebar exposed on the span #1 side of pier cap #1.

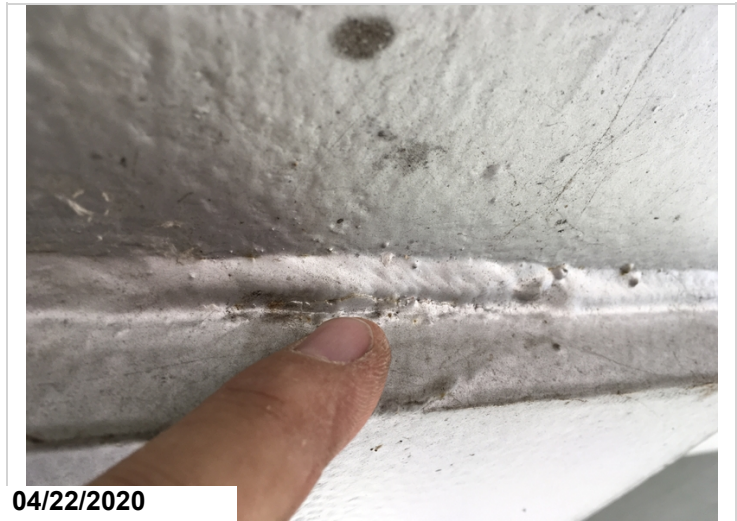
Possible crack or slag inclusion at the end of the cover plate on beam #3 span #5 at the beginning of the plate. Will monitor.

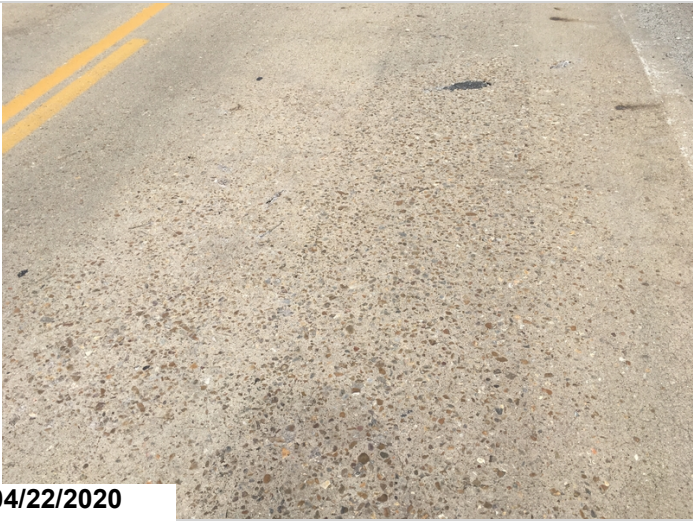
driving surface condition. Showing moderate wear. The driving surface has numerous areas of shallow delamination also.

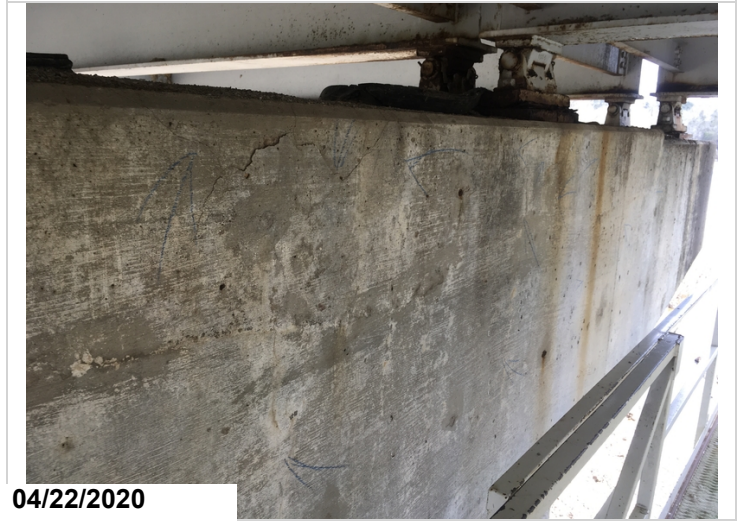
Pier #2 cap condition. Showing cracking and one small delamination.

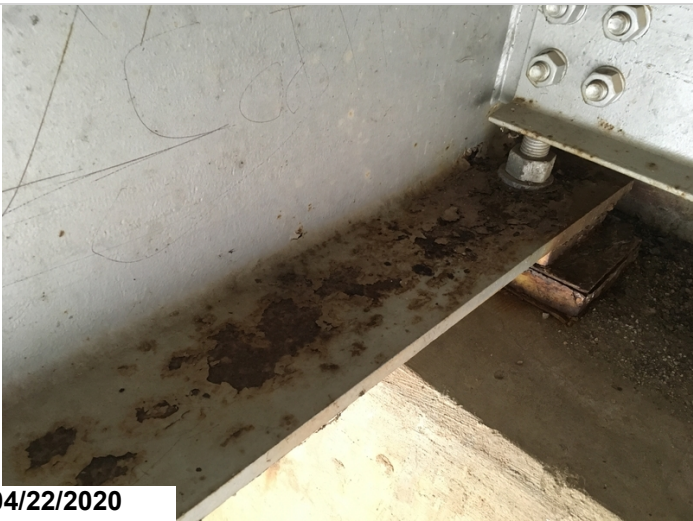
2' of corrosion on the top of the bottom flange of beams 1-4 at abutment #1.

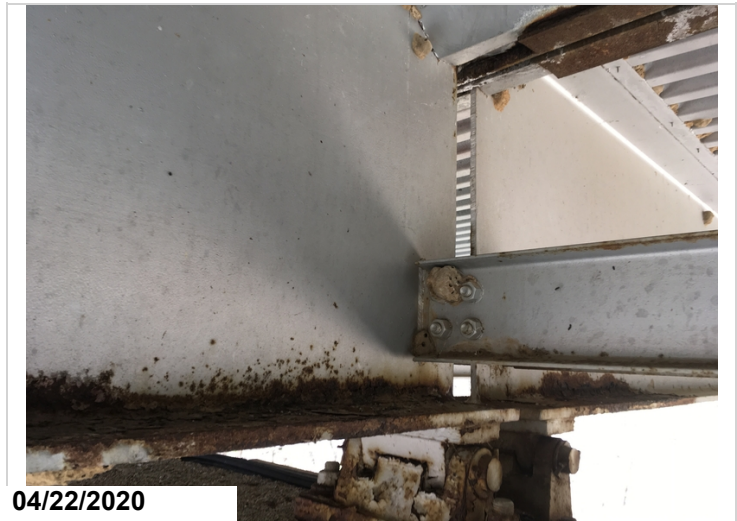
Beam end condition of beam #2 at pier #2. Typical.

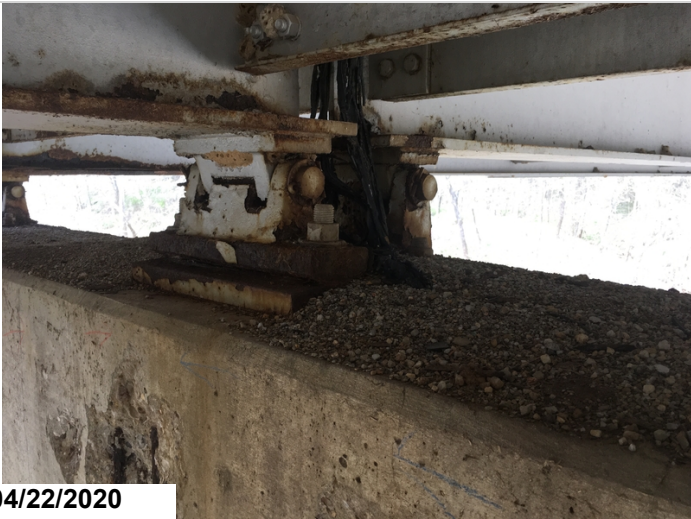
bearing condition at pier #1. Typical of all 4 moveable and all 4 fixed at this location. Note the build up on the cap due to missing joint seal.

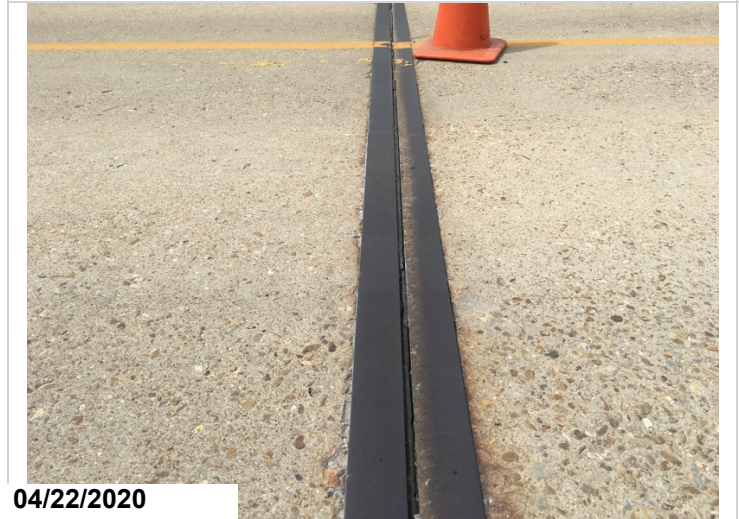
Joint seal over pier #2 is nearly adjacent.

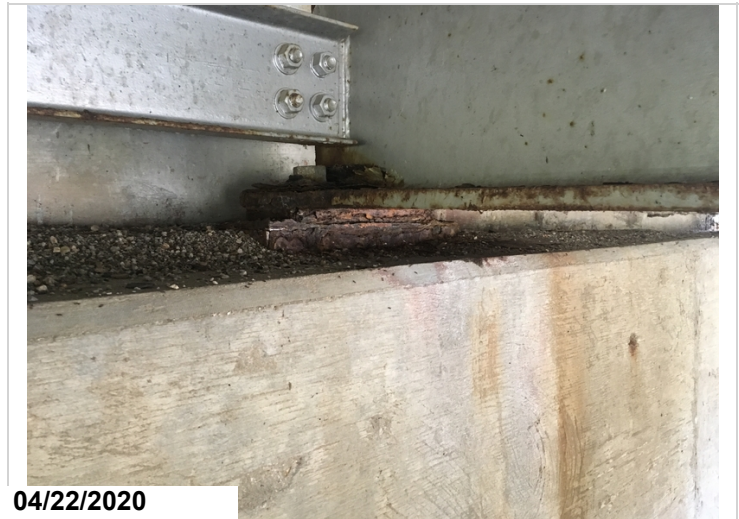
Fixed bearing condition at abutment #2. All 4 have heavy corrosion with flaking rust.

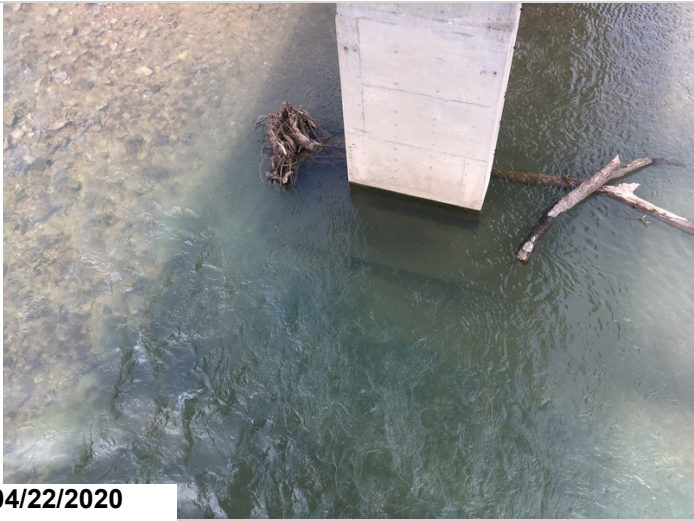
The top of the pier #2 footing is entirely exposed with 4" of vertical face exposed.

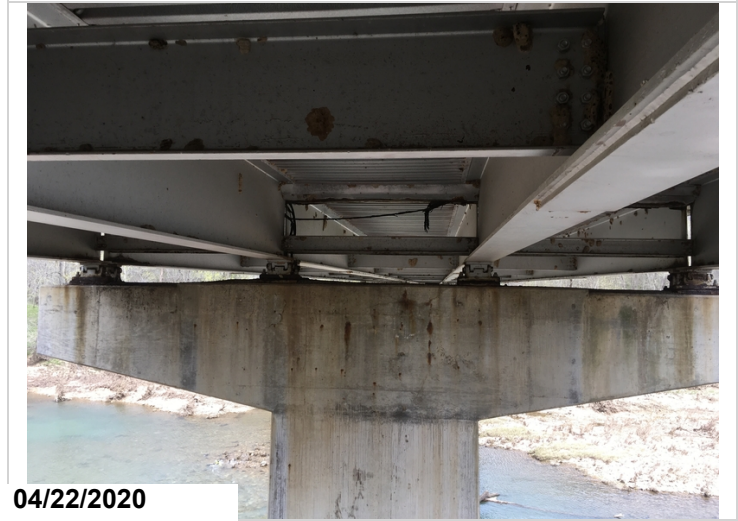
Pier #1 cap condition. Note the joint seal hanging in bay #2.

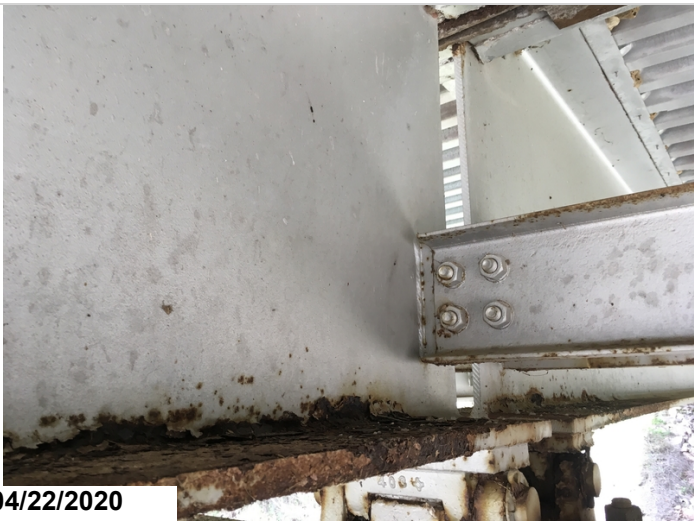
Beam end condition of beam #2 at pier #4. Typical of beams #2,3. Worst case condition at this location.

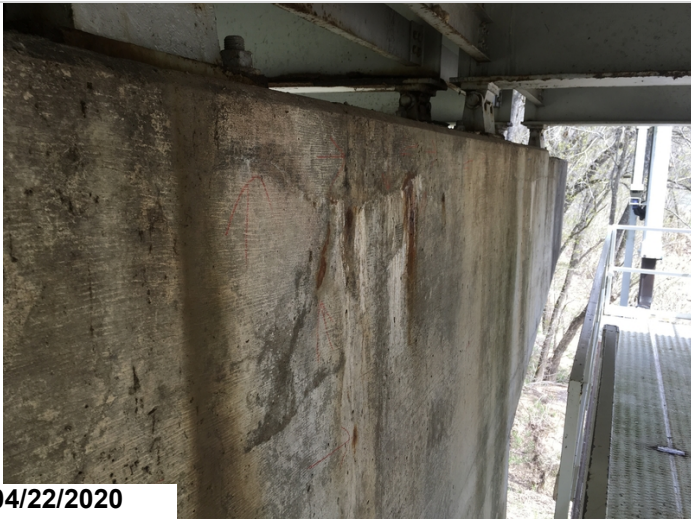
Pier #4 cap condition. Showing horizontal cracking that has begun to leach efflorescence and rust staining.

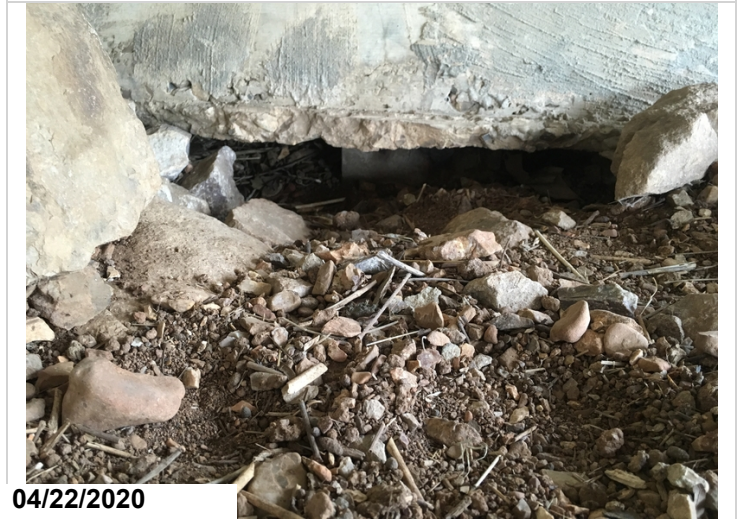
A steel pile is exposed under beam #2 at abutment #1.

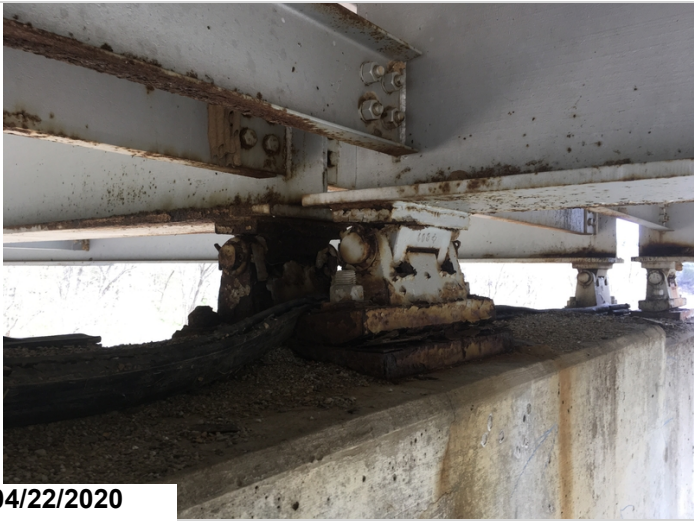
Bearing condition at pier #2. Typical of all 4 fixed and all 4 moveable bearings at this location. Note the joint seal on the cap.

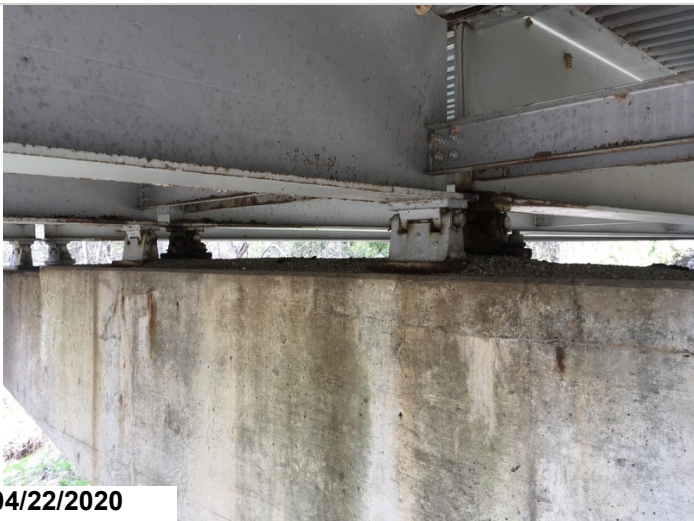
Bearing condition at pier #4. Typical of all 4 moveable and all 4 fixed bearings at this location.

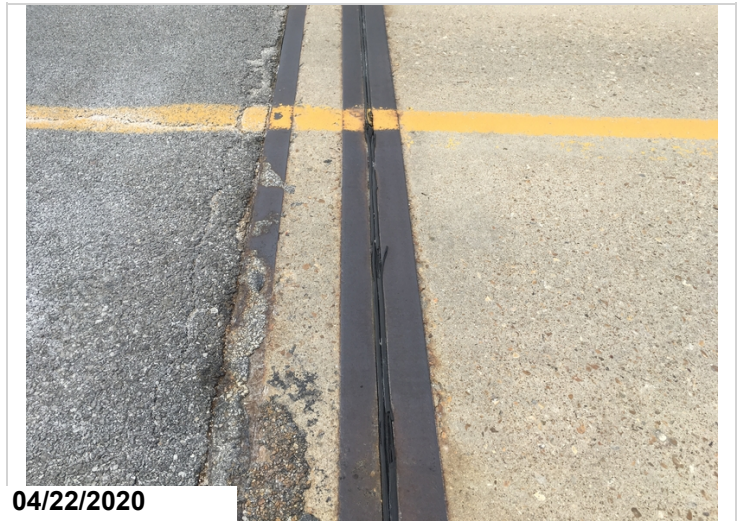
Abutment #1 compression joint seal condition. Showing cracking.

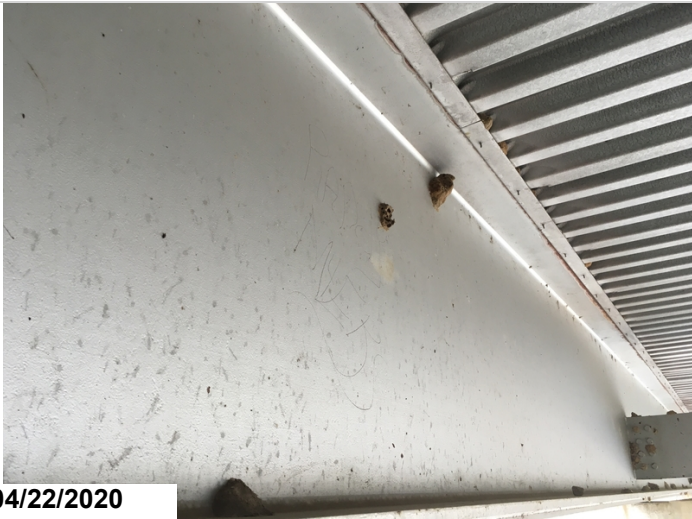
Typical paint condition of the superstructure. Loss of gloss with no chalking.

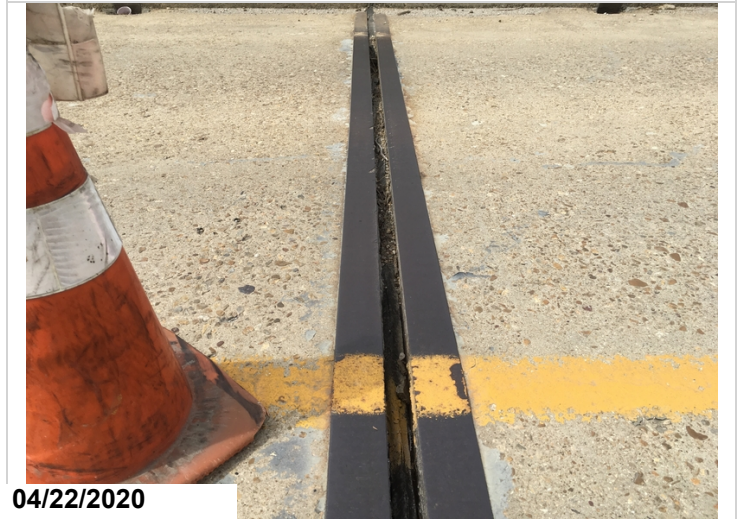
Dislodged joint seal condition. Typical over the piers.

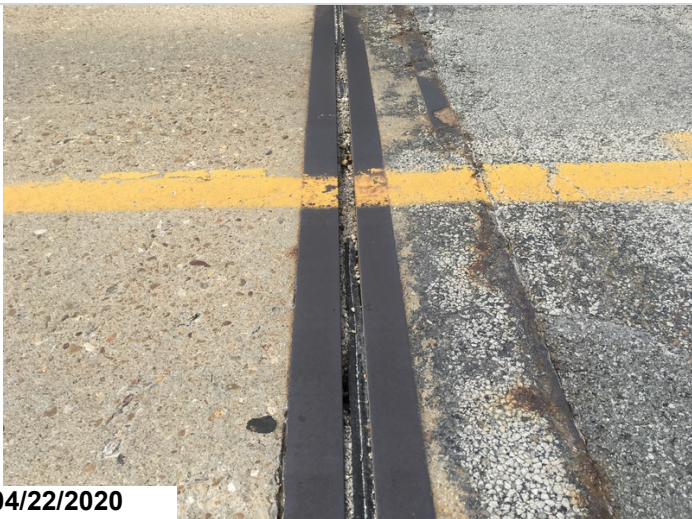
Compression joint seal condition at abutment #2. Showing loss of adhesion and debris impactation.

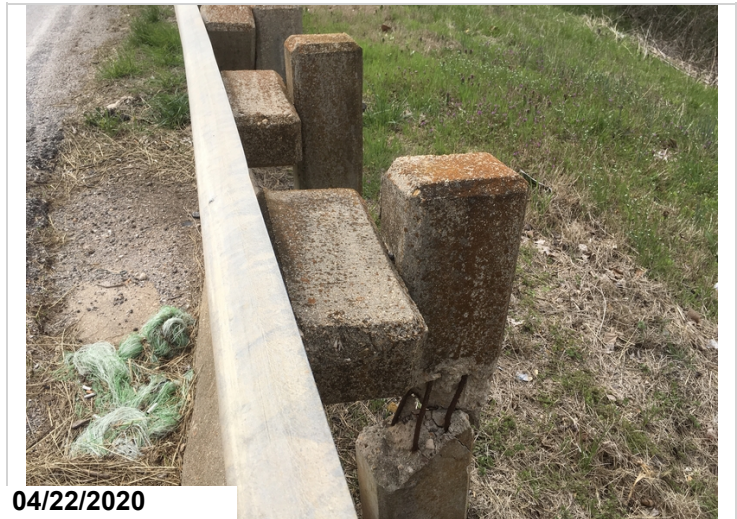
Concrete post damage at the left beginning transition railing.

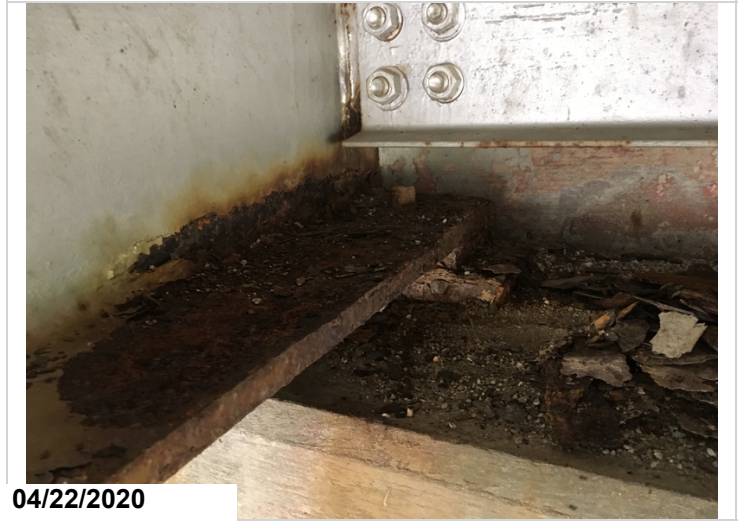
Heavy corrosion and the anchor bolt nut is missing at beam #3 abutment #2.

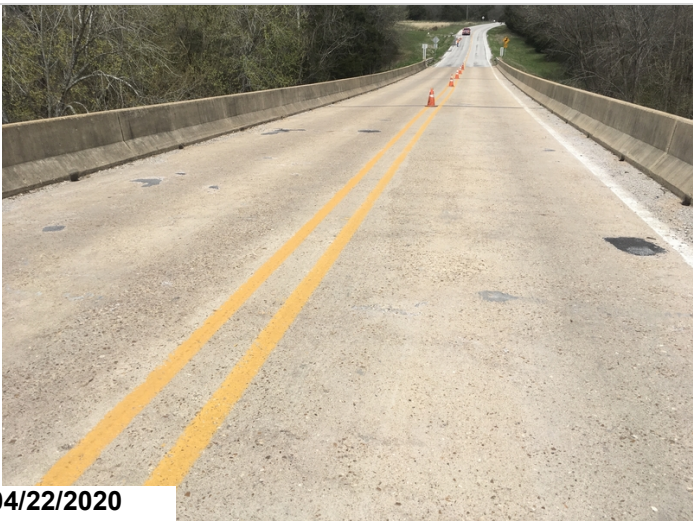
Pot holes and delamination in both lanes of span #3.

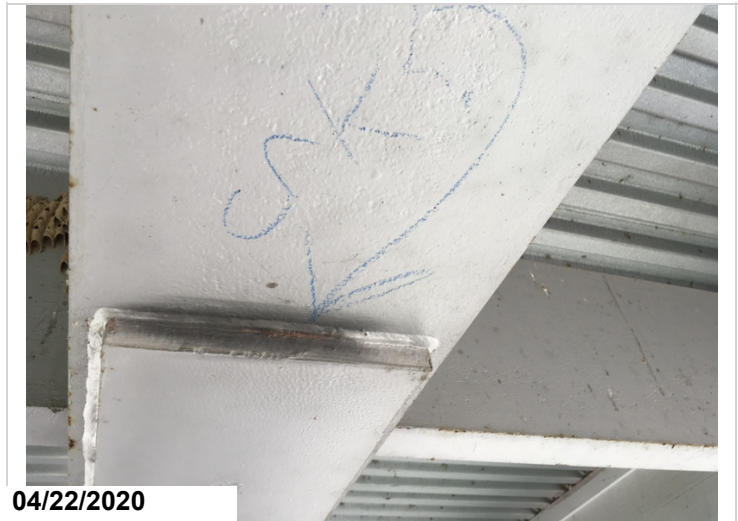
Possible crack or slag inclusion at beam #3 span #5 at the beginning of the cover plate. Will monitor.

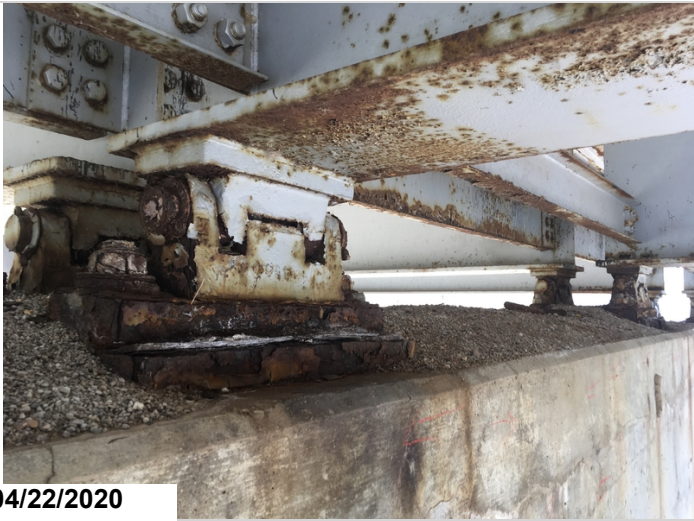
Bearing condition at pier #3. Typical of all 8 moveable bearings at this location.

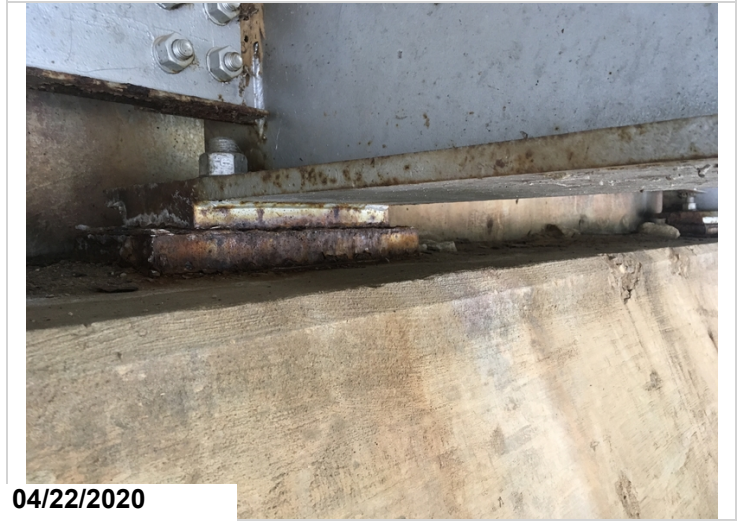
Fixed bearing condition at abutment #1. Typical of all 4 at this location.

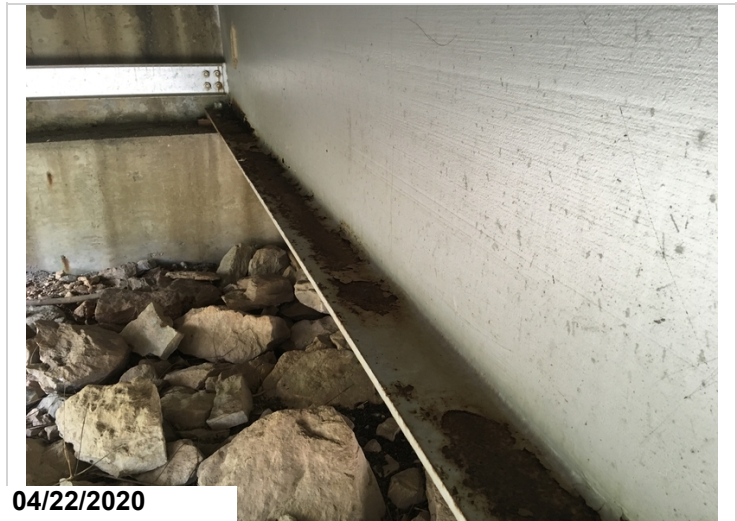
Corrosion on the top of the bottom flange of beam #2 at abutment #2 for 25'

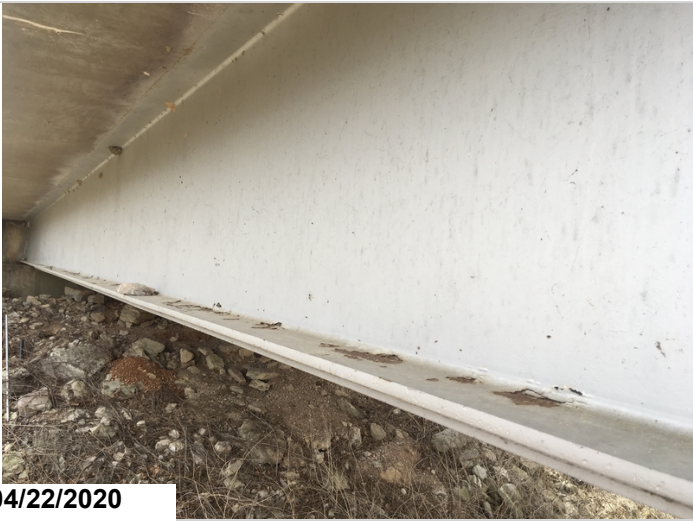
Flaking paint with general rusting on the bottom flange of beam #4 in span #1.

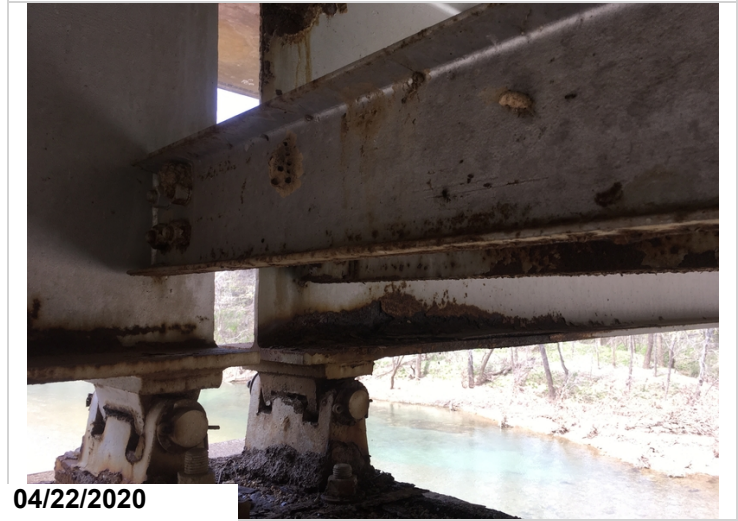
Beam end condition over pier #1. Typical of both outside beams 8' of corrosion. The inside beams have corrosion for 3'.

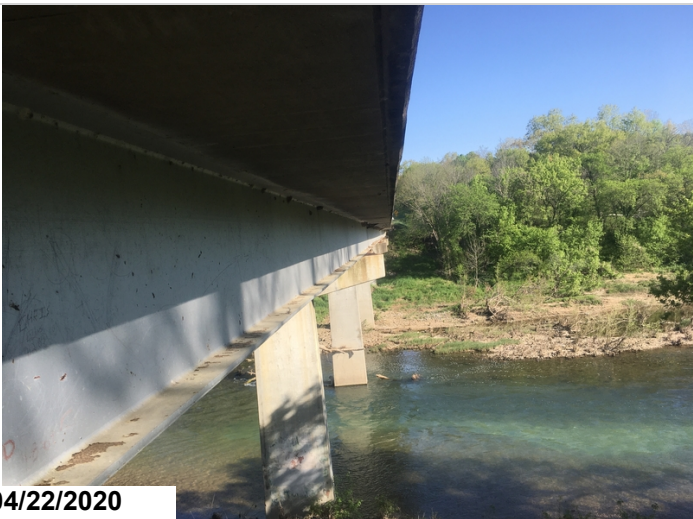
Corrosion on the top of the exterior bottom flange of beam 4 in span 1.

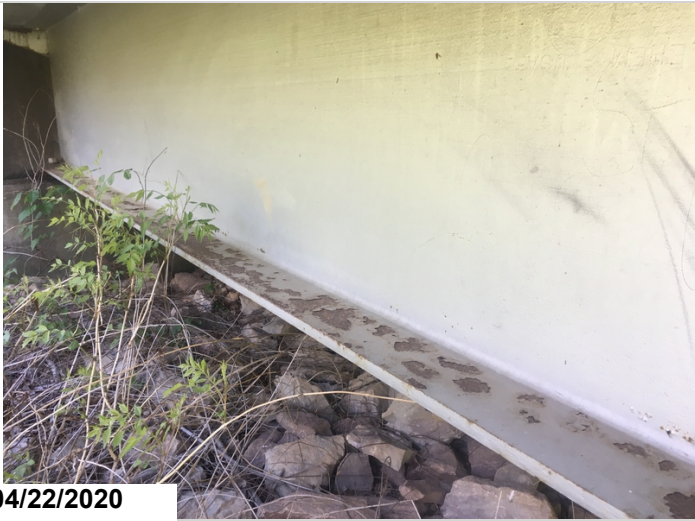
Flaking paint with minor corrosion on the exterior bottom flange of beam 1 in span 5.

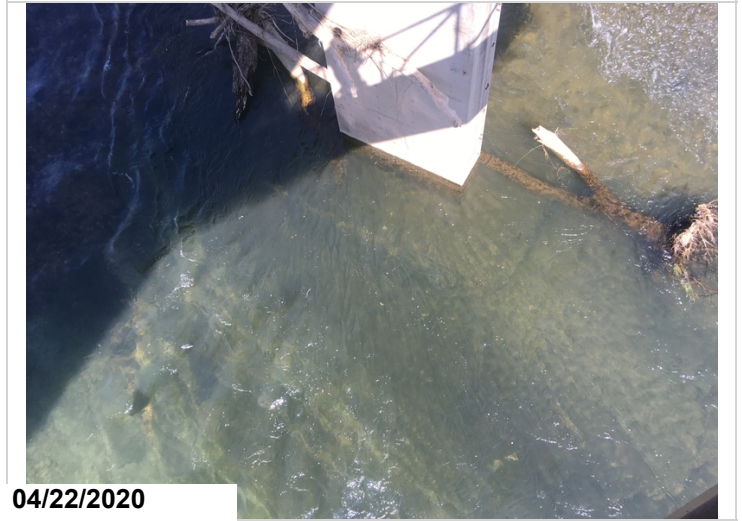
The top of the footing is exposed at pier 2. The footing is cast in solid rock.

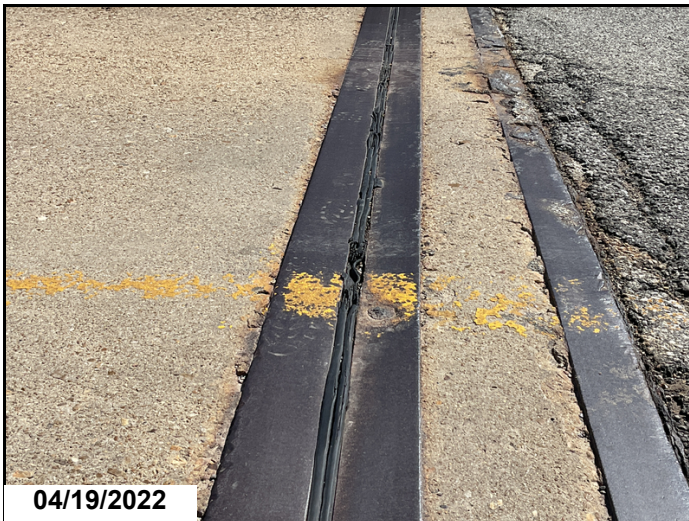
Sections of the joint seal are completely missing, other locations have sections that have lost adhesion and are leaking.

Abutment #1 joint seal condition

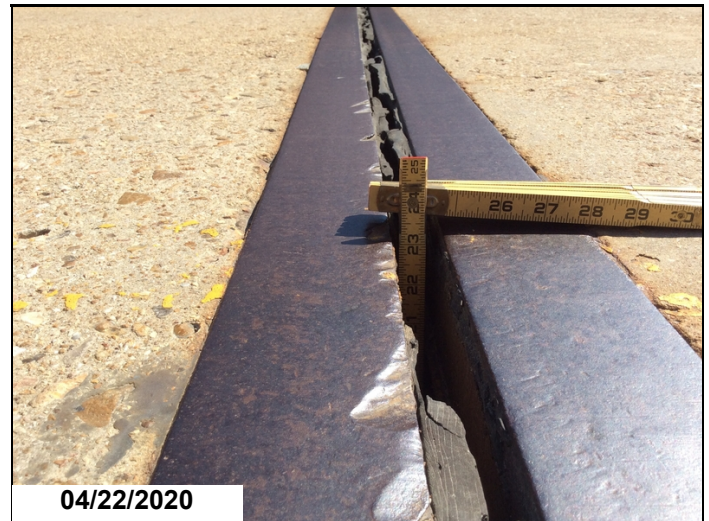
Joint seal at bents #1- #4 lose of adhesive with large portions missing.

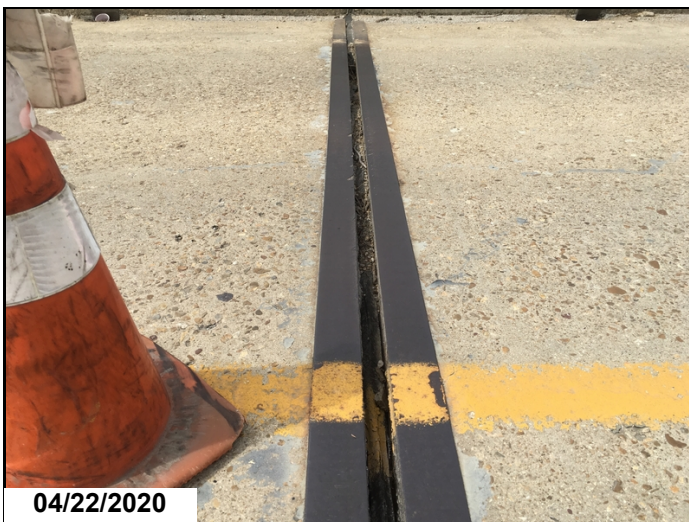
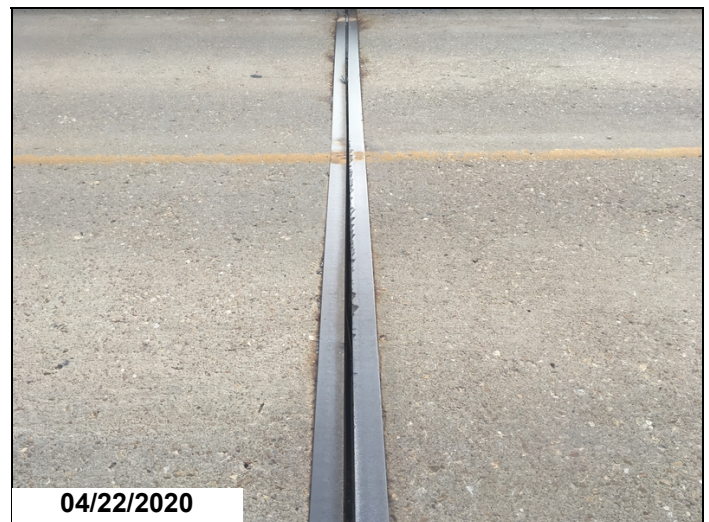
Pier 1 joint seal condition.

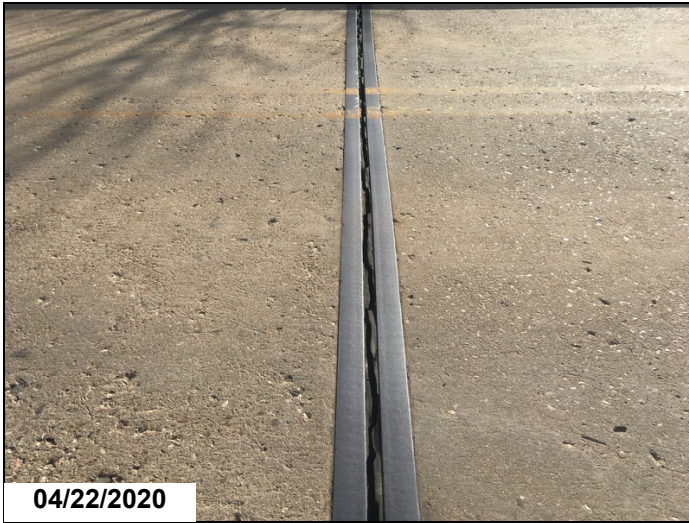
Pier 4 joint condition. Completely in cs4 leakage.

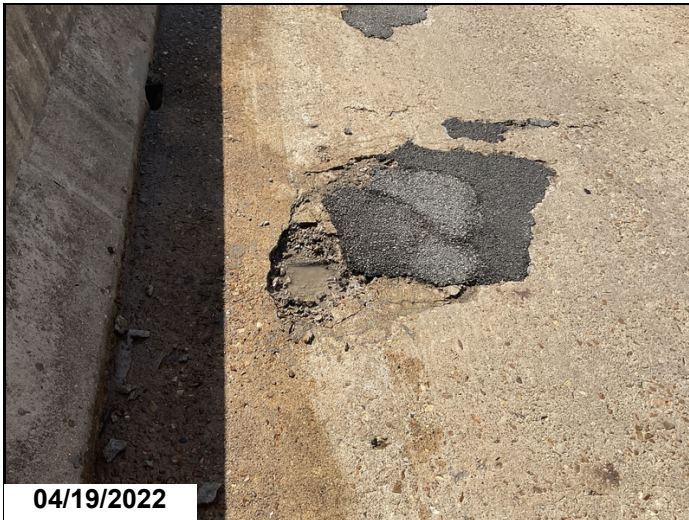
The driving surface of the deck has sealable cracks in all spans with shallow delaminations in span #1 and delaminations and potholes with exposed rebar in span #3.

Pot hole with exposed rebar in the right lane of span #3.

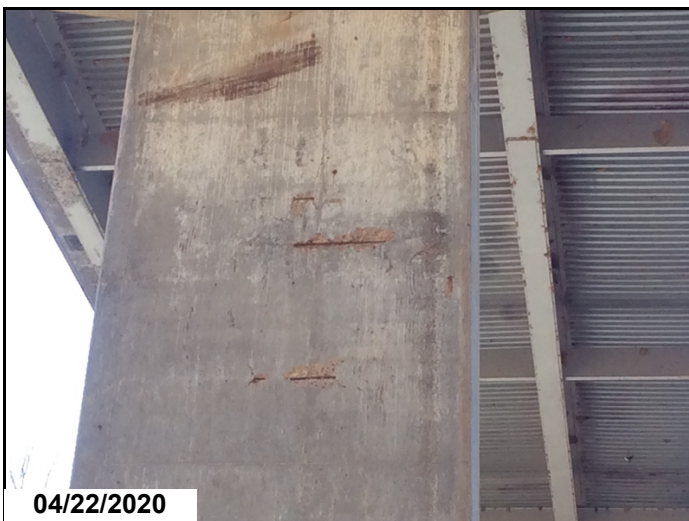
The vertical face of the pier #1 cap has spalls with rebar exposed on the span #1 side.
Large spalls with exposed rebar exist on the back side of the piers #2, #3 columns 15' down from cap on the span #3 side., large delaminations are also present in the same area.

Exposed rebar back side bent #2 column

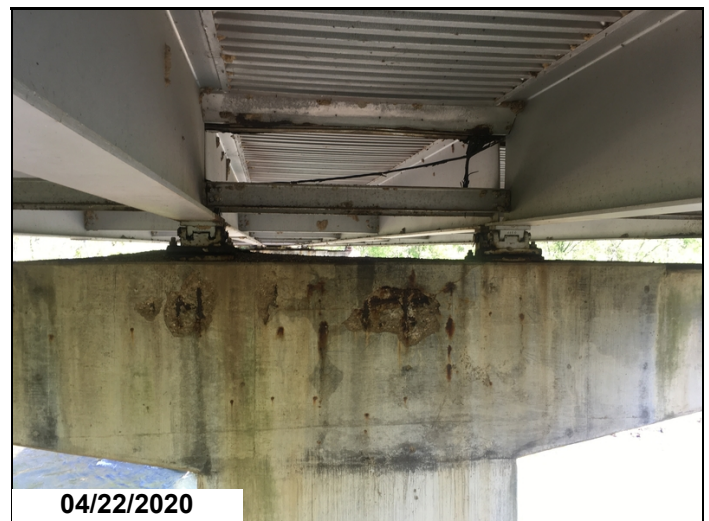
Spalling on the span 1 side of the cap with rebar exposed. Note the joint seal condition.

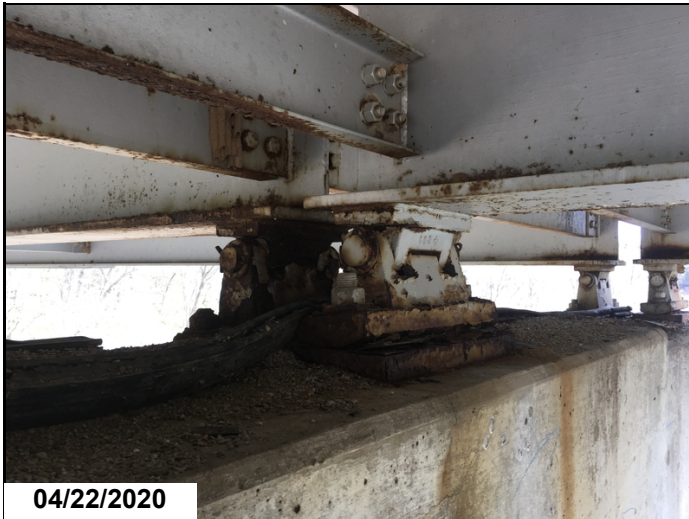
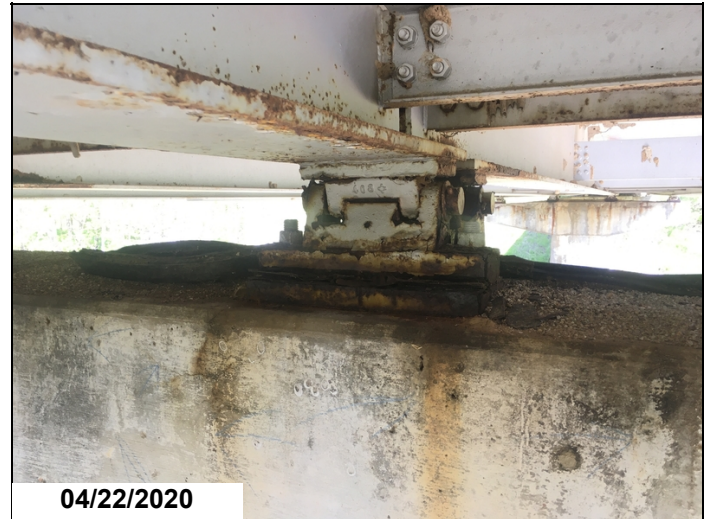
All moveable and fixed bearings have corrosion with flaking rust and/or pack rust due to leaking joint seals. Beam #3 at the beginning of span #4 has 1/16" section loss for 5'. The superstructure has numerous areas of cs3 corrosion throughout, especially at the ends of the spans.

Bearing and beam end condition at pier 2. Note the joint seal and build up on the cap.

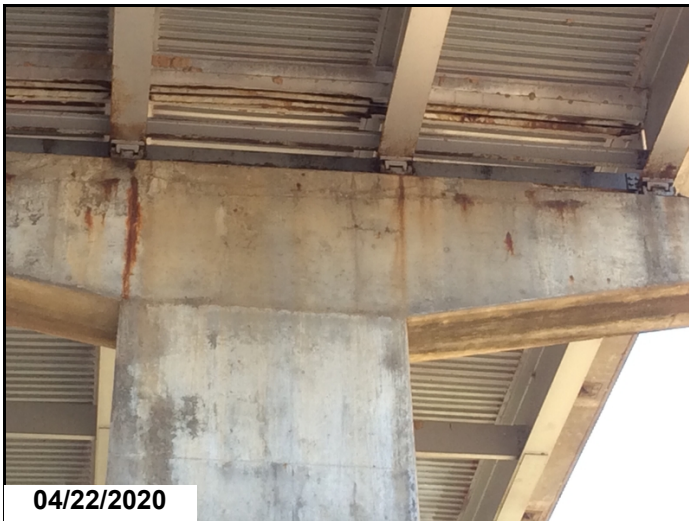
The cap of piers #3,4 have a large horizontal rust stained crack on the vertical faces with areas of delamination.

Ahead side of bent #3 cap rust stained cracking under girders #2 and #3

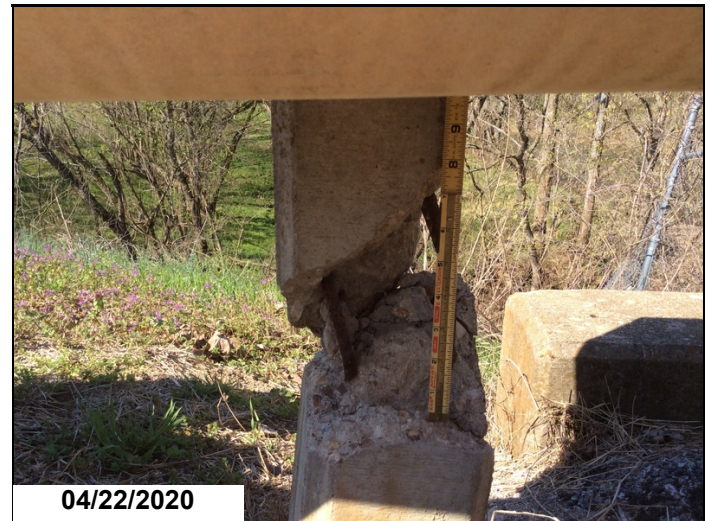
The 8th and 11th approach guard rail post on the left side is broken with exposed rebar due to vehicle damage.

Beginning bridge 2nd guardrail post left side broken

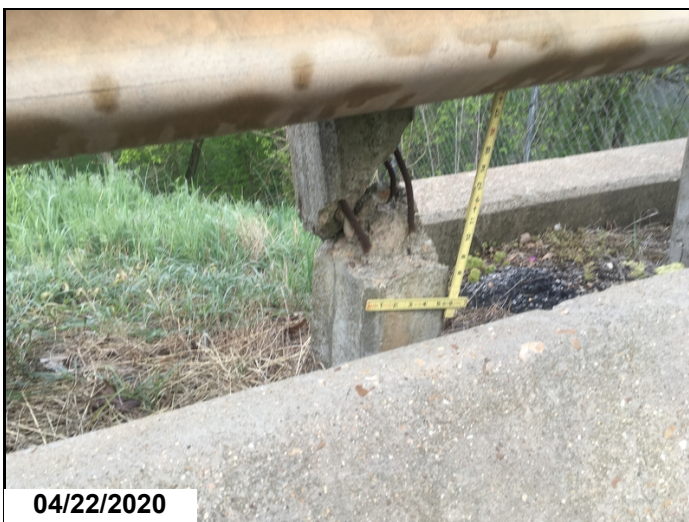
Concrete approach railing post is damaged at the left beginning of the structure.
