Asset #05883(Routine)

SH 143 Carroll over FLAT ROCK CREEK

Location: 5.80 North of JCT of US 62&SH143

Team Lead: Benjamin Smith Inspection Date: 04/23/2024

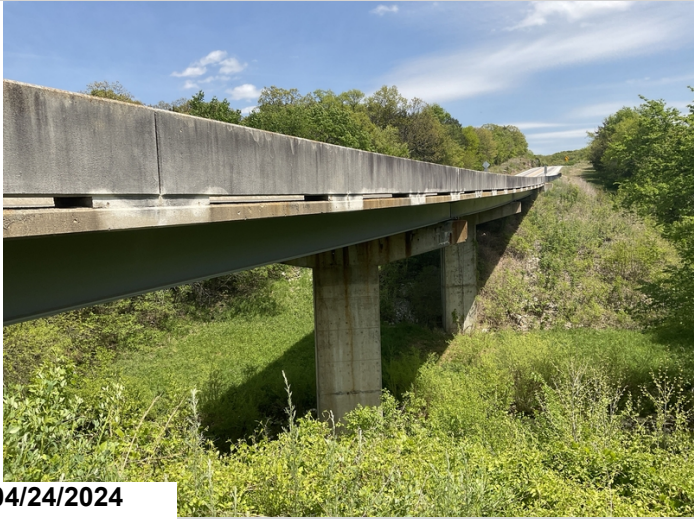
Elevation view.

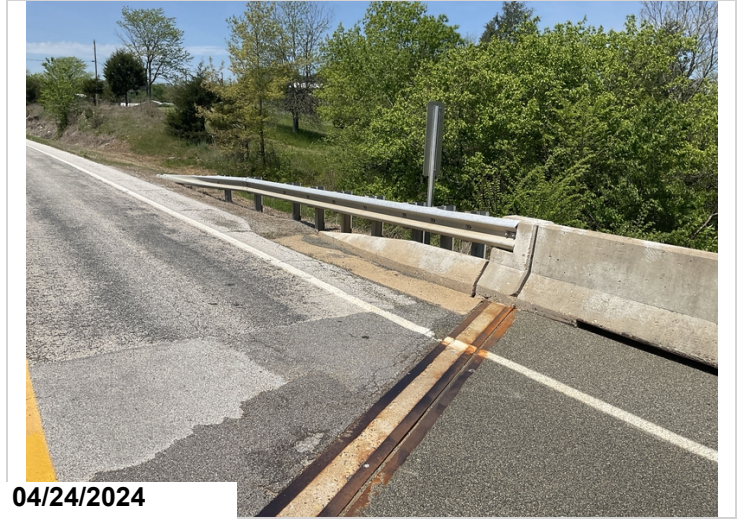
Transition area.

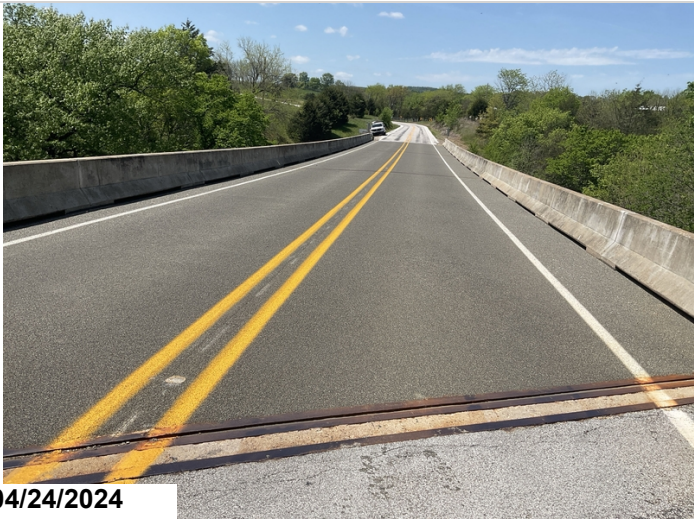
Driving surface view.

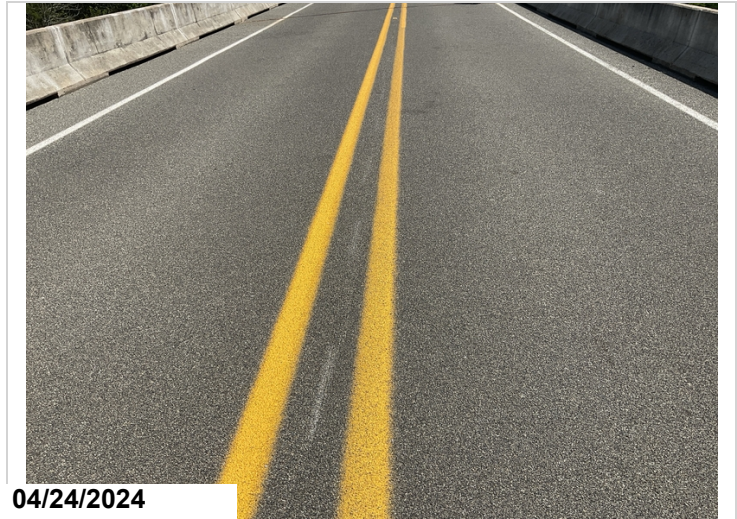
The deck has a polymer overlay with no deficiencies.

New polymer overlay condition.

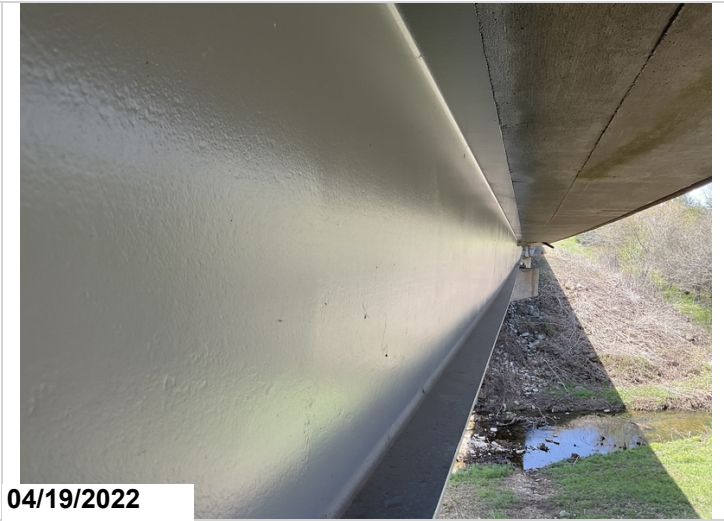
The superstructure was repainted under contract in 2016. Cs2 corrosion is bleeding through at the bearings.

General view of the paint condition

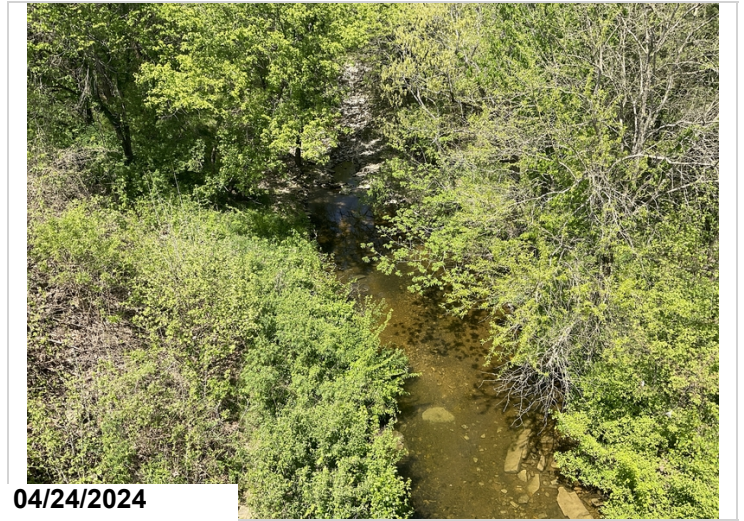
The upstream channel is vegetated. The banks have minor erosion.

Upstream channel view.

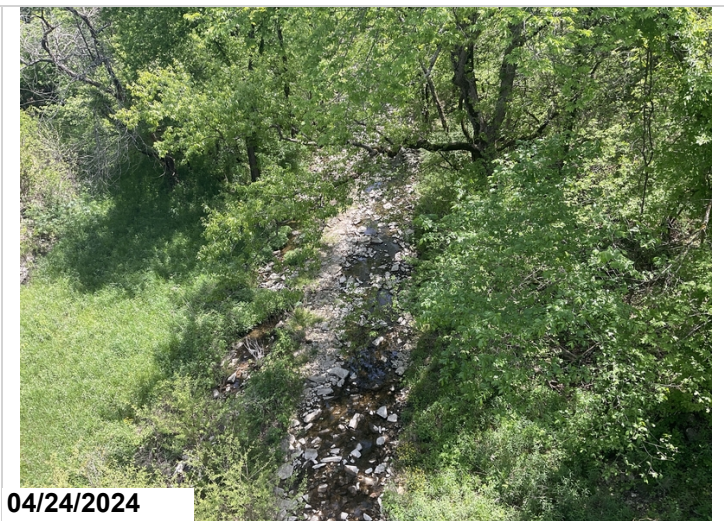
The downstream channel is vegetated. The banks have minor erosion.

Downstream channel view.

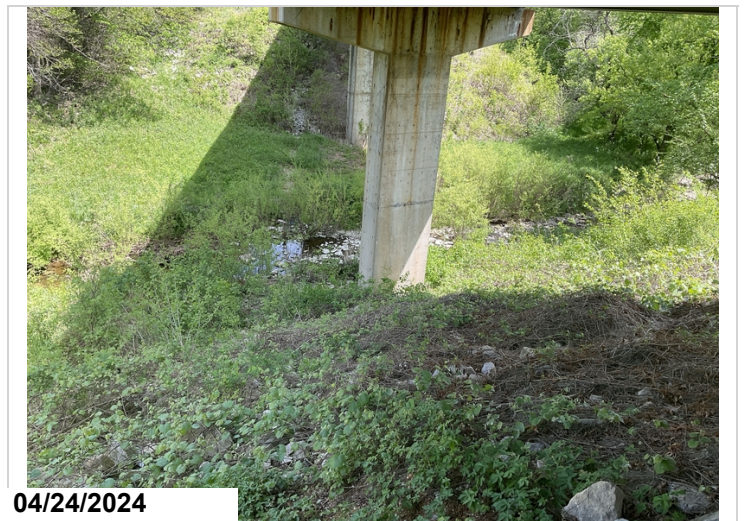
The channel beneath the structure has minor erosion on the banks. No significant scour was noted.

Channel beneath the structure.

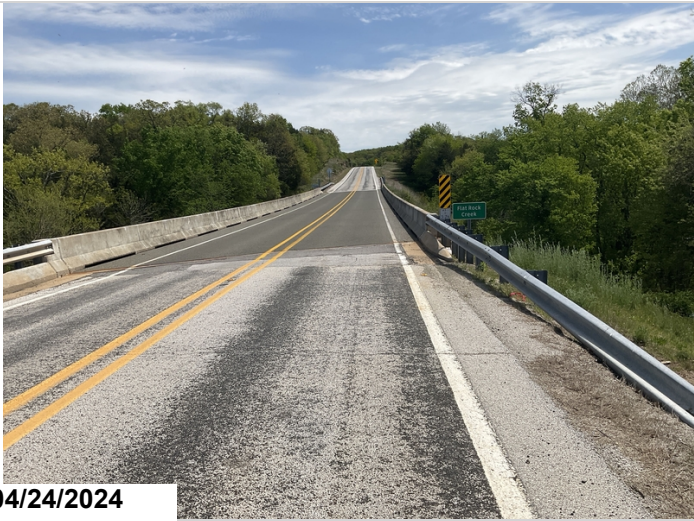
Approach view in direction of log mile.

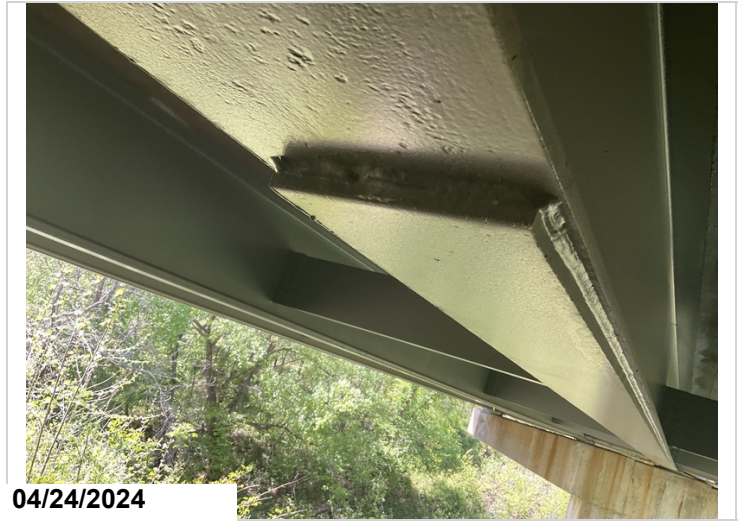
E detail. Bottom flange cover plates.

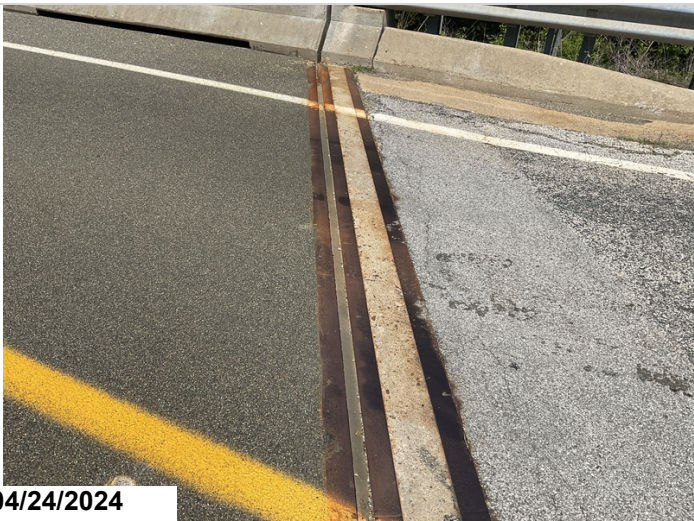
Abutment #2 seal condition. no deficiencies noted.

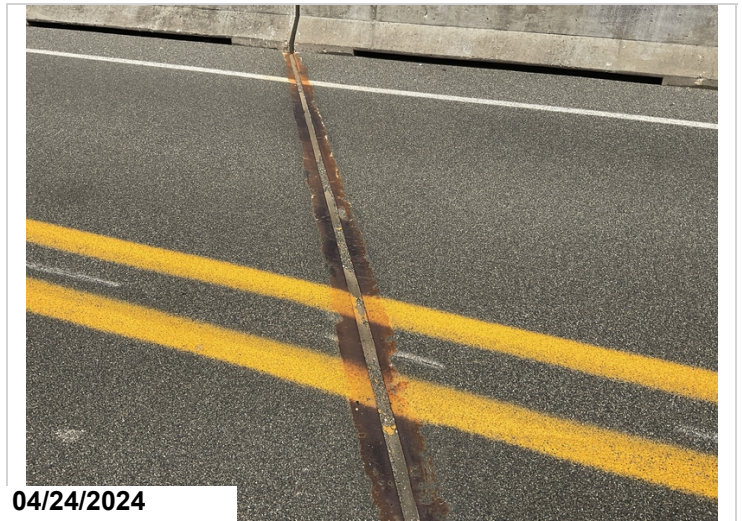
Pier #2 seal condition. no deficiencies noted.

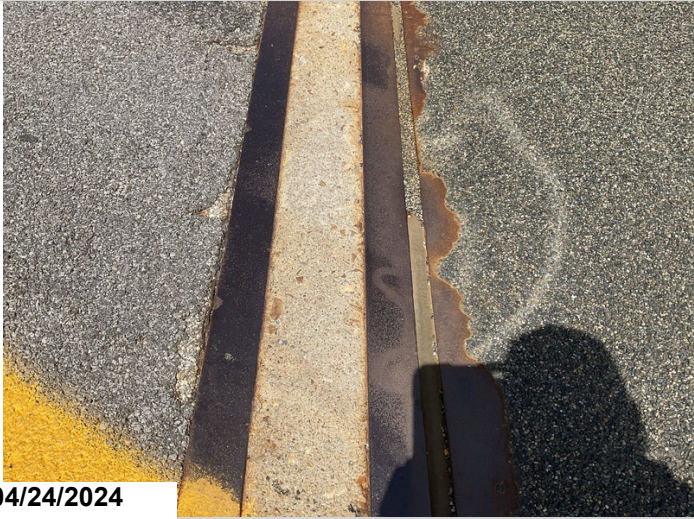
Abutment #1 pourable seal condition. no deficiencies noted.

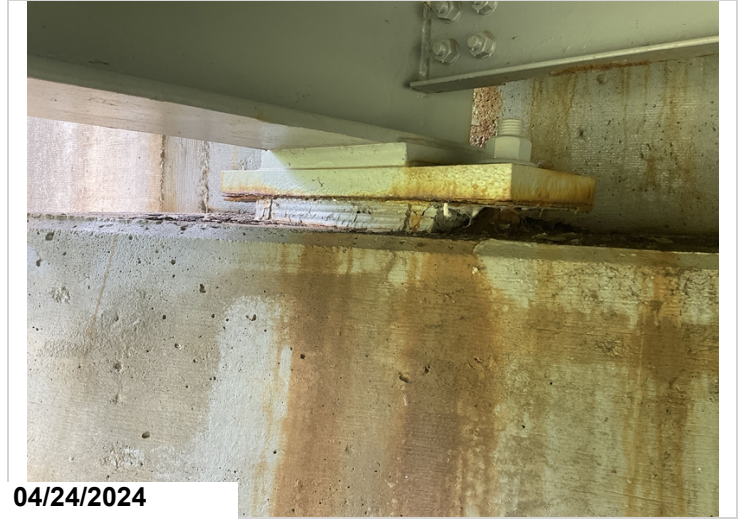
Cs3 corrosion on bearing #4 at abutment #1.

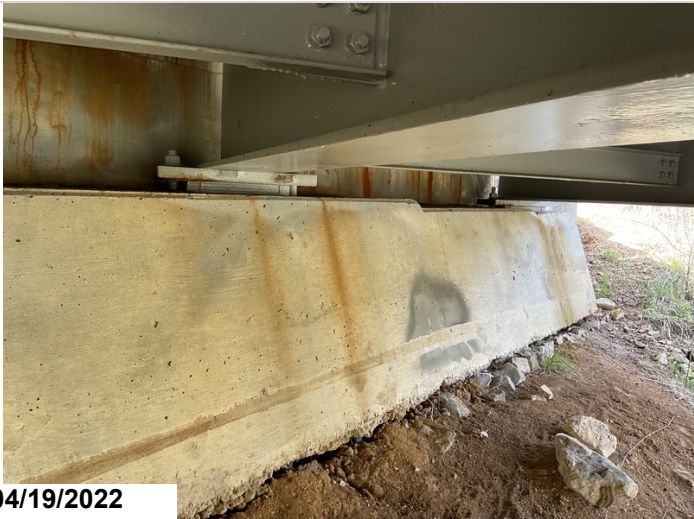
Sole plate corrosion at abutment #1.

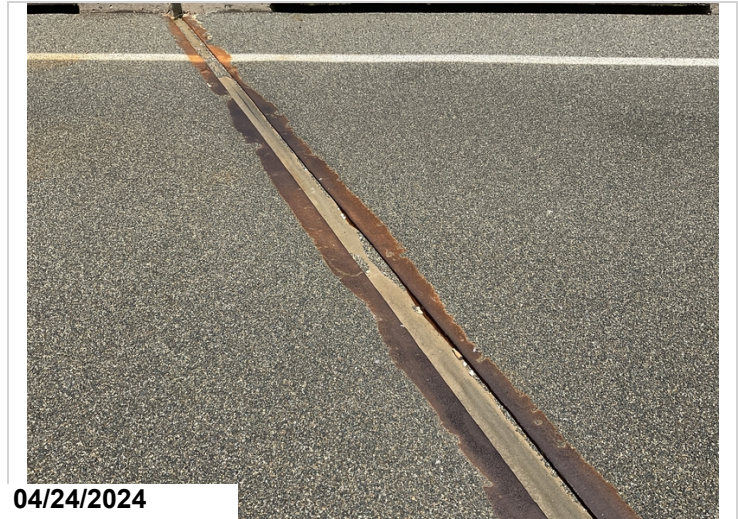
Pier #1 seal showing 2' of cs3 leakage.

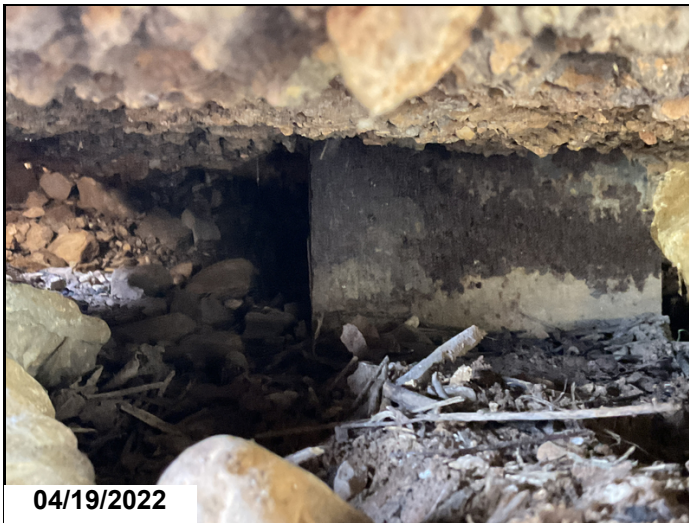
Abutment #1 has 6-8" of embankment settlement at the bridge seat that has exposed the tops of three of the steel piles.

Exposed piling at abutment #1.
