Asset #A0676(Routine)

US 62/412 Marion over TOWN BRANCH

Location: 0.01 MI W JCT SH 14-US 62

Team Lead: Benjamin Smith, Inspection Date: 08/01/2023

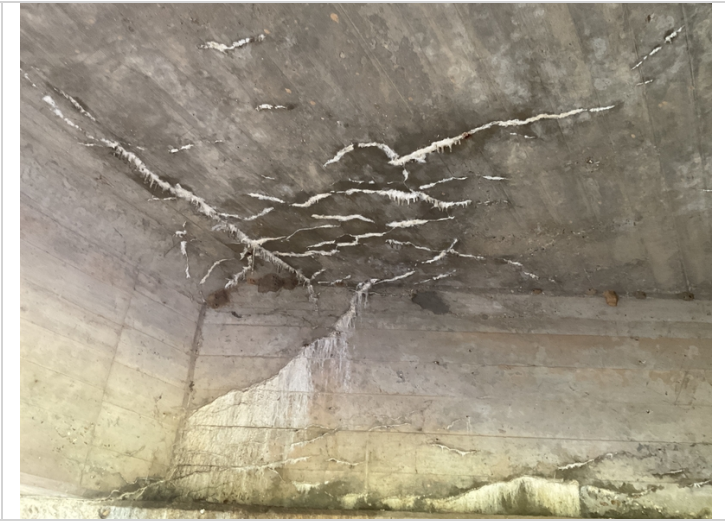
Typical cs3 map cracking with efflorescence in random locations. Bay #1 of span #3 pictured.

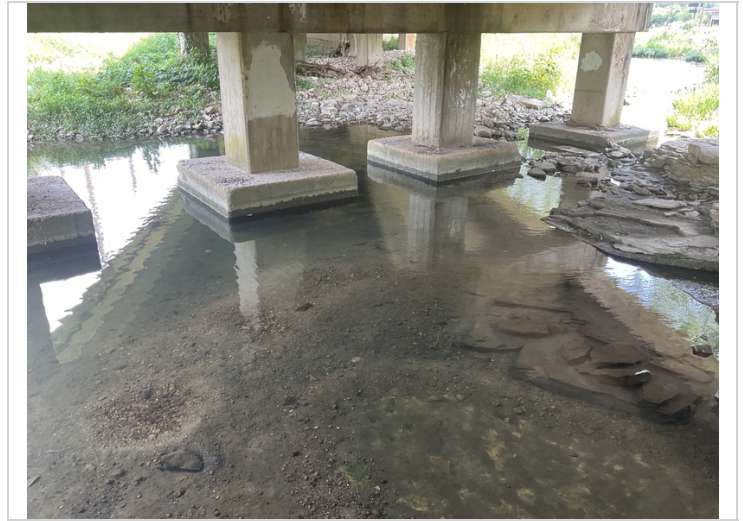
61 - Channel/Channel Protection (7 - Bank protection is in need of minor repairs. River control devices and embankment protection have a little minor damage. Banks and/or channel have minor amounts of drift.)

Comment: The upstream and downstream embankment at abutment #1 is armored with stone and cinder block masonry.

View of the channel beneath the structure.

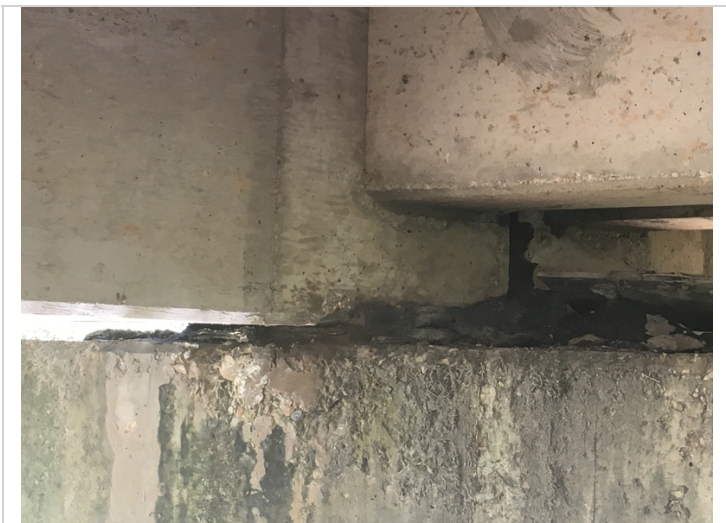
<p>(311) Bent #2 bearings- Bearings #1,#2,#3 over bent #2 are barely observable. Bearing #4 has cs3 corrosion with section loss.</p>							
330	Metal Bridge Railing	LF	208	208	0	0	0

Beam #4 in span #3 bearing condition.

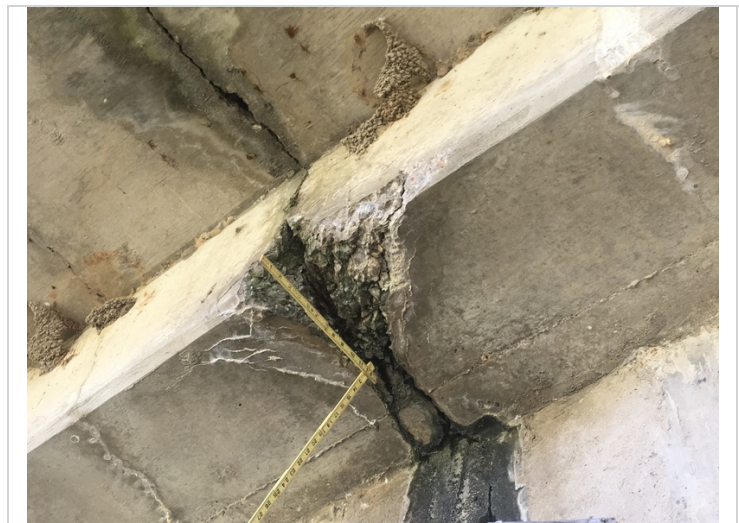
The left overhang in span #1 has a large spall with exposed rebar at the end of span.

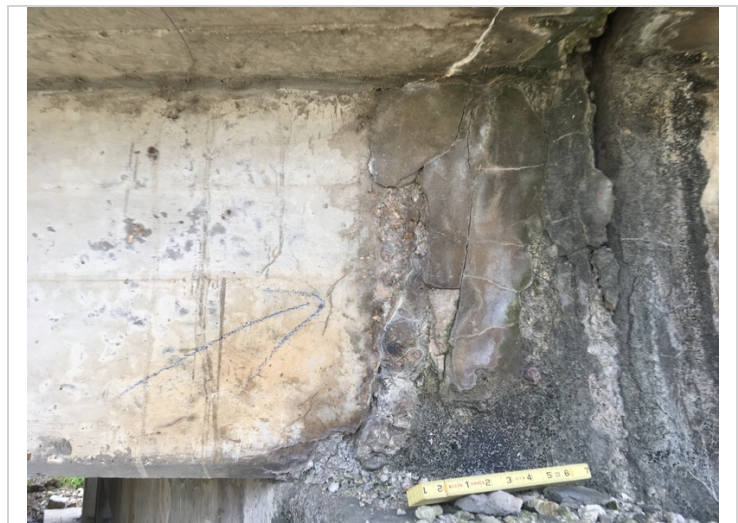
Span #4- all four tee beams have minor vertical flexure cracking, the exterior beginning left of beam #1 has a 2' spall. Tee beam #3 has 1' of delamination at the beginning of the span. Tee beam #4 has 1' of delamination on the exterior face at the beginning of the span.

Exterior face of beam #1 at the beginning of span #4 showing 2' of spalling.

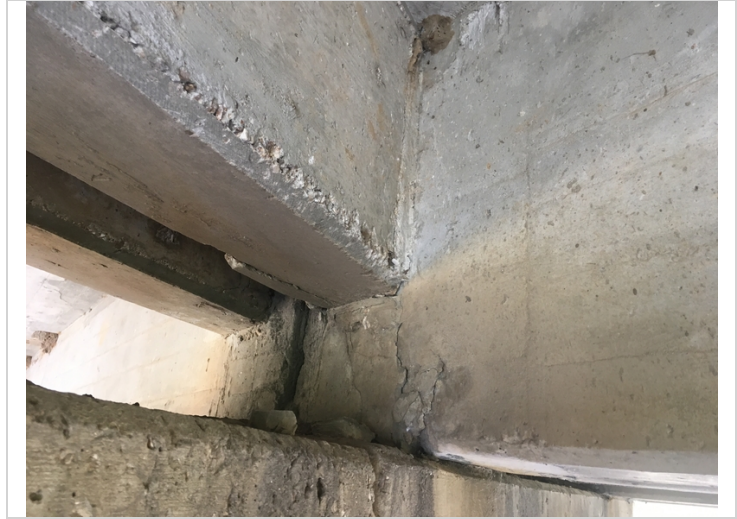
Spalling at the beginning of beam #3 at the beginning of span #3.

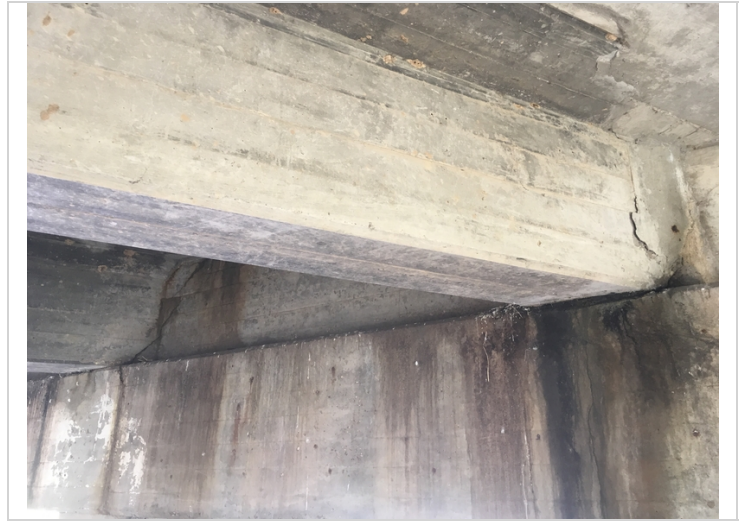
(110) 4 concrete tee beam system.							
Span #1- The tee beams have vertical hairline flexure cracking. Tee beam #1 has a 1' patched area on the exterior face at the end of the span. Tee beam #2 has a 1' delamination at the end of the span. Tee beam #3 has 1' of exposed rebar at the end of the span. The diaphragm between beams #2,3 and #3,4 have diagonal cracking.							
Span #2- The tee beams have minor vertical flexure cracking. The beam ends of beam #1 have been patched for 2' , the beginning and end of the beam has 1' of exposed cs3 rebar each.							
Beam #2- Minor insignificant spalling was noted at some beam ends and on the exterior face of beam #4.							
Beam #3- has an insignificant spall on the bottom at mid span.							
Beam #4-							
Span #3- all four tee beams have vertical flexure cracking. Beams #1-3 have 1' of efflorescence cracking at the beam ends at the end of the span. Beam #3 has 1' of spalling at the beginning of the span. Beam #4 has a delamination on the exterior face at the end of the span. Diaphragm between tee beams #2,3 at the beginning of span #3 has spalling with exposed rebar. All 3 diaphragms at the end of span #3 have cracking with efflorescence.

Delamination at the end of tee beams #2,3 at the end of span #1.

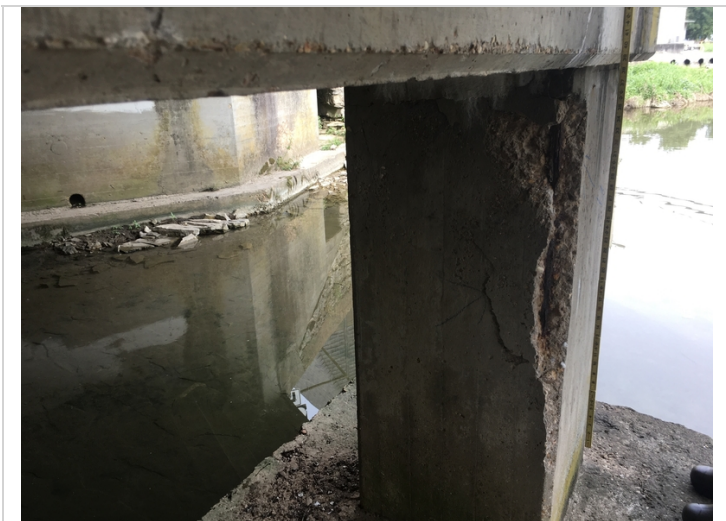
Large spall with rebar exposed on column #1 of bent #1.

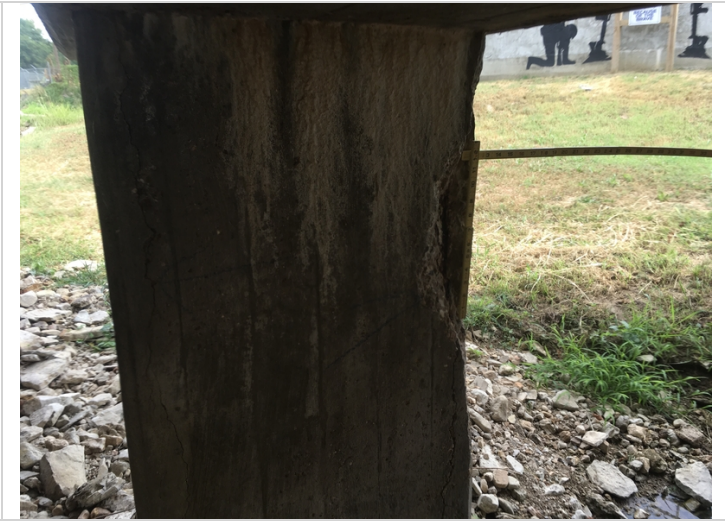
Spalling with rebar exposed on column #1 of bent #2.

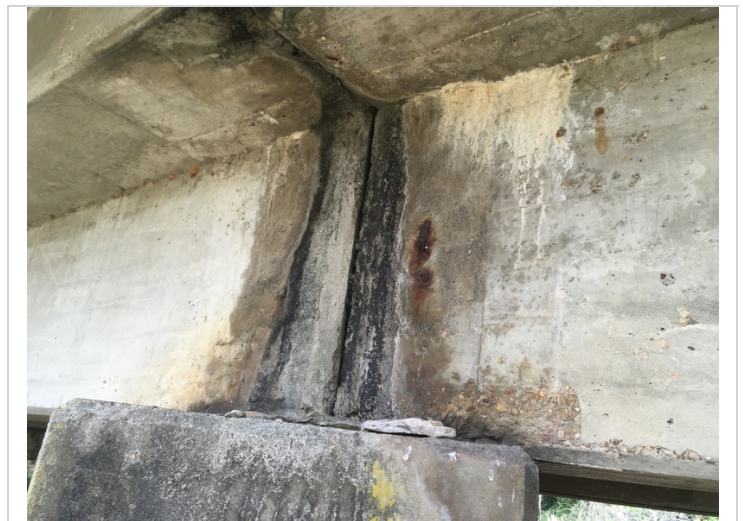
Spalling with rebar exposed at the end of beam #1 in span #2.

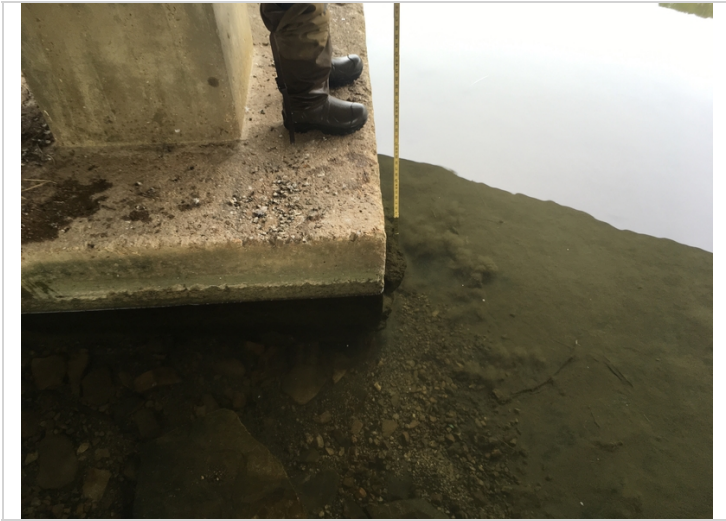
<p>(220) Abutment #1 footing- has 11' of cs3 spalling/honeycombing and 30' of abrasion cs3.</p> <p>Bent #1</p> <p>Column #1 footing- has 3' of cs3 abrasion and 2' of cs3 spalling.</p> <p>Column #2 footing- has 3' of cs3 abrasion and 2' of cs3 spalling.</p> <p>Column #3 footing- has 4' of cs3 abrasion and 1' of cs3 spalling.</p> <p>Column #4 footing- has 5' of cs3 abrasion.</p>

28" of the vertical face of the column footings at bent #1.
Typical of all at bent #1.

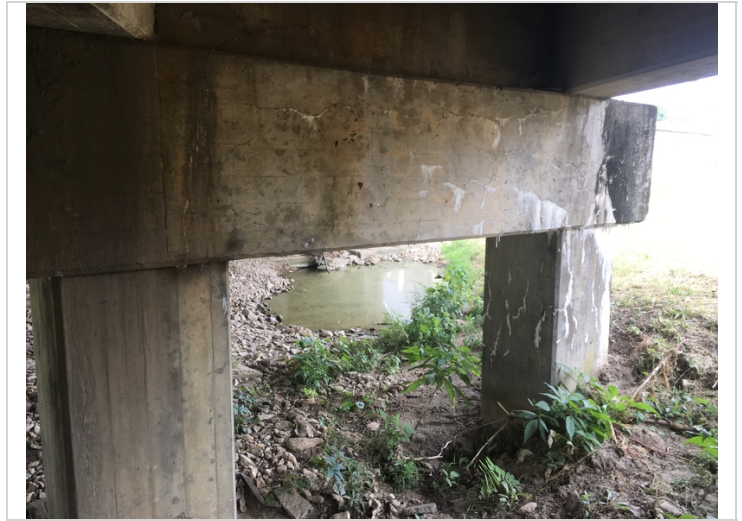
Efflorescence map cracking at the left end of bent #3 and
column #1.

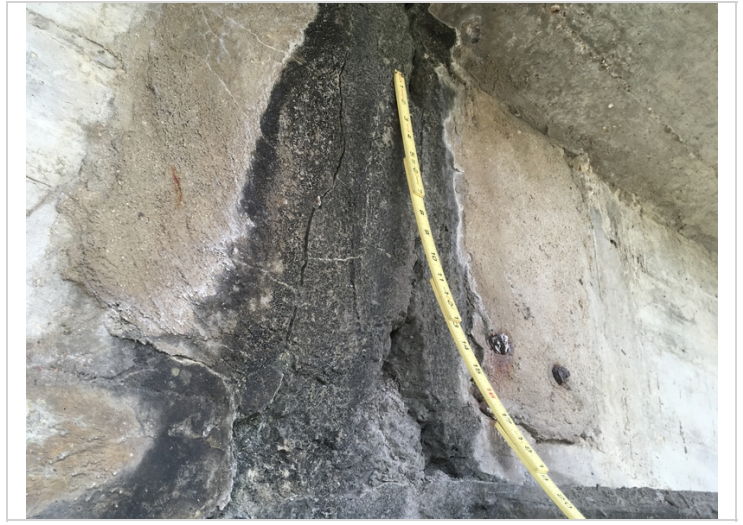
Vertical cracking at the beginning of tee beam #1 at the beginning of span #2.
