Asset #05367 (Routine, Underwater type 2)

SH 27 Searcy over WATTS CREEK

Location: 7.8MI SW JCT SH 333

Team Lead: Benjamin Smith, Inspection Date: 11/15/2022

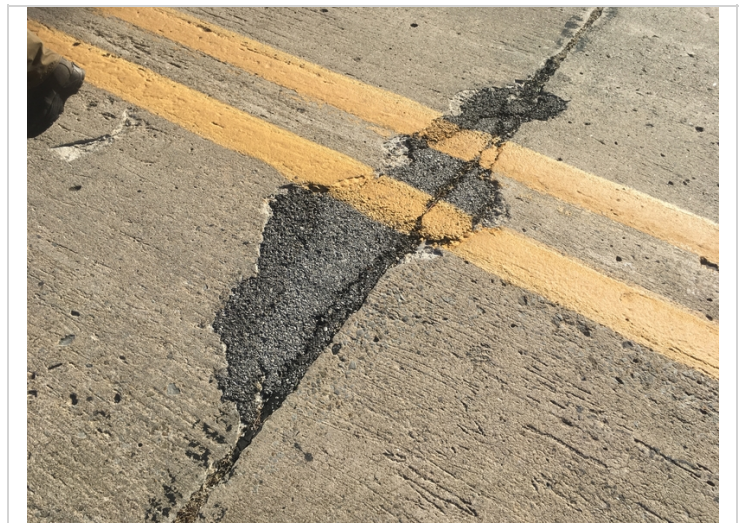
Repaired pot holes at the beginning of span 3.

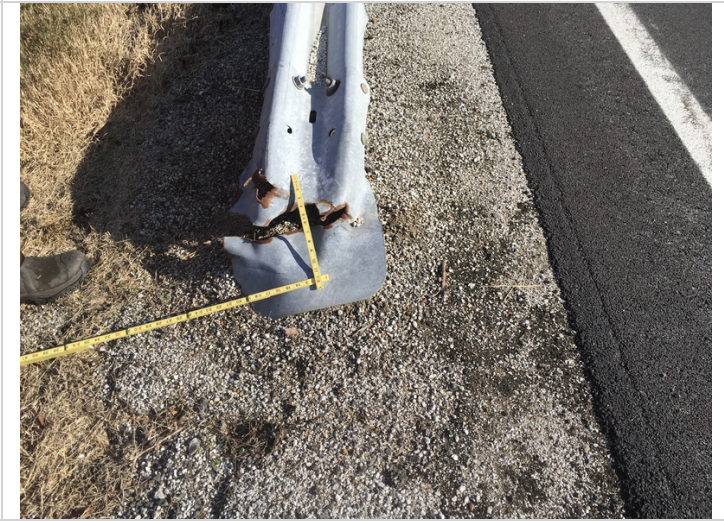
Left beginning approach railing termination has mower damage.

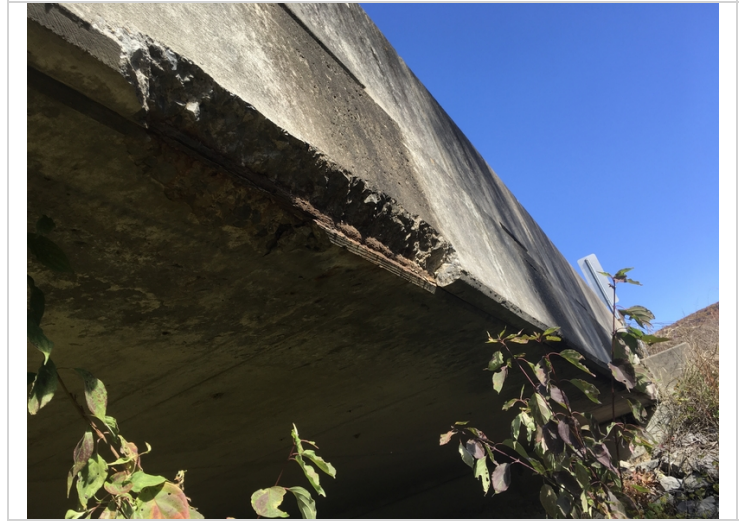
Span #1- the left drip edge has 8' of cs3 delamination and 2' of spalling with exposed rebar. The right drip edge has 12' of cs3 delamination and 1' of spalling with exposed rebar.							
Span #2- the left drip edge has 3' of cs3 delamination. The right drip edge has 5' of cs3 delamination and 19' of spalling with exposed cs3 rebar.							
Span #3-the left drip edge has 6' of delamination and 1' of spalling with exposed rebar. The right drip edge has 9' of cs3 delamination and 12' of spalling with exposed cs3 rebar.

Spalling with rebar exposed at the right drip edge of span #3.

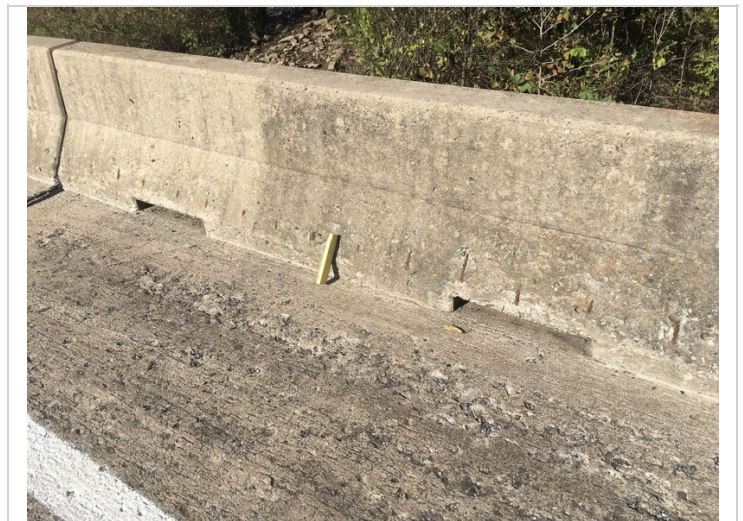
Areas of shallow exposed rebar along the bottom of the parapet walls.

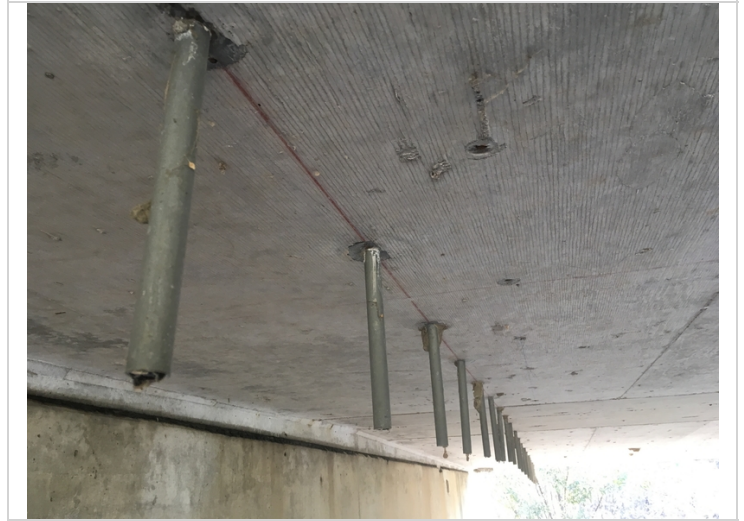
Pipes through the slab at the end of span #1.

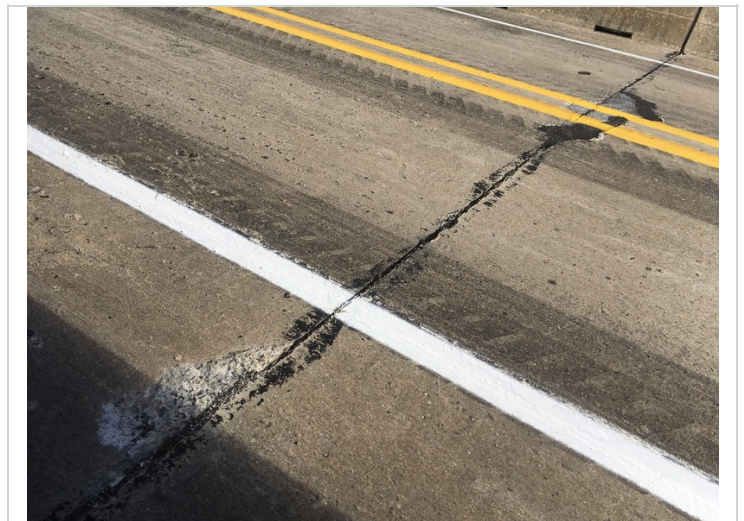
Spalling in the driving surface of the deck at the end of span #2, beginning of span #3.

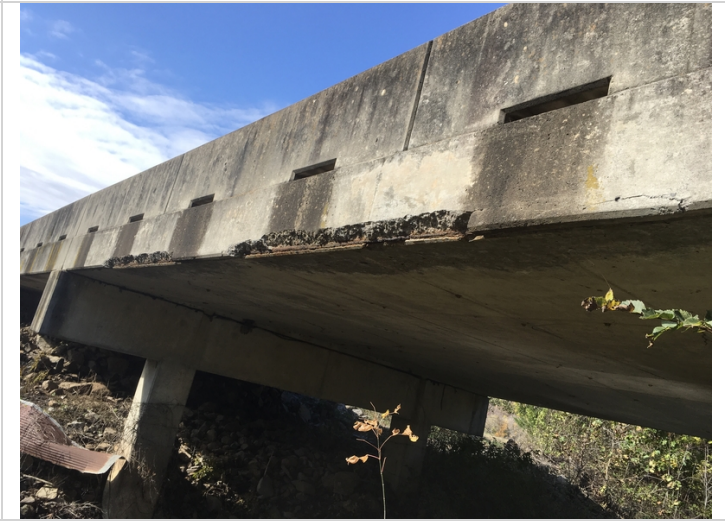
Spalling with exposed rebar at the right drip edge of span #2.

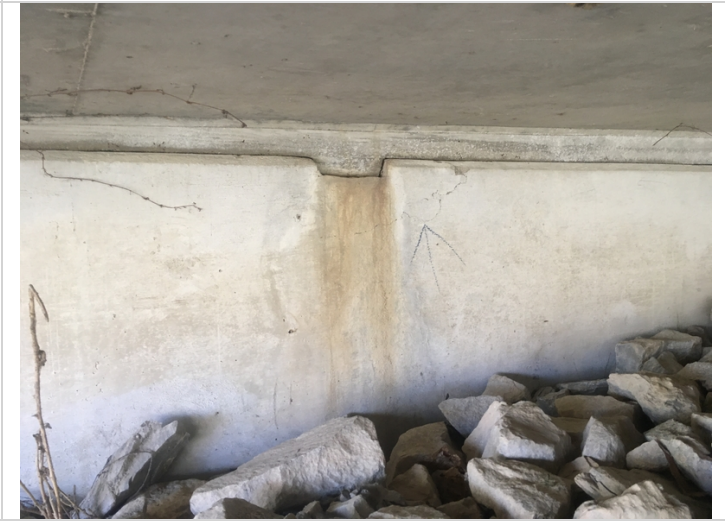
ELEMENTS	DESCRIPTION	UNITS	TOTAL	CS1	CS2	CS3	CS4
205	Reinforced Concrete Column	EA	4	4	0	0	0
<p>(205) Bent #1 columns- Column #1- no deficiencies noted. The footing has cover. Column #2- no deficiencies noted. Column #2 has a small insignificant spall on the interior face that is not large enough to quantify. The footing has cover.</p> <p>Bent #2 columns- Column #1- no deficiencies noted. The footing has cover. Column #2- no deficiencies noted. The footing has cover.</p>							
215	Reinforced Concrete Abutment	LF	70	53	15	2	0
1080	Delamination/Spall/Patched Area	LF	2	0	1	1	0
1090	Exposed Rebar	LF	1	0	0	1	0
1130	Cracking (RC and Other)	LF	14	0	14	0	0
<p>(215) Abutment #1- has 8' of vertical hairline cracks. The vertical face has 1' of spalling with 1' of shallow rebar exposed beneath the left keyway. The rip rap is in place and functioning as intended.</p> <p>Abutment #2- has 6' of vertical hairline cracks with 1' of cs3 delamination next to the left keyway. The rip rap is in place and functioning as intended.</p>

Delamination next to the left keyway at abutment 2.

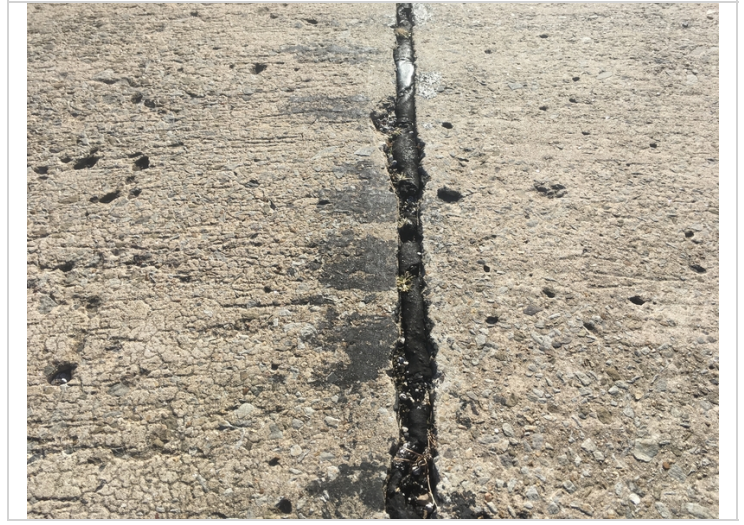
Joint seal condition over bent 1.

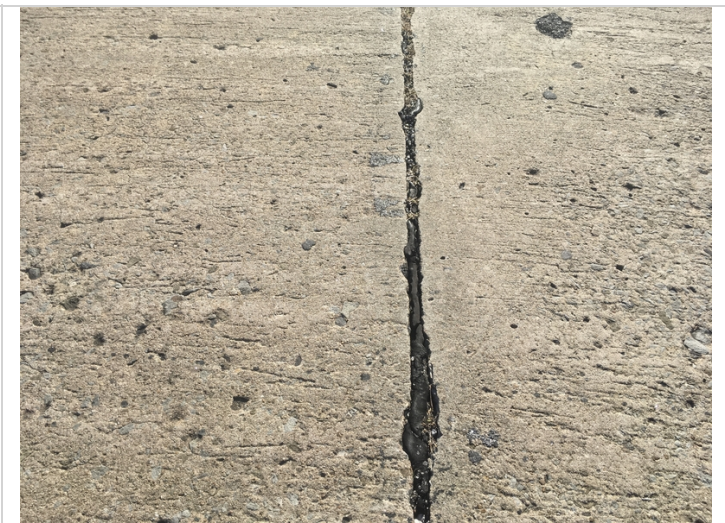
Joint seal condition over bent 2.

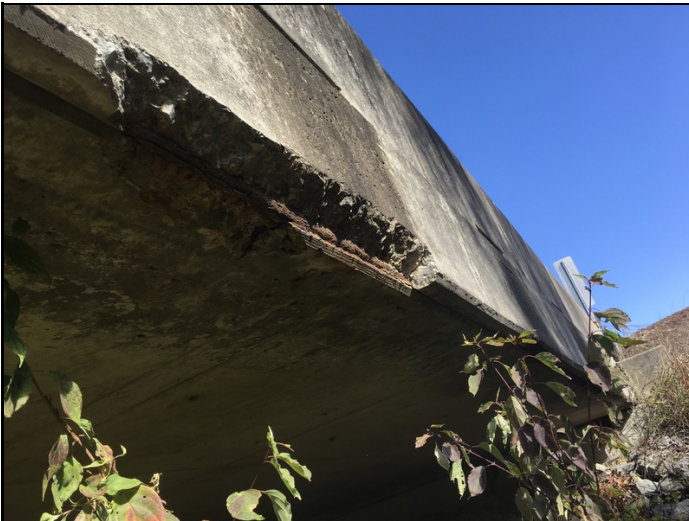
The left drip edge on the underside of the slab in span #1 has spalls and delamination.
The right drip edge on the underside of the slab in spans #2,3 has large spalls with rebar exposed.
The tops of the left and right cap ends have spalling with no exposed rebar for 1' each.

Spalling with rebar exposed at the right drip edge of span #3.

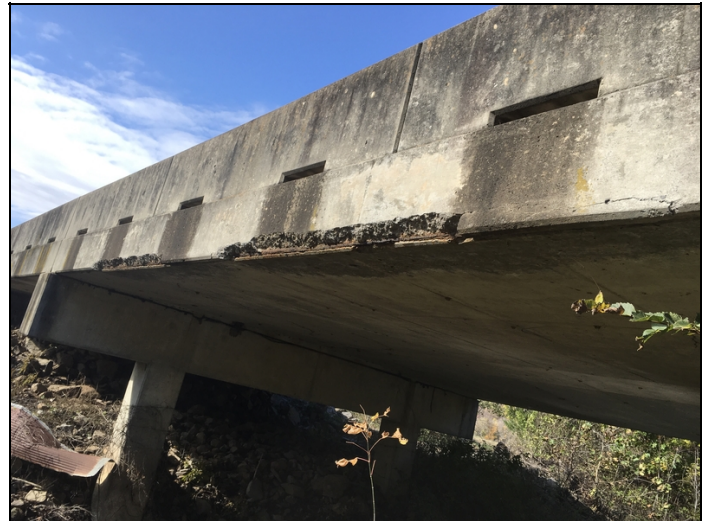
Spalling with exposed rebar at the right drip edge of span #2.
