Asset **#M0664**(Routine, Underwater type 2)

SH 27 Searcy over COTTON HOLLOW

Location: 5.1MI SW JCT SH 333

Team Lead: Nathan Rowland, Inspection Date: 11/16/2022

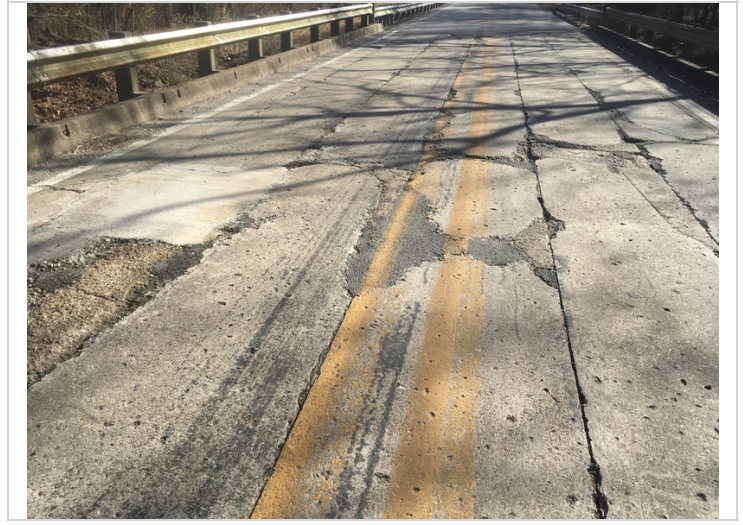
Typical view of the driving surface.

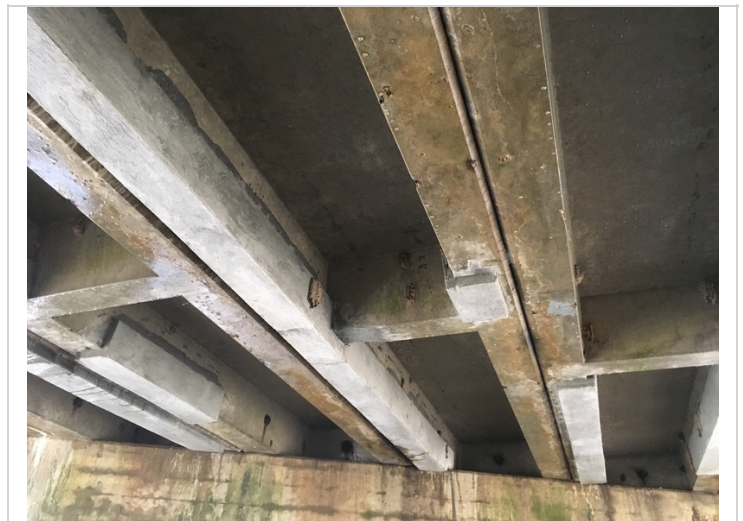
Typical view of the undersurface and repaired areas.

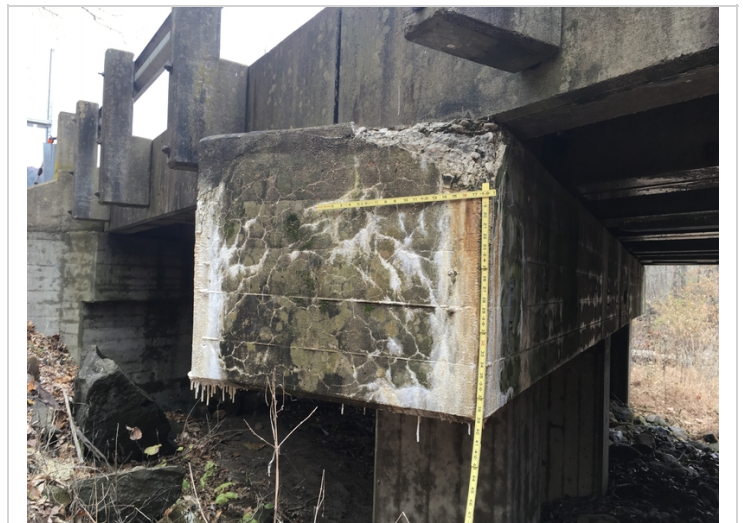
| ELEMENTS | DESCRIPTION | UNITS | TOTAL | CS1 | CS2 | CS3 | CS4 |
|--|---|---|---|---|---|---|---|
| <p>(234) 11/16/2022 WNR & DBM: Abutment #1 cap- has 3' of cs3 delamination and 1' of vertical hairline cracking.</p> <p>Bent cap #1- has 11' of vertical, horizontal and map cracking and 3' of spalling on the top outer ends of the caps.</p> <p>Bent cap #2- has 2' of exposed rebar on the span #2 side, 7' of delamination and spalling, and 2' of vertical hairline cracking.</p> <p>Bent cap #3- has 11' of spalled and delaminated areas and 5' of vertical hairline cracking.</p> <p>Abutment #2 cap- has 1' of spalling with no rebar exposed under the left stem of unit #2.</p> | | | | | | | |

View of the right cap end of bent #1. Showing spalling and efflorescence map cracking. Typical also of the left end of the cap.

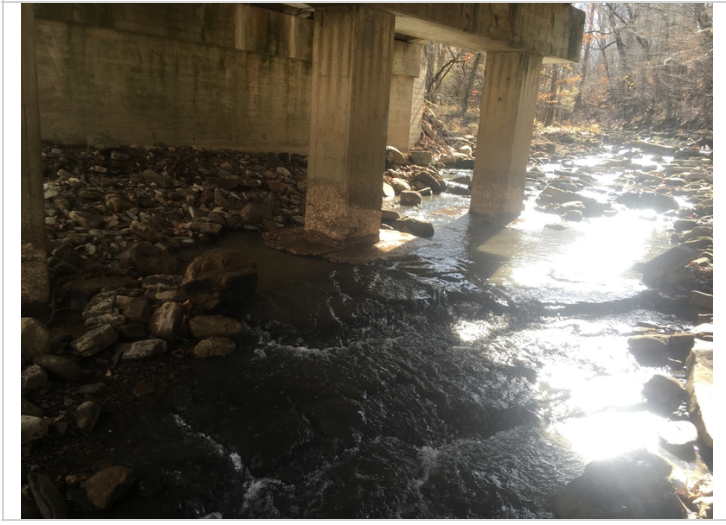
| ELEMENTS | DESCRIPTION | UNITS | TOTAL | CS1 | CS2 | CS3 | CS4 |
|--|---|---|---|---|---|---|---|
| <p>(220) 11/16/2022 WNR & DBM: Bent #2 column footings- columns #1,2 have the 5' of the tops of the footing exposed at each column. Both footings have cs2 abrasion for the full width. The footings are cast in solid rock.</p> <p>Bent #3 column footings- columns #1,2,3 have 5' of the tops of the footings exposed at each column. All 3 columns have cs2 abrasion for the full width. The footings are cast in solid rock.</p> | | | | | | | |

Exposed column footings at bent #3. Typical.

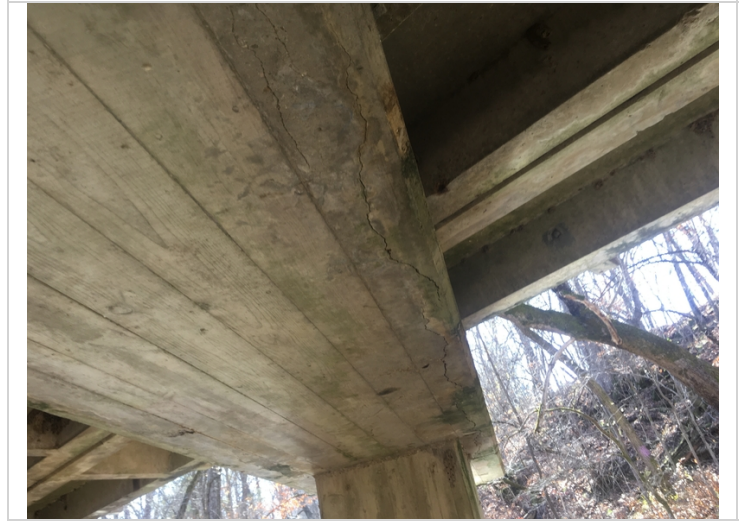
Large delamination on the under surface of the bent #3 cap.

Bent 3 cap- the undersurface of the cap has a large delamination between columns 2,3

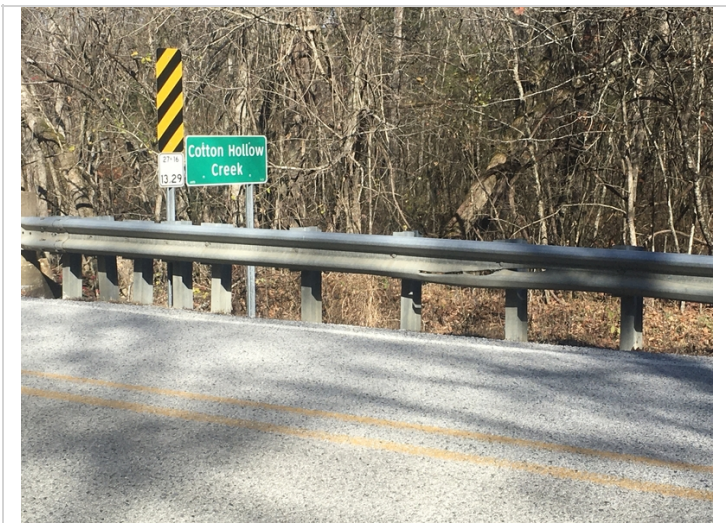
| ELEMENTS | DESCRIPTION | UNITS | TOTAL | CS1 | CS2 | CS3 | CS4 |
|---|---|---|---|---|---|---|---|
| <p>(330) 11/16/2022 WNR & DBM: Right side metal railing- the front side has areas of pin point rusting and the back side has corrosion for the full length. The right beginning approach railing has no posts supporting the rail.</p> <p>Left side metal railing- the front and back side has corrosion for the full length. The left ending approach railing has a tear in the face of the rail.</p> | | | | | | | |

4' long tear in the face of the left ending approach railing.

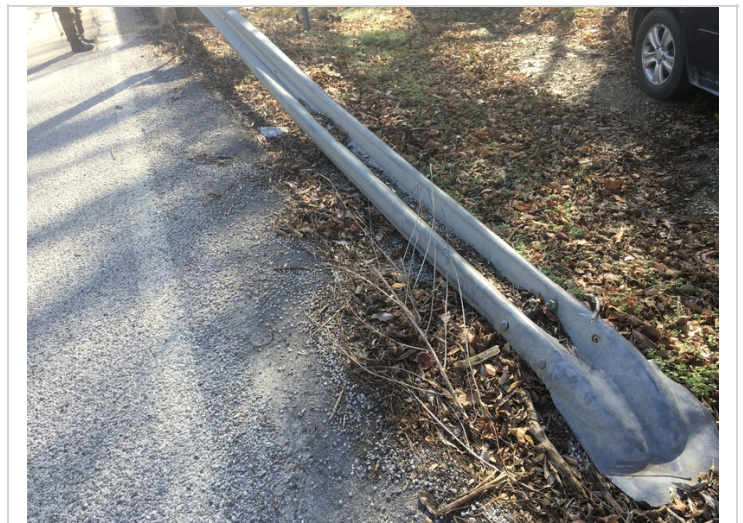
No posts supporting the beginning right approach railing.

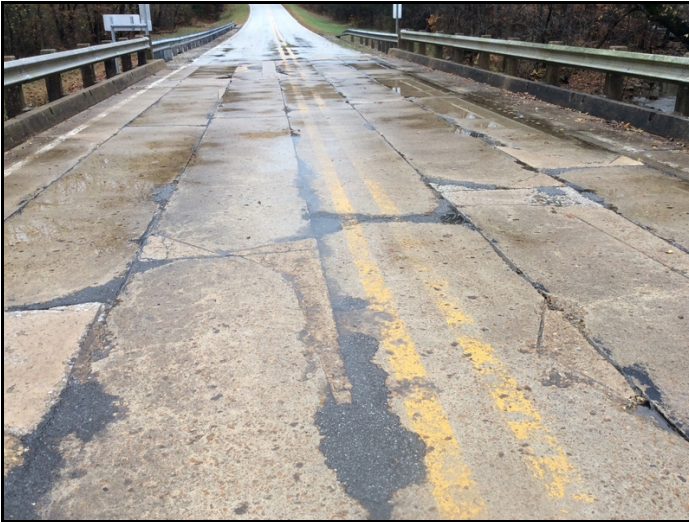
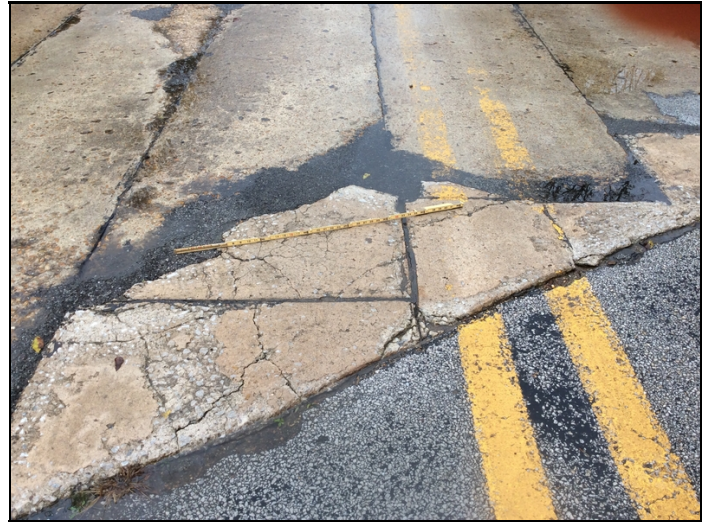
The driving surface of the deck has spalls, some patched areas are unsound.

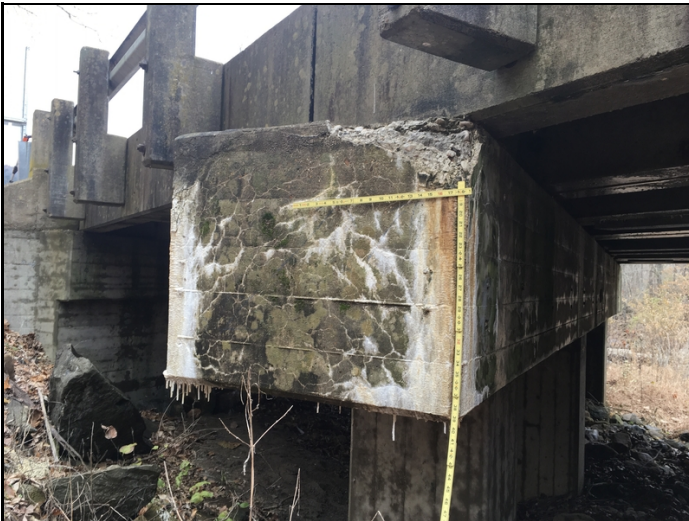
Bent 1 cap- The left and right ends of the cap have spalling and efflorescence map cracking.

View of the right cap end of bent #1. Showing spalling and efflorescence map cracking. Typical also of the left end of the cap.

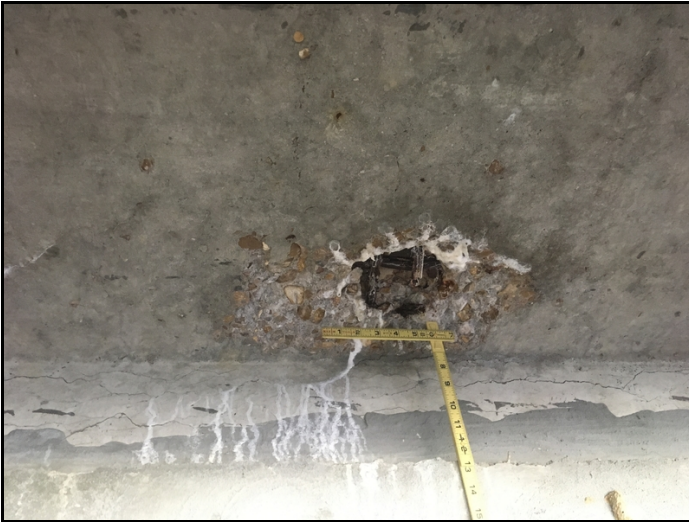
The undersurface of the deck has spalling with rebar exposed

Spalling with exposed rebar in the undersurface of the deck. Typical of several locations.

Type of Work: Repair (General)

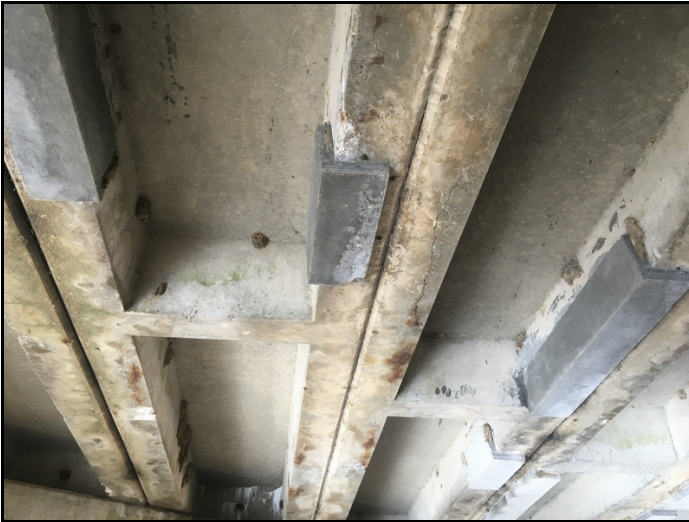
The channel beam stems have areas of delamination at random locations throughout the structure.

Repaired and unrepaired delamination on the channel beam stems. Typical.

Type of Work: Repair (General)

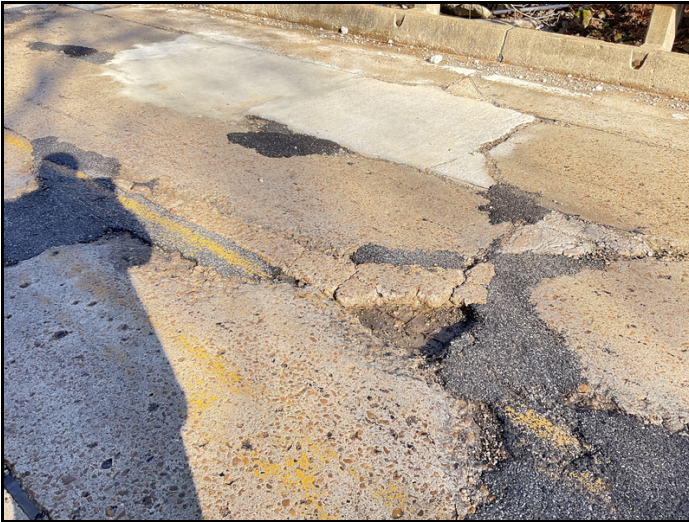
Spalling/pothole - Basketball sized spall in the driving surface in span #1 end of unit #3

Basketball sized spall in the driving surface in span #1
end of unit #3

Type of Work: Repair (General)
