Asset #M0665(Routine, Underwater type 2)

SH 27 Searcy over HALSTEAD CREEK

Location: 3.1MI SW OF JCT SH 333

Team Lead: Nathan Rowland, Inspection Date: 11/16/2022

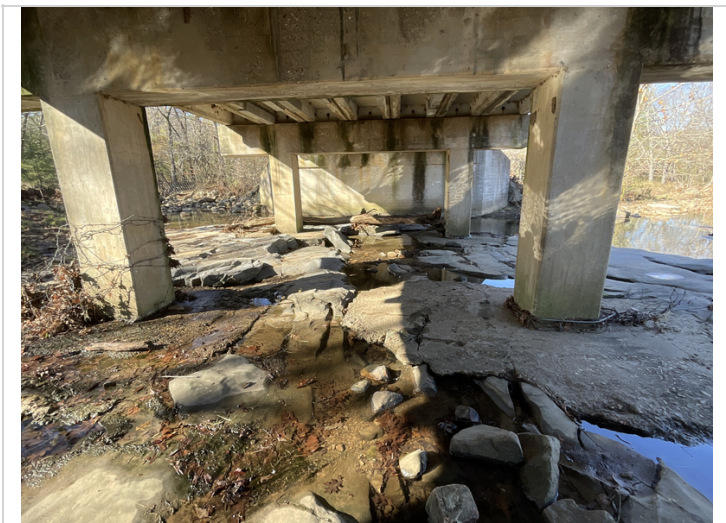
(220) 11/16/2022 WNR & DBM: Abutment #1 footing- the concrete footing is exposed for the full length of the abutment. The footing has abrasion for the full length. Bent #1 column footings- columns #1,2 both have 5' of exposed footing each. Both footings have cs2 abrasion. The footings are cast in solid rock. Bent #2 column footings- columns #1,2 both have 5' of exposed footing each. The left footing has 1' of cracking and 4' of abrasion. The right footing has 5' of abrasion. The footings are cast in solid rock. Abutment #2 footing- the concrete footing is exposed for the full length of the abutment except for 4' at the left wing wall. The footing has 1' of cs2 cracking and 1' of cs3 cracking.							
234	Reinforced Concrete Pier Cap	LF	52	30	10	12	0
1080	Delamination/Spall/Patched Area	LF	12	0	0	12	0
1130	Cracking (RC and Other)	LF	10	0	10	0	0

View of exposed footings at columns

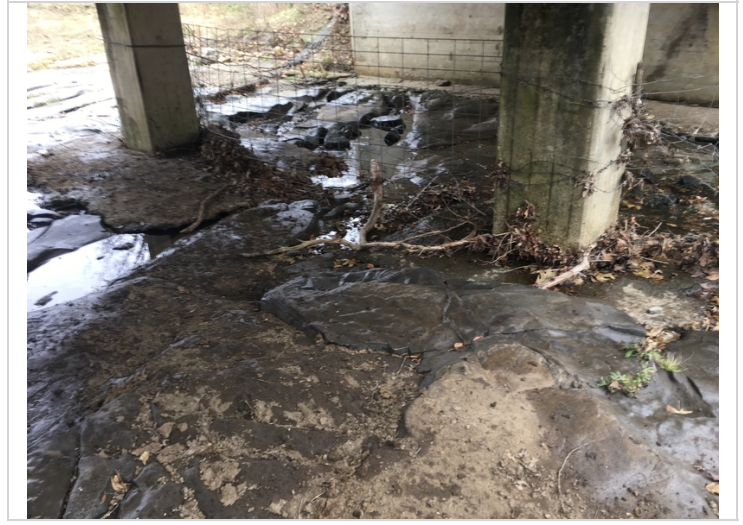
Exposed footings cast in solid rock.

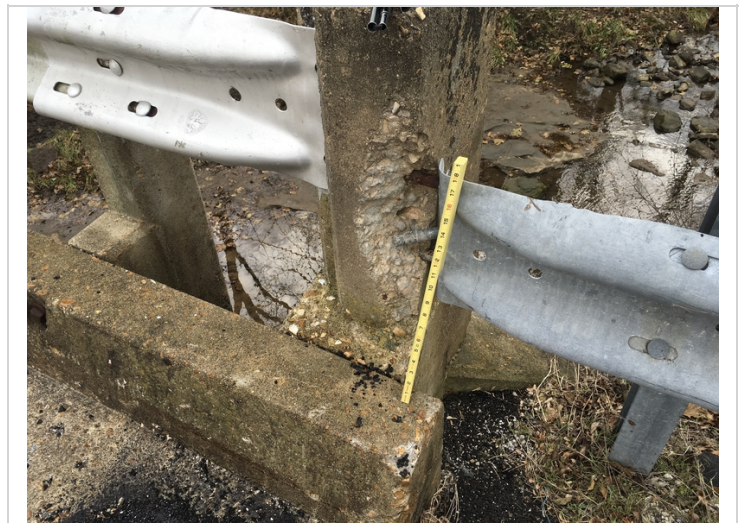
ELEMENTS	DESCRIPTION	UNITS	TOTAL	CS1	CS2	CS3	CS4
3440	Effectiveness (Steel Protective Coatings)	LF	171	0	171	0	0
(330) 11/16/2022 WNR & DBM: Right side metal railing- Concrete end post at beginning of span #1 right side has vehicle damage, and has loose connection due to spalling. The rail has cs2 corrosion on the back face at random locations. The front face of the rail has been repainted. Left side metal railing- The rail has cs2 corrosion on the back face at random locations. The front face of the rail has been repainted.

Right beginning end post has a large spall with exposed rebar.

The right beginning of the bridge end post is broken with rebar and anchoring exposed.

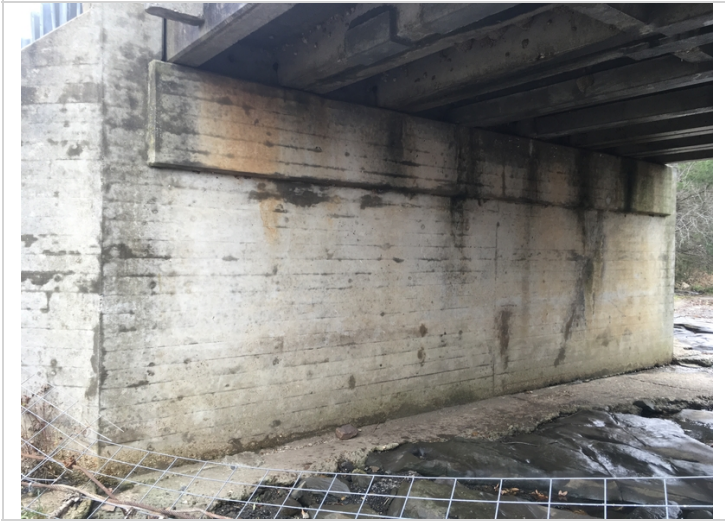
(215) 11/16/2022 WNR & DBM: Abutment #1- has 10' of vertical and diagonal hairline cracking with 8' of cs2 abrasion at the base of the wall. Abutment #2- has 14' of diagonal and vertical hairline cracks. The right embankment has erosion behind the wing wall.							
220	Reinforced Concrete Pile Cap/Footing	LF	114	0	113	1	0
1130	Cracking (RC and Other)	LF	3	0	2	1	0
1190	Abrasion/Wear (PSC/RC)	LF	111	0	111	0	0

General view of abutment #2.

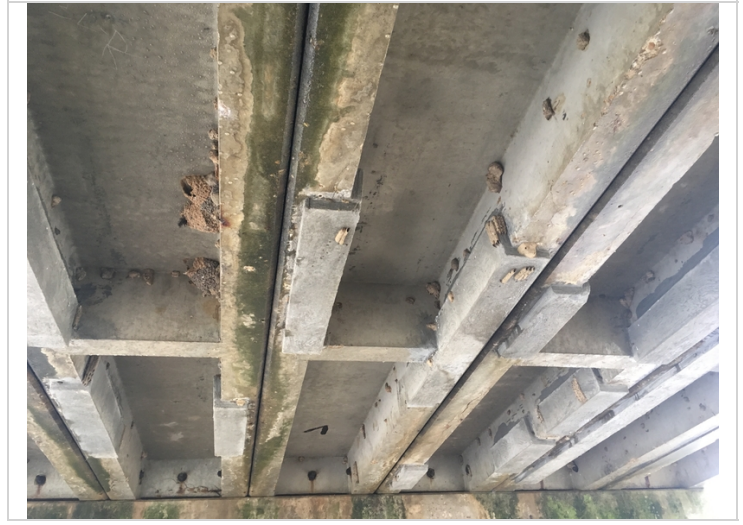
Typical view of the undersurface.

The channel beam stems have small spall with rebar exposed and areas of delamination in all 3 spans.

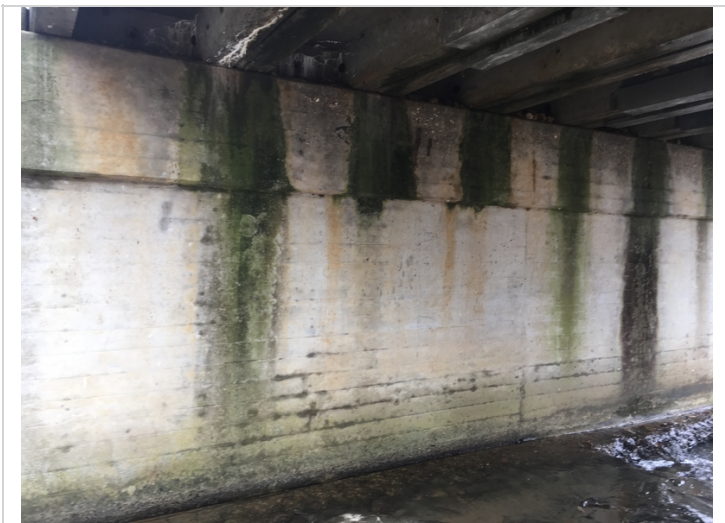
General view of abutment #1.

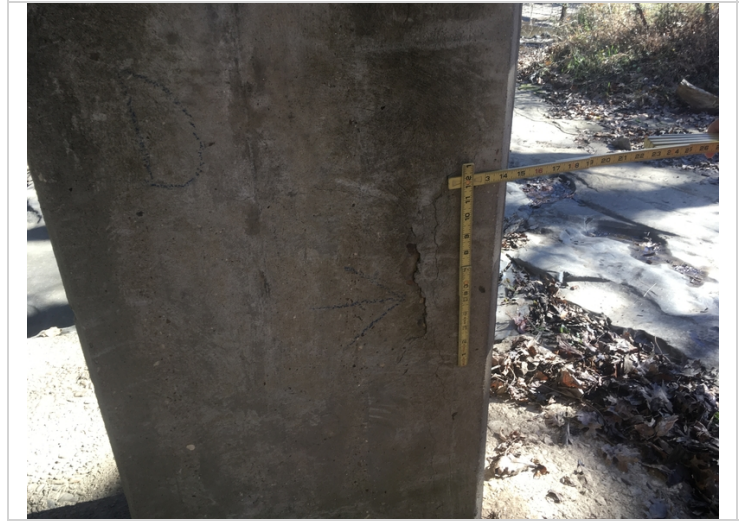
(205) 11/16/2022 WNR & DBM: Bent #1 columns- Column #1- has a large spall with exposed rebar at the interior base and spalling on the span #2 side with cs2 abrasion Column #2- has a large vertical delamination on the span #1 upstream face with cs2 abrasion. Bent #2 columns- Column #1- has vertical delamination at the top of the column with cs2 abrasion Column #2- has cs3 abrasion for 2" along the extreme base of the column.							
215	Reinforced Concrete Abutment	LF	98	73	25	0	0
1130	Cracking (RC and Other)	LF	17	0	17	0	0
1190	Abrasion/Wear (PSC/RC)	LF	8	0	8	0	0

Delamination on column #2 of bent #1.

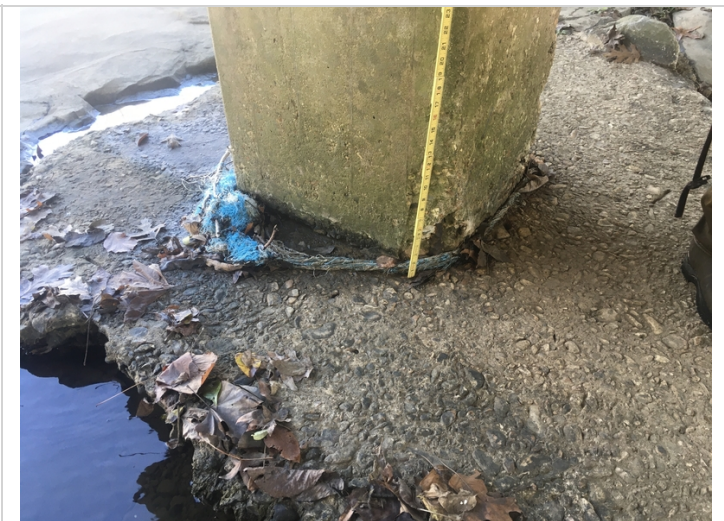
Spalling with rebar exposed on column #1 of bent #1.

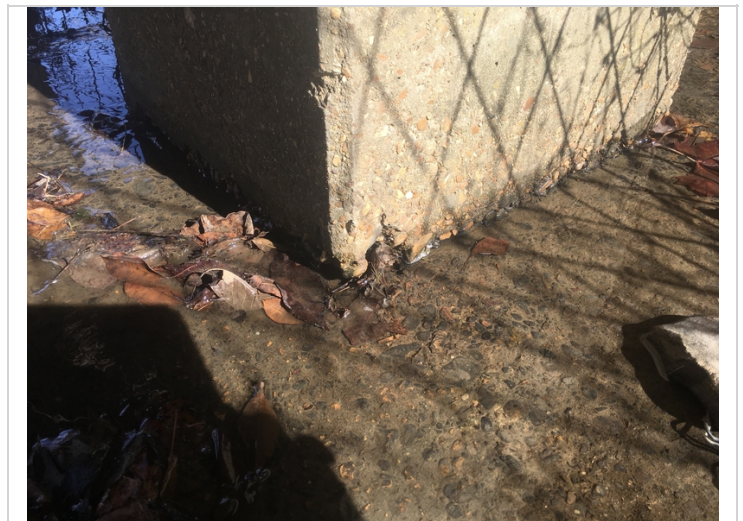
Cs3 abrasion on the extreme lower portion of column #2 of bent #2.

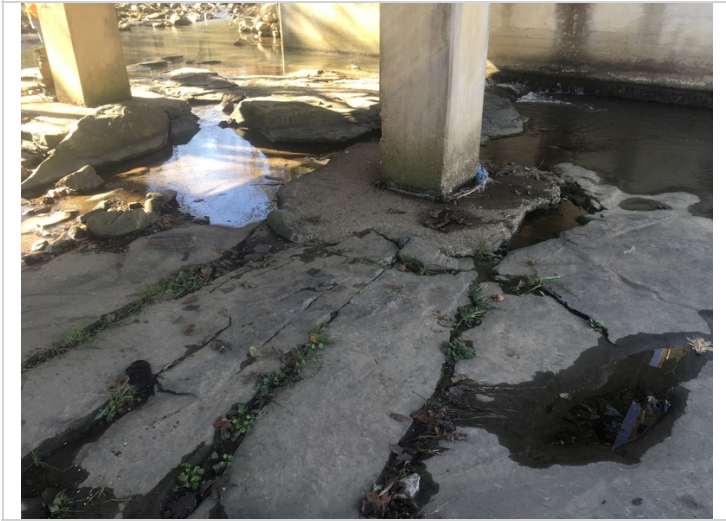
Exposed column footings. The footings are cast in solid rock.
Typical view.

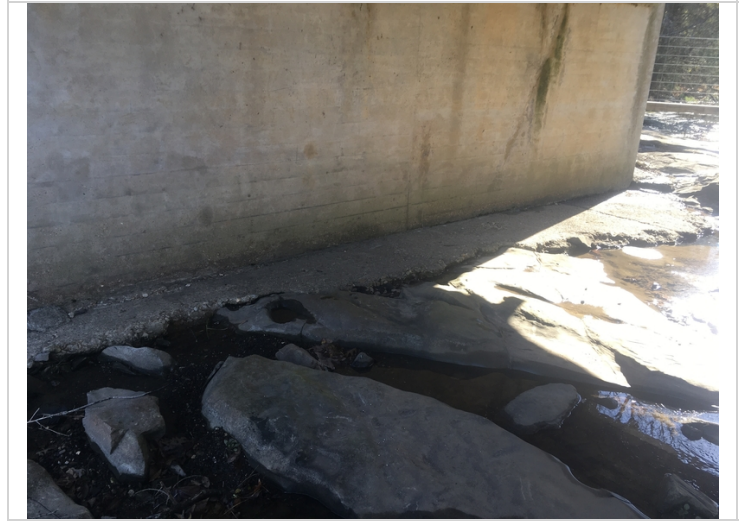
Exposed abutment #2 footing. Typical also of abutment #1.
