Asset #M0667 (Routine)

SH 27 Searcy over DITCH

Location: 1MI SW JCT SH 333

Team Lead: Benjamin Smith, Inspection Date: 11/09/2023

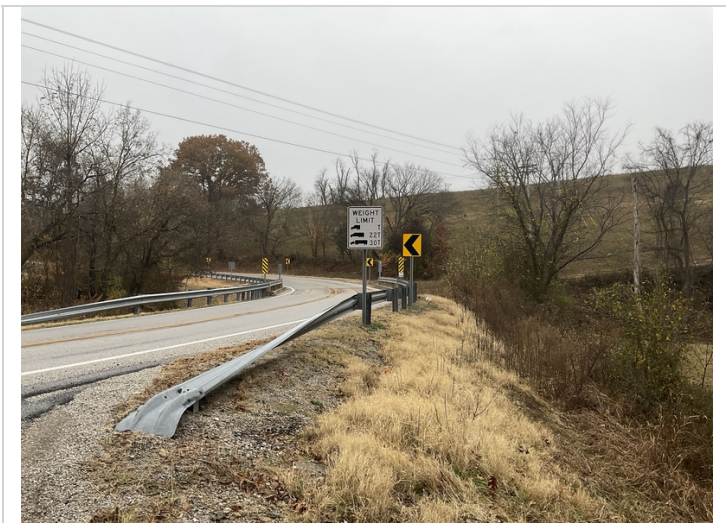
Ending load posting.

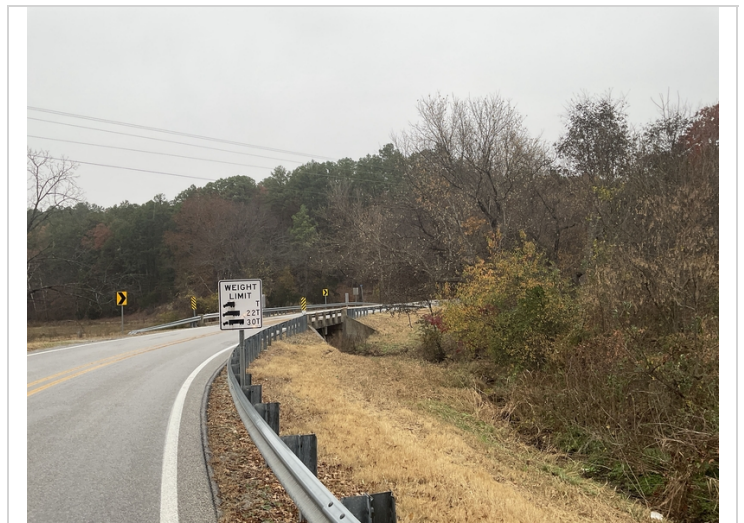
Beginning load posting.

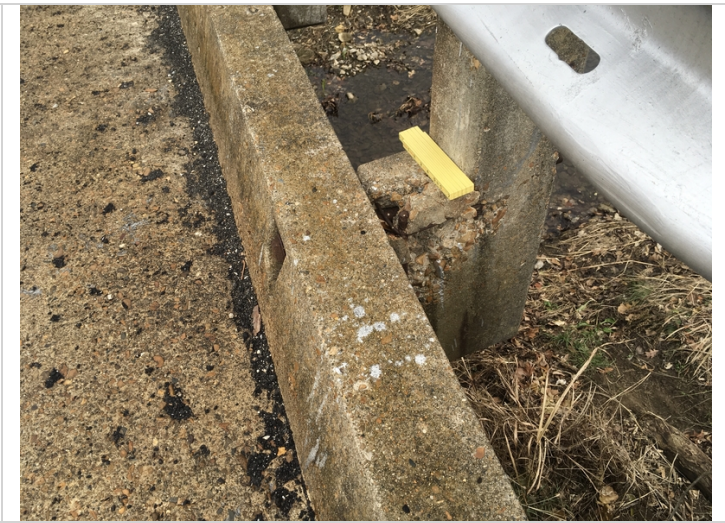
Right side post #2 has vehicle damage.

Concrete posts #2 and #7 on the right side of the structure have vehicle damage.

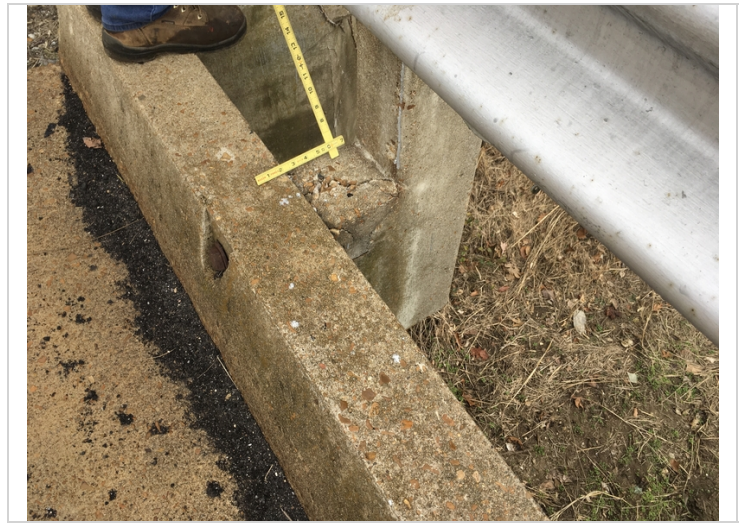
Right side post #7 has vehicle damage.

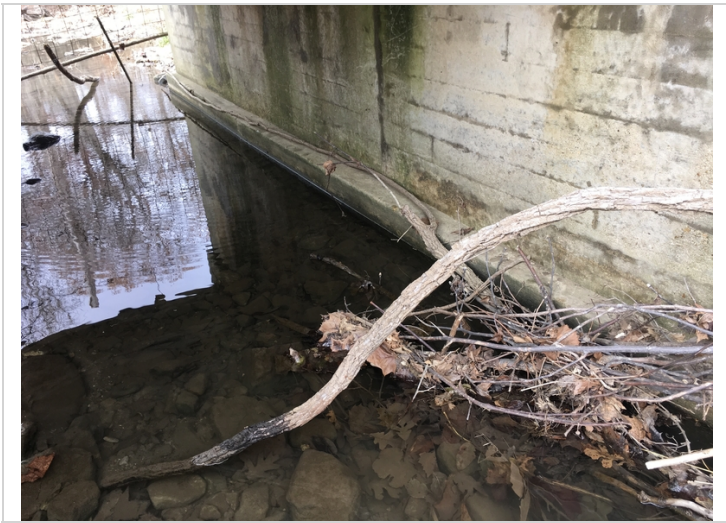
(220) 11/16/2022 WNR & DBM:							
Abutment #1 footing- has cover. Pier wall 1 footing- Span 1 side- The concrete footing is exposed for the full length of the pier wall. (26') on the span 1 side. 3 hairline vertical cracks were noted. Span 2 side- has 11' of the upstream end of the footing exposed with no deficiencies.							
Abutment #2 footing- has cover.							
234	Reinforced Concrete Pier Cap	LF	26	4	13	9	0
1080	Delamination/Spall/Patched Area	LF	7	0	0	7	0
1090	Exposed Rebar	LF	2	0	0	2	0
1130	Cracking (RC and Other)	LF	13	0	13	0	0

Exposed footing on the span #1 side of the pier wall.

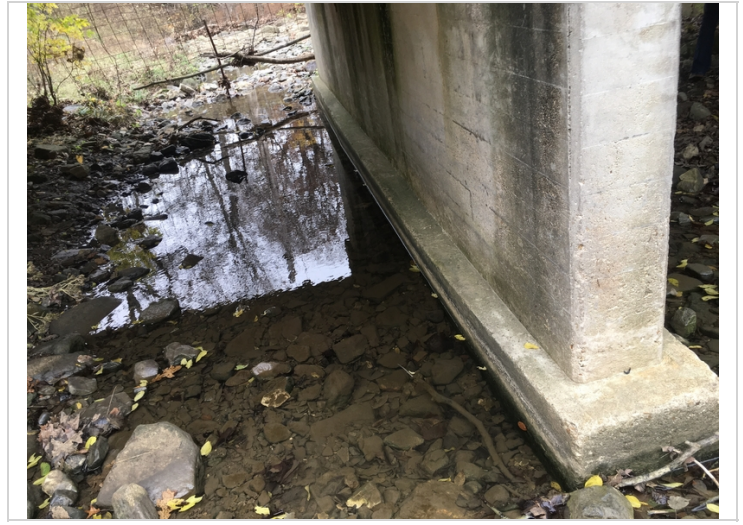
Exposed footing for the length of the pier wall on the span 1 side.

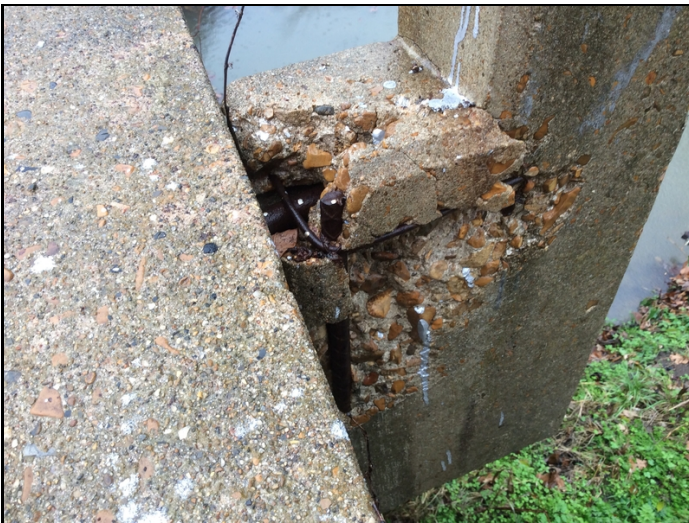
Spall with exposed rebar at post #2 at right side of span #1.

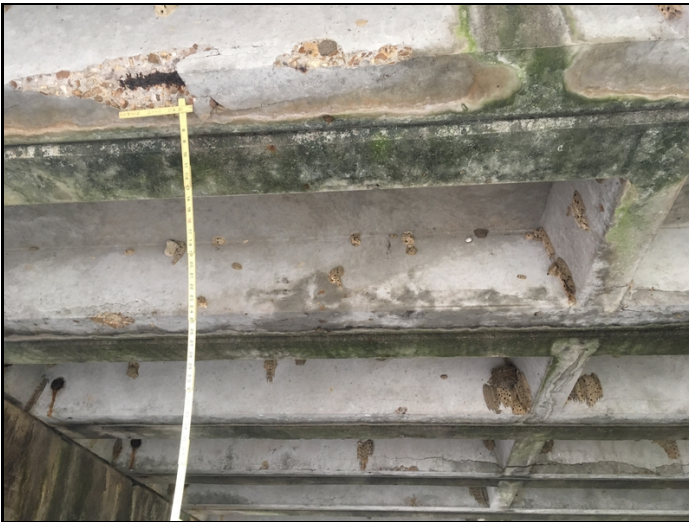
The channel beam stems have large areas of delamination in both spans. Units #1,7 in span #1 and unit #2 in span #2 have a spalling with exposed rebar.

Spalling with exposed rebar on unit 1 in span 1.

Bridge crew
