Asset #M0670(Routine, Underwater type 2)

SH 27 Searcy Co. over DITCH

Location: .8 M E of SH 333

Team Lead: Nathan Rowland, Inspection Date: 11/16/2022

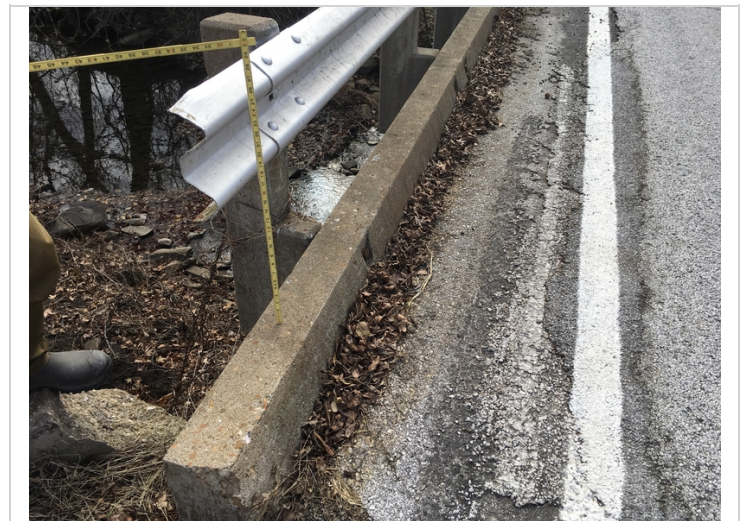
The railing end post on the right side of abutment #2 has been displaced due to collision damage and is exposing an unprotected end of the metal railing.

The concrete end post on the right side of the railing at abutment #2 has been displaced due to collision damage, this has exposed the untreated end of the metal guard rail.

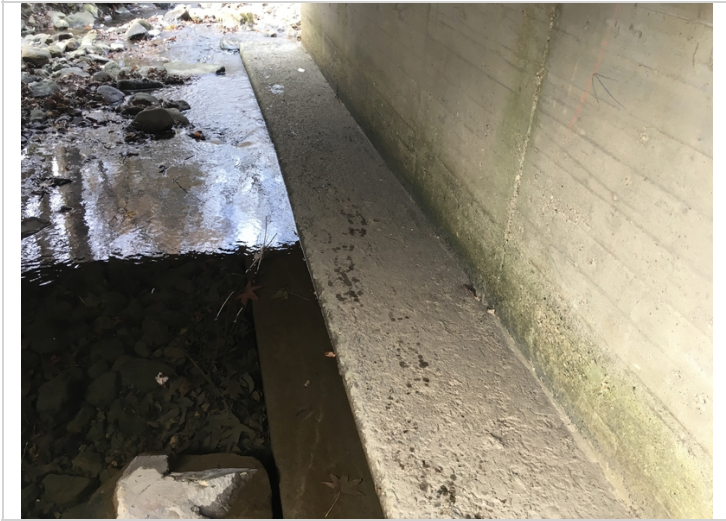
(210) 11/16/2022 WNR & DBM:							
Pier wall #1- has 7 vertical hairline cracks with minor abrasion for the length of the wall for 2'. The top of the footing is exposed for 11' at the downstream end of the span #2 side.							
Pier wall #2- has 6' of vertical cracking, 1' of exposed rebar on the span #2 side, and 1' of impact spalling on the upstream side. The top of the footing is exposed with 4" of vertical face exposed for the length of the wall on both sides.							
215	Reinforced Concrete Abutment	LF	74	50	22	2	0
1080	Delamination/Spall/Patched Area	LF	3	0	1	2	0
1130	Cracking (RC and Other)	LF	9	0	9	0	0
1190	Abrasion/Wear (PSC/RC)	LF	12	0	12	0	0

Exposed footing on the span #2 side of pier wall #2 for the length of the wall.

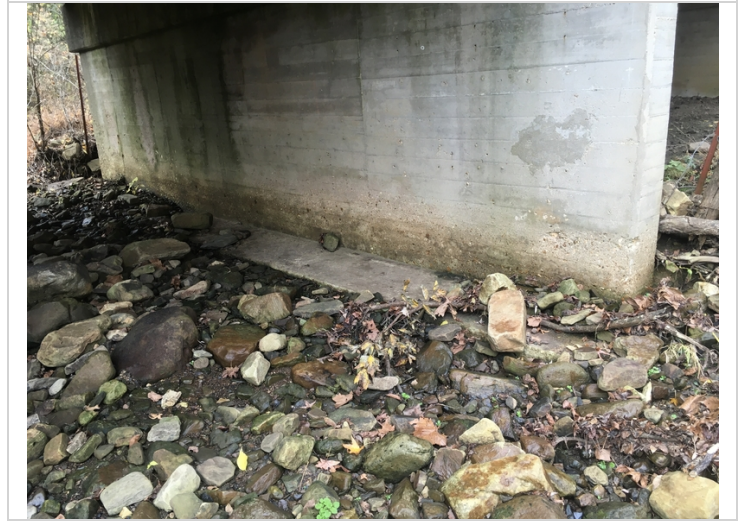
(220) 11/16/2022 WNR & DBM:							
Abutment #1 footing- has cover.							
Pier wall #1 footing- has 18' of the footing exposed, the footing has abrasion.							
Pier wall #2 footing- has 26' of the footing exposed, the footing has abrasion.							
Abutment #2 footing- has 26' of the footing exposed the footing has abrasion with 1' of vertical cracking and 8' of spalling on the upper edge of the footing.

Exposed footing at pier wall 1.

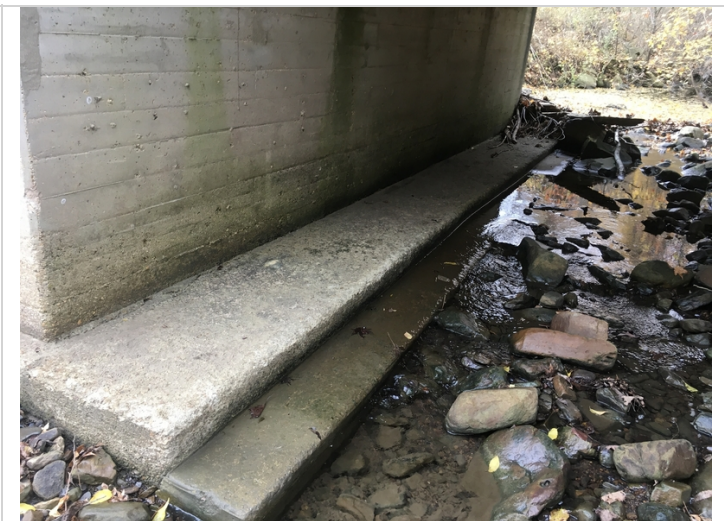
Exposed footing at pier wall 2.

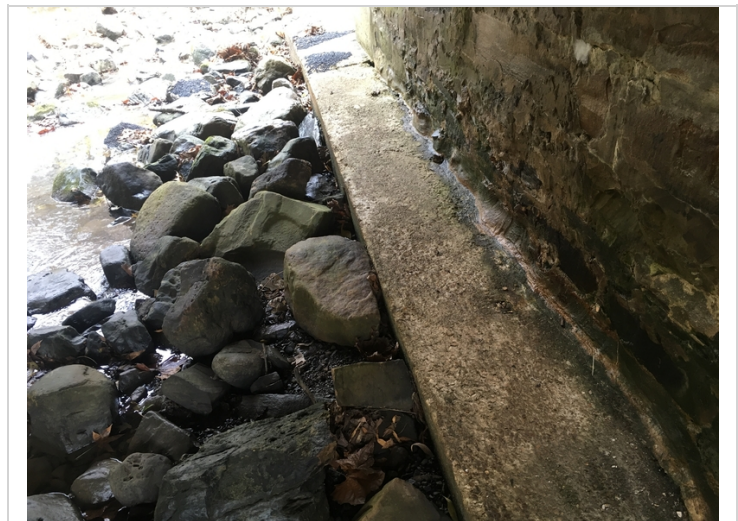
Exposed footing at abutment 2.

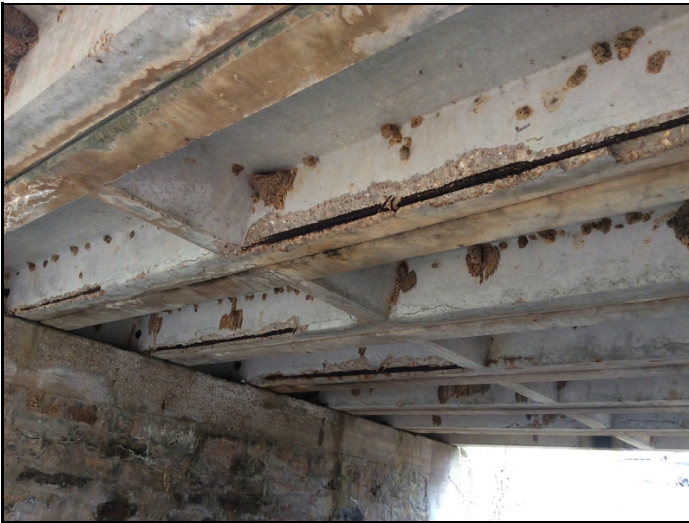
The stems of the pre-cast channel units have numerous areas of spalling with exposed primary rebar, and longitudinal delamination in all spans.

Span #3-General view of spalling with exposed reinforcing steel in stems of channel units.

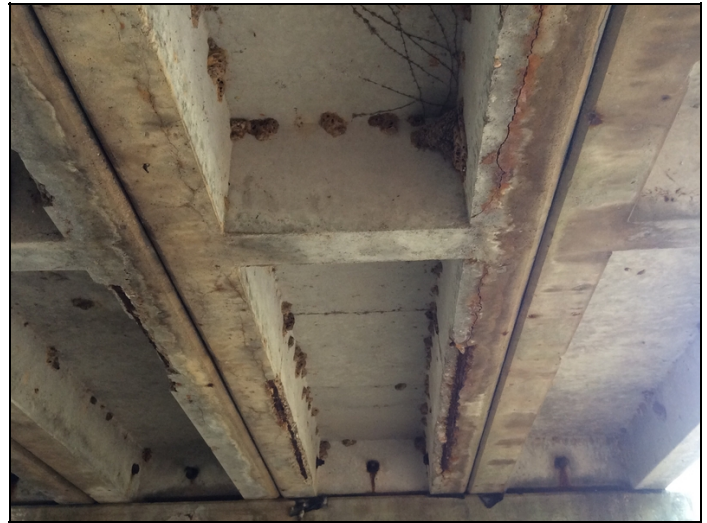
Unit #6- has 6' total of exposed rebar in both stems, and 10' of delamination.

Span #2, unit #6-Spalling with exposed reinforcing steel in stems.

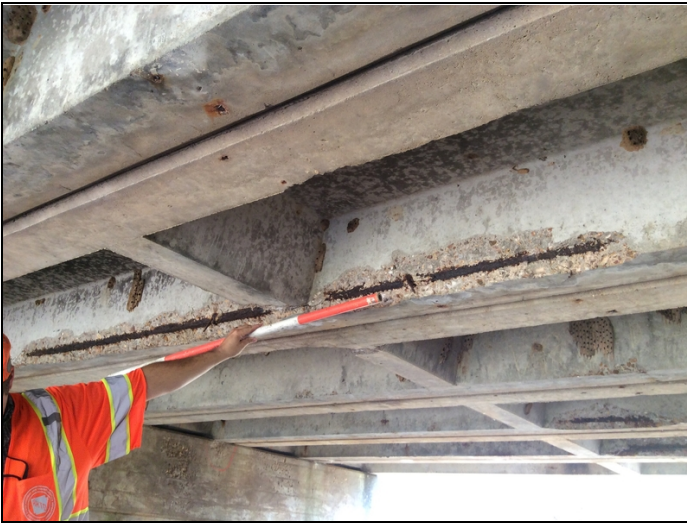
The right stem of unit #3 has an area of spalling with exposed primary rebar that is 12' long. The exposed rebar has measurable section loss.

Span #1, unit #3, Right stem with spalling and exposed reinforcing steel.

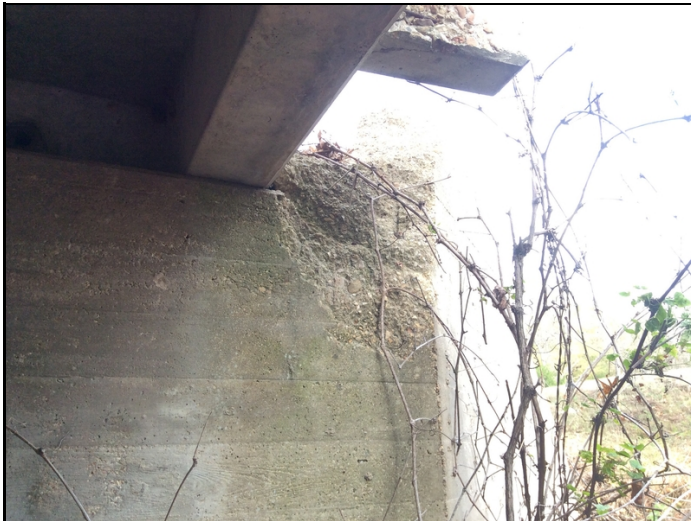
(215) 11/16/2022 WNR & DBM:							
Abutment #1- The vertical face of the wall has 8 vertical cracks. The wing walls are integral.							
Abutment #2- The right side of the abutment wall has a large spall with no rebar exposed in the upper portion where the concrete end post has been broken off. The right wing wall has minor abrasion for 12' at the bottom. The left wing wall has 1' of spall at the top edge and 1' of vertical cracking. The top of the footing is exposed for the length of the abutment with up to 14" of vertical face exposed. The wing walls are integral.							
217	Masonry Abutment	LF	22	19	3	0	0
1610	Mortar Breakdown (Masonry)	LF	3	0	3	0	0

Spall on the Right side of abutment #2 breastwall.

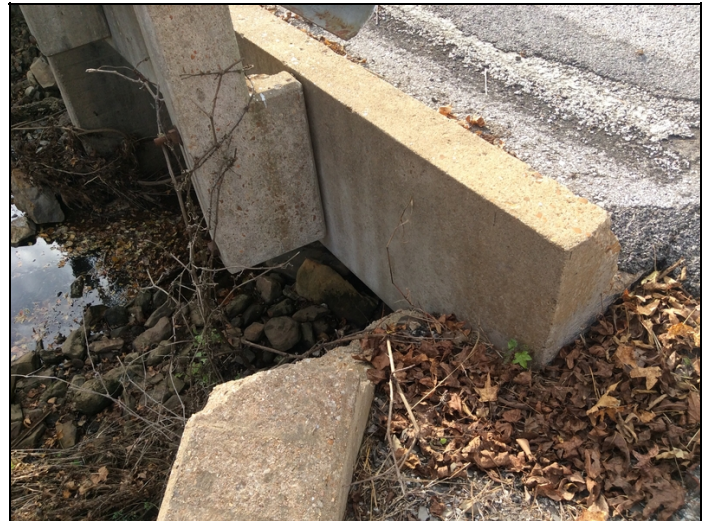
Abutment #2, Right side railing missing end post.

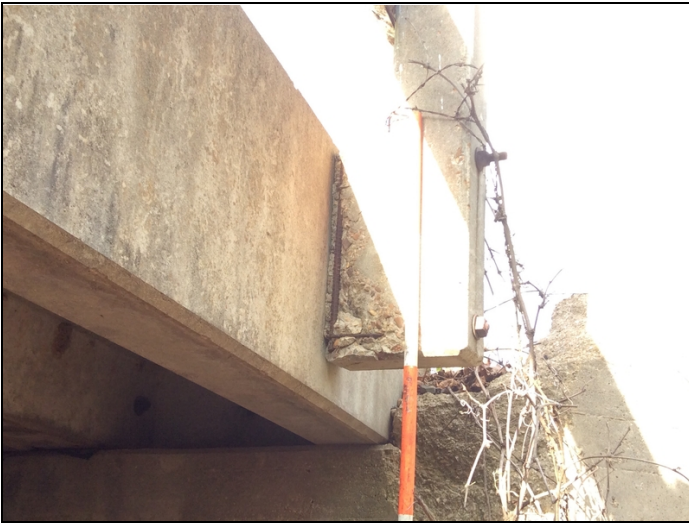
Concrete post #9 on the right side of the structure is damaged with rebar exposed.

Spalling with exposed reinforcing steel to bridge railing post.
