Asset #M0672(Routine)

SH 27 Searcy over DITCH

Location: 2.1 M NE OF SH 333

Team Lead: Benjamin Smith, Inspection Date: 11/09/2020

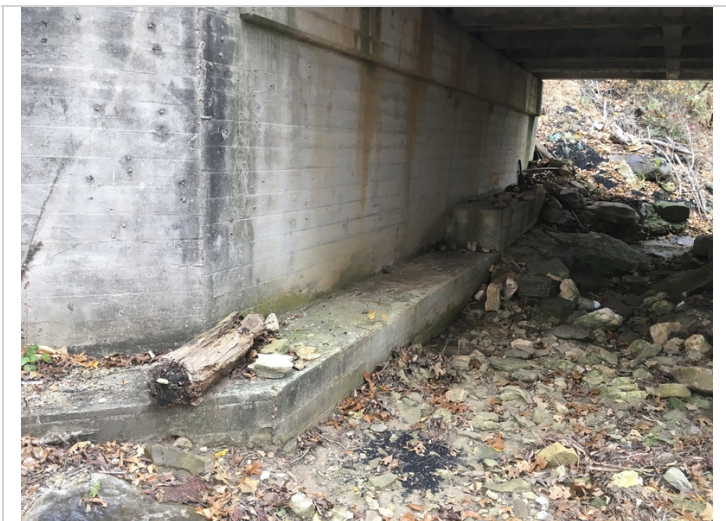
Exposed footing at abutment 2.

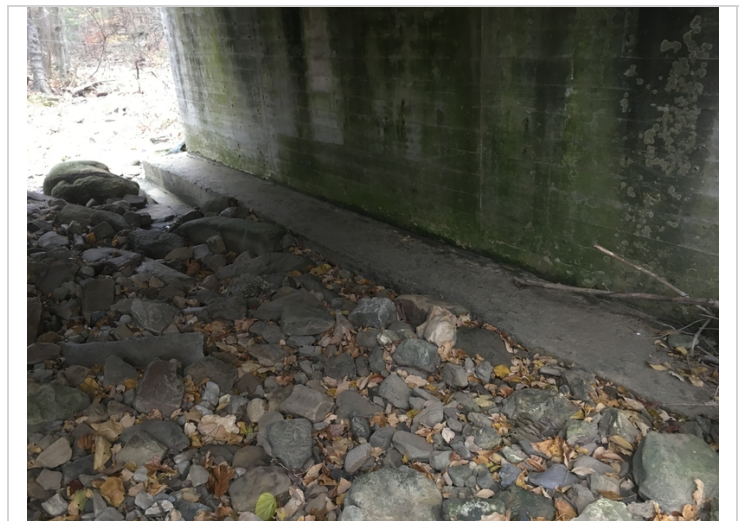
Exposed footing for the full width of pier wall 2.

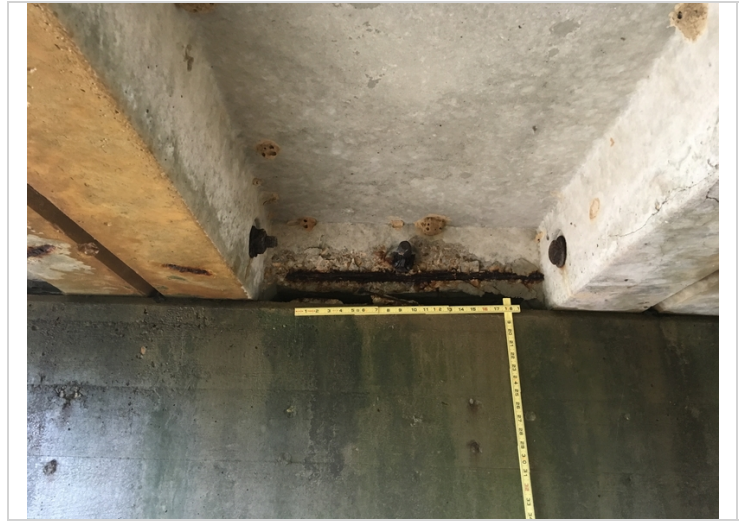
110	Reinforced Concrete Open Girder/Beam	LF	315	0	294	21	0
1080	Delamination/Spall/Patched Area	LF	43	0	43	0	0
1090	Exposed Rebar	LF	241	0	220	21	0
1130	Cracking (RC and Other)	LF	31	0	31	0	0
<p>(110) Both stems of all channel units in all 3 spans have shallow exposed rebar or spalls due to insufficient coverage during the construction process.</p> <p>Span #1- The right stem of units #3,4,6,7 have deep spalling with exposed longitudinal primary rebar at the beginning and near mid span of span #1. The diaphragms have areas of spalling with exposed rebar over bent #1 in bays #2,6.</p> <p>Span #2- The right stems of channel units #1,4,5,6 in span #2 have areas of spalling with exposed primary longitudinal rebar. Unit #7 has efflorescence cracking on the left stem for the length of the span. The unit #6 diaphragm at the end of the span has spalling with exposed rebar.</p> <p>Span #3 The right stem of units # 2,3,5 have areas of exposed primary longitudinal rebar. The left stem of unit #3 has an area of exposed primary rebar in span #3. Units #2,4 have spalls with exposed rebar on the diaphragms at the beginning of the span.</p>

Spall with rebar exposed in the diaphragm of unit #2 at the end of span #1. Typical.

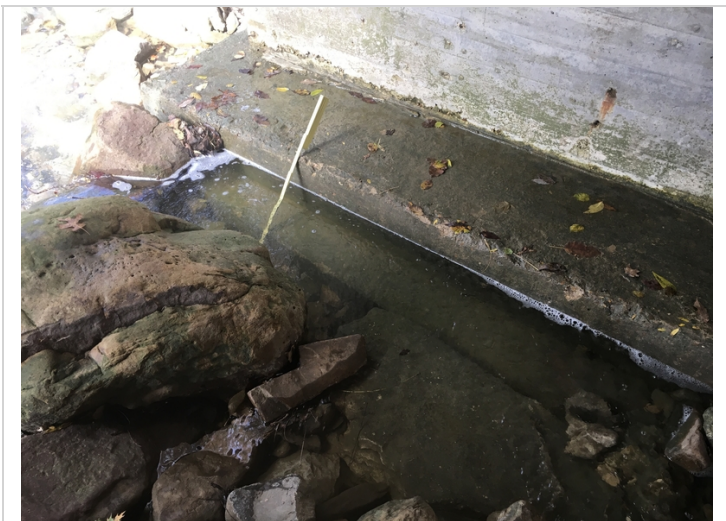
(210) Pier wall #1- has 2' of shallow exposed rebar near the mid section on the span #1 side, the wall also has 2 vertical full height hairline cracks.							
Pier wall #2- has the footing exposed for the length of the wall on the span #2 side with up to 20" of vertical face exposed near the outlet end. The wall has 1' of vertical hairline cracking near the mid section.							
215	Reinforced Concrete Abutment	LF	102	98	3	1	0
1080	Delamination/Spall/Patched Area	LF	1	0	0	1	0
1130	Cracking (RC and Other)	LF	3	0	3	0	0

Exposed footing with 20" of vertical face exposed on the span #2 side of pier wall #2.

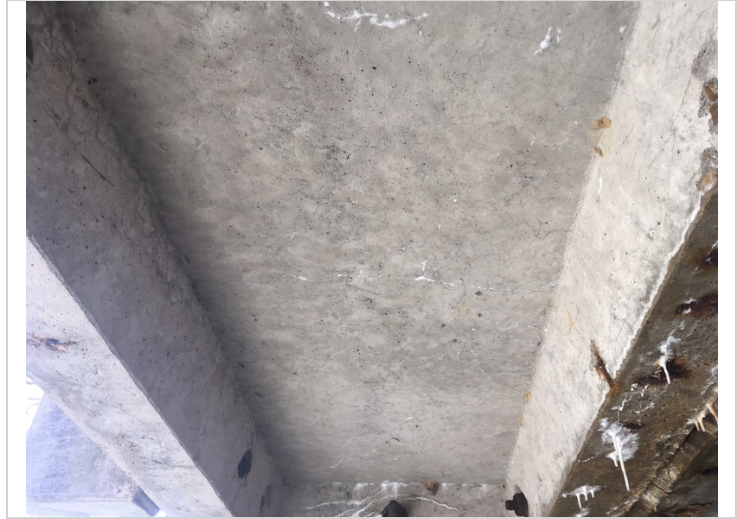
Efflorescence map cracking in the undersurface of the deck of unit #7 typical in spans #1,2,3.

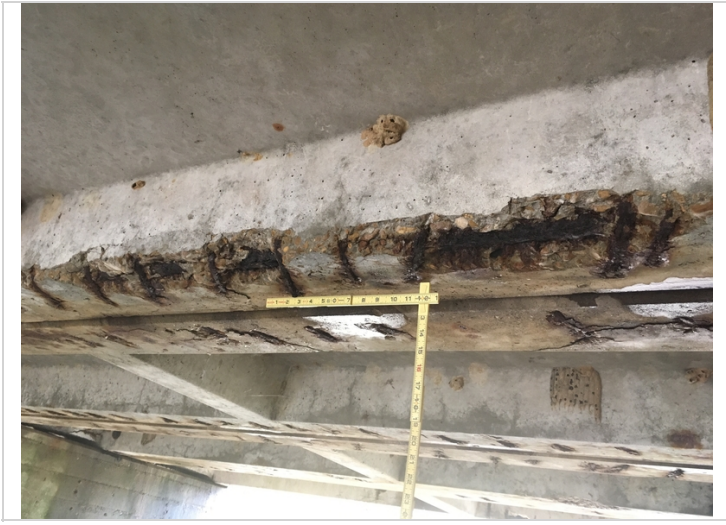
Deep spalling with exposed primary longitudinal rebar in the right stem of unit #4 in span #1. Typical of several locations.

Superstructure - Both stems of all channel units have cracking with spalling that is exposing rebar due to insufficient coverage during the construction process. Numerous delaminated areas exist through out structure. The right stem of unit #6,7 has areas of exposed primary rebar near mid span of span #1. The right stem of units #3,4 in span #1 have areas of spalling with exposed rebar. Areas of spalling with exposed rebar exist in the diaphragms over bent #1. The right stems of channel units #1,4,5 in span #2 have areas of spalling with exposed primary rebar. Span #3- The right stem of units # 2,3,5 have areas of exposed primary rebar. The left stem of unit #3 has areas of exposed primary rebar in span #3.

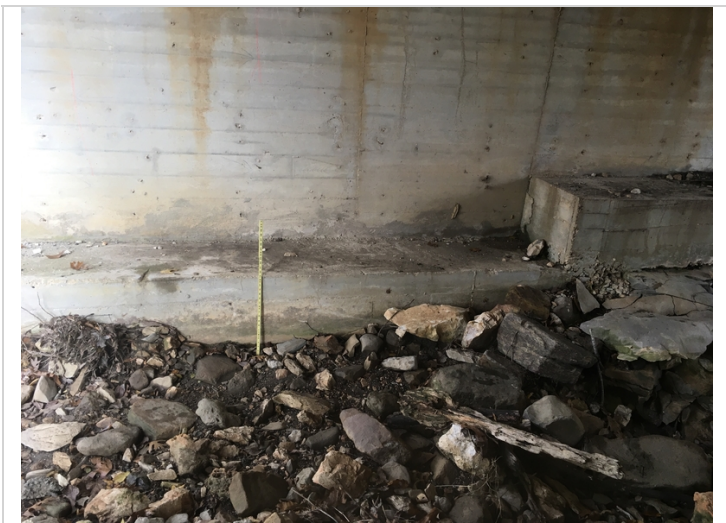
(215) Abutment #1- has 3' of hairline vertical cracking and 1' of cs3 spalling on the end of the right integral wing wall.							
Abutment #2- has 15' of vertical and diagonal hairline cracks. The footing is exposed for the length of the abutment with 19" of vertical face exposed.							
220	Reinforced Concrete Pile Cap/Footing	LF	52	26	25	1	0
1080	Delamination/Spall/Patched Area	LF	1	0	0	1	0
1190	Abrasion/Wear (PSC/RC)	LF	25	0	25	0	0

19" of vertical face of the footing exposed at abutment #2 for the length of the abutment.

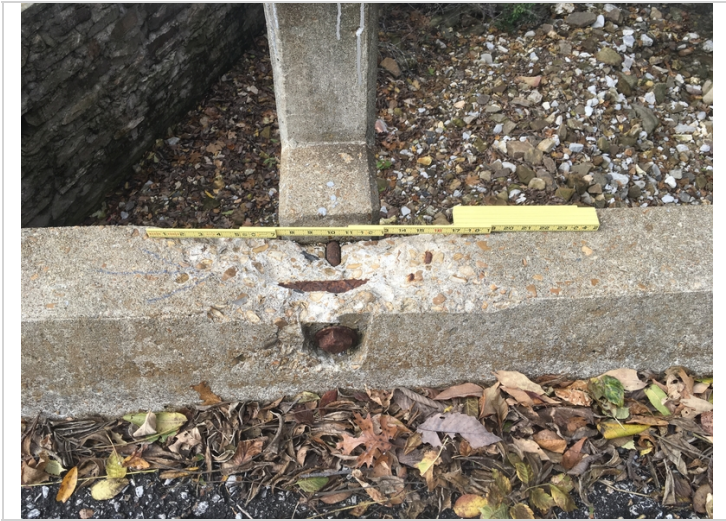
Spall with exposed rebar on the left curb at post #3.

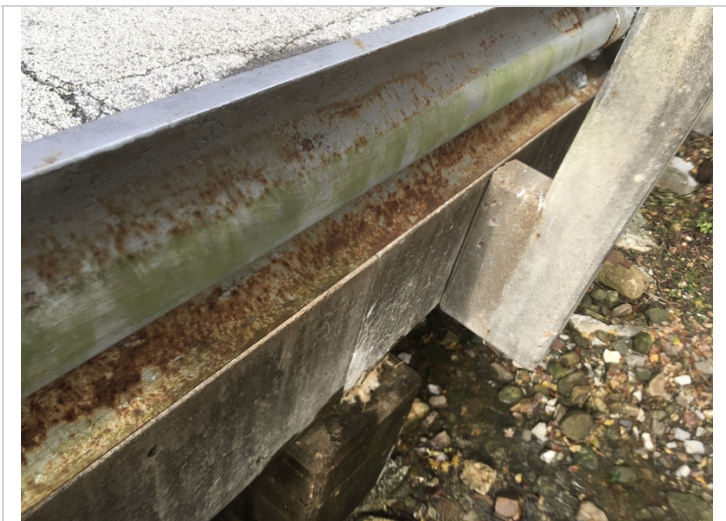
(330) Right side railing- the front side has pin point rusting throughout and the back side has a light rust coating.							
Left side railing- the front side has pin point rusting throughout and the back side has a light rust coating.

General view of the back side of the bridge railing.

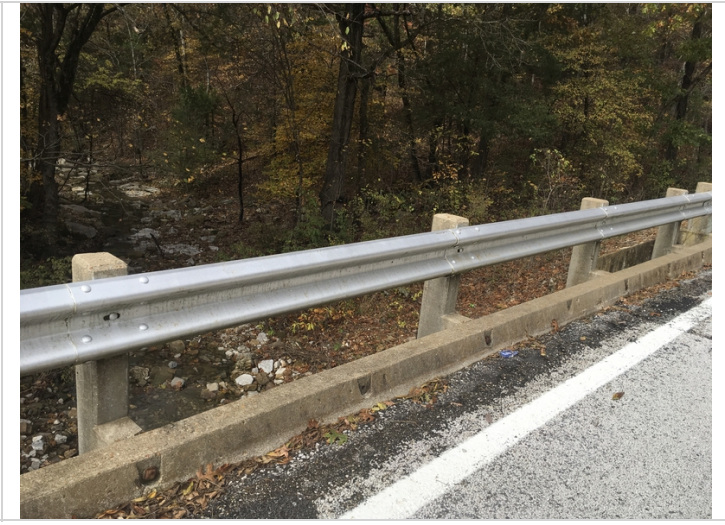
General view of the front face of the metal railing.

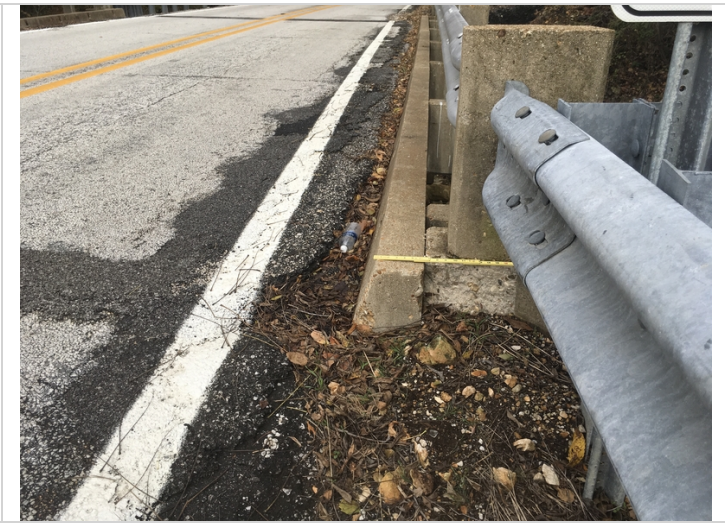
12" of concrete exposed to traffic. Typical of all 4 corners.
