Asset #M0673(Record Change)

SH 27 Searcy over Forest Creek

Location: 4MI NE JCT SH 333

Team Lead: Benjamin Smith, Inspection Date: 03/02/2023

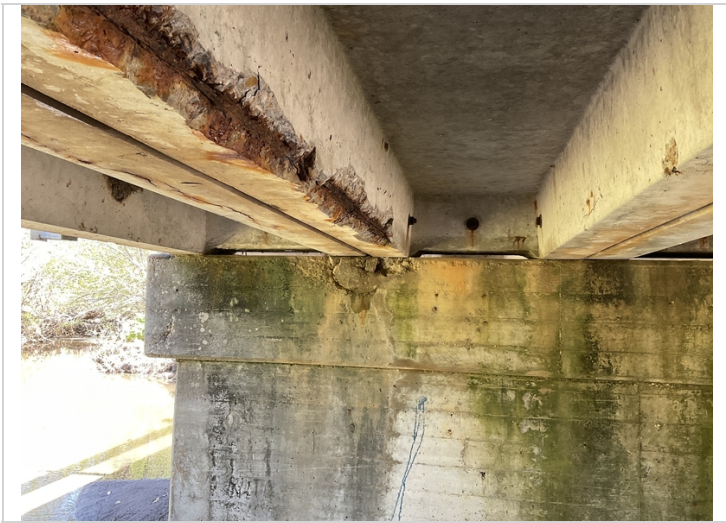
Spalling of cap at bent #1 span #1 under units #1 and #2

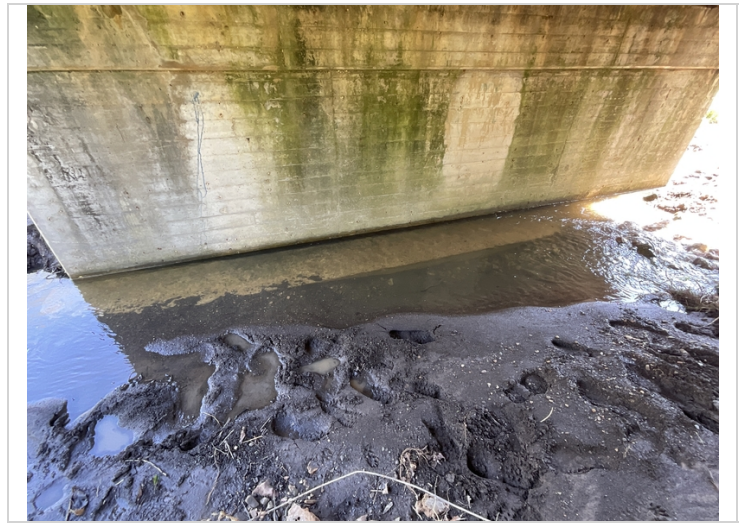
Footing at bent #1 behind side is exposed.

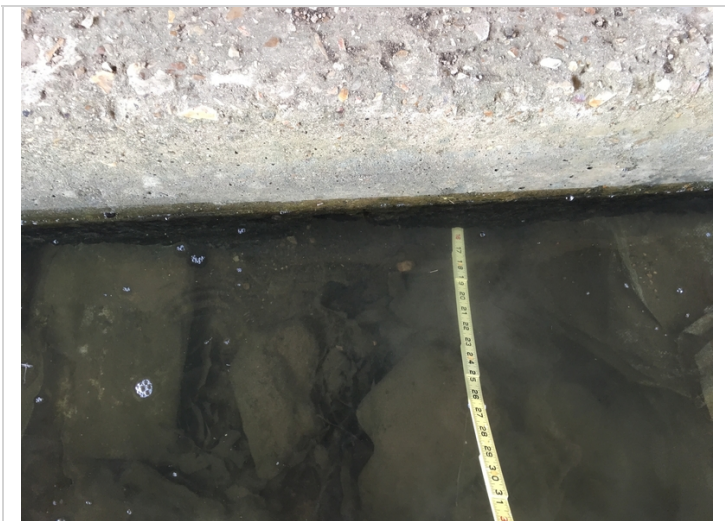
The U W type 2 frequency is 12 months due to item #113 being less than 5 due to scour at abutment #2.

16" of undermining at the mid section of the abutment #2 footing.

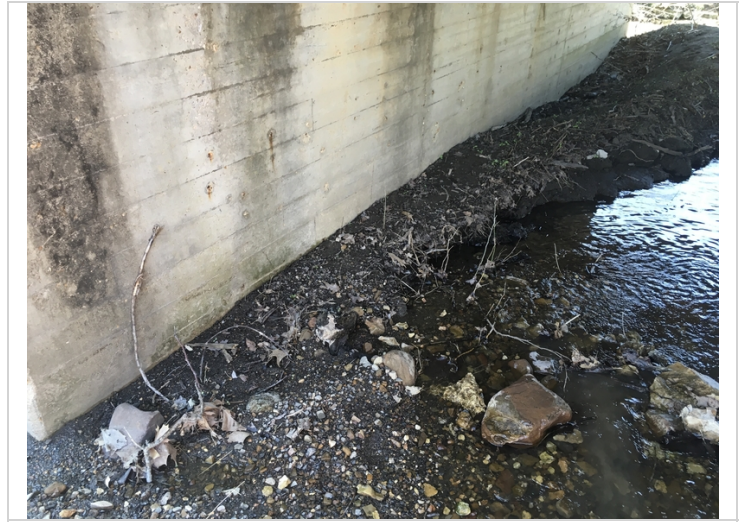
Pier wall #2 has cover over the footing.

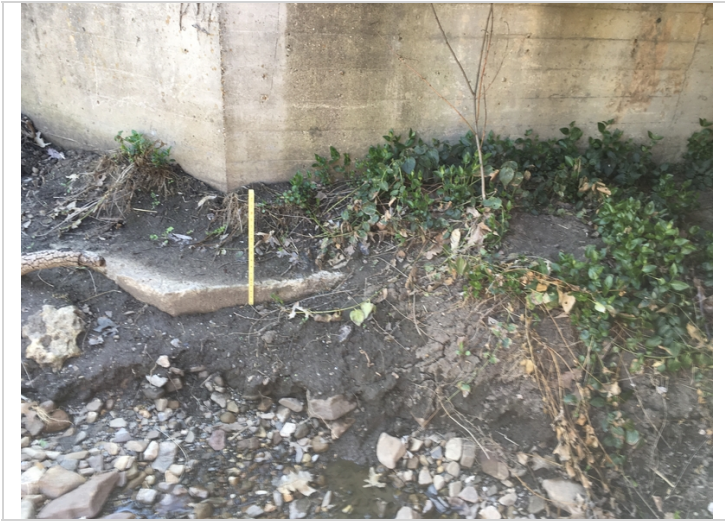
The footing is exposed at the right upstream corner of pier wall #1. With 4" of vertical face exposed for 4'.

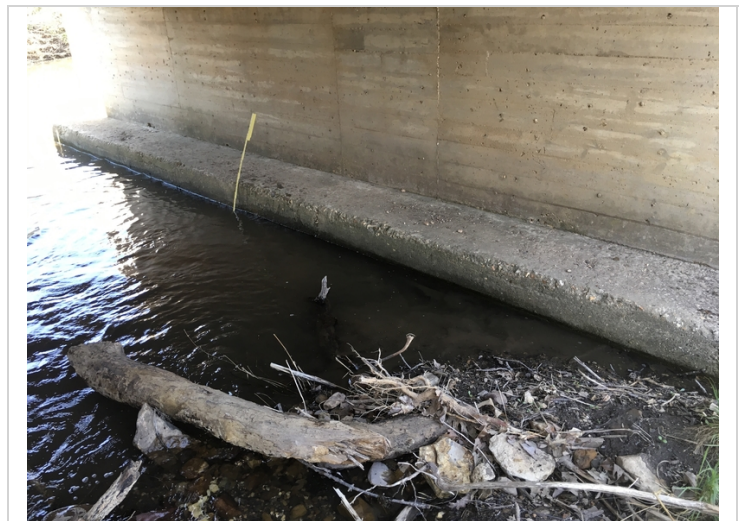
General view of the abutment #2 footing. Showing 22" of vertical face exposed.

The top edge of the pier wall #2 footing is exposed for 18' in span #2. The abutment #2 footing is exposed for the full length of the abutment with up to 10" of vertical face exposed. No undermining was noted.

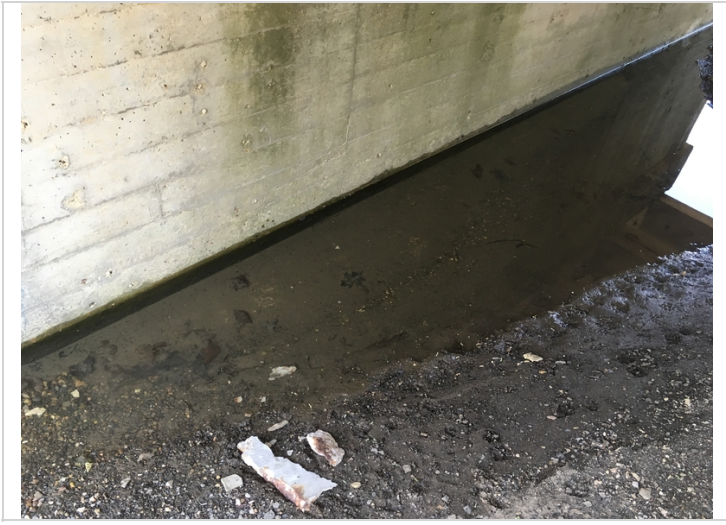
15' of the top of the footing is exposed on the span #1 side of pier wall #2.

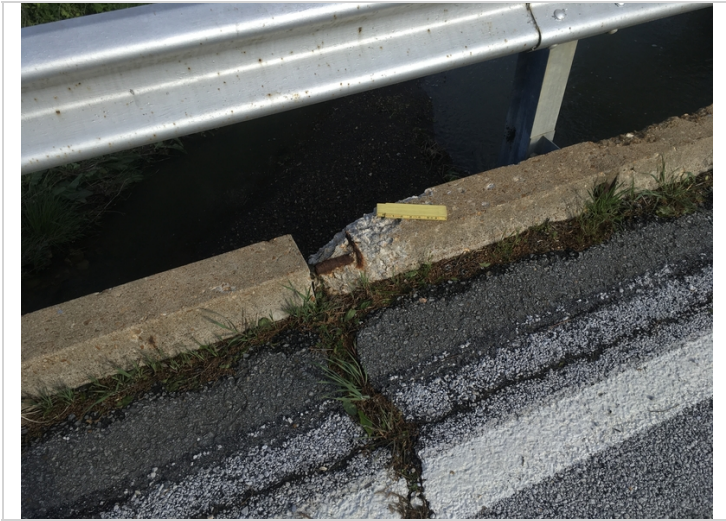
Spalling with rebar exposed on the left curb of span 2.

Span #1- Channel beams # 1,2,4,6,7 have large spalls with rebar exposed on the bottoms of the stems. The left curb at the beginning of span #2 has a spall with rebar exposed.

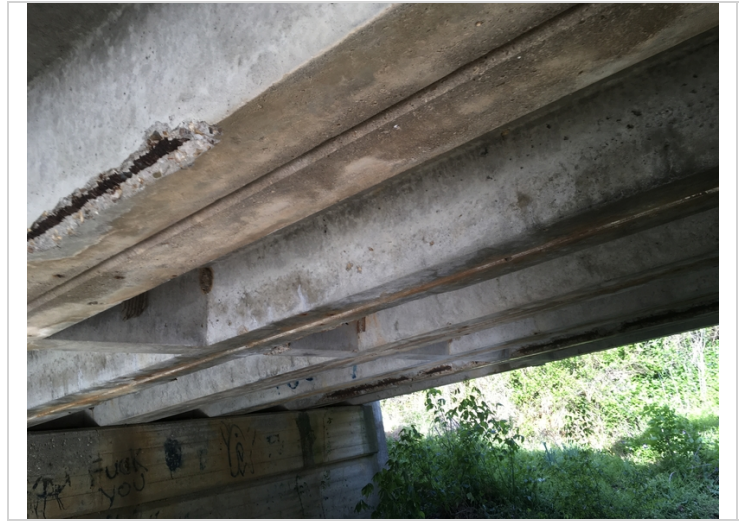
Span #1 has 34' total of spalls with exposed rebar. RCCB #1 has 4' of spalling with exposed rebar on the right stem with 6' of delamination on the right stem.

RCCB #2 has 12' of spalling with exposed rebar on the left stem. RCCB #3 has 2' of delamination on the left stem. RCCB #4 has 7' of exposed rebar on the right stem. RCCB #5 has minor vertical hairline flexure cracking. RCCB #6 has 2' of spalling with exposed rebar on the left stem and 6' of spalling with exposed rebar on the right stem. RCCB #7 has 2' of spalling with exposed rebar on the left stem with minor insignificant spalling on the left and right stems.

Span 1 undersurface. Showing spalling with rebar exposed.

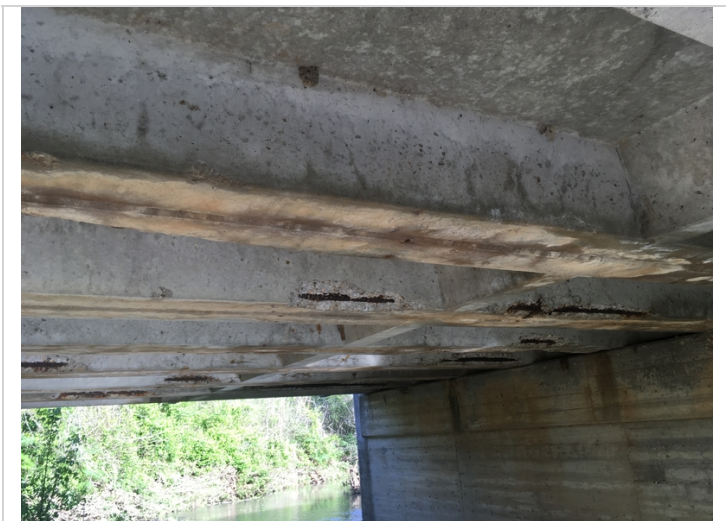
Span #2- RCCB #1 has map cracking with efflorescence on the diaphragm over pier wall #2 and the outside face of the channel beam, and in the deck undersurface near the end of the span. The right stem has 2' of delamination. RCCB #2 has 10' of spalling with exposed rebar on the left stem. RCCB #3 has 2' of spalling with exposed rebar and 4' of delamination on the left stem, the right stem has 2' of spalling with exposed rebar. RCCB #4 has 14' of spalling with exposed rebar on the right stem with 1' of delamination. The left stem has 4' of spalling with exposed rebar and 3' of delimitation. RCCB #5 has 1' of spalling with exposed rebar on the left stem and 1' of delamination on the right stem. RCCB #6 has 6' of spalling with exposed rebar on the left stem and 3' of spalling with exposed rebar on the right stem. RCCB #7 has minor insignificant spalling on the right stem.

Span 2 undersurface showing spalling with rebar exposed.

Span #2- Channel beams # 2,3,4,5,6 have large spalls with rebar exposed on the bottoms of the stems.

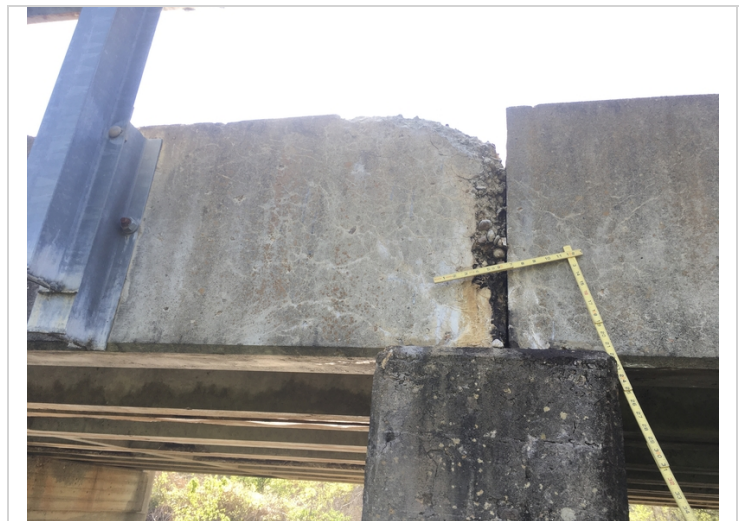
The outside face of RCCB 1 at the beginning of span 2 showing map cracking with efflorescence. Spalling with exposed rebar exists in the same footage.

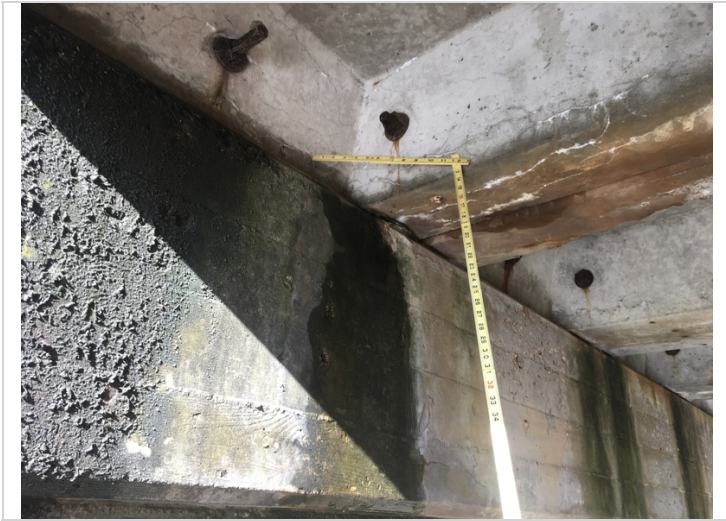
Map cracking with efflorescence on RCCB 7 at the beginning of span 2.

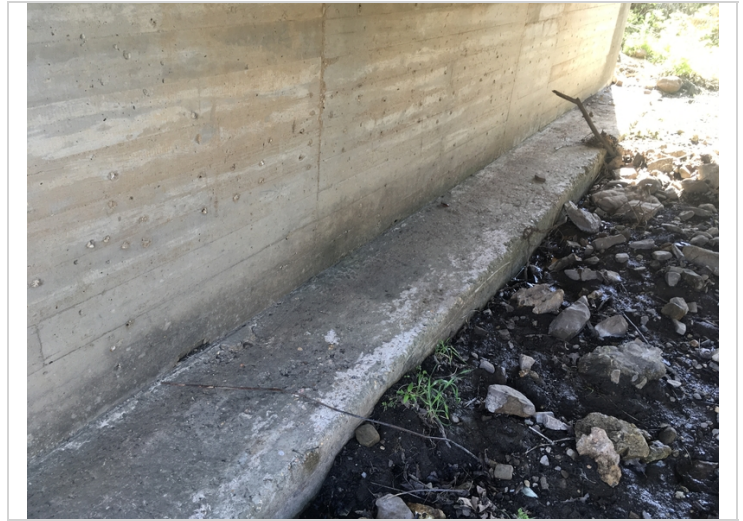
Exposed footing at abutment #2. Showing spalling on the outer edge.

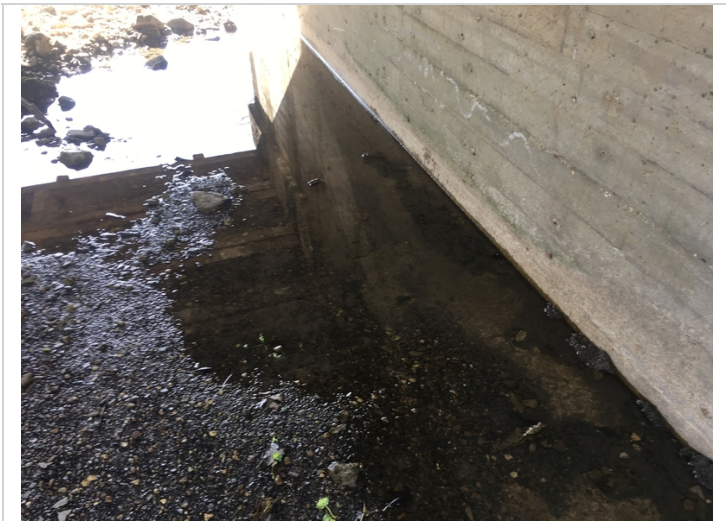
General view of the exposed footing at pier wall #2.

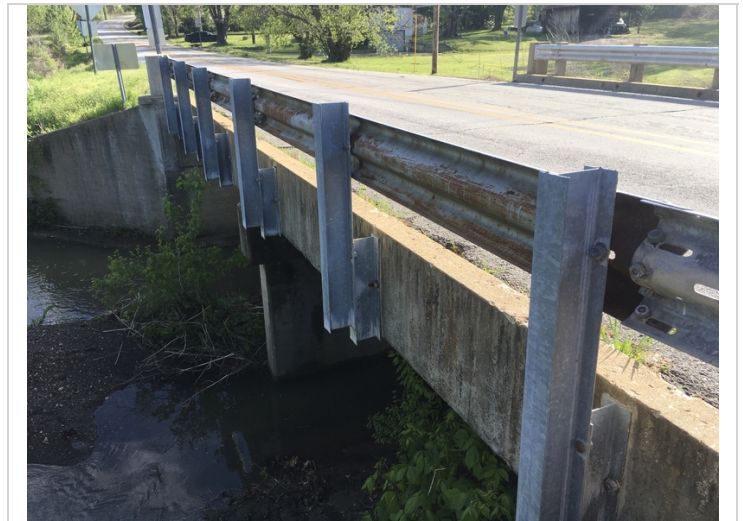
View of the corrosion on the back side of the metal railing.
