Asset #05910(Routine, Underwater type 2)

SH 112 Benton 2 over SPRING CREEK

Location: 2.32 MI N WASHINGTON CO L

Team Lead: Nathan Rowland Inspection Date: 05/02/2024

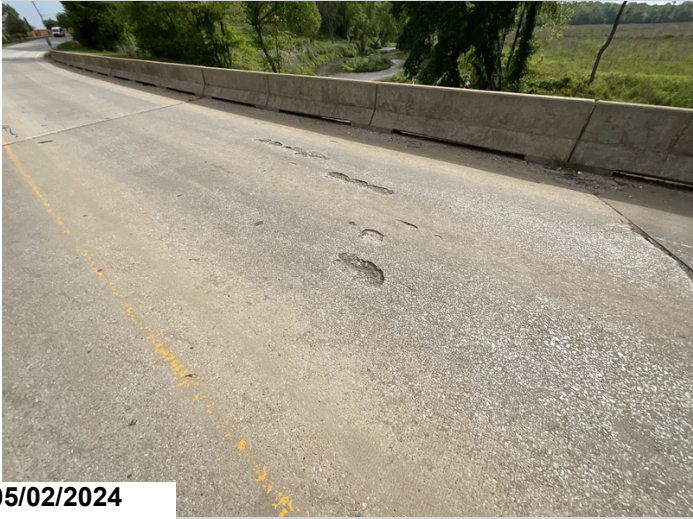
Span #5 right lane spalling with steel exposed

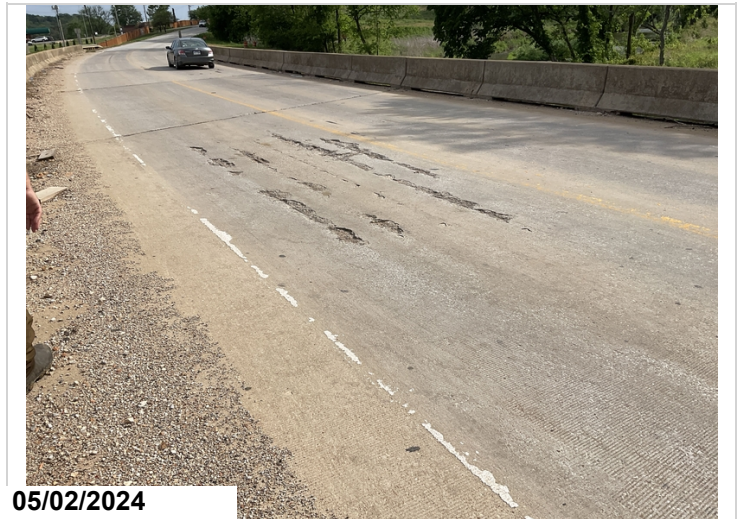
Span #3 spalling with steel exposed

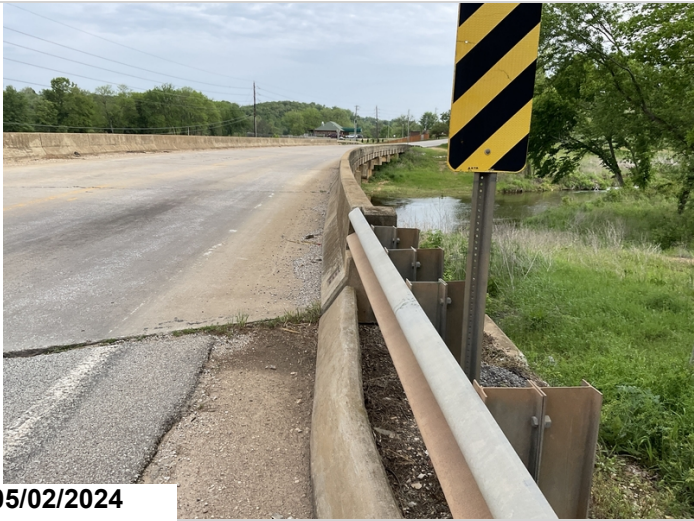
Beginning of bridge log miles sign is missing

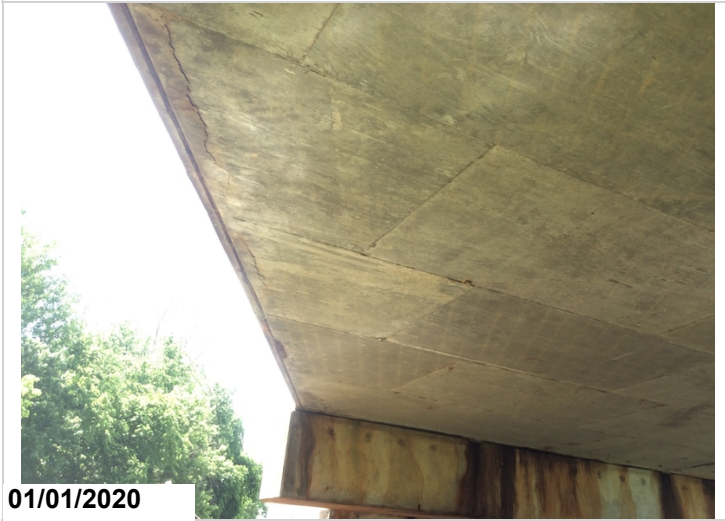
Typical view of right side undersurface of deck with cracking spalling and delaminations.

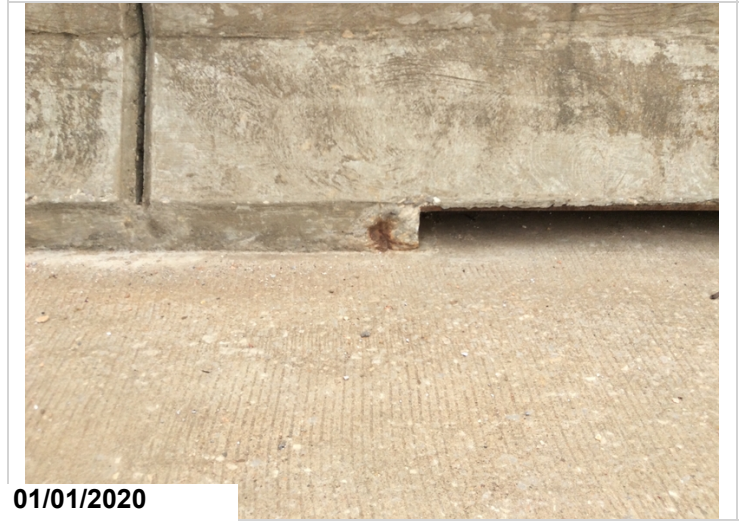
Span #6 railing right has spalling with steel exposed at the base of parapet.

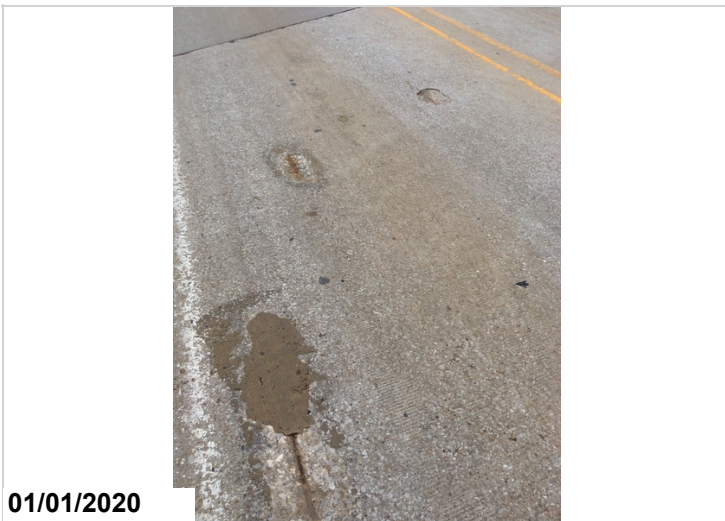
Span #5 right lane spalling with steel exposed.

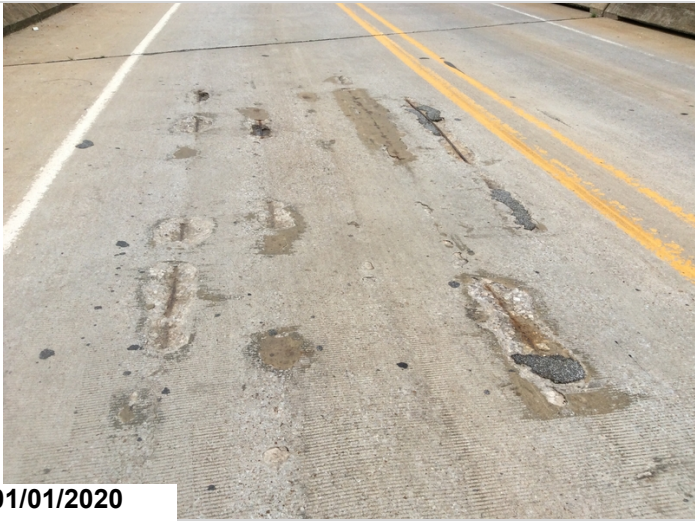
Span #3 left lane large spalls with steel exposed.

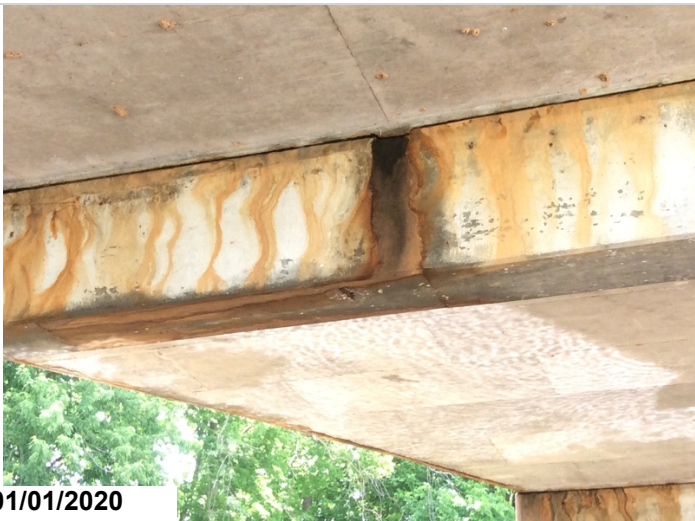
Bent #3 cap underneath spalling with steel exposed.

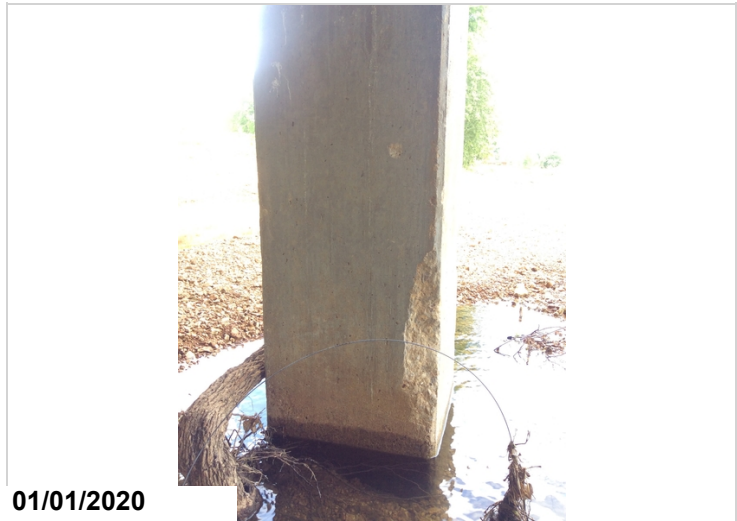
Bent #3 column #1 has spalling ahead side.

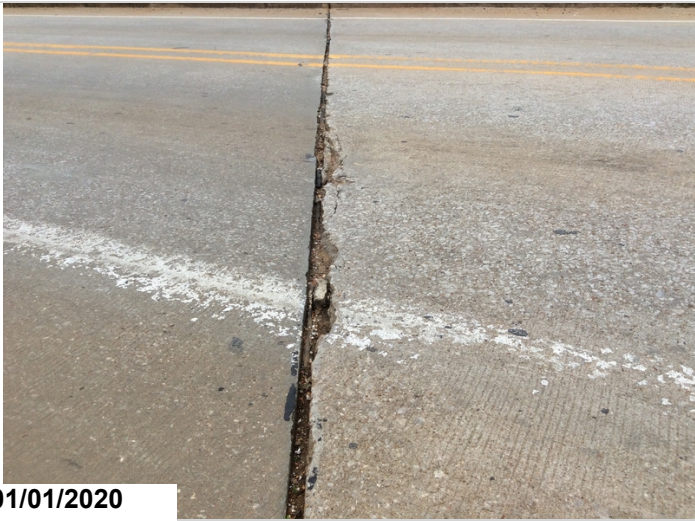
Bent #5 right spalling adjacent to construction joints.

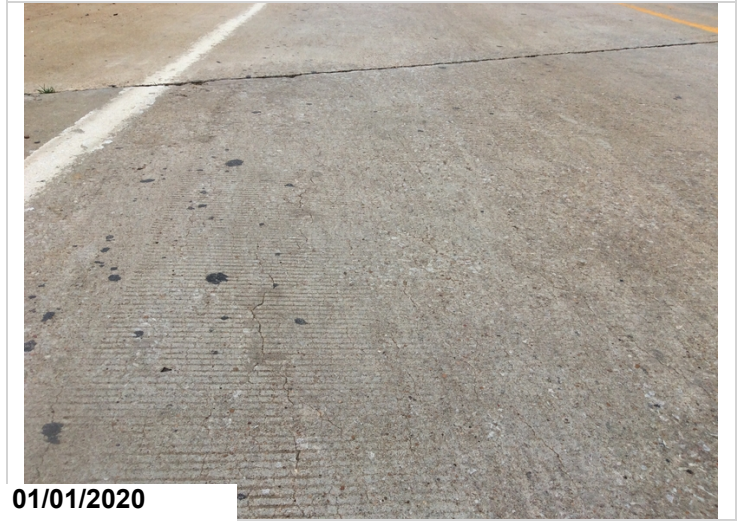
Span #1 deck cracking typical in wheel paths.

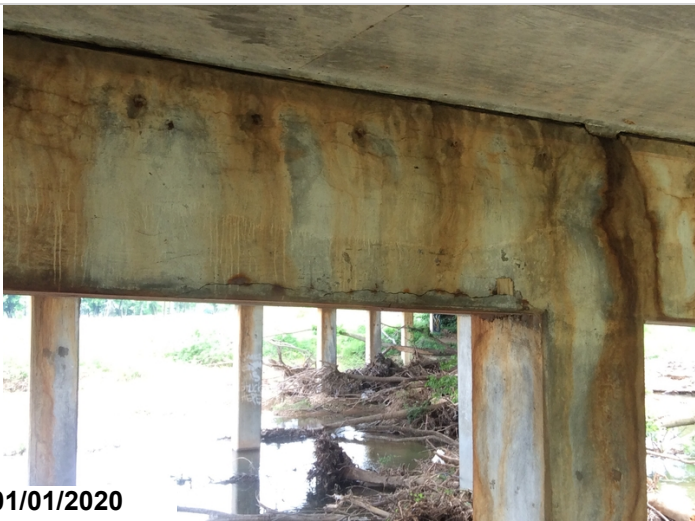
Horizontal cracking at bent #2 behind side.

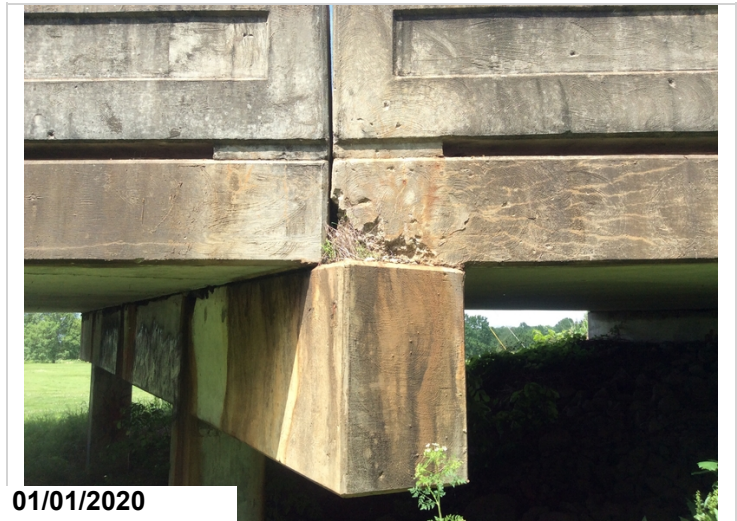
Typical spalling of deck over bent caps on the right side.

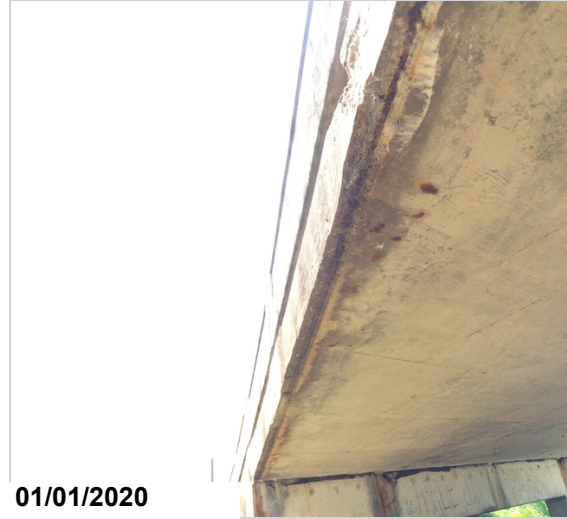
Deck span #2 right soffit has approximately 22' of spalling with steel exposed.

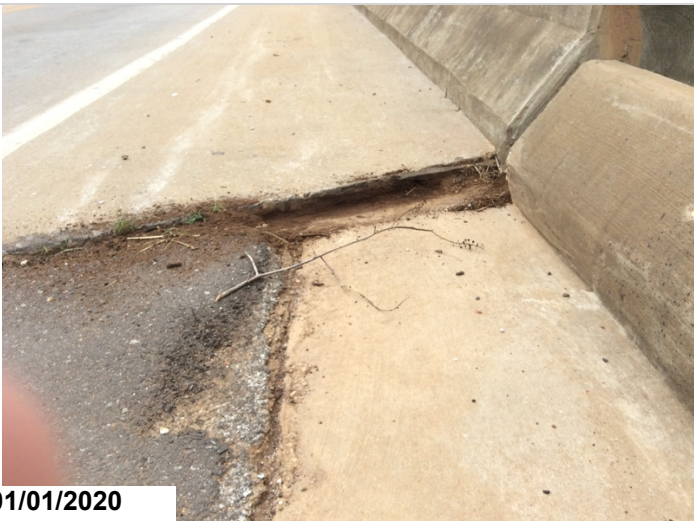
Abutment #2 right approach gutter has approximately 3" lip.

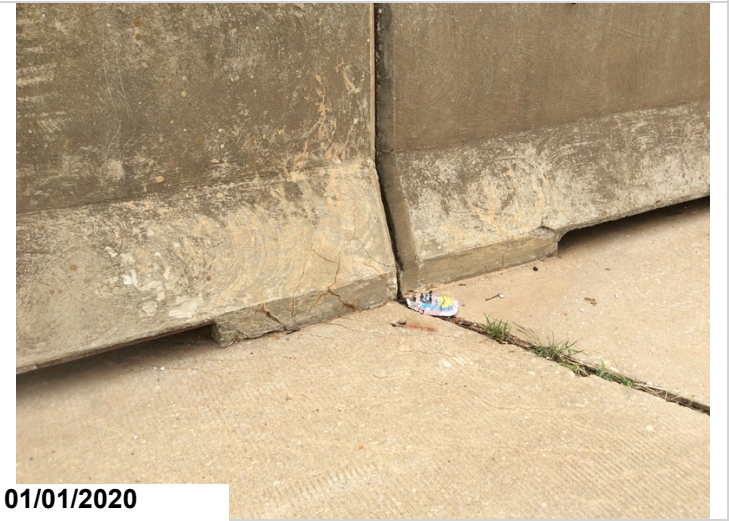
Bent #8 right deck and parapet - has area of map cracking.

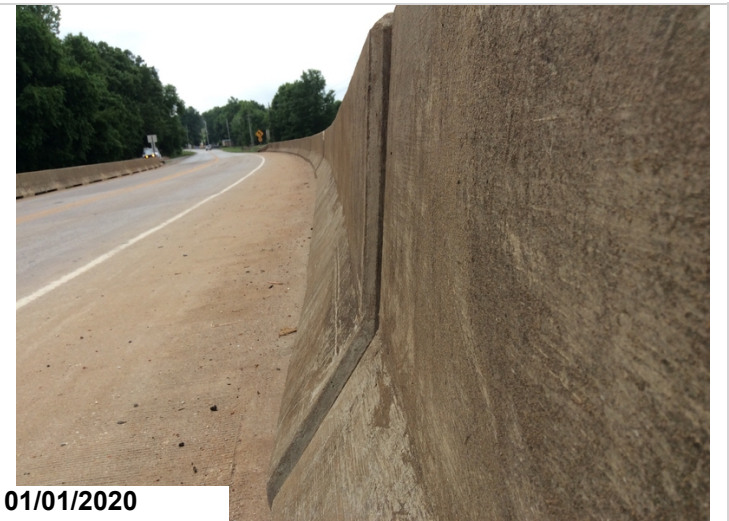
Parapet left railing has section that is not flush with rest of railing.

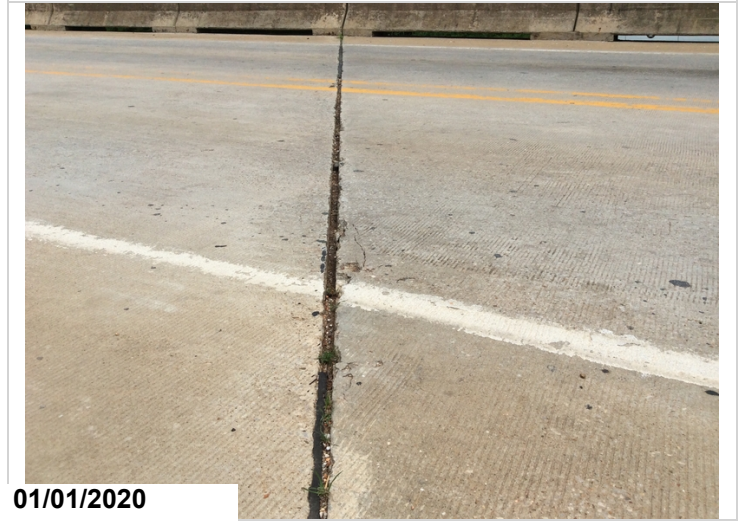
Deck bent #2 construction joint - joint material is missing.

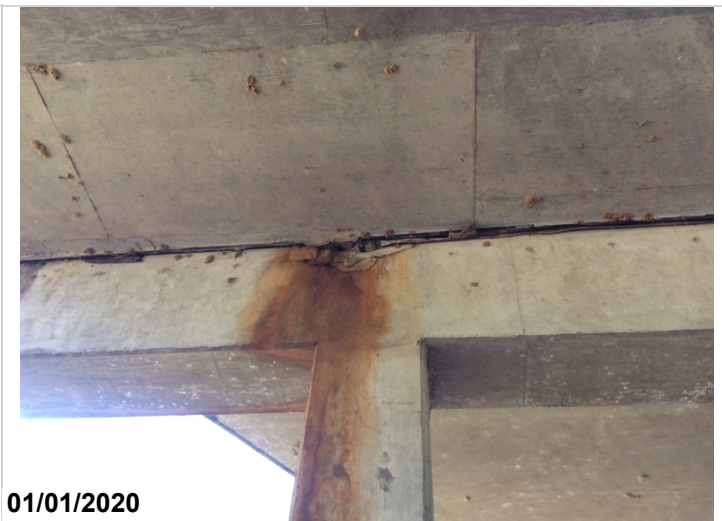
Bent #4 cap over column #1 behind side - spalling at keyway typical.

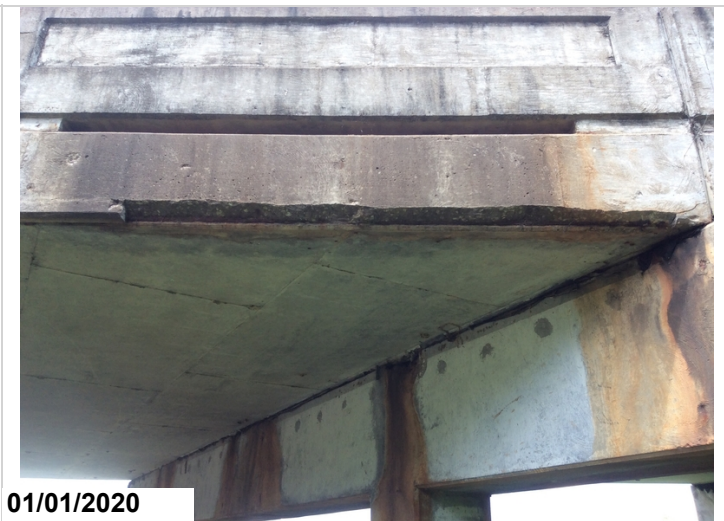
Span #7 right adjacent bent #7 spalling with steel exposed.

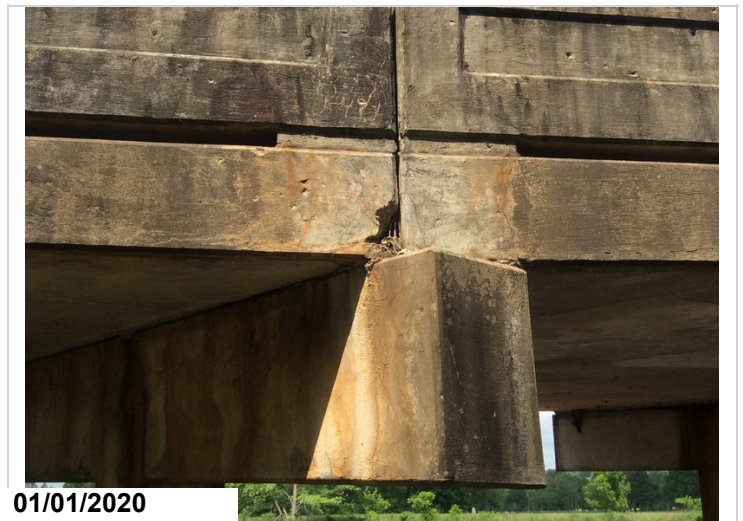
Spalling in side of deck above bent caps typical.

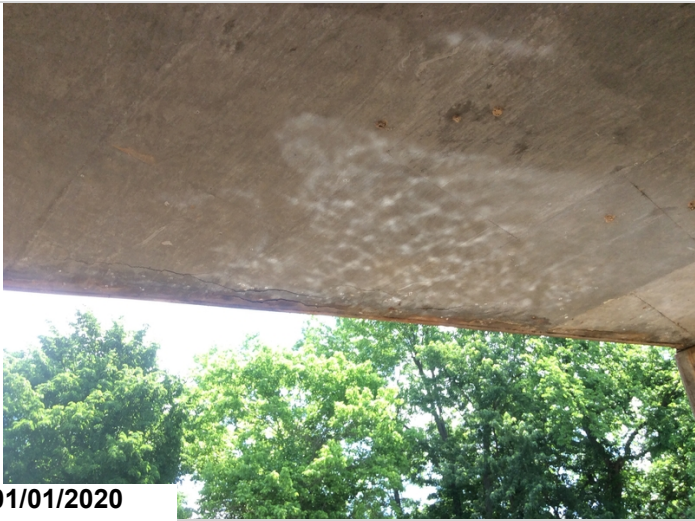
Cracking and delaminated areas typical to the right side of deck undersurface.

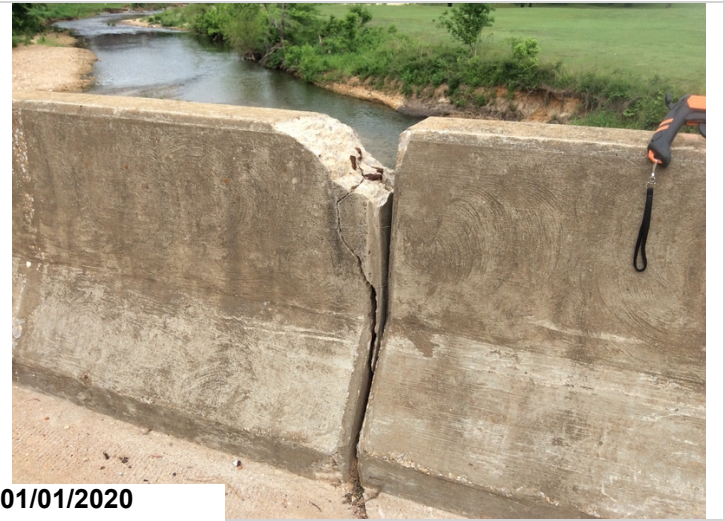
Deck railing left at bent #5 has large spall with steel exposed.

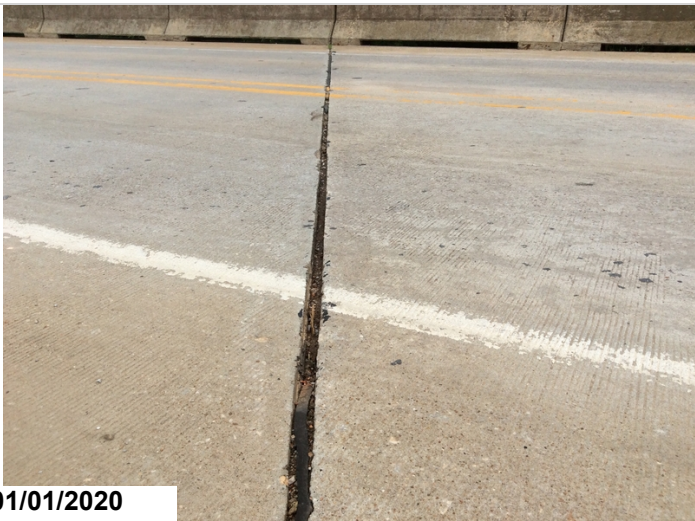
Bent #2 joint material missing.

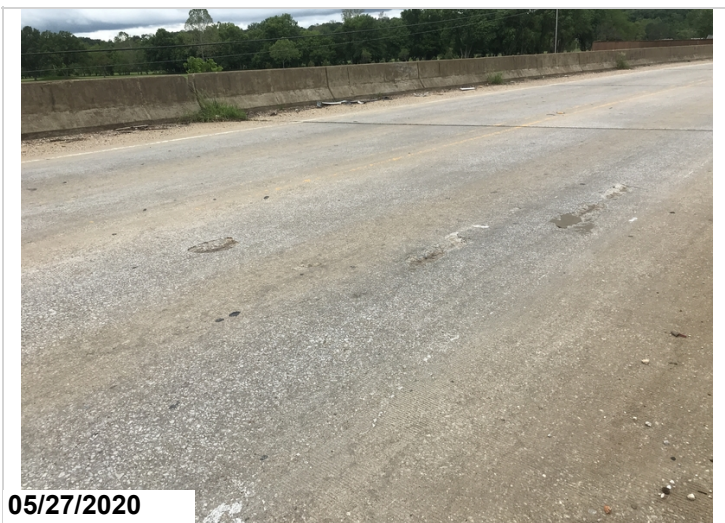
Spalling with steel exposed deck surface span #5.

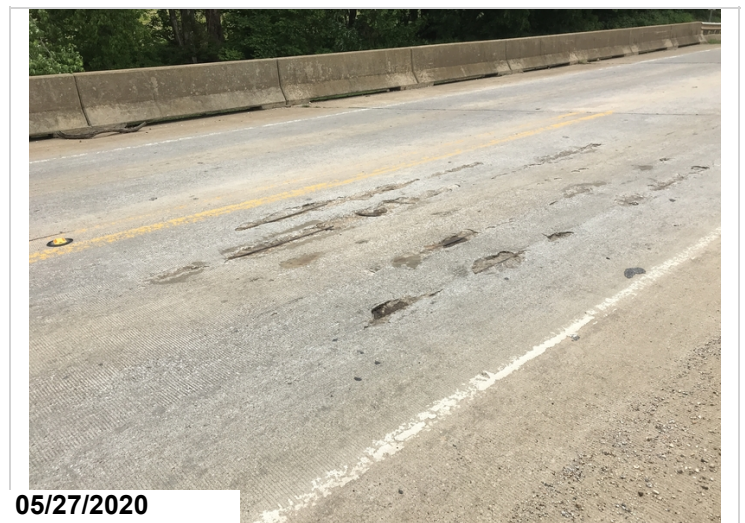
Span #3 spalling with steel exposed

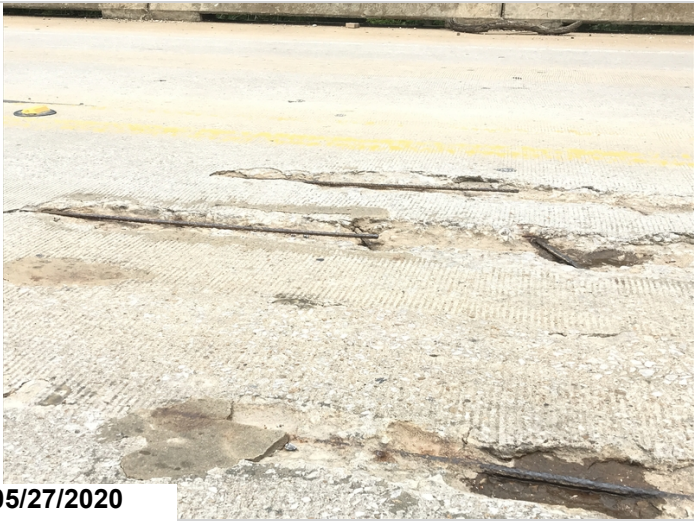
Span #3 spalling with steel exposed Loose steel has the potential to project into roadway.

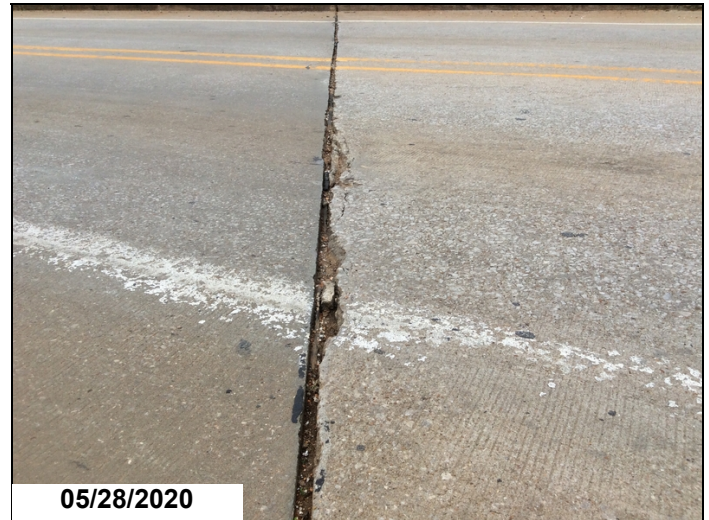
Deck pourable joint seal has lost adhesion and is displaced in some location allowing water to accumulate in joints and on top of caps.

Bent #5 right spalling adjacent to construction joints.

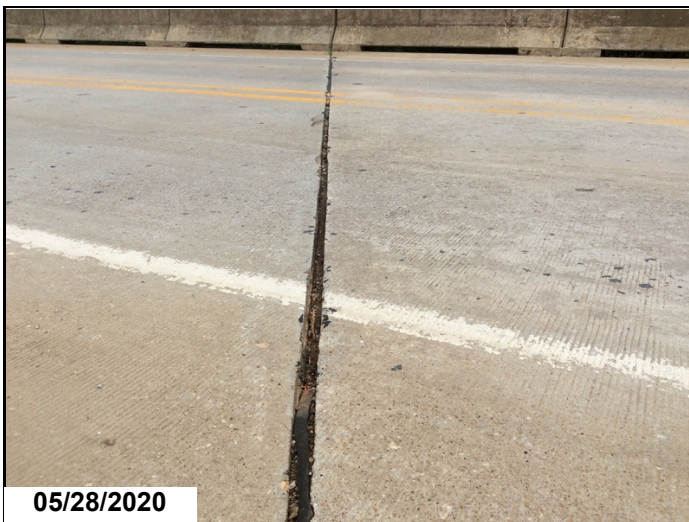
Bent #2 joint material missing.

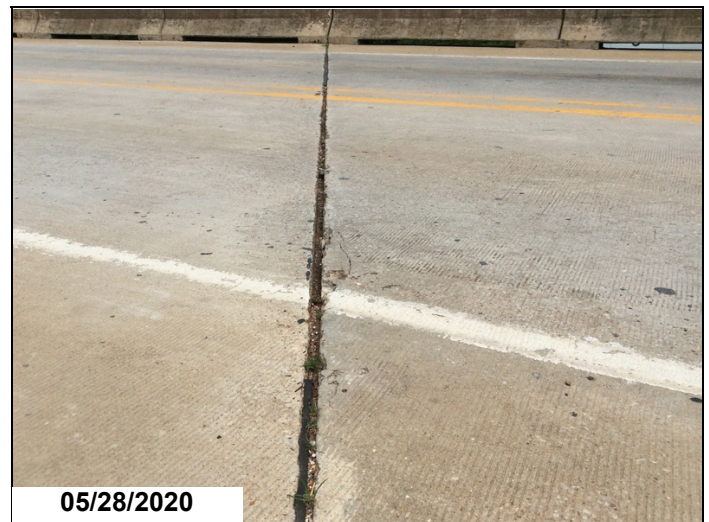
Deck bent #2 construction joint - joint material is missing.

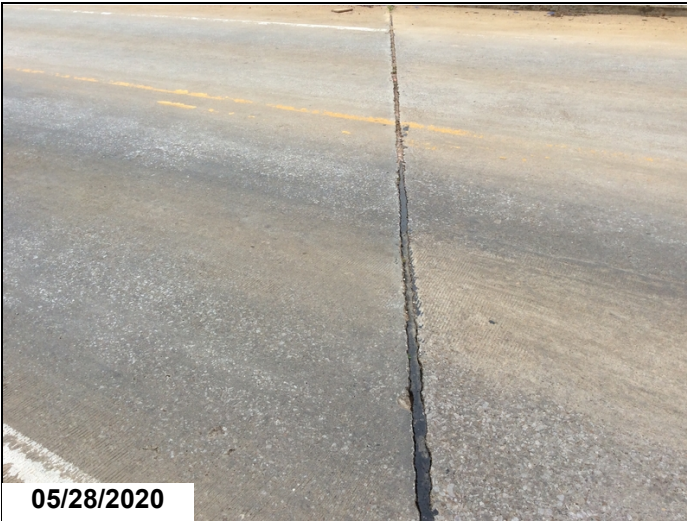
Joint seal condition over bent #1. Typical of all locations.

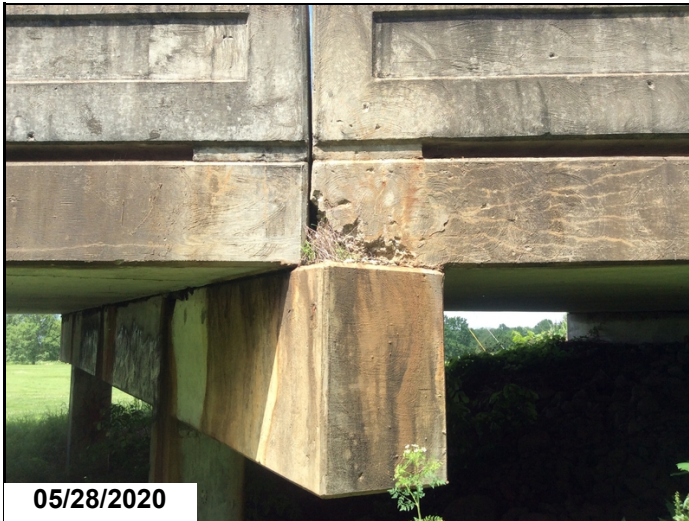
- The vertical face of caps at keyways for all bent caps have small to large spalls.
- The right vertical face of the bridge deck over bents #1,2,3,5,6, and 8 has spalls with steel exposed in some locations.

Typical spalling of deck over bent caps on the right side.

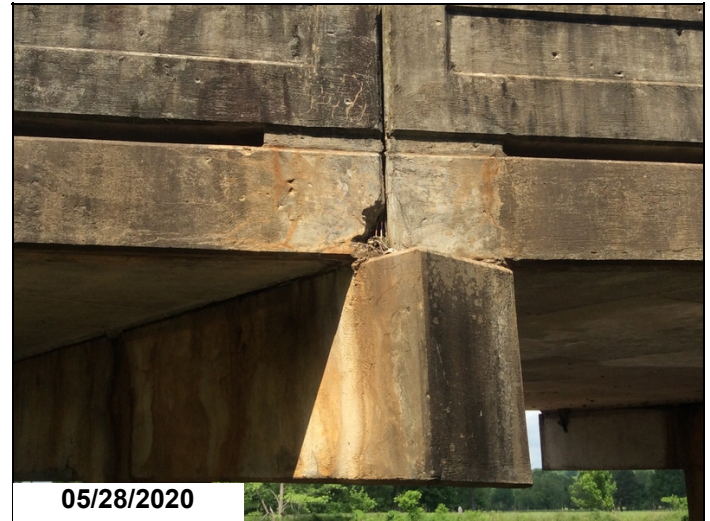
Spalling in side of deck above bent caps typical.

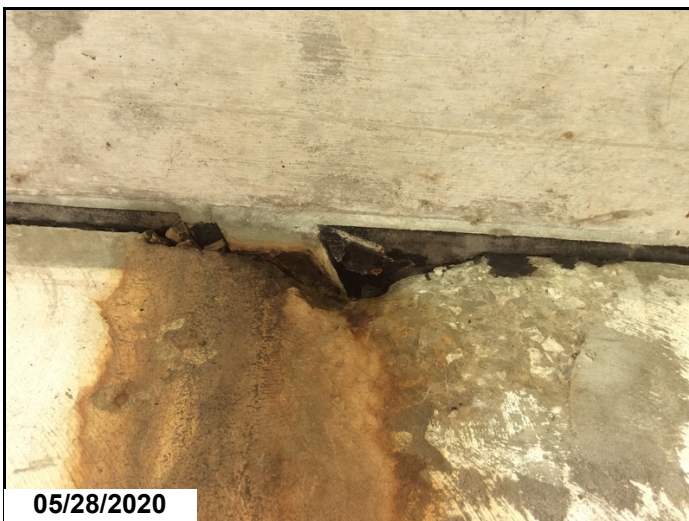
Spall with rebar exposed at top of cap at left side of bent 8.

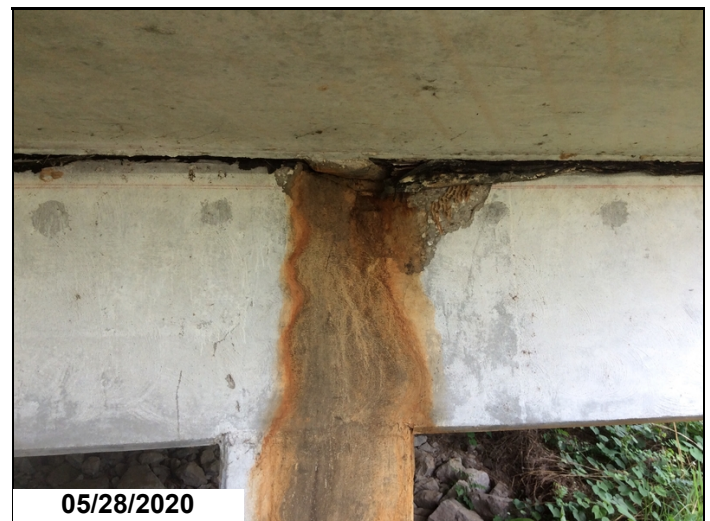
Spalling at key way bent #1 ahead side above column #1.

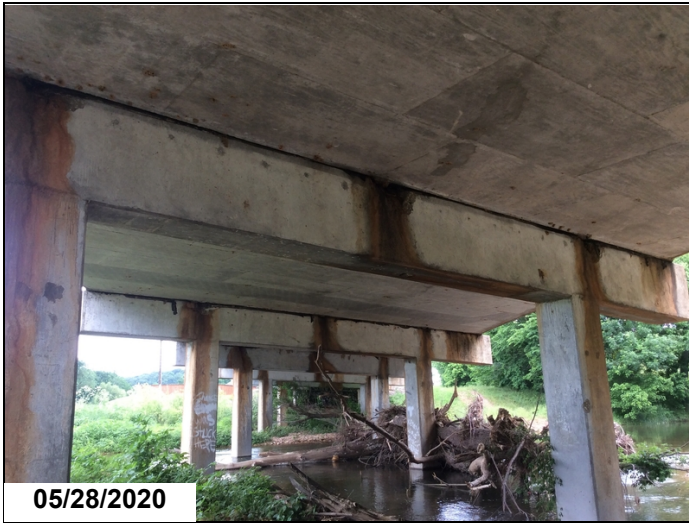
Exposed rebar at bent #3

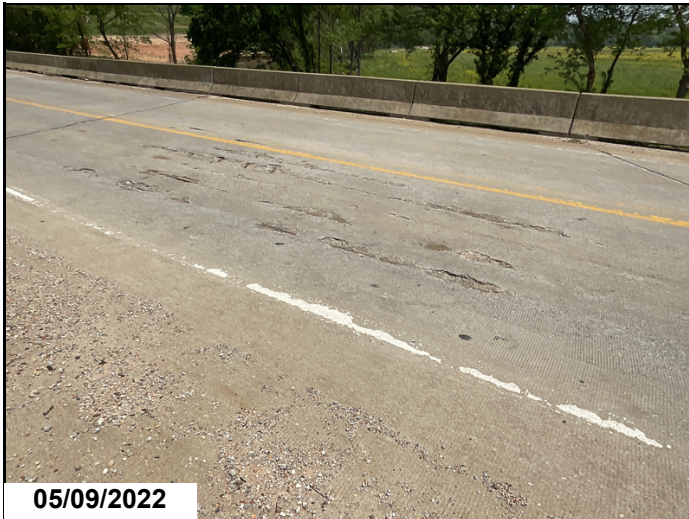
Deck surface span #3 left lane has multiple areas of spalling with steel exposed.

Span #3 spalling with steel exposed in the left lane.

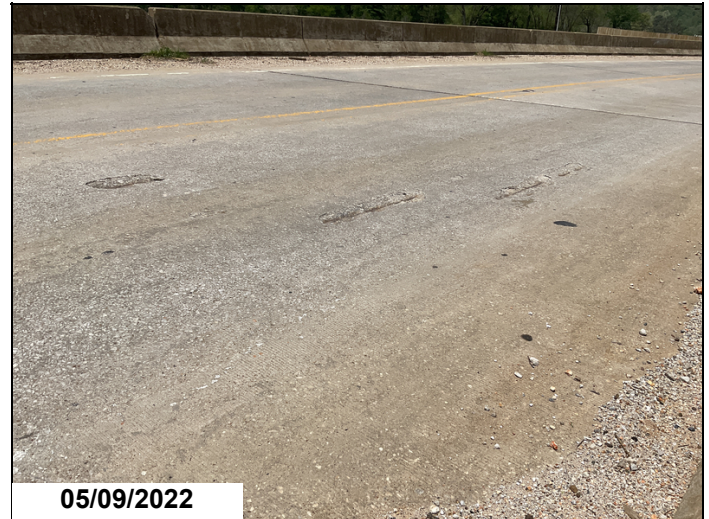
Span #5 spalling with steel exposed in the right lane.

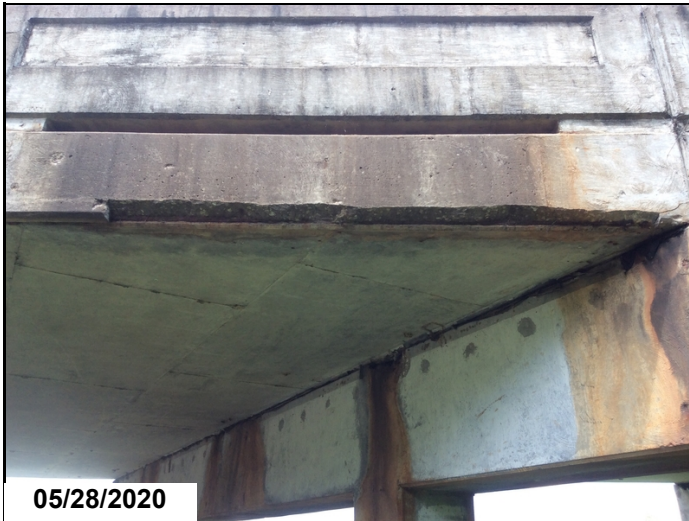
-Span #7 right has spalling with 8' of steel exposed adjacent Bent #7.

Span #7 right adjacent bent #7 spalling with steel exposed.

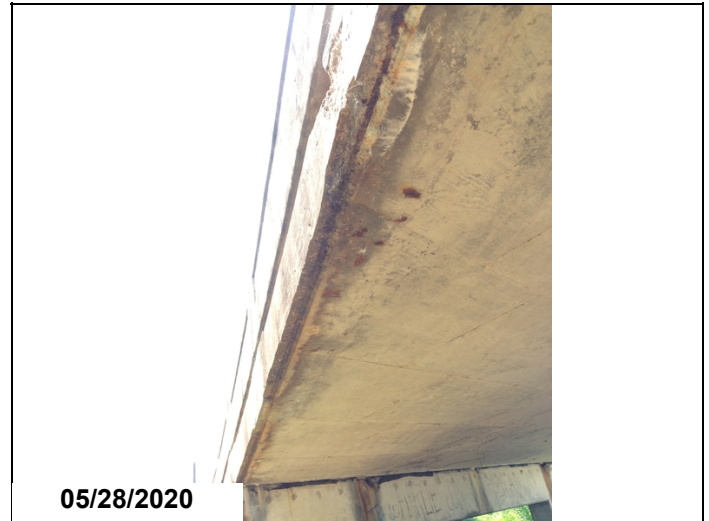
-Deck span #2 right has approximately 22' of spalling with steel exposed.

Deck span #2 right soffit has approximately 22' of spalling with steel exposed.

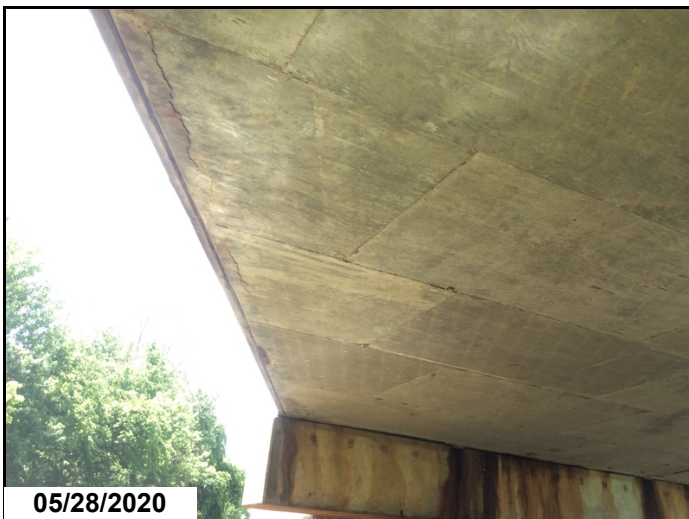
Typical view of right side undersurface of deck with cracking spalling and delaminations.

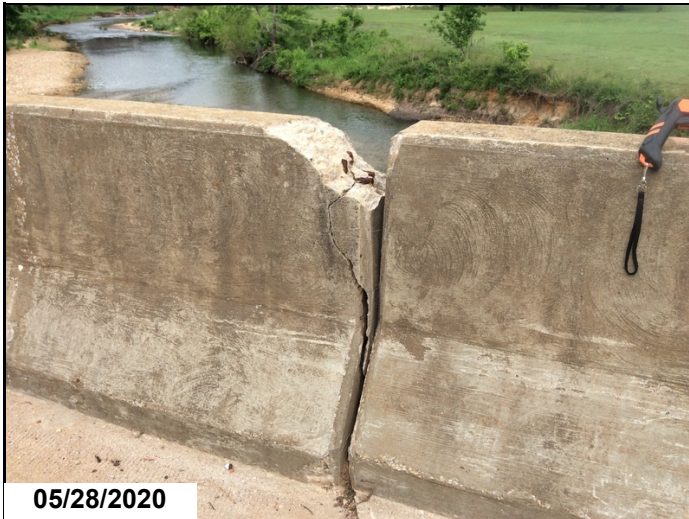
- Deck railing left at bent #5 has large spall with steel exposed.
- The North West approach railing has vehicle damage.

Deck railing left at bent #5 has large spall with steel exposed.

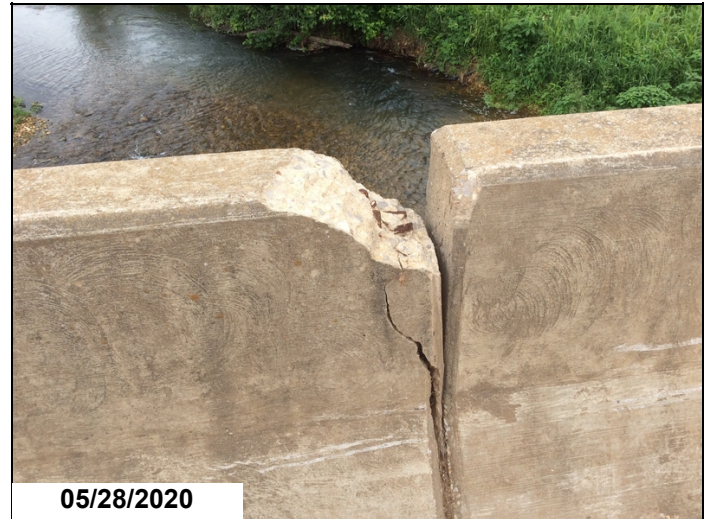
Bridge rail damage at left side over bent #5.

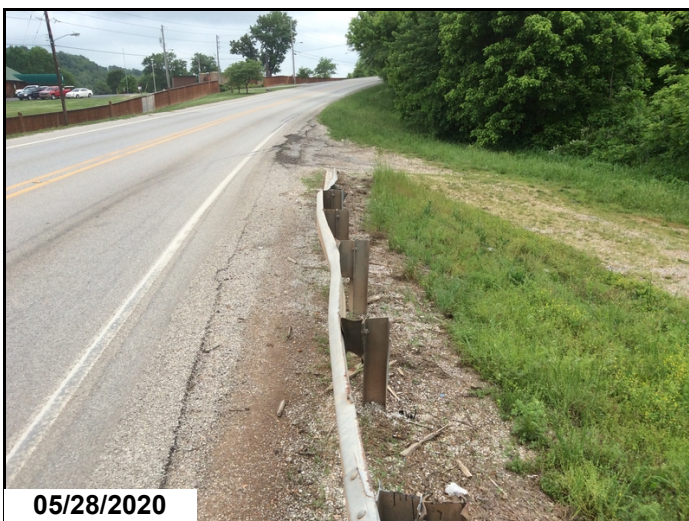
Abutment #2 right approach railing has vehicle damage.

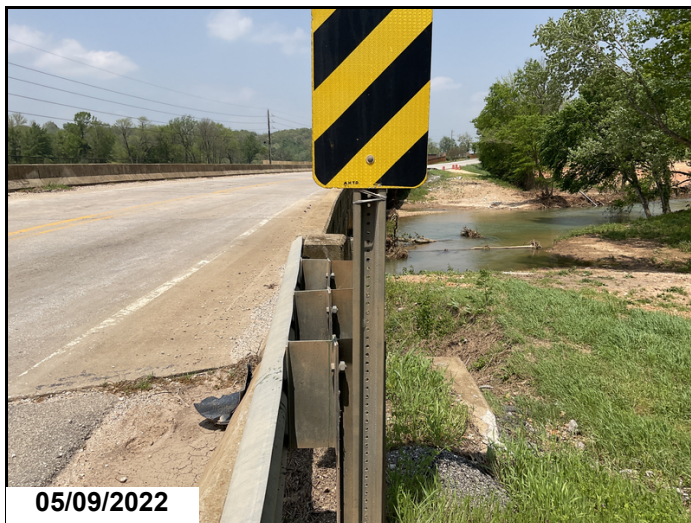
Missing log mile sign southeast side of bridge .
