Asset #05911(Routine)

SH 112 Benton 2 over OSAGE CREEK

Location: 5.06 MI N WASHINGTON CO L

Team Lead: Anthony Wood Inspection Date: 07/17/2024

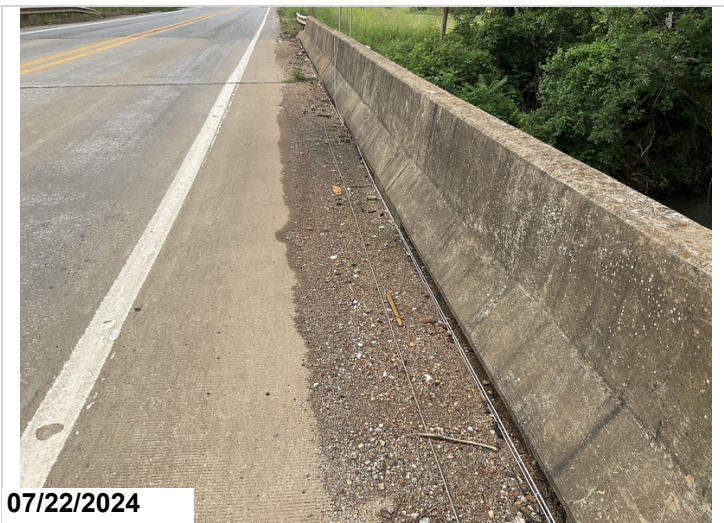
Typical debris in gutter lines.

**A-55 - Deck Washing Needed** (Y)

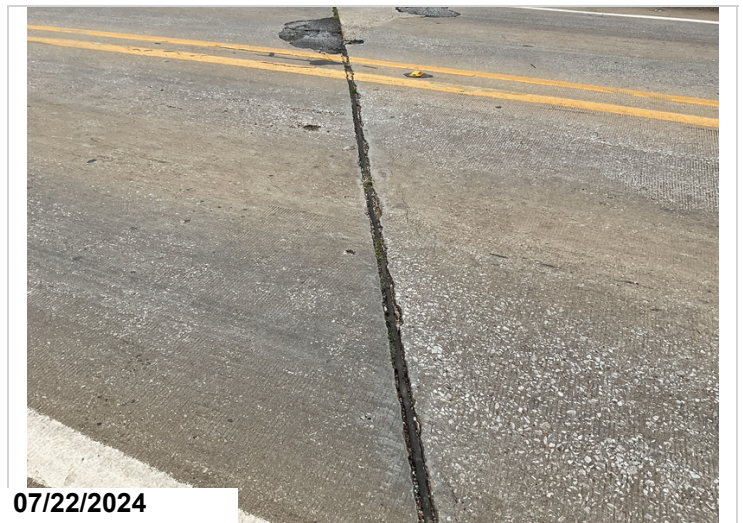
Typical joints.

**A-56 - Joint Cleaning/Flushing Needed** (Y)

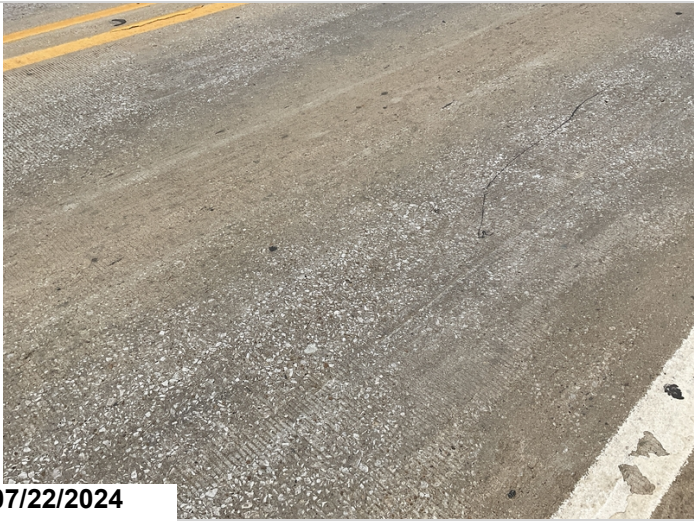
Typical abrasion & cracking in wheel paths.

**A-61 - Polymer Overlay Advised** (Y)

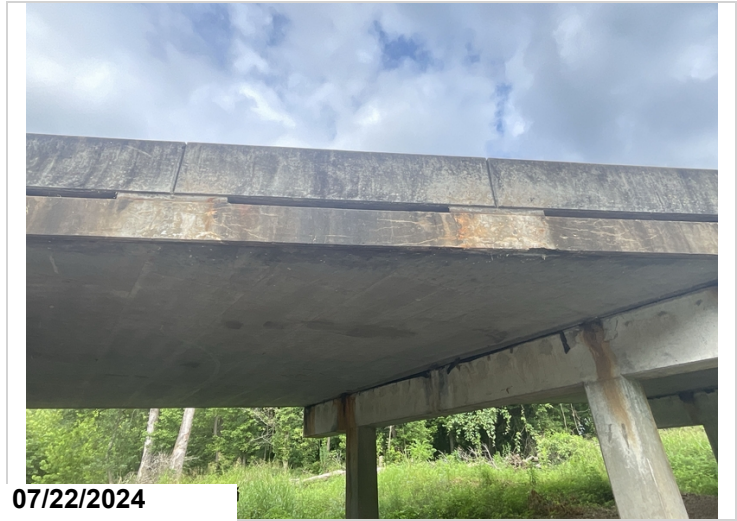
Span 5, Right: Cracking with efflorescence with build-up.  
6SF CS3

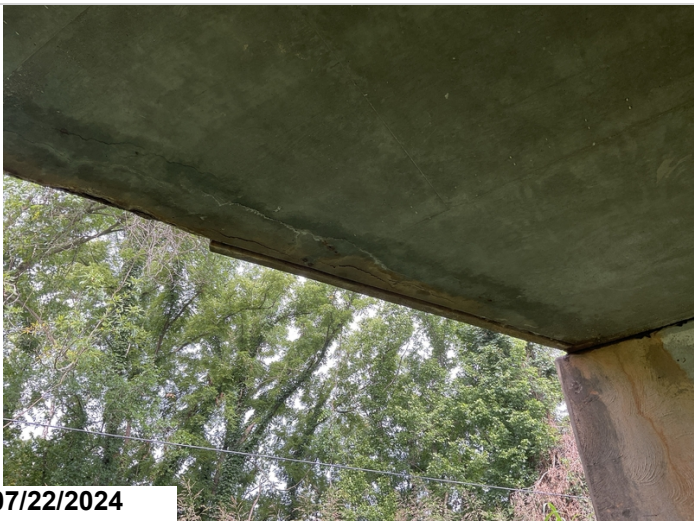
Spans 4 - 9: Delam. 86SF CS2

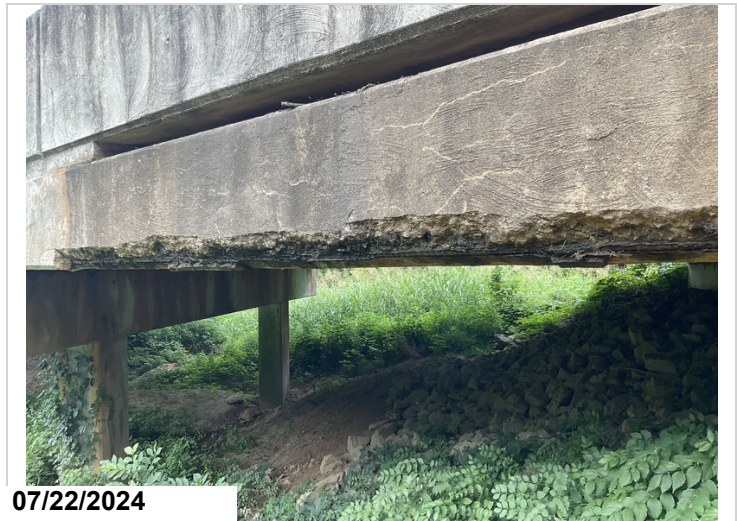
Spans 4 - 9: Spalling with exposed reinforcing steel with  
section loss. 115SF CS3

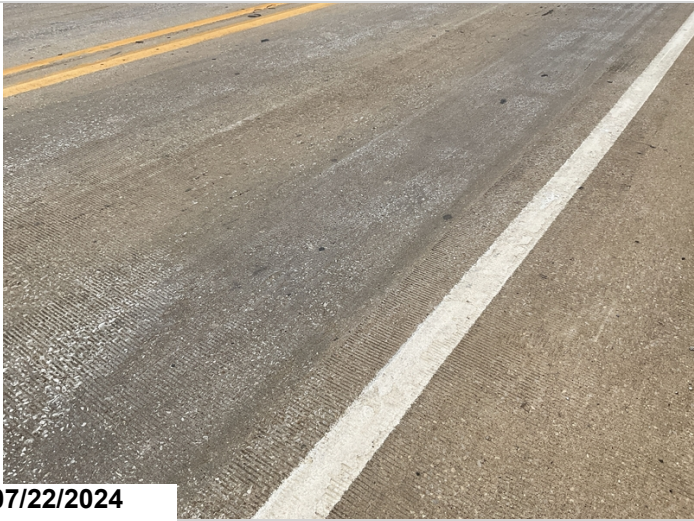
Span 1 - 9, Left: Map cracking. 630SF CS3

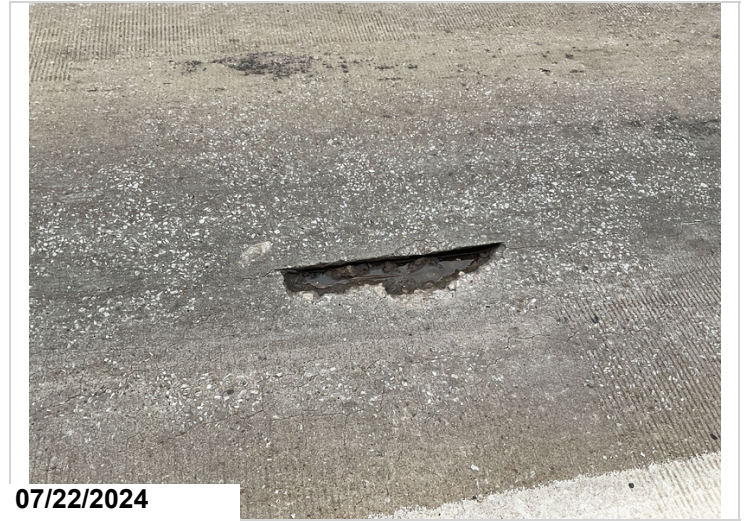
Span 9: Spalling with exposed reinforcing steel with section loss. 2SF CS3

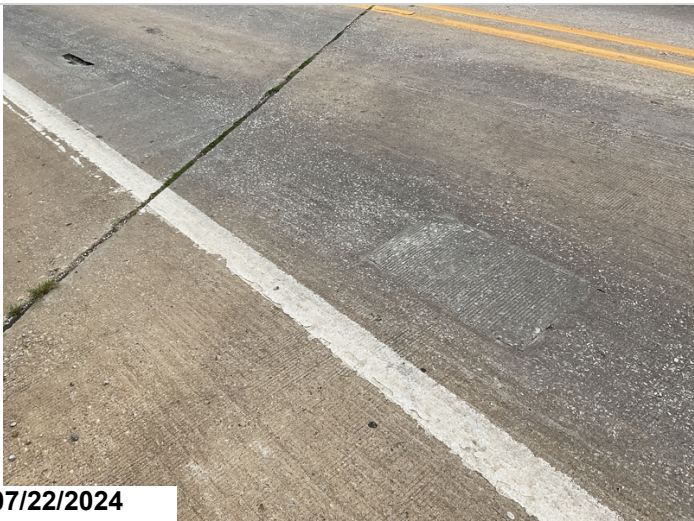
Span 8 & 9: Sound patches. 22SF CS2

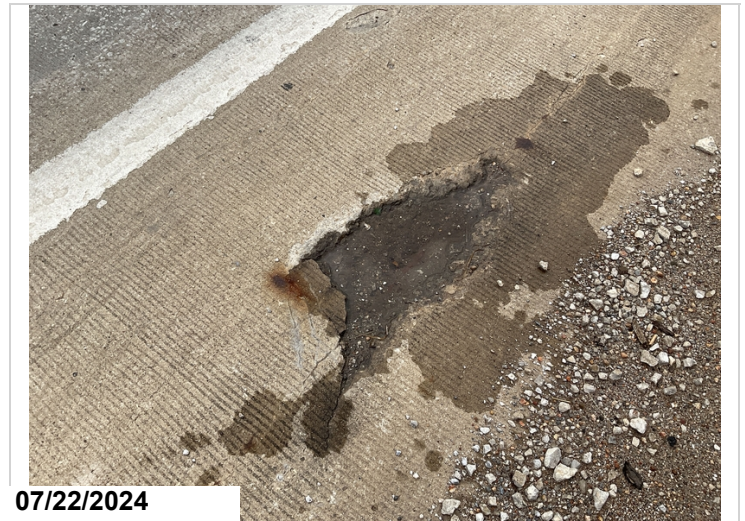
Span 8: Spalling with exposed reinforcing steel with section loss. 5LF CS3

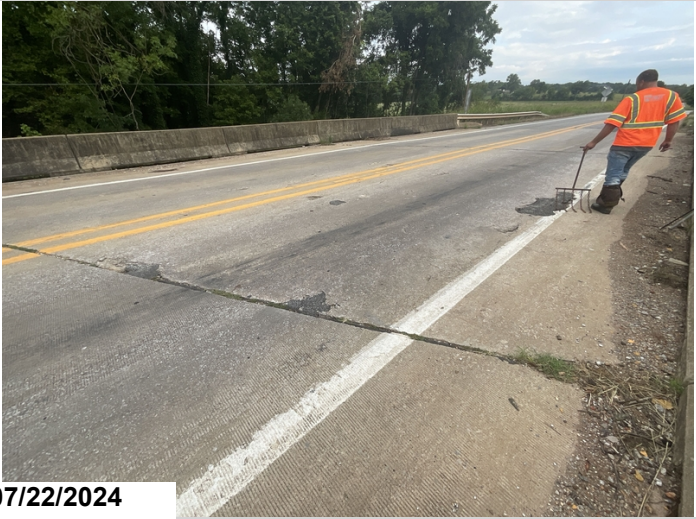
Span 8: Spalling with and without asphalt patches 17SF CS3  
Span 8: Delam. areas 108SF CS2

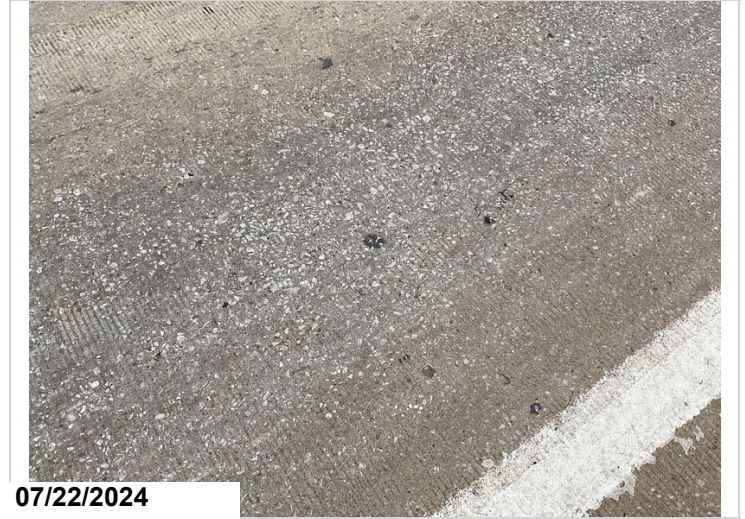
Spans 4 - 6: Map cracking. 120SF CS3

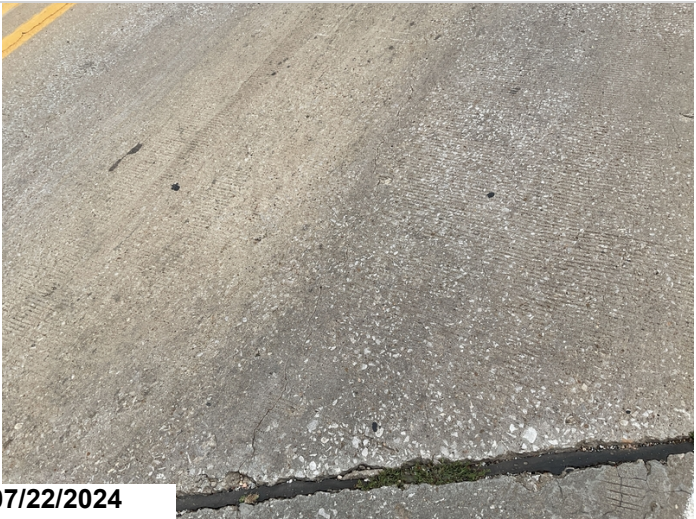
Span 4, Right: Longitudinal cracking. 10SF CS2

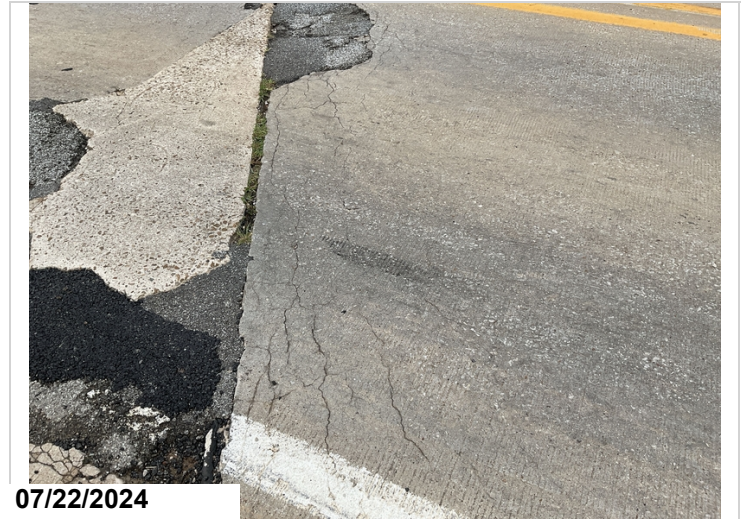
Span 3, Right: Cracking. 8SF CS3

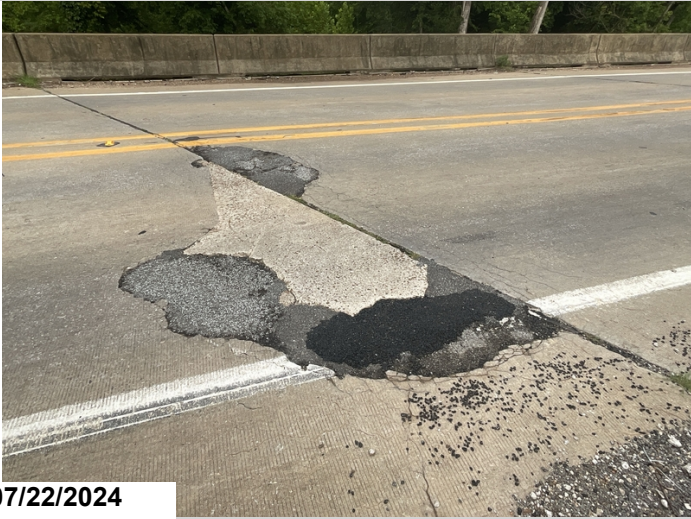
Span 2 & 3, Right: Spalling with sound and unsound patches. 24SF CS3

Span 2 & 3, Right: Spalling with sound patches. 5SF CS2

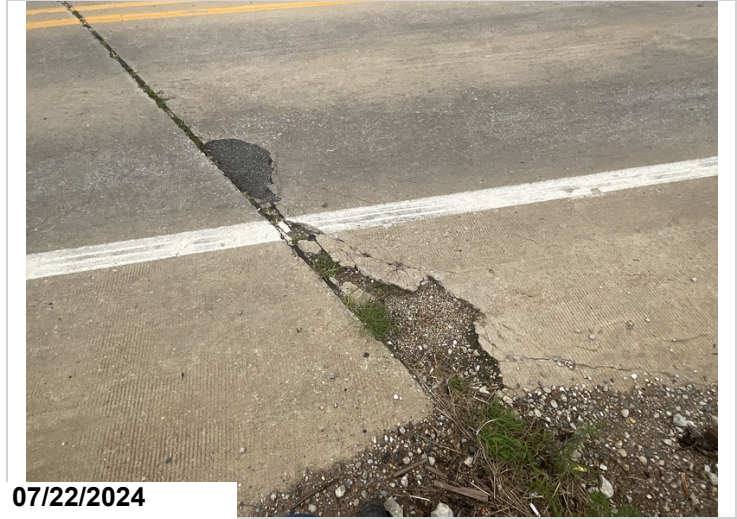
Span 2, Right: Spalling with and without asphalt patches. 5SF CS3

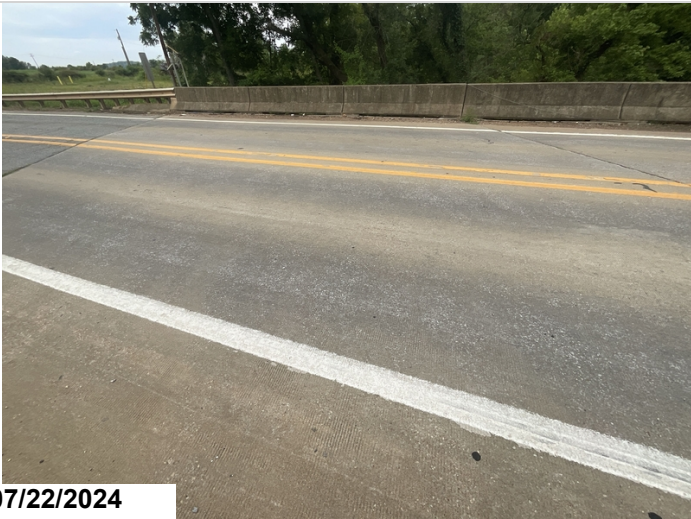
Spans 1 - 8: Typical abrasion in wheel paths. 2520SF CS2

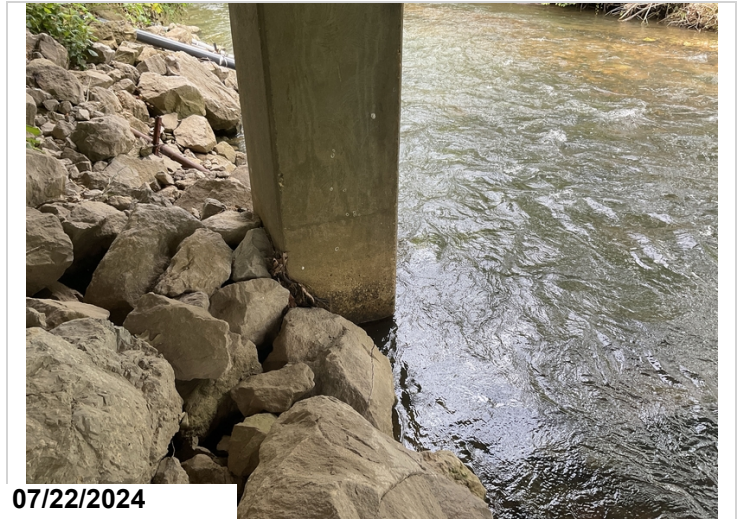
Bents 1 - 4, Columns 1 & 2: Minor abrasion.

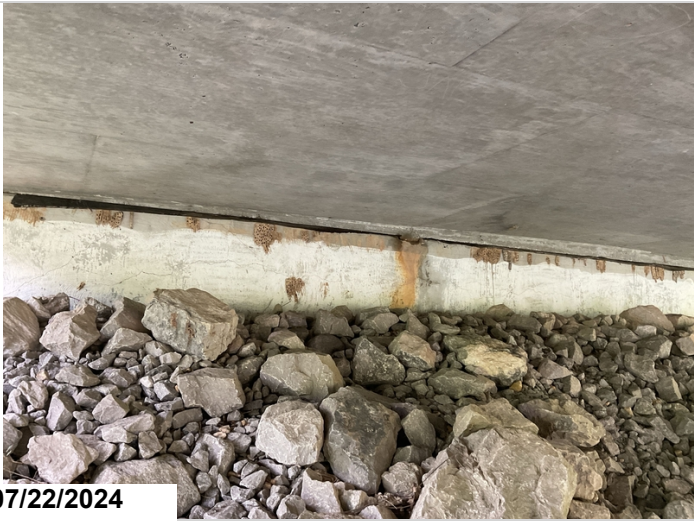
Abutment 1: Minor cracking. 41LF CS2

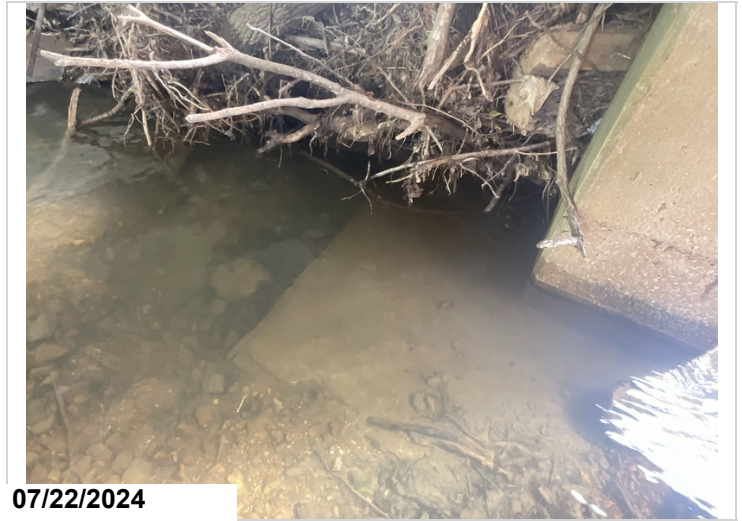
Overall, the scour condition is good with moderate drift causing localized scour at bent 4.

Bent 4, Column 1: Footing exposed with minor scour.

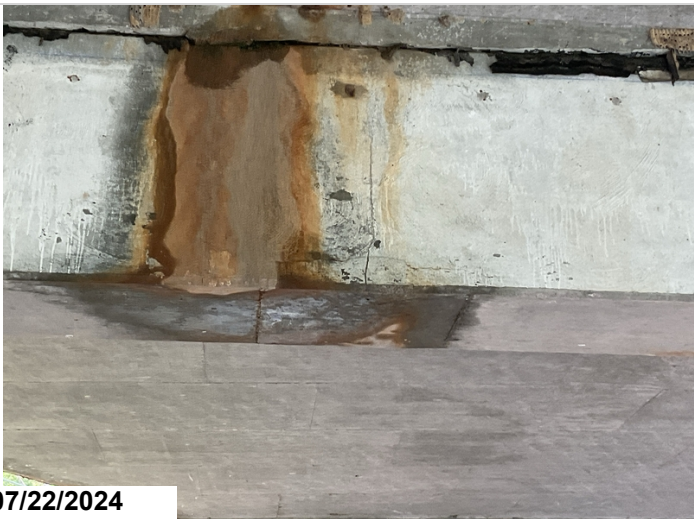
Bent 3, Center: Minor cracking. 2LF CS2

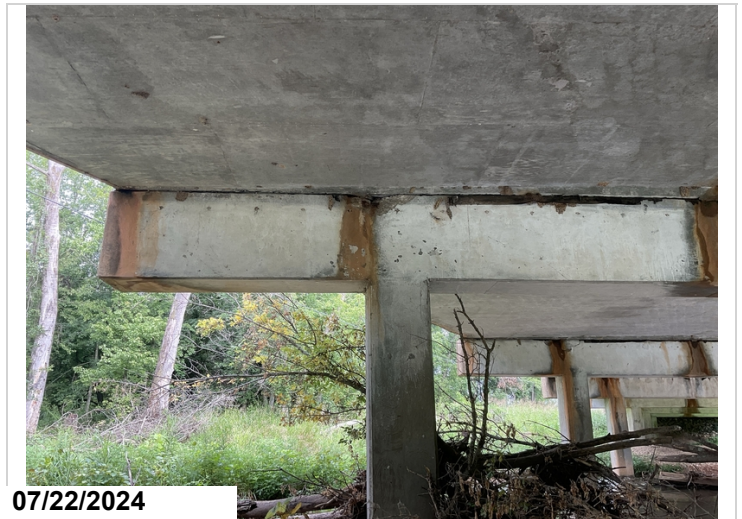
Bent 3, Left: Spalling with exposed reinforcing steel with section loss. 2LF CS3

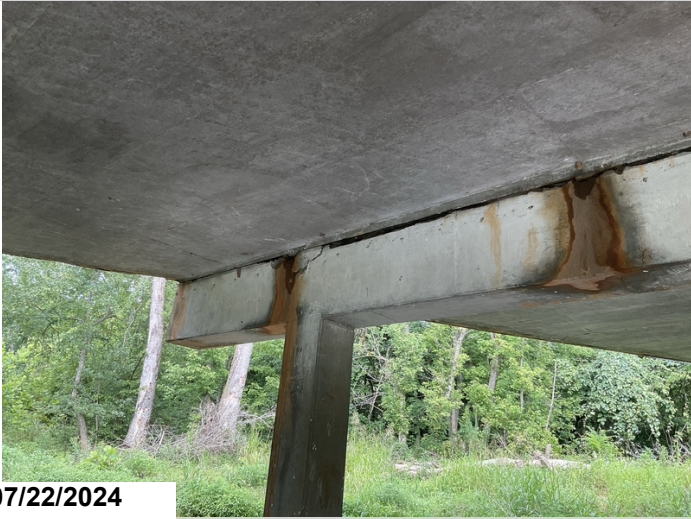
Bent 4, Left & Right: Delam. 2LF CS2

Bent 4, Left & Right: Spalling. 2LF CS3

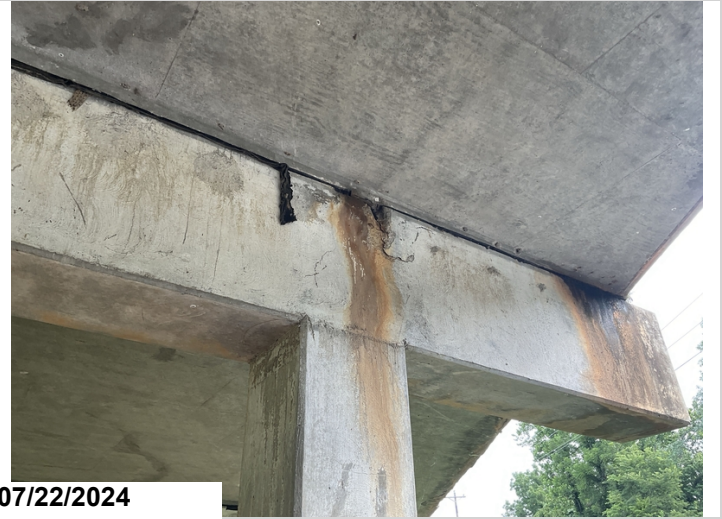
Bent 5, Right: Spalling. 2LF CS3

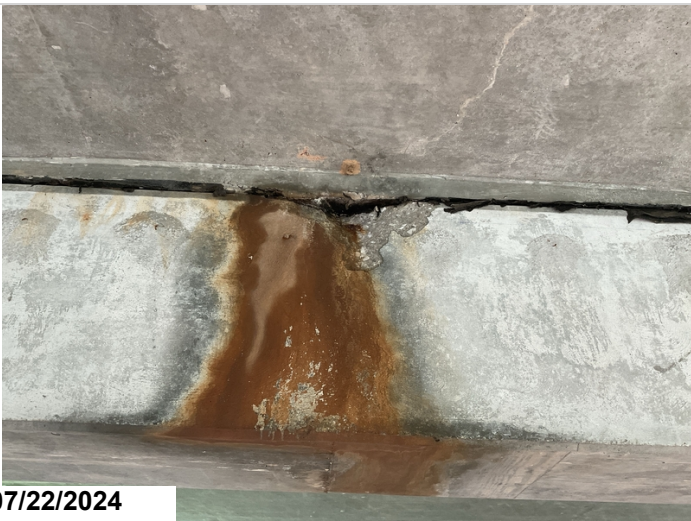
Bent 6, Center: Spalling. 2LF CS3

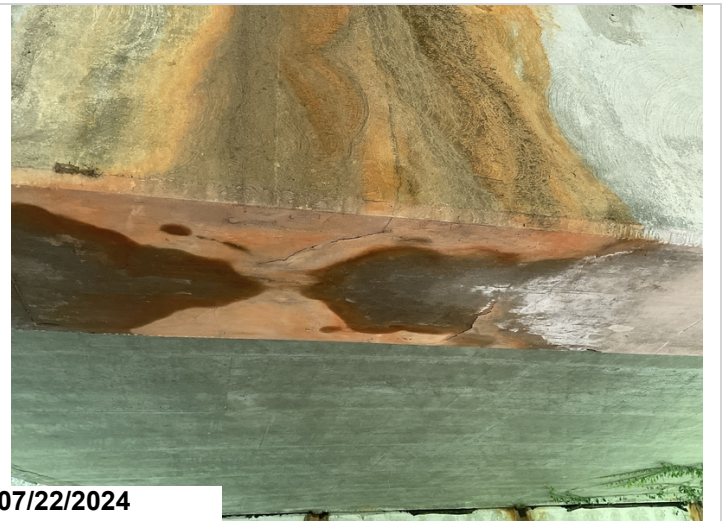
Bent 7, Center: Cracking. 2LF CS2

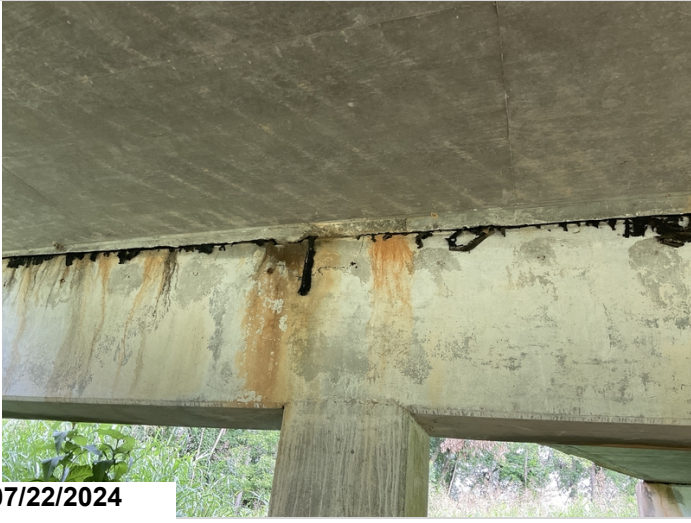
Bent 7, Left: Delam. 2 LF CS2

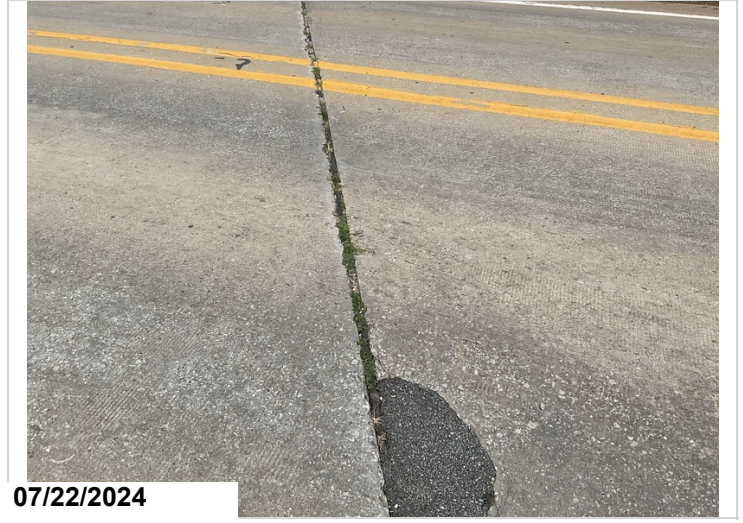
Overall, the joints are in poor condition with all joints having adhesion failure and areas of missing joint material.

Typical joints.

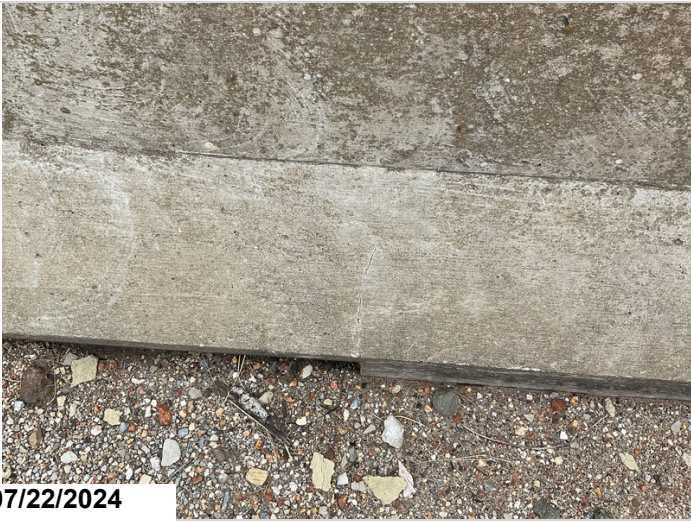
Cracking. 182LF CS2

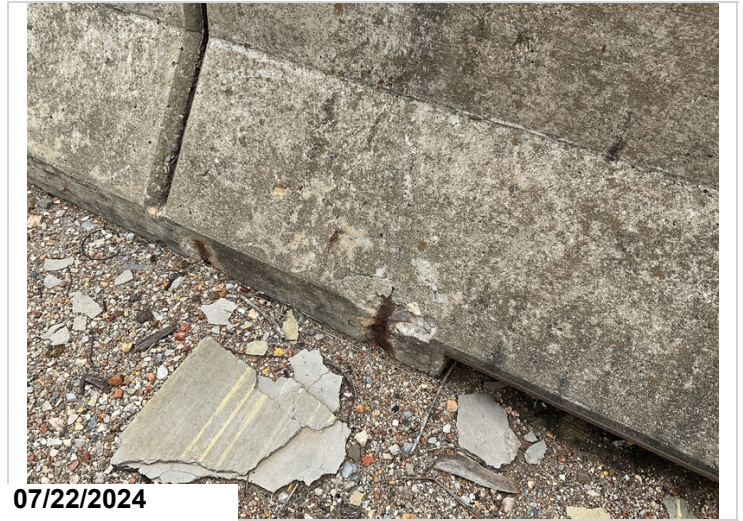
Spalling with exposed reinforcing steel with section loss. 5LF  
CS3

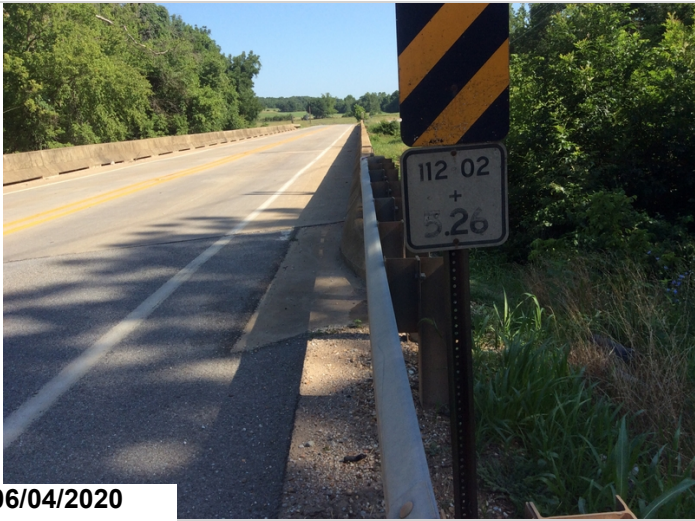
Log mile sign not visible.

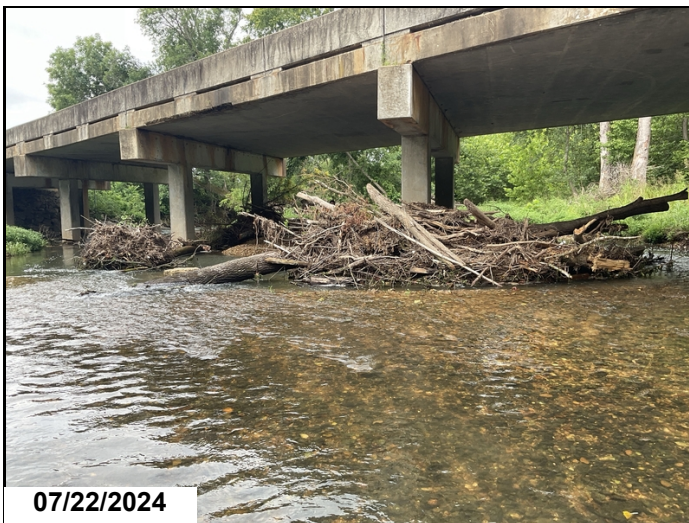
-The channel has large trees and drift cause localized scour.

Bents 3 - 5: Large drift blocking channel. Localized scour at bent 4.

Type of Work: Channel Work/Drift Removal

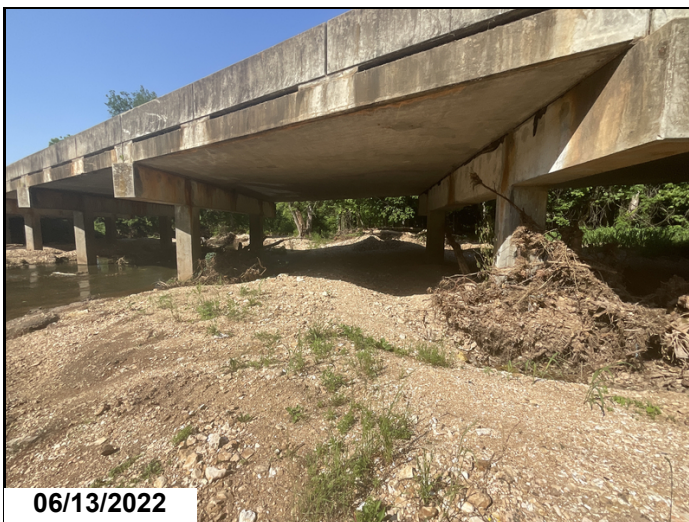
Large trees at bents 4-6 that are causing localized scour.

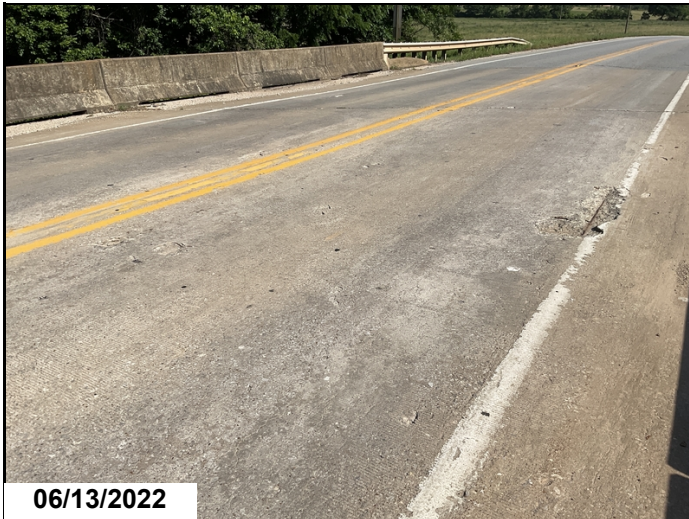
Deck surface span #8 spalling with steel exposed

Type of Work: Deck Repair

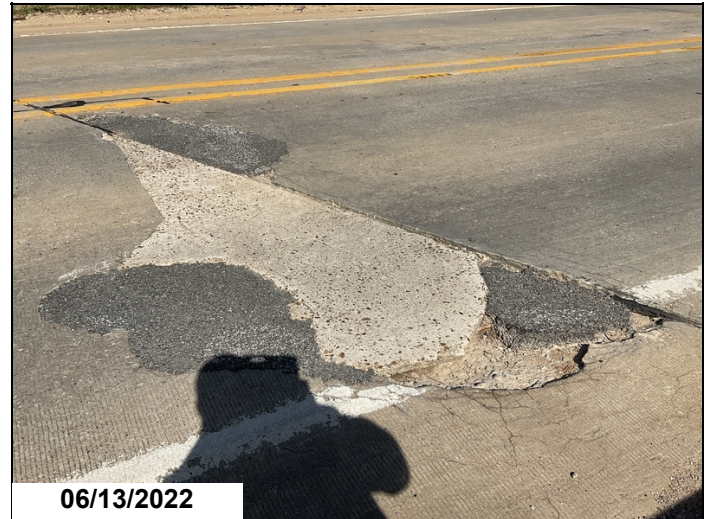
Deck surface over bent #2 concrete and asphalt patches right side. Some of the asphalt patching is failing at this inspection

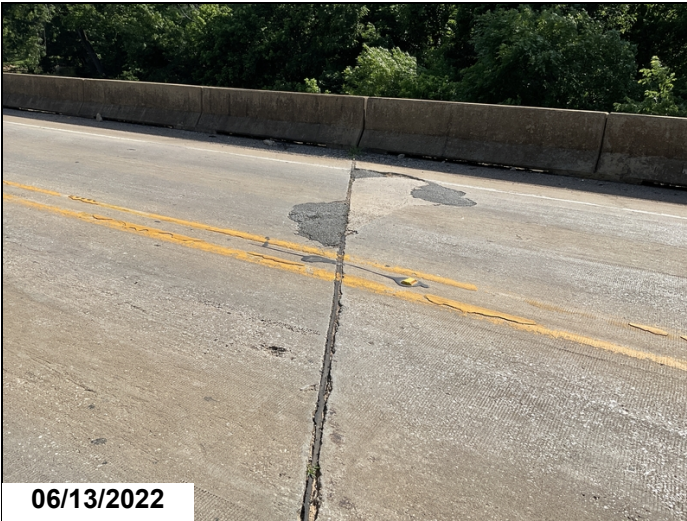
Deck surface over bent #2 concrete and asphalt patches right side. Some of the asphalt patching is failing at this inspection

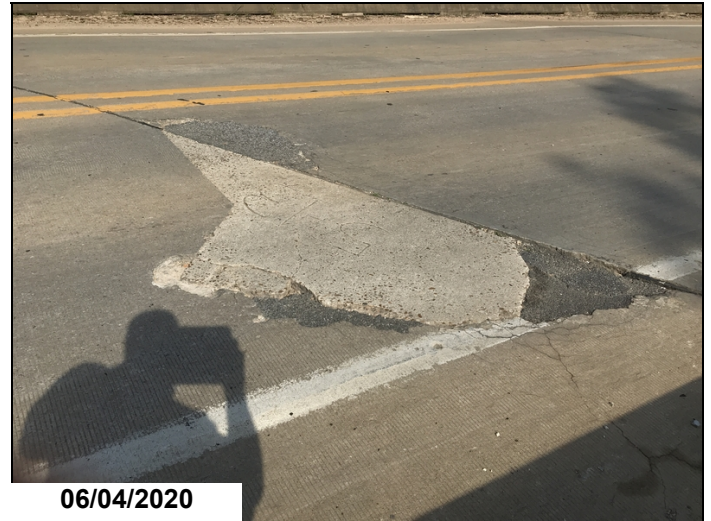
Deck span #2 right failing concrete and asphalt patches.

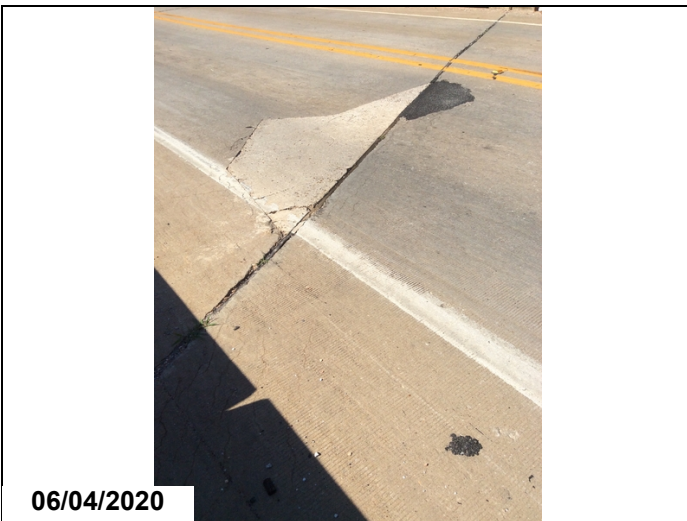
Deck surface Span 2 & 3 at bent 2 right side spalling patched areas.

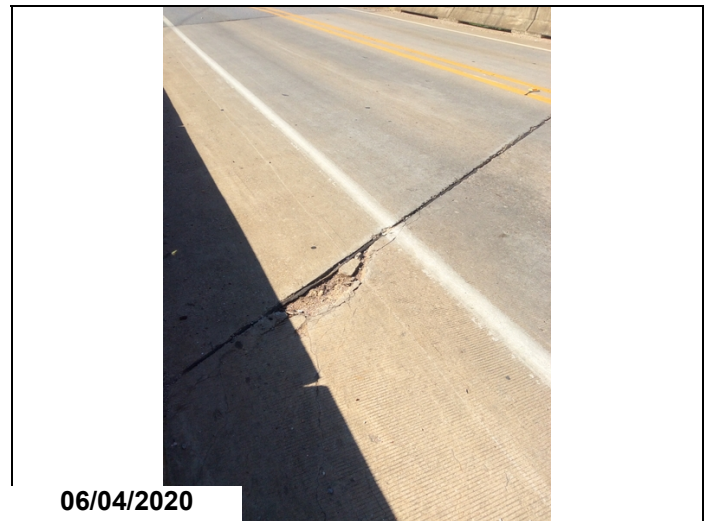
Deck surface Span 2 at bent 1 right spalled area.

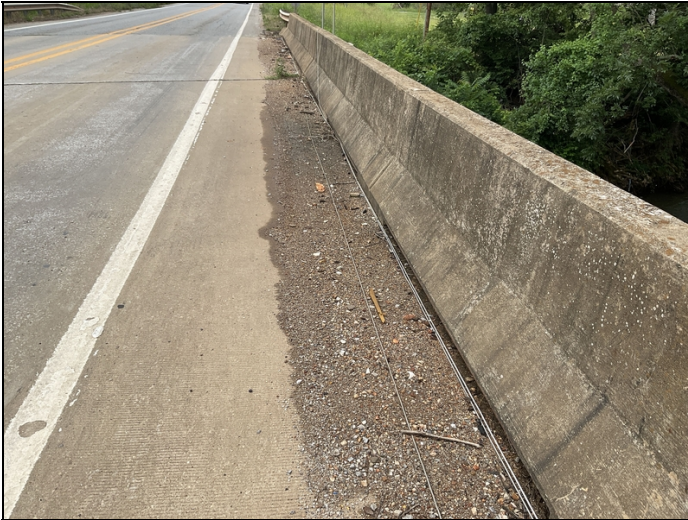
Typical debris in gutter lines.

**A-55 - Deck Washing Needed (Yes)**

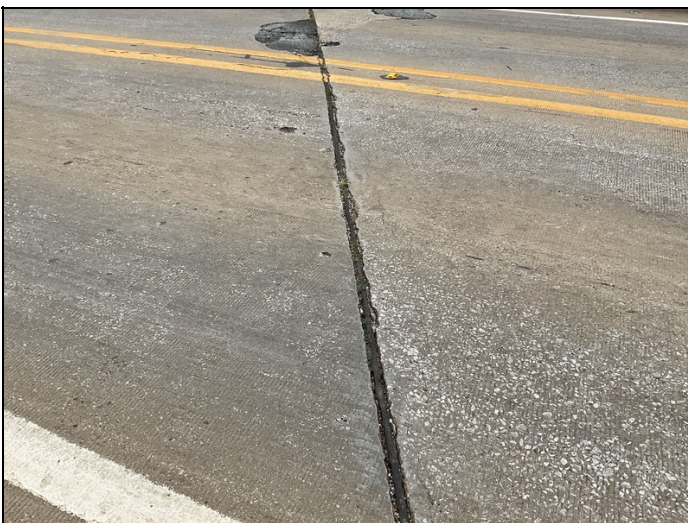
Typical joints.

**A-56 - Joint Cleaning/Flushing Needed (Yes)**

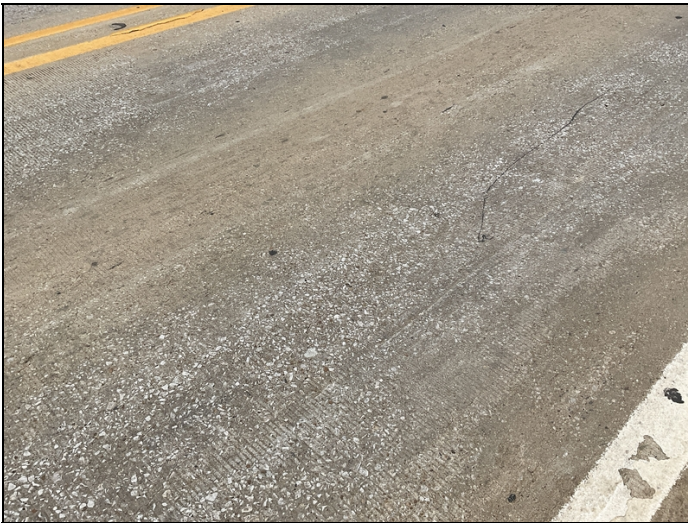
Typical abrasion & cracking in wheel paths.

**A-61 - Polymer Overlay Advised (Yes)**

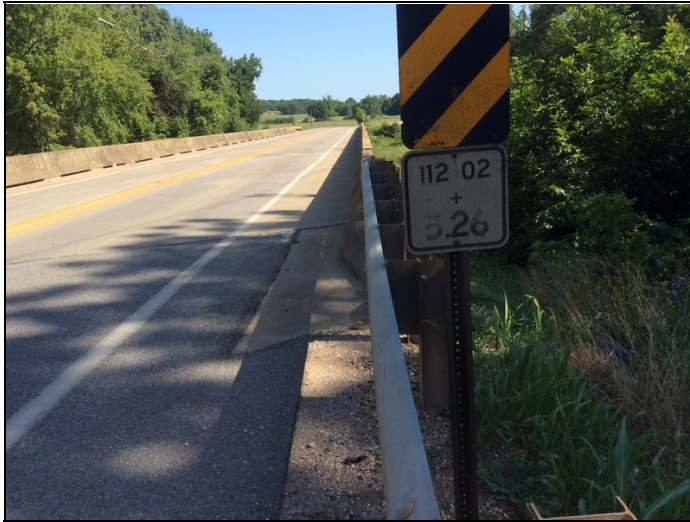
Log mile sign not visible.

**A-63 - Missing/Incorrect Log Mile Signage (Yes)**
