Asset #07307(Routine)

SH 112 over SH 612

Location: 1 Mi. N Wash Co Line.

Team Lead: Nathan Rowland **Inspection Date:** 07/27/2023

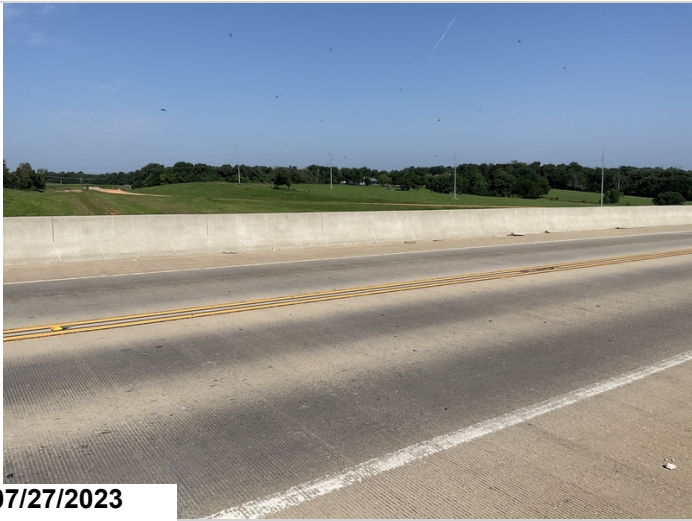
(331) Right side parapet- has 46' of vertical cracking at the saw joints and random locations.							
Left side parapet- has 68' of vertical cracks at the saw joints and other random locations.							
No deficiencies noted in the metal approach railing.

Typical cracking in parapet

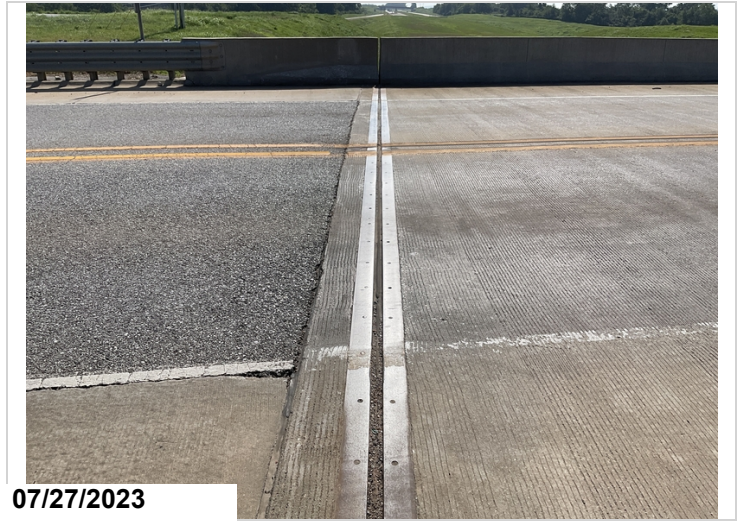
ELEMENTS	DESCRIPTION	UNITS	TOTAL	CS1	CS2	CS3	CS4
301	Pourable Joint Seal	LF	87	62	23	2	0
2310	Leakage	LF	2	0	0	2	0
2350	Debris Impaction	LF	23	0	23	0	0
(301) Abutment #1 seal- has 1' of cs3 leakage at the mid section with 11' of cs2 debris impaction in the gutter lines.							
Abutment #2 seal- has 1' of cs3 leakage in the left lane due to a small tear with 12' of cs2 debris impaction.							
310	Elastomeric Bearing	EA	15	15	0	0	0

View of joint at abutment #2

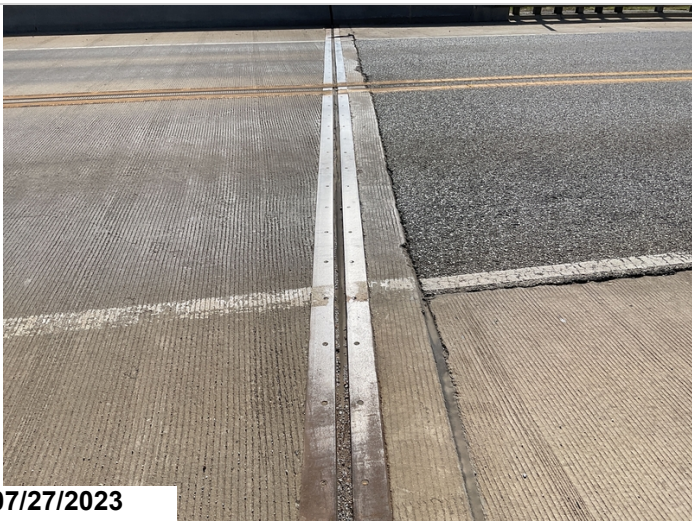
View of joint at abutment #1

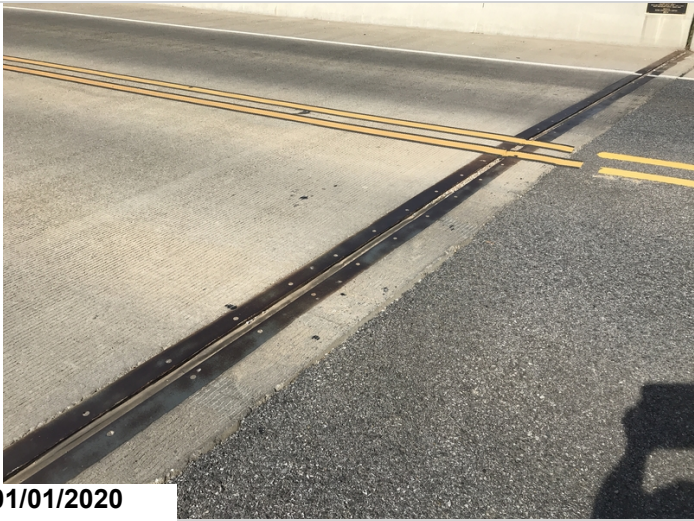
(215) 07-27-2023 WNR & DBM: - The tops of abutment backwalls have hairline longitudinal cracks at random spacing visible from the driving surface that have been sealed by contractor forces. -The cracks in some locations extend down the vertical face of backwall with efflorescence visible. Abutment #1- has 3' of cs2 efflorescence in the vertical face of the back wall. No cracking was noted in the bridge seat. No deficiencies noted on the MSE portion of the abutment. Abutment #2- has 3' of cs2 efflorescence in the back wall. The bridge seat has 1' of vertical cracking at a step down. No deficiencies noted on the MSE portion of the abutment.							
234	Reinforced Concrete Pier Cap	LF	43	43	0	0	0

Contractor has placed sealant for longitudinal cracking on top of abutment #2 backwall.

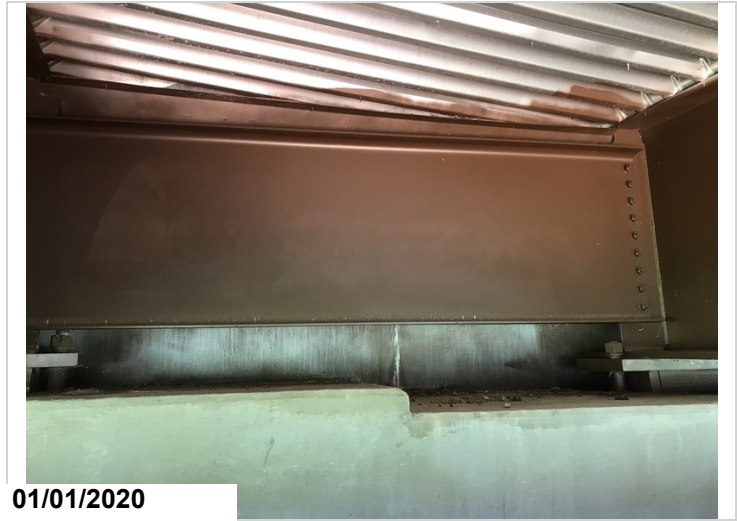
Abutment # 1 bay #2 efflorescence in abutment backwall

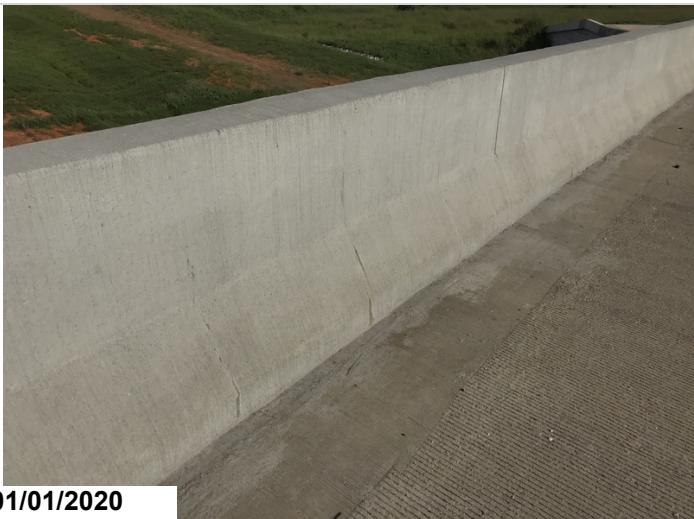
Typical cracking in parapet

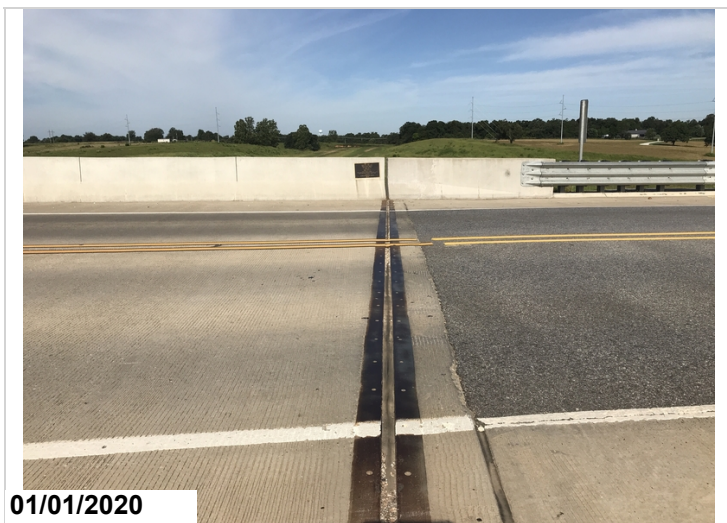
Abutment #2 joint material

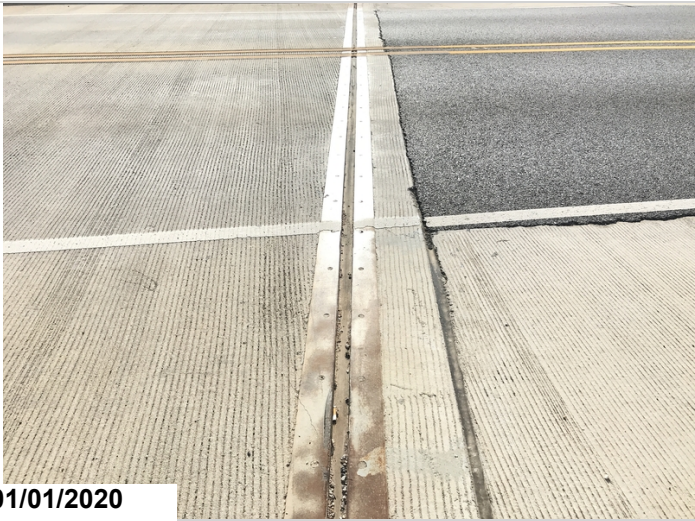
Abutment #1 joint material.

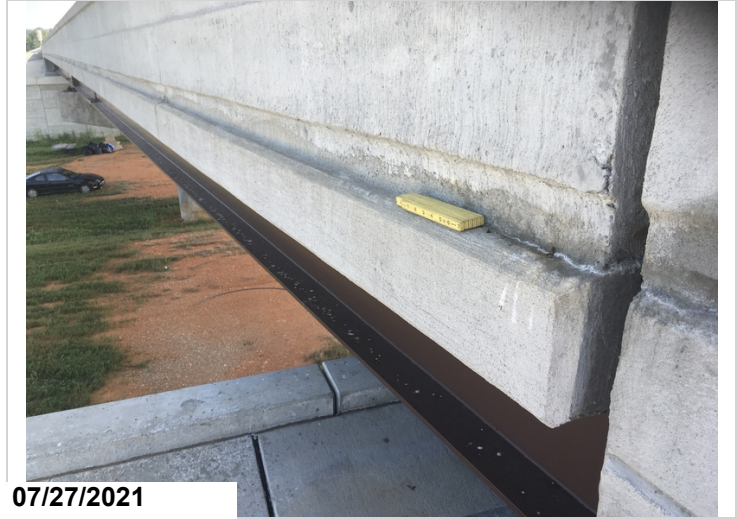
07/27/2021

The beginning left deck edge of the exterior of span #1 has 1' of cs2 efflorescence.

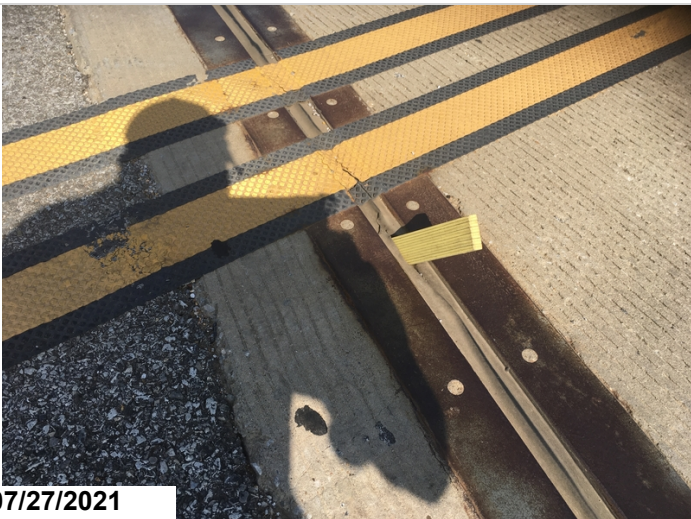
07/27/2021

torn area in the abutment #1 pourable seal. right lane.

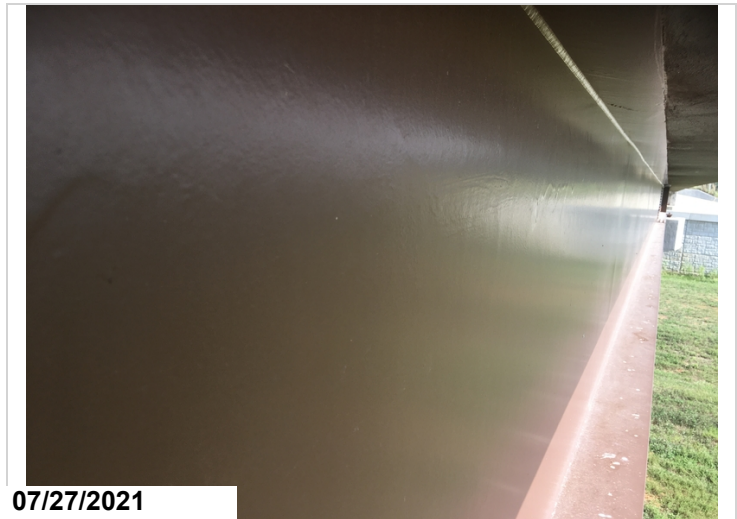
07/27/2021

(107) 07-27-2023 WNR & DBM: -No noteworthy deficiencies at this inspection. The paint system still has gloss.							
210	Reinforced Concrete Pier Wall	LF	14	14	0	0	0

General paint condition. Still showing gloss.

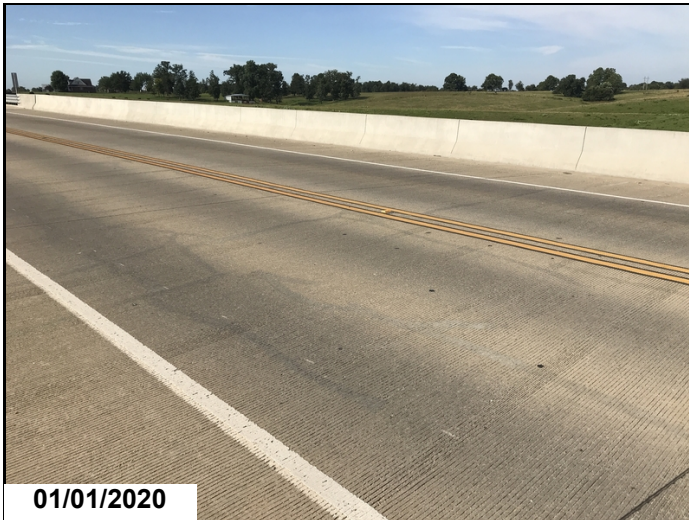
01/01/2020

The driving surface of the deck has sealable cracking in both lanes.

Contractor has placed a type of sealant as a repair for deck cracking.

07-27-2023 WNR & DBM: maintenance forces have placed an epoxy type of repair since the last inspection.
