Asset #07062(Routine, Underwater type 2)

Benton SH 59 over FLINT CREEK

Location: 1.55 MI S JCT SH12

Team Lead: Nathan Rowland Inspection Date: 07/10/2023

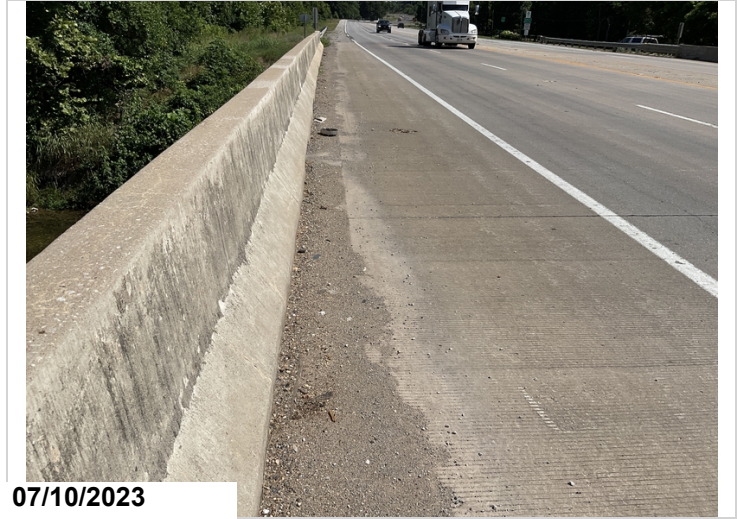
Typical debris in gutterline

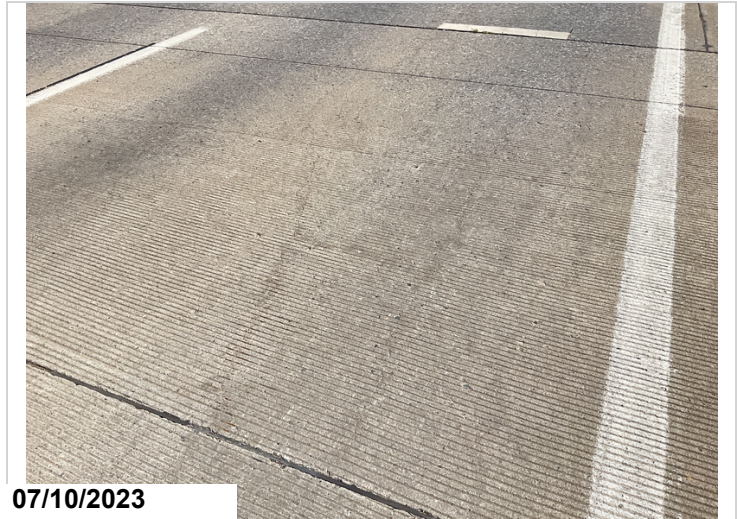
Typical view of deck cracking

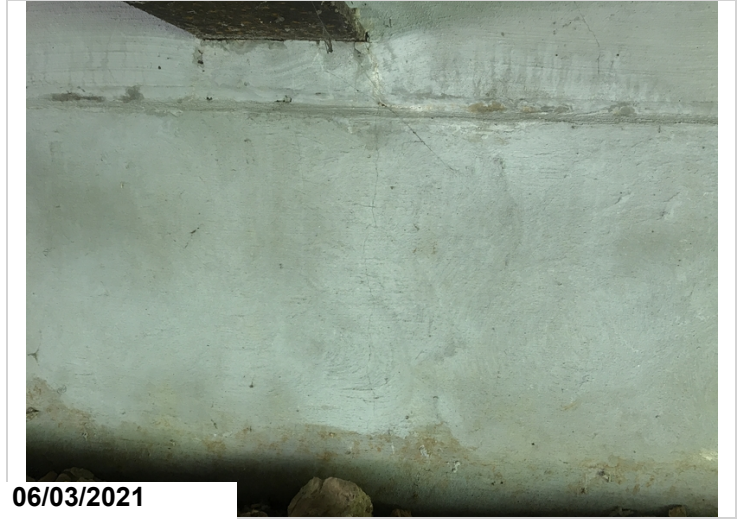
Vertical cracking at abutment #2.

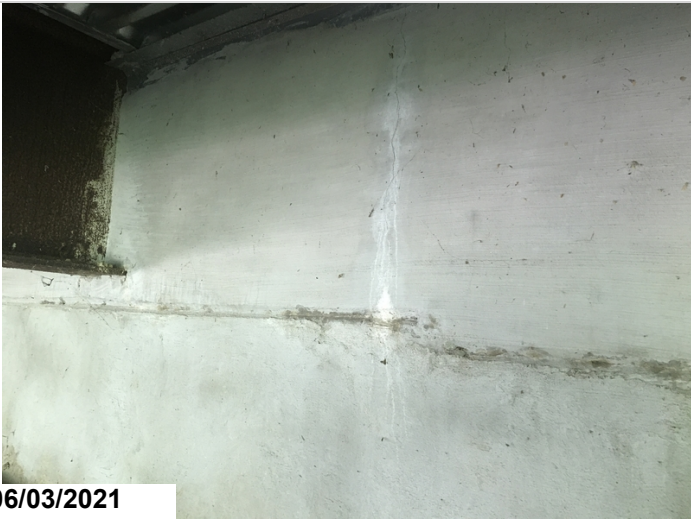
Vertical cracking with efflorescence at abutment #2.

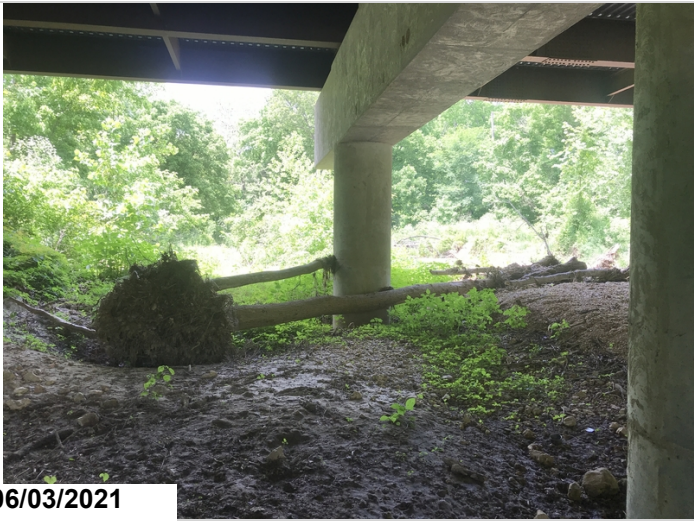
(205) 07/10/2023 WNR & DBM: Bent #1: -Heavy streambed material accumulation under span #2 has directed the channel flow into bent #1 causing localized scour at the bases of columns #2 and #3 and eroding the North embankment. Bent #2: -The channel has moderate drift accumulation at bent #2. -Large tree bent #2 column #3.							
215	Reinforced Concrete Abutment	LF	196	115	81	0	0
1120	Efflorescence/Rust Staining	LF	3	0	3	0	0
1130	Cracking (RC and Other)	LF	30	0	30	0	0
1190	Abrasion/Wear (PSC/RC)	LF	48	0	48	0	0

Large tree bent #2 column #3.

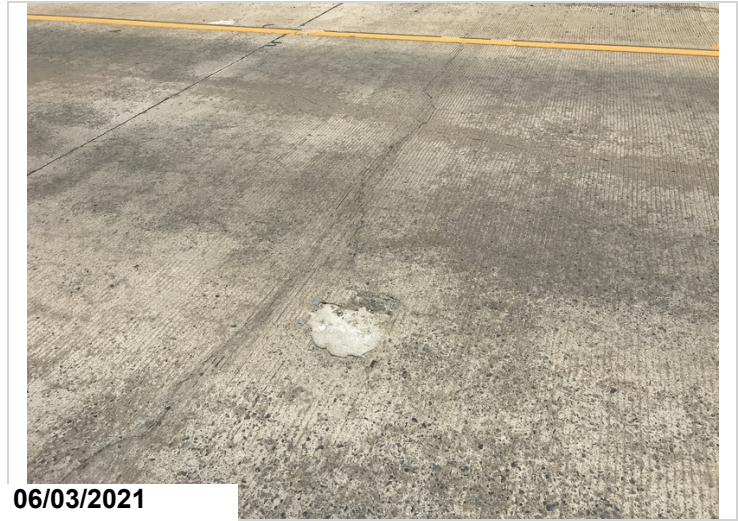
View of failing repairs in North abutment

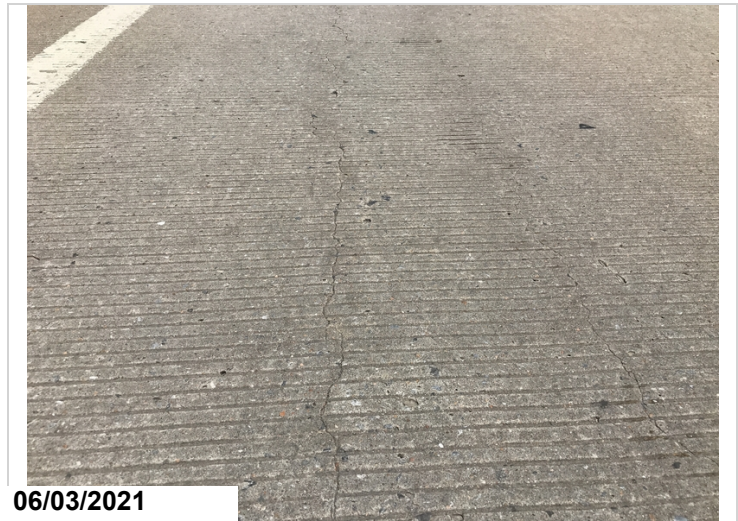
Typical view of longitudinal cracking.

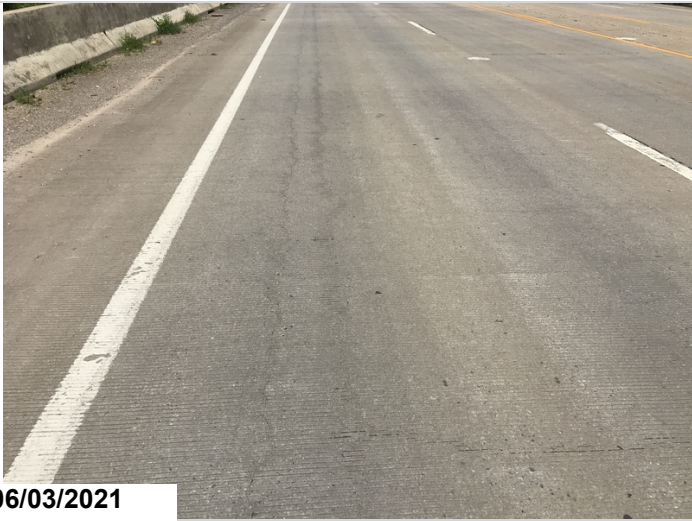
Typical view of longitudinal cracking.

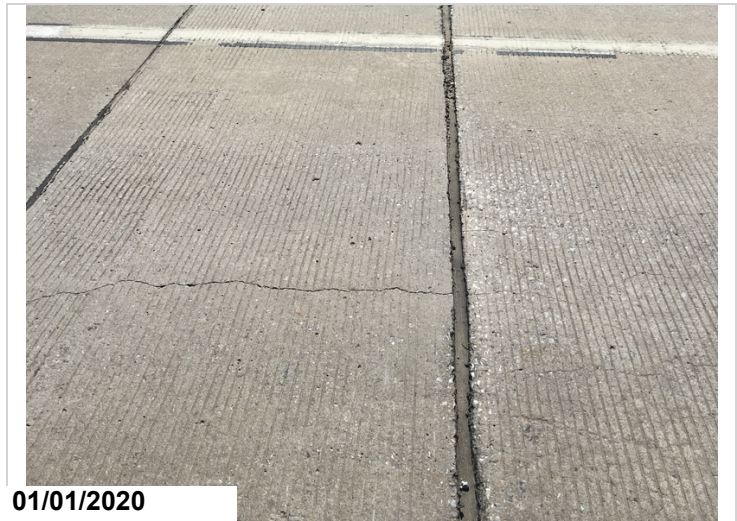
(301) 07/10/2023 WNR & DBM: - The pourable joint sealant has debris impaction on the left and right shoulders at both bridge ends.							
310	Elastomeric Bearing	EA	18	18	0	0	0

Pourable joint seal condition at the abutments.

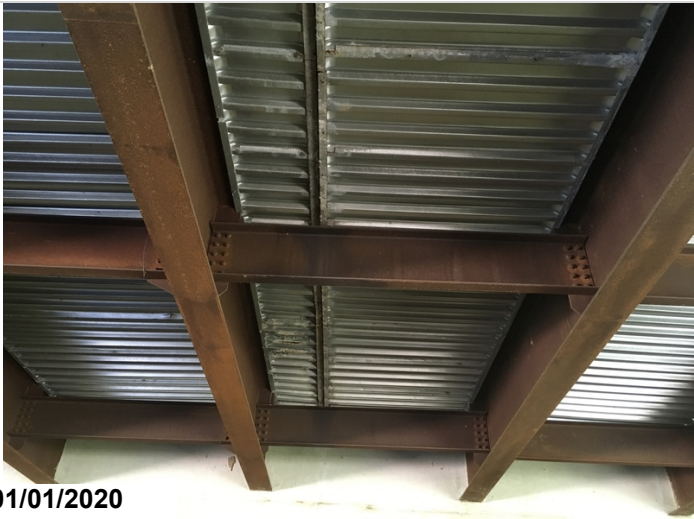
Sip corrosion in bay #4 at abutment #1. Typical of all 3 spans.

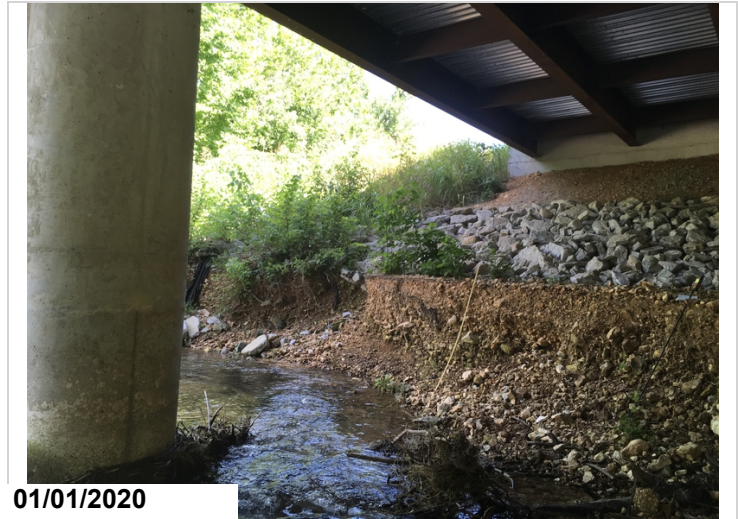
ELEMENTS	DESCRIPTION	UNITS	TOTAL	CS1	CS2	CS3	CS4
- Embankment erosion exists at the base of the abutment #1 slope. The width from bank is 14' 3" to column #3 at bent #1 measurement taken under beam #8. -The top of abutment #2 (South abutment) has 13 transverse cracks visible from the driving surface. The cracks extend down the vertical face of abutment in locations, in some of these locations exists CS efflorescence. -The top of the abutment backwall has light abrasion in the wheel paths of the Northbound lanes. -The beams are cast into the abutment and hairline cracking is propagating from the bottom flange in locations.							
234	Reinforced Concrete Pier Cap	LF	154	154	0	0	0

Embankment erosion at the abutment #1 slope. The width from bank is 14' 3" to column #3 at bent #1.

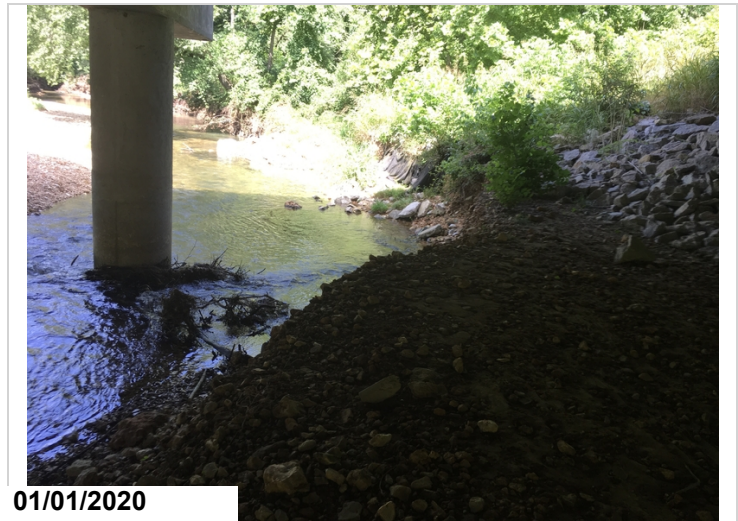
General view of abutment #1 embankment erosion.

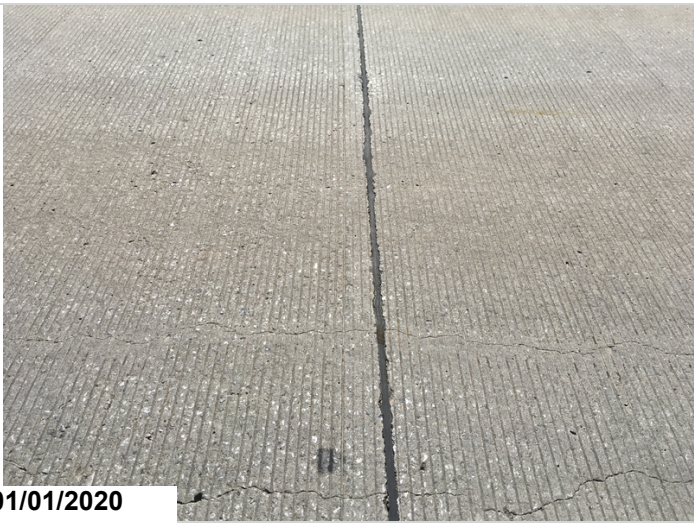
Porable construction joint seal condition.

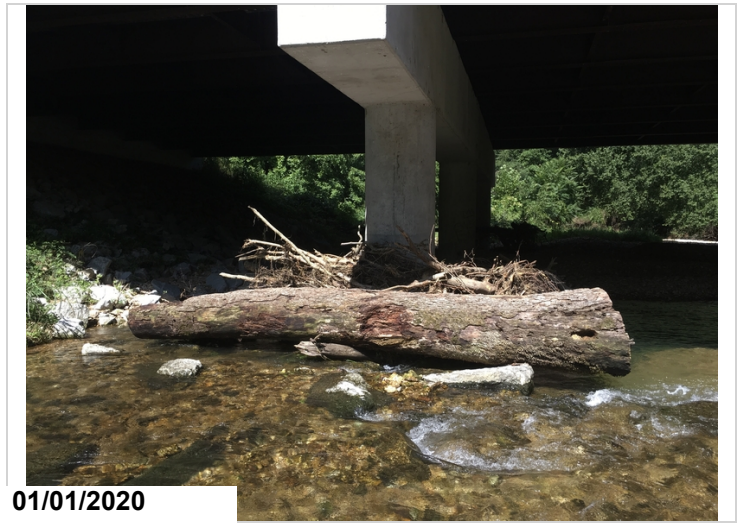
Drift accumulation at the upstream side of bent #2.

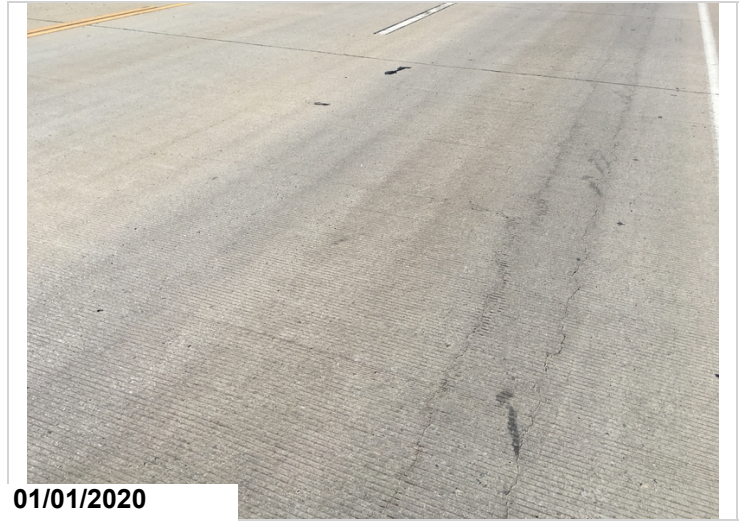
Typical view of driving surface. Note the longitudinal cracking.

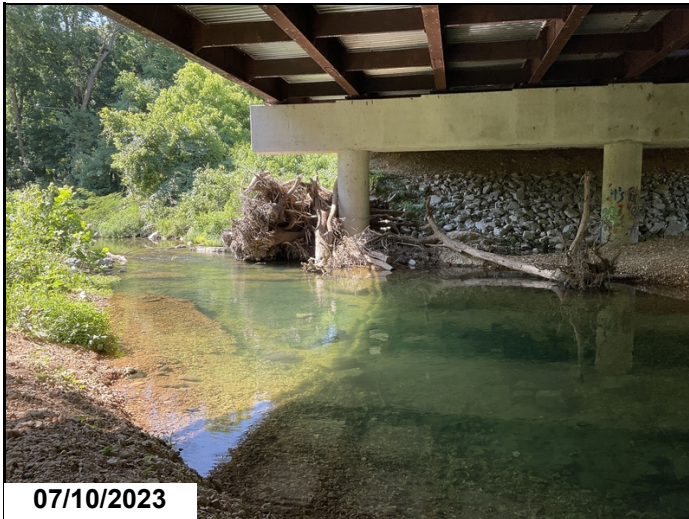
- The channel has moderate drift accumulation at bent #2.
- Large tree bent #2 column #3.

Bent #2 upstream large tree and drift is causing localized scour

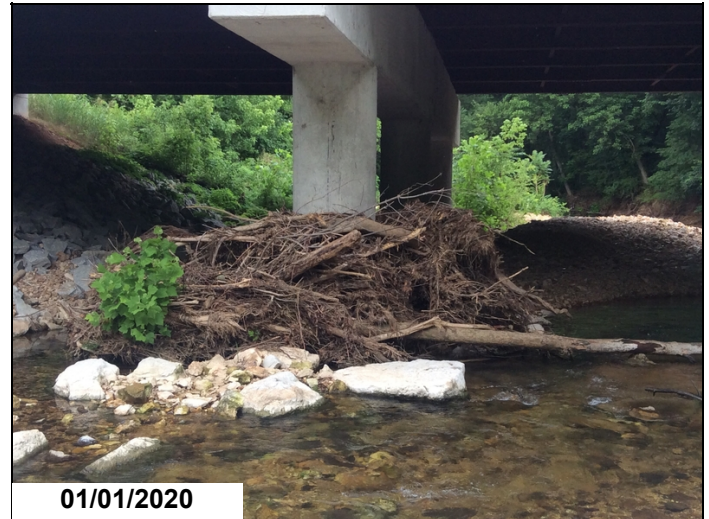
Channel-Drift accumulation at bent #2.

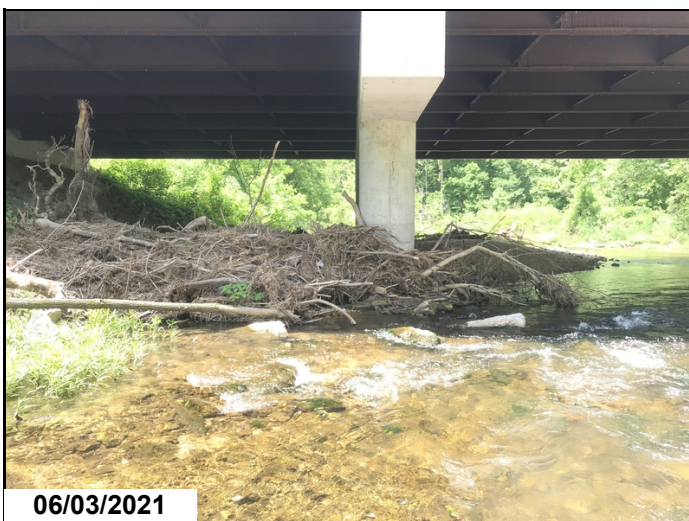
Heavy drift accumulation at bent #2

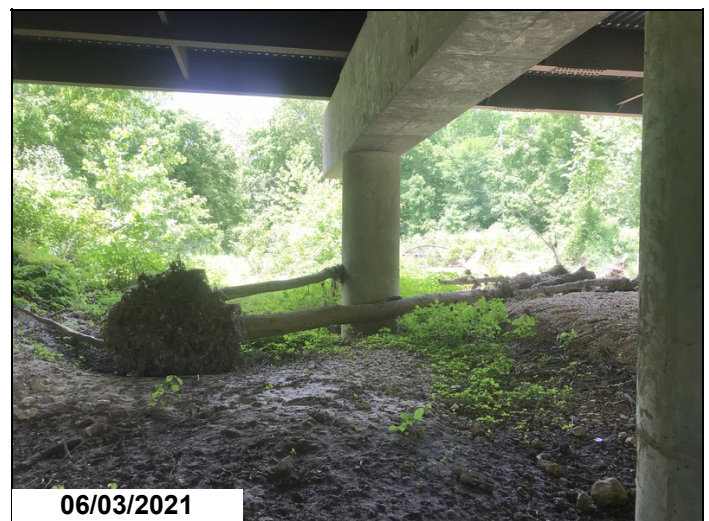
Large tree bent #2 column #3.

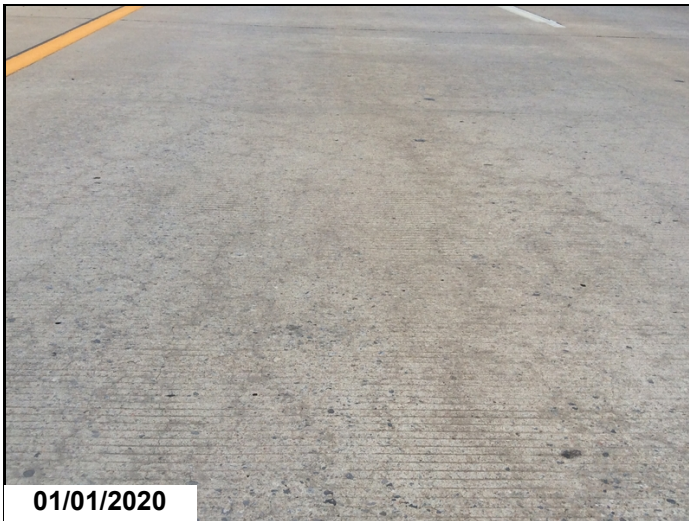
The North and South approach slabs have sealable transverse and longitudinal cracking. The South approach slab has mapcracking in the Southbound lanes.

South approach slab, Southbound lanes-Mapcracking.

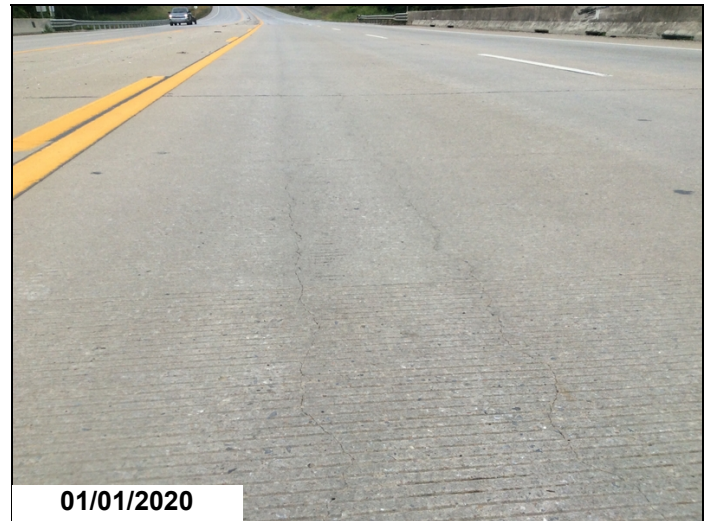
Deck / approach slabs - The driving surface of the deck has numerous full length longitudinal cracking in all spans and full width transverse cracking in several locations throughout.

Longitudinal cracking inside Southbound lane.

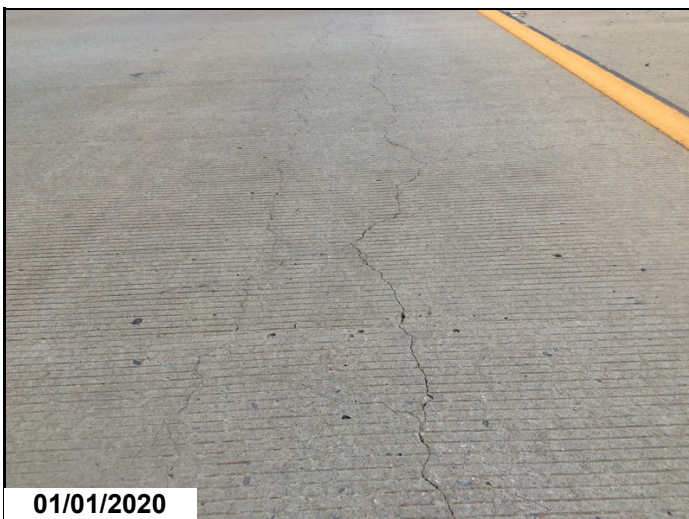
Span #3-Deck cracking.

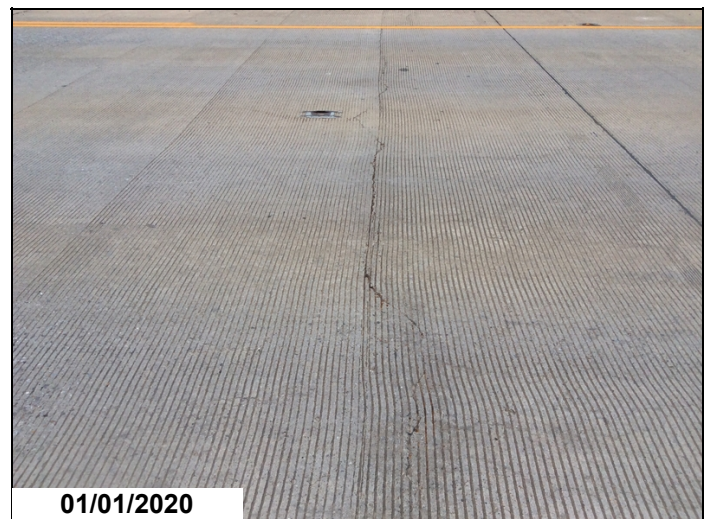
North approach slab-Transverse cracking.
