Arnold Road ID:4x59x1xA, Arnold Log mile:19.985

Asset #X1294(Routine)
SH 59 SD Benton 2 over BRANCH
Location: 0.8 MI S JCT S H 12

Team Lead: Nathan Rowland Inspection Date: 02/14/2024

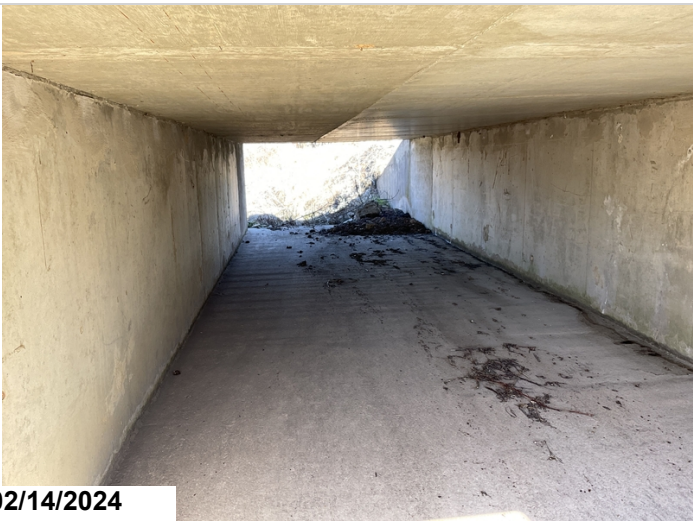
Barrel #2

| ELEMENTS | DESCRIPTION | UNITS | TOTAL | CS1 | CS2 | CS3 | CS4 |
|--|---|---|---|---|---|---|---|
| -The wingwalls are monolithic and are added to the quantity of the box culvert as of this inspection. -Wingwalls have full eight diagonal cracks. The barrel #2 left wing wall has 1' of cs2 efflorescence. -Full height vertical cracking in all barrels -Barrel 1 top slab near mid span has a transverse crack with cs2 efflorescence accumulation. Barrel #2- the back wall has 2' of cs2 efflorescence. No deficiencies noted in the barrel floor. | | | | | | | |

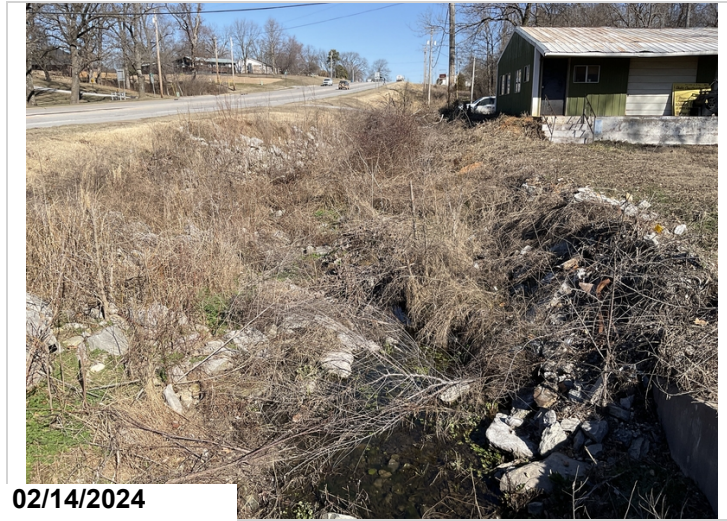
Upstream view

| ELEMENTS | DESCRIPTION | UNITS | TOTAL | CS1 | CS2 | CS3 | CS4 |
|--|---|---|---|---|---|---|---|
| The inlet end of the channel is armored with rip rap. | | | | | | | |

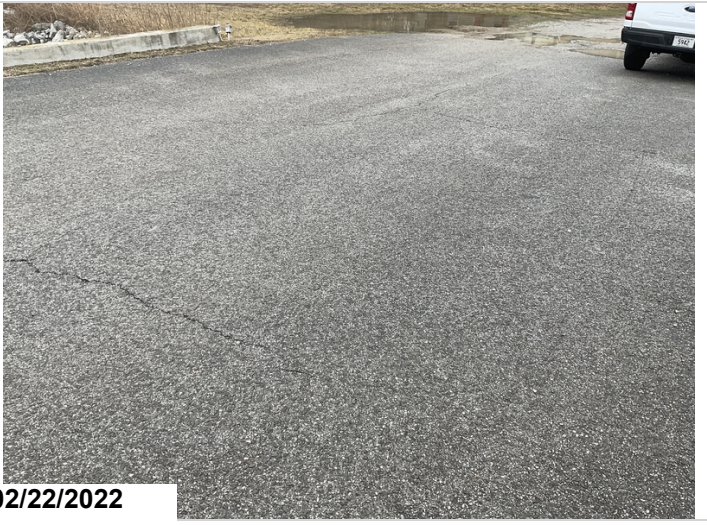
| ELEMENTS | DESCRIPTION | UNITS | TOTAL | CS1 | CS2 | CS3 | CS4 |
|--|---|---|---|---|---|---|---|
| (241) Driving surface- has an asphalt overlay with minor cracking. | | | | | | | |

Typical view of the driving surface.
