Asset #X1307(Routine)
SH 59 Benton 2 over BRANCH
Location: 0.6 MI N JCT of US 412

Team Lead: Nathan Rowland Inspection Date: 07/10/2023

General Observation

7/10/2023 WNR & DBM: Routine inspection conducted this date. See element notes for documentation.

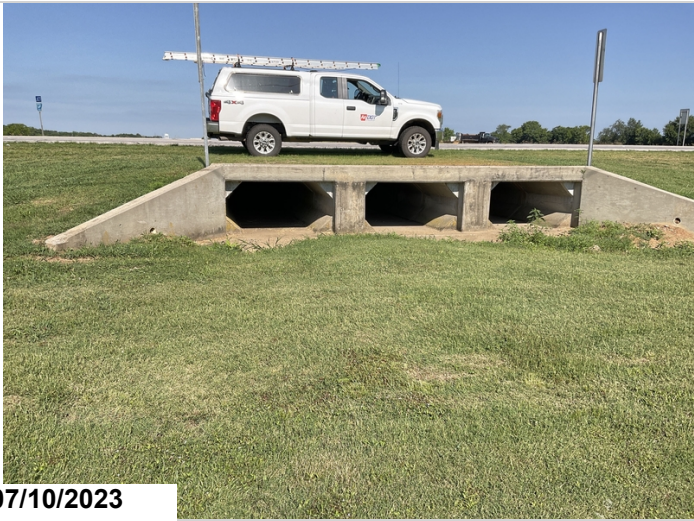
Elevation looking west

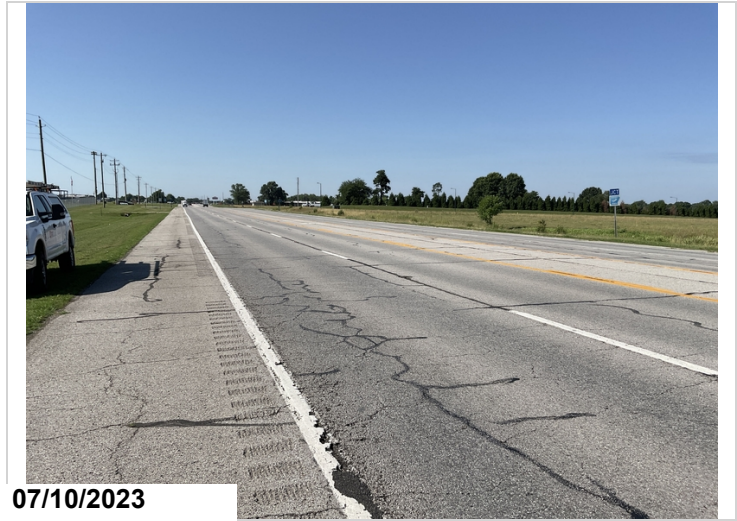
Inventory looking South

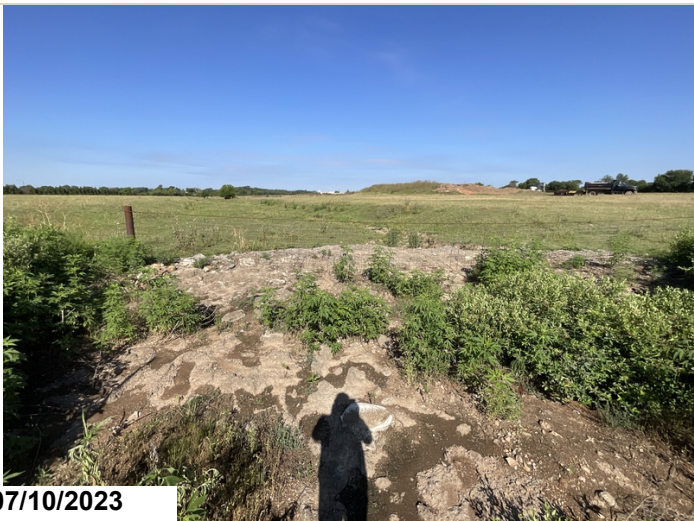
Downstream view

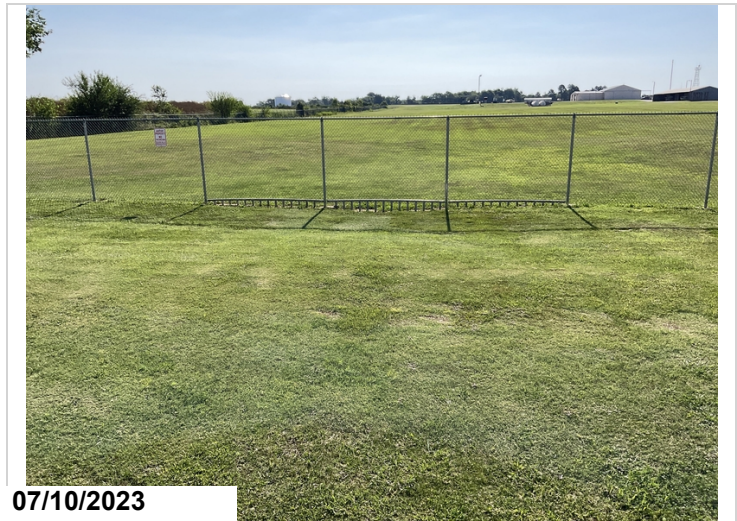
Upstream view

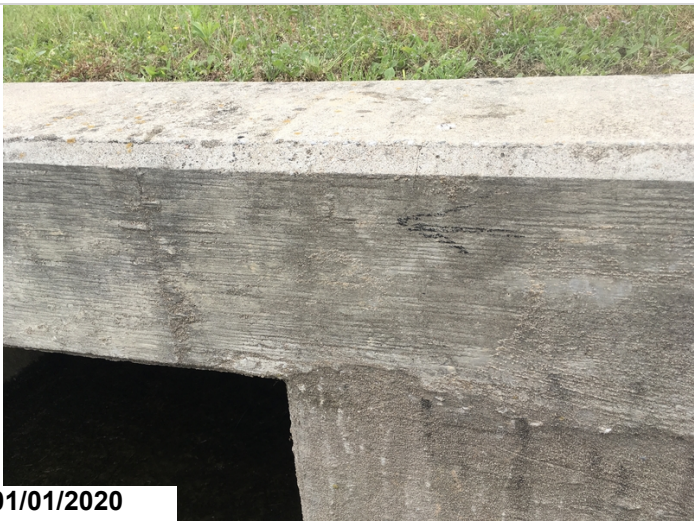
Typical cracking at the head walls.

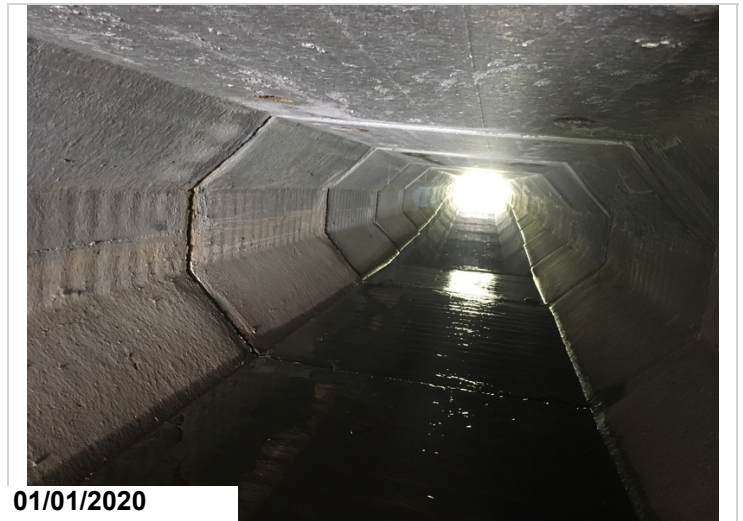
Typical view of interior of barrels.

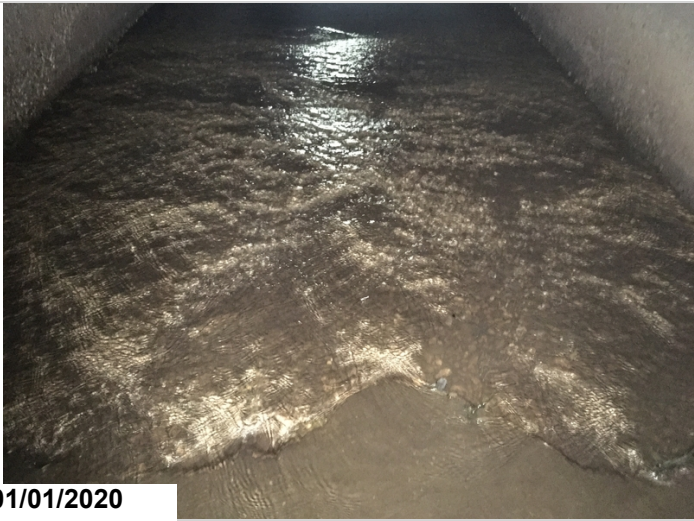
View of abrasion in barrel floor.

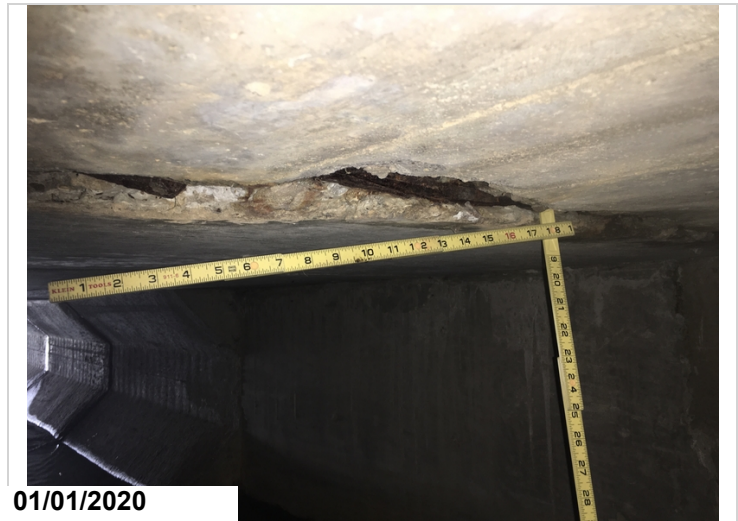
Barrel #2, top slab-Exposed reinforcing steel at construction joint where culvert was widened approximately 40' from inlet end.

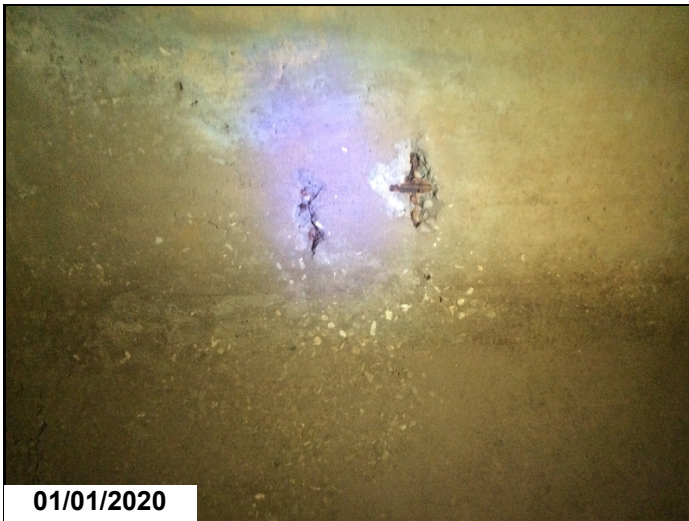
Culvert - Barrel #1, wall #1, 5th unit from right side has an area of shallow spalling with exposed reinforcing steel. The top slab of barrel #2 has exposed reinforcing steel at construction joint where culvert was widened in the past located approximately 40' from left end. The exposed reinforcing steel in both locations have active corrosion with measurable section loss.

01/01/2020
Barrel #1, wall #1, 5th unit from left side.

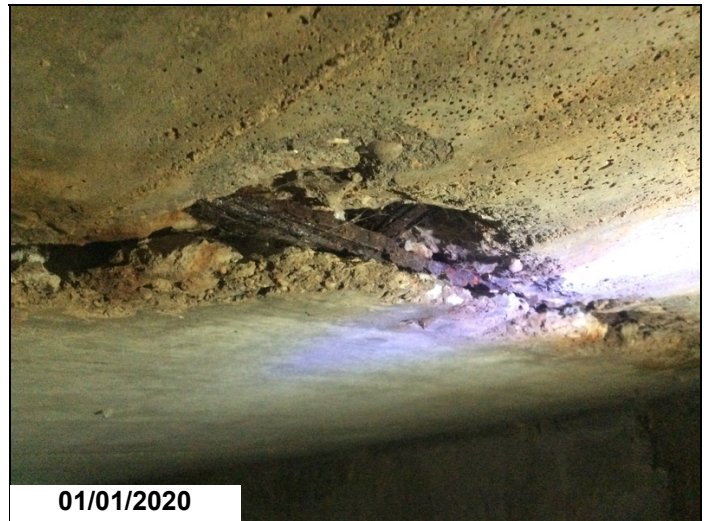
01/01/2020
Barrel #2, top slab-Exposed reinforcing steel at construction joint where culvert was widened.
