Asset #X1316(Routine)

SH 59 Benton 2 over BRANCH

Location: 1.5 MI NORTH JCT US 412

Team Lead: Nathan Rowland **Inspection Date:** 07/10/2023

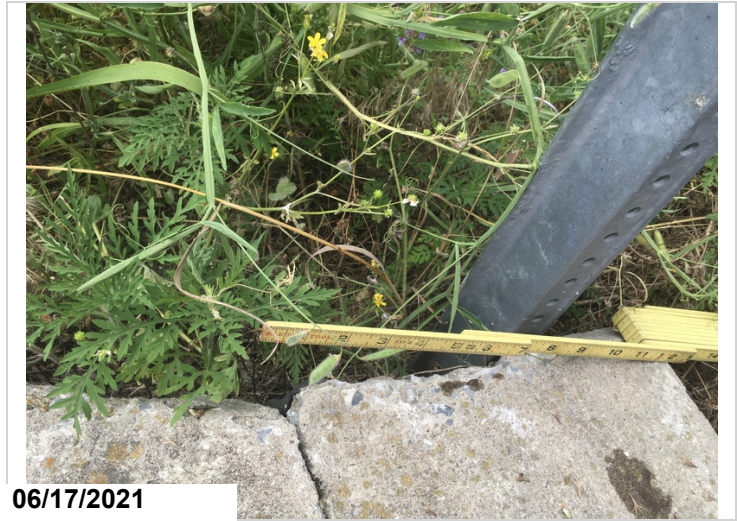
- Barrel #2 has 1' of scour at the inlet end.							
-The left headwall has areas of map cracking with efflorescence over all 3 barrels and a shallow spall at each end of the headwall.							
The right headwall has no deficiencies.

Shallow spill at the end of the left headwall.

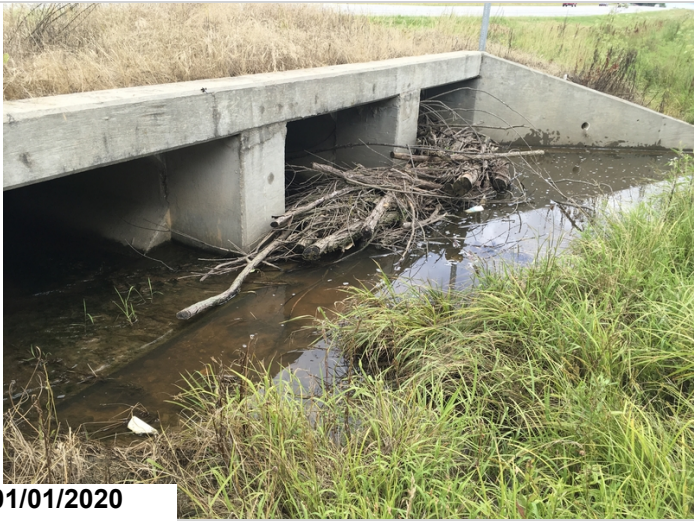
Drift accumulation at the inlet end of barrels #1,2.

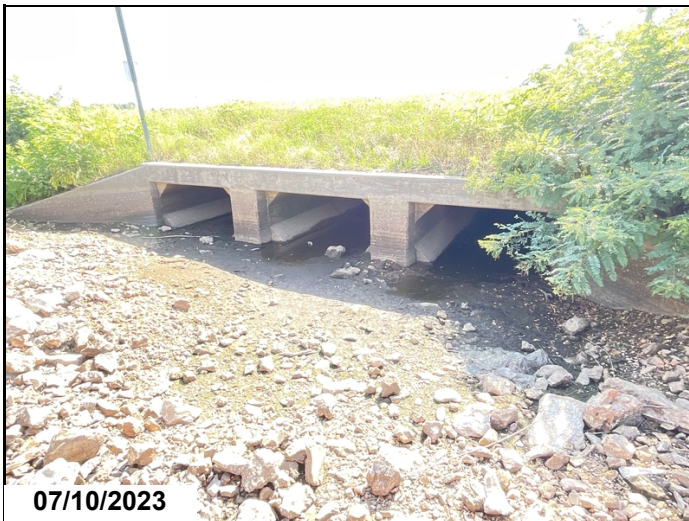
7/10/2023 WNR: Drift and debris has been remove since the last inspection

Streambed accumulation removed

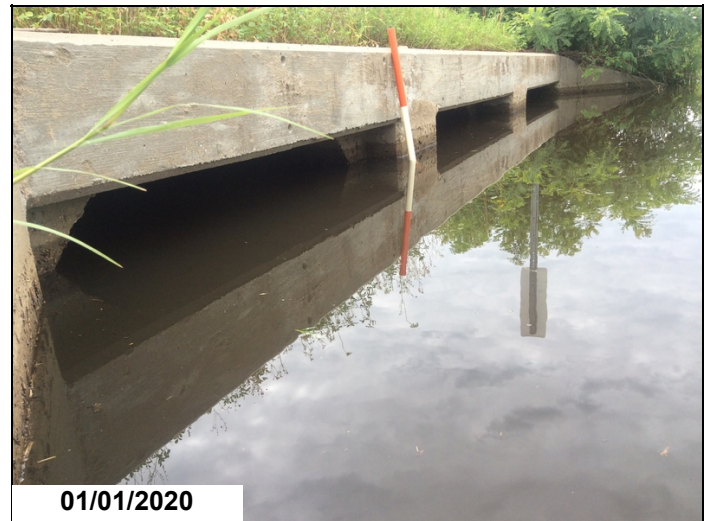
Standing water.

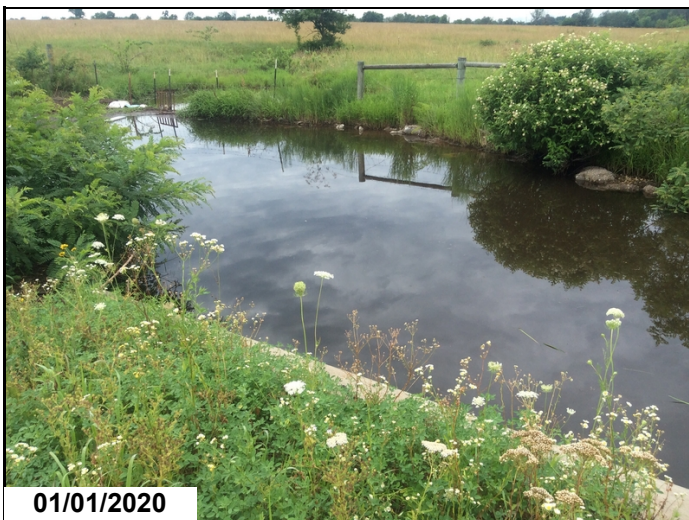
Standing water.

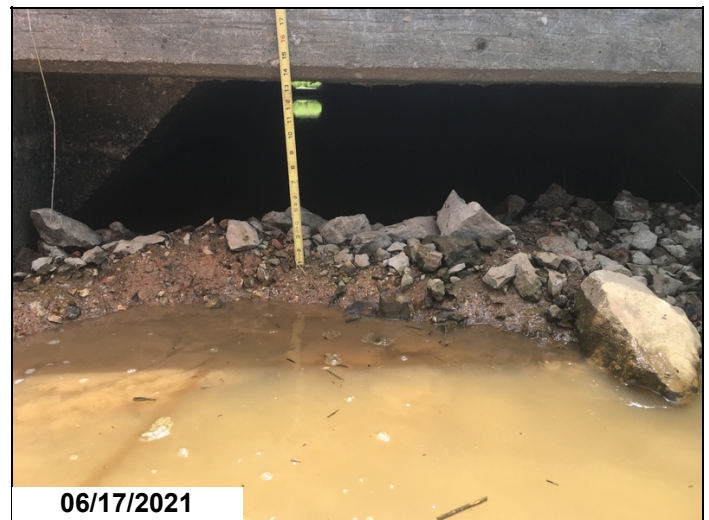
(241) 7/10/2023 WNR & DBM:							
-Top portion of pre-cast units have areas of exposed reinforcing wire/steel visible in lifting lug holes in locations.							
-The top slab portion of unit in barrel #2 near inlet end has a shallow spall with no exposed reinforcing steel.							
-The channel has stream bed material build up that restricts flow approximately 50% to barrels #2 and #3.							
Barrel #1 has 1' of stream bed material build up at the outlet end due to utility installation.							
Barrel #2 has 14" of stream bed material build up at the outlet end due to utility installation.							
Barrel #3 has 2' of stream bed material build up at the outlet end due to utility installation.

Channel - The channel and the barrel outlets have stream bed material build up due to erosion from a nearby utility being installed. the barrels gave from 12" to 24" of build up in a 36" culvert.

Barrel #3 has 2' of stream bed material build up at the outlet end.
