Asset #X1317(Routine)
SH 59 Benton 2 over BRANCH
Location: 0.9 MI S JCT SH 12

Team Lead: Nathan Rowland Inspection Date: 04/24/2023

General Observation

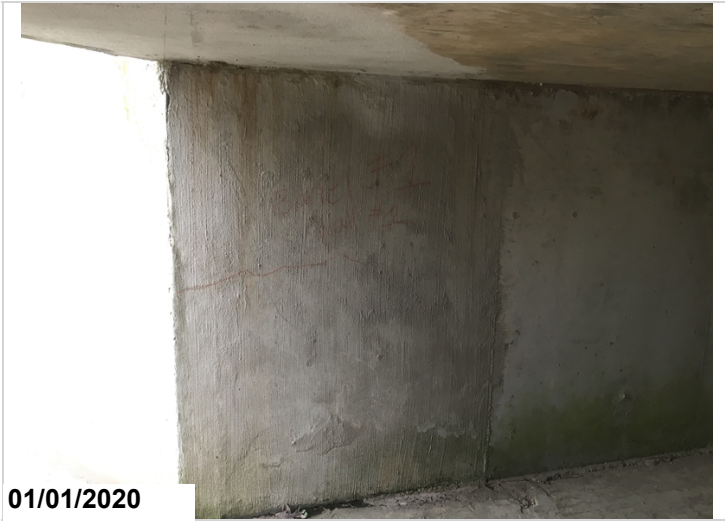
(241) 4/24/2023- WNR & DBM:							
-The East side of Barrels #1 and #2 have streambed material accumulation that restricts channel flow approximately 90%. -Channel at the outlet end has trees and vegetation growing restricting flow and promoting drift accumulation. -Barrel #1, wall #1 at the Northeast wingwall juncture has full-height vertical crack and basketball-sized spall with steel exposed. -Barrel #3, top slab has softball-sized spall with no exposed reinforcing steel adjacent to southeast wingwall. -The top slab in all barrels have numerous transverse and diagonal cracks with rust staining and efflorescence. -The walls in all barrels have hairline vertical cracks at random spacing. -Barrel #3 wall #3 right has a short duration hairline horizontal crack.

Barrel #3 wall #3 right has a short duration hairline horizontal crack.

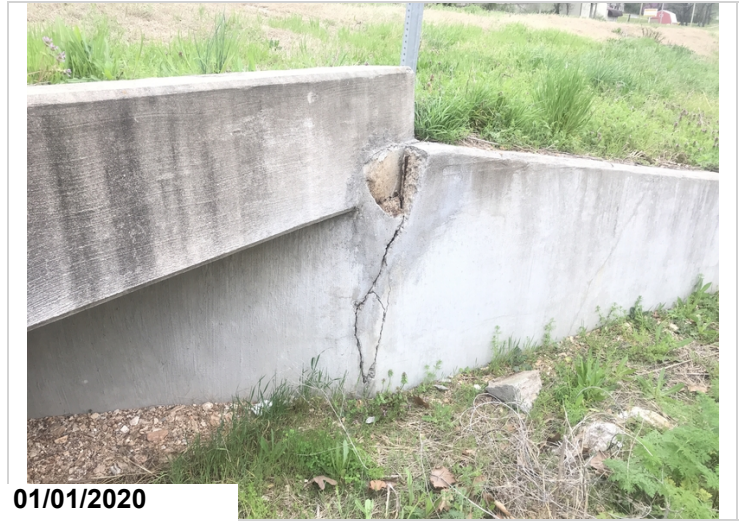
Northeast wingwall vertical cracking with basketball sized spall with steel exposed.

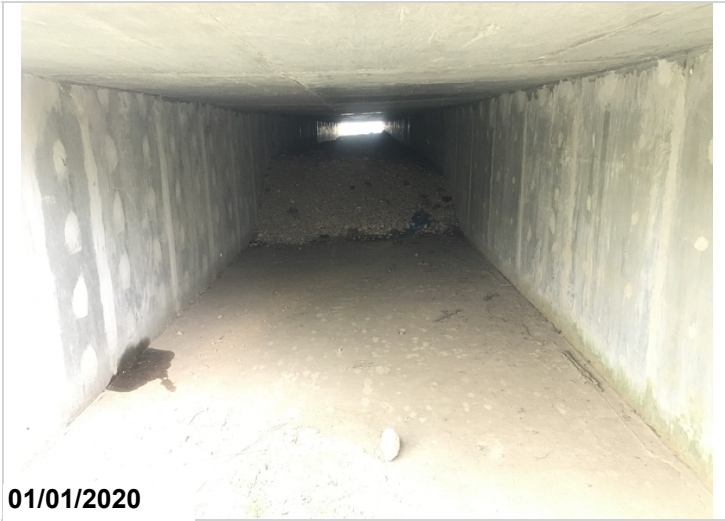
Barrel #1 has gravel accumulation restricting barrel by 60%.

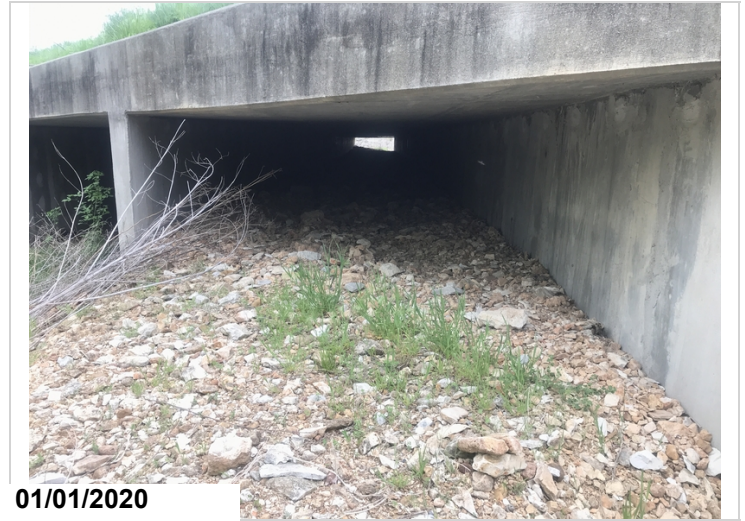
Barrel #2 has gravel accumulation restricting barrel by 60%.

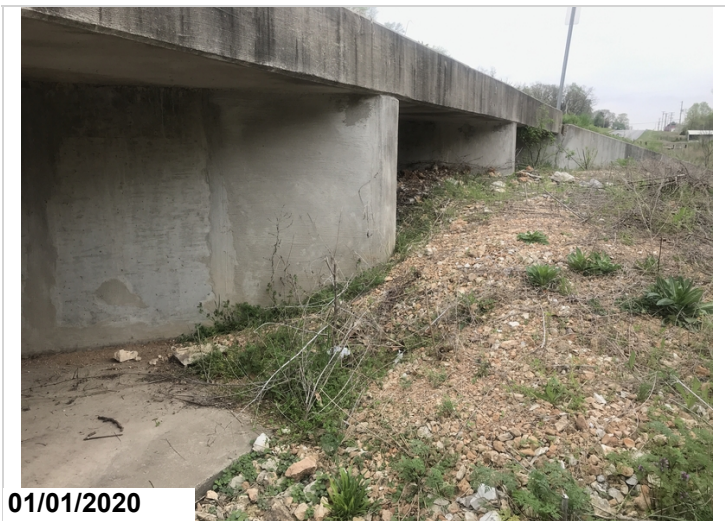
Barrels #1 & #2 left approximately 60% of gravel accumulation.

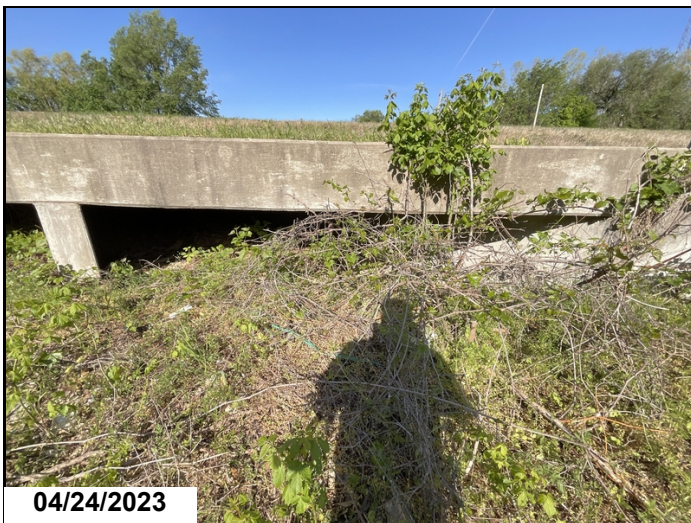
Channel - The interiors of barrels #1 and #2 have streambed material accumulation that restricts flow approximately 60%. Channel at the outlet end has trees and vegetation growing that restricts flow and promotes drift accumulation.

Barrel #1 gravel build

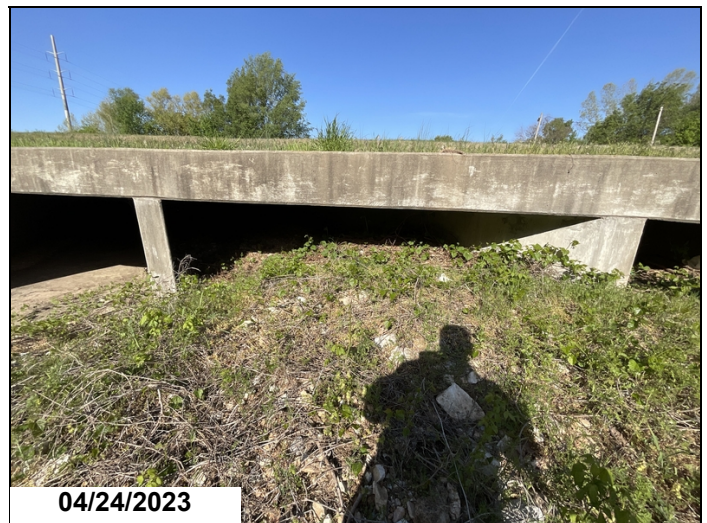
Barrel #2 gravel build

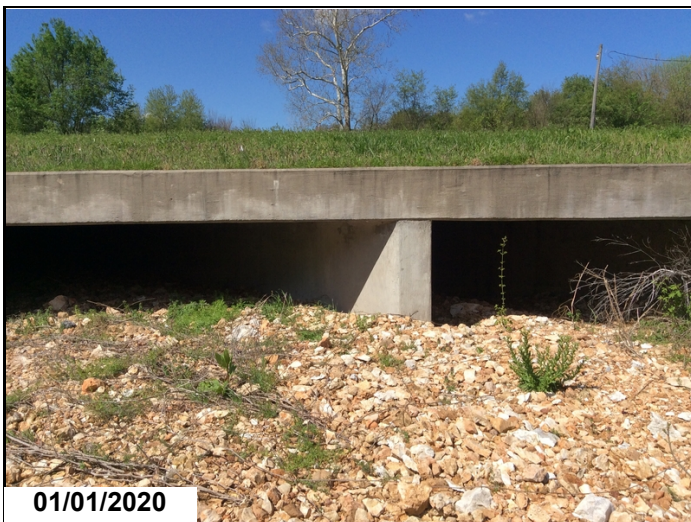
Barrels #1 & #2 have heavy gravel accumulation outlet end.

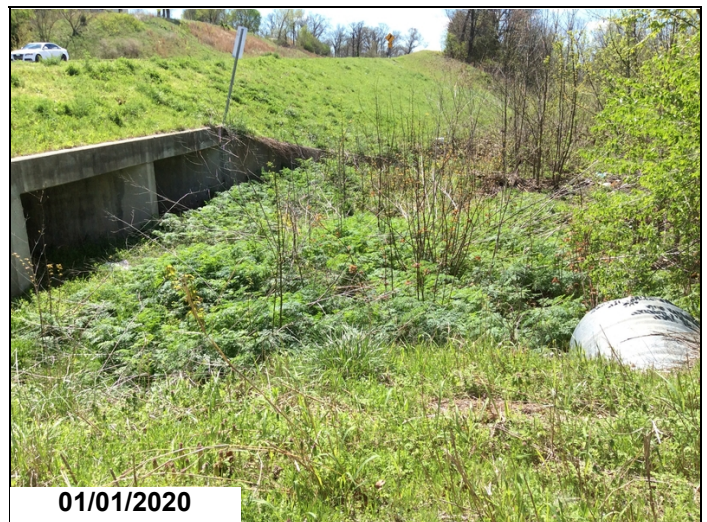
West channel has vegetation restricting water flow.

A-64 - Vegetation Removal Requested
