**Asset #X1318(Routine)**  
**SH 59 Benton 2 over BRANCH**  
**Location: 2.1 MI N JCT of US 412**

**Team Lead: Nathan Rowland Inspection Date: 07/10/2023**

7/10/2023 WNR & DBM: Routine inspection conducted this date. See Element notes for documentation.

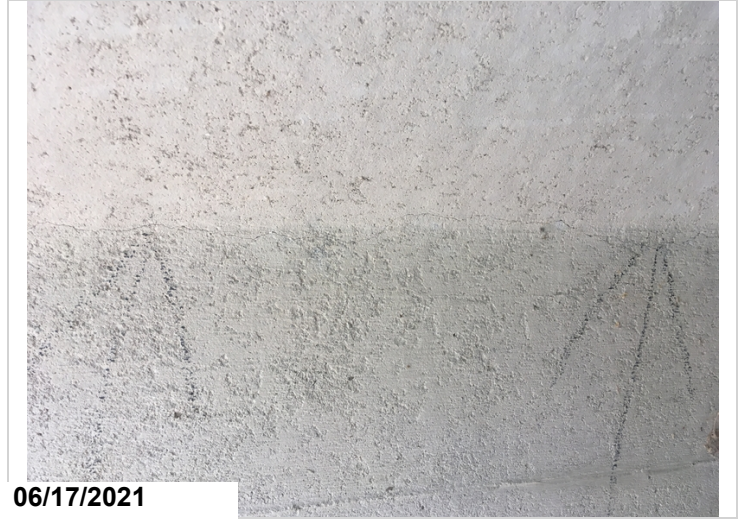
06/17/2021

Hairline horizontal cracking at the upper haunch area in precast units.

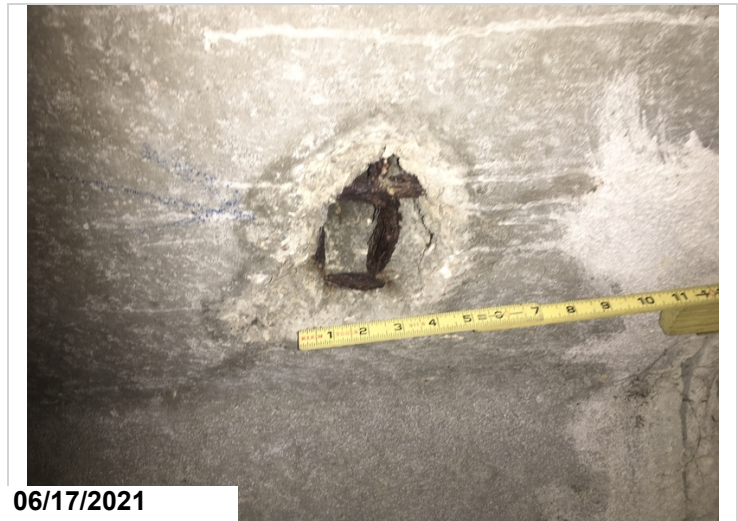
06/17/2021

Unit #10 has a spall with rebar exposed in the top slab at a lifting lug area.

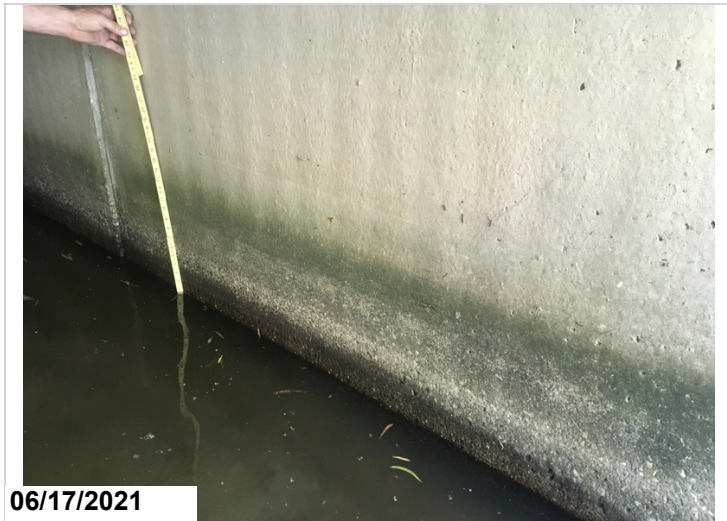
Abrasion on the lower 2' of all precast units in barrel #1.

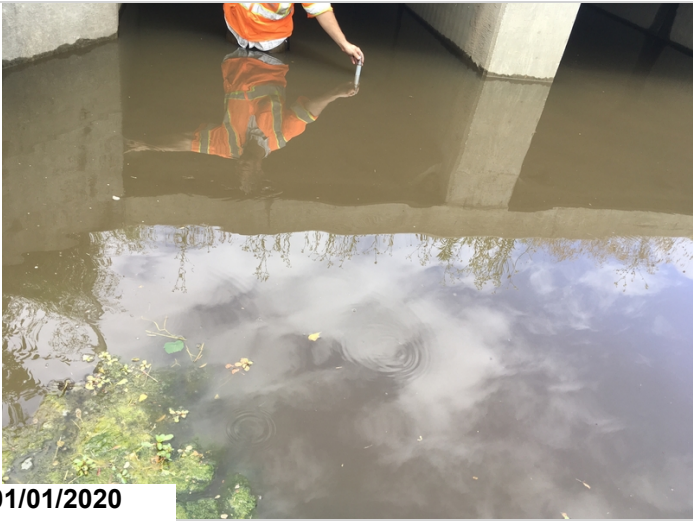
The inlet end of barrel #3 has a 2' deep scour hole.

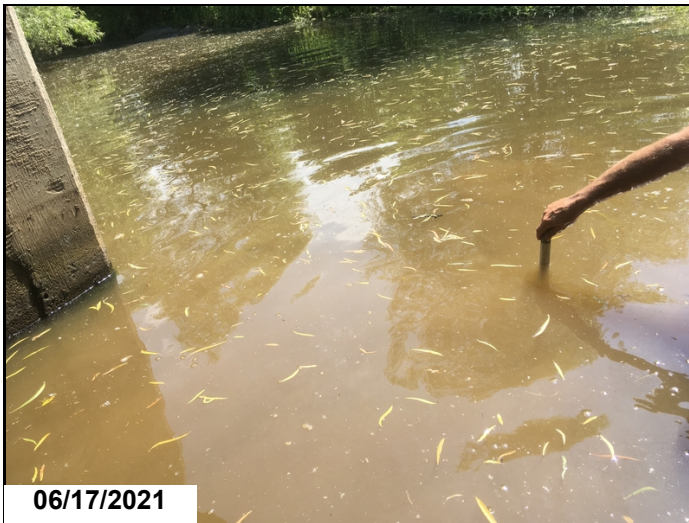
The outlet end of barrels #2,3 have a 3' deep scour pocket with no undermining of the precast units.

Barrels #2,3 have 3' of scour at the outlet end.

**Priority:** D- Routine

**Type of Work:** Repair (General)

**Status:** Monitor
