Asset #06396(Routine)

US 62 S-5 Carroll over DRY CREEK

Location: 5.46 MI NW BOONE CO LINE

Team Lead: Nathan Rowland Inspection Date: 08/08/2023

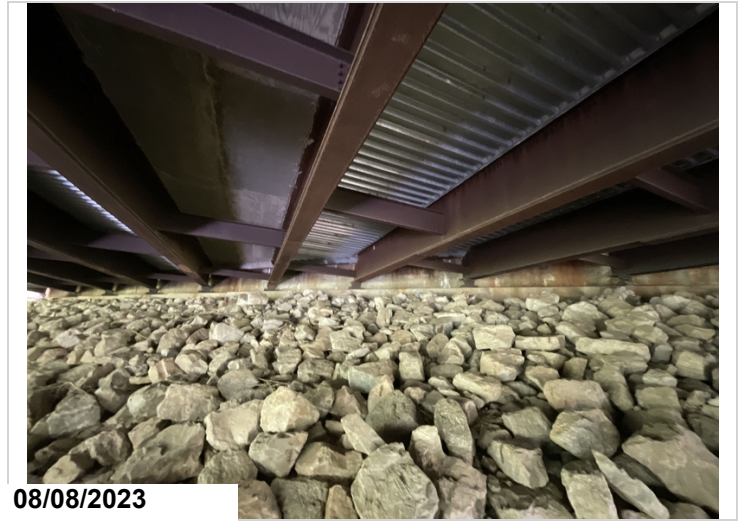
View of abutment #1 bearing area

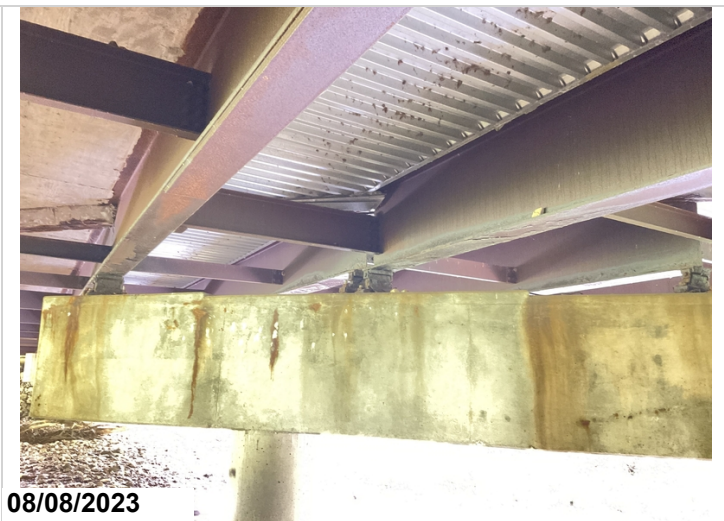
(311) 8-8-2023 WNR & DBM:							
Abutment #1 moveable bearings- 9 of the 10 have cs3 corrosion with flaking rust and minor section loss. Bearing #5 has cs2 corrosion due to leaking joint seals. Bearing #10 at abutment #1 has the exterior anchor bolt missing.							
Bent #1 bearings- 7 of 10 moveable bearings have cs3 corrosion with flaking rust, the remaining 3 have cs2 corrosion.							
Bent #2 bearings- bearings #1,5,6,7,8,9 have cs3 corrosion. Bearings #2,3,4,10 have cs2 corrosion.							
313	Fixed Bearing	EA	30	7	7	16	0
1000	Corrosion	EA	23	0	7	16	0
515	Steel Protective Coating	SF	30	7	0	7	16
3430	Oxide Film Degradation Color/Texture Adherence(Steel Protective Coatings)	EA	23	0	0	7	16

Bent #1 girders at bearing #7 have flaking rust adjacent to expansion joint

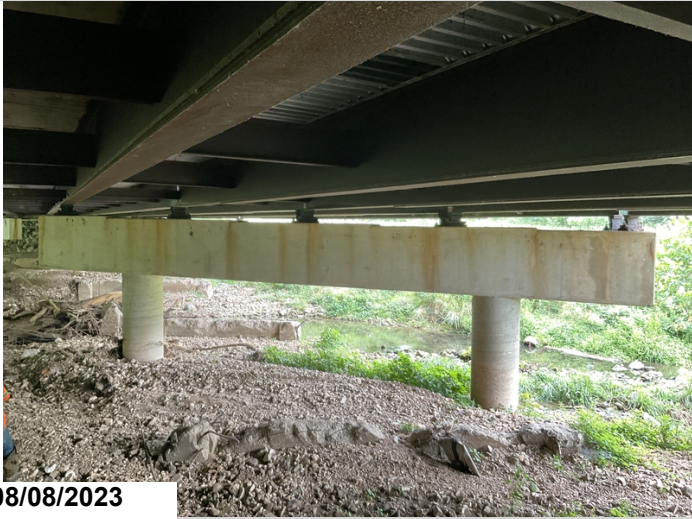
Bent #2 left side ahead side

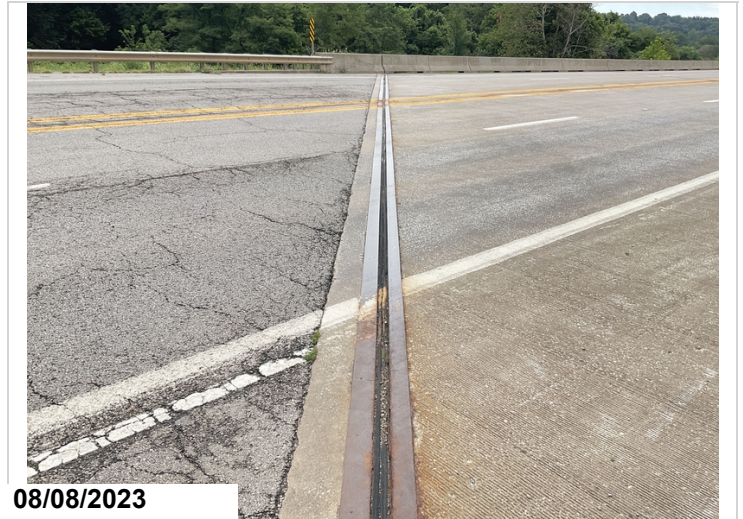
ELEMENTS	DESCRIPTION	UNITS	TOTAL	CS1	CS2	CS3	CS4
2320	Seal Adhesion	LF	158	0	158	0	0
2330	Seal Damage	LF	64	0	64	0	0
(302) 8-8-2023 WNR & DBM:							
Abutment #1 seal- is leaking for the full width of the abutment with pack rust on the armoring plates that is causing the seal to lose adhesion and leak.							
Bent #1 seal- has pack rust on the armoring plates that is causing the seal to lose adhesion and leak.							
Bent #2 seal- has pack rust on the armoring plates that is causing the seal to lose adhesion and leak.							
Abutment #2 seal- has 64' of damage with pack rust on the armoring plates that is causing the seal to lose adhesion and leak.							
311	Movable Bearing	EA	30	0	8	22	0
1000	Corrosion	EA	30	0	8	22	0
515	Steel Protective Coating	SF	30	0	0	8	22
3430	Oxide Film Degradation Color/Texture Adherence(Steel Protective Coatings)	EA	30	0	0	8	22

View of joint at abutment #1

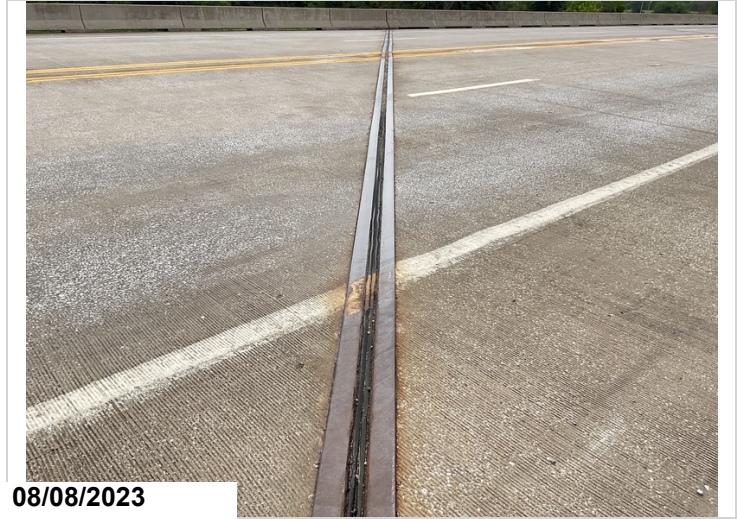
View of joint at bent #1

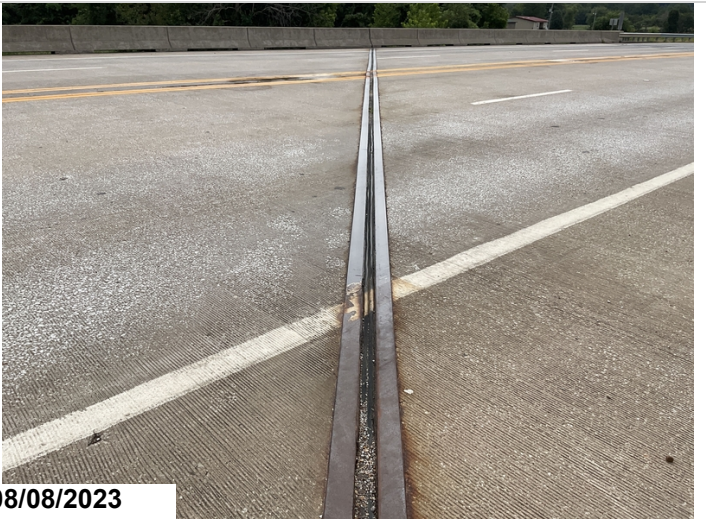
View of joint at bent #2

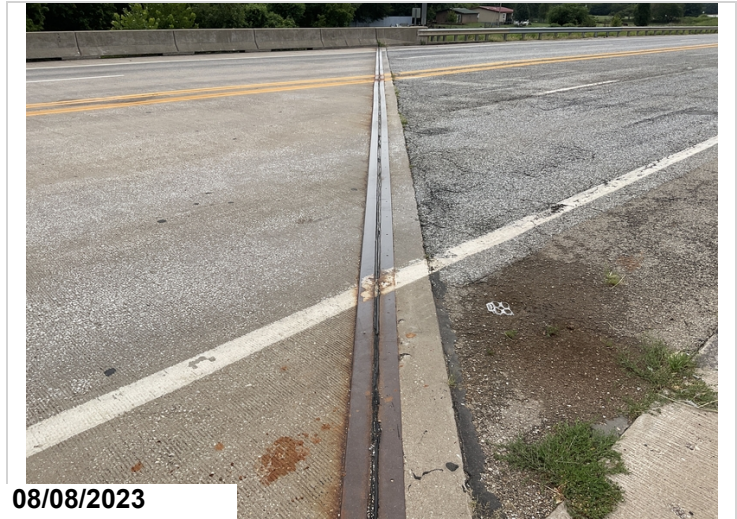
View of joint at abutment #2

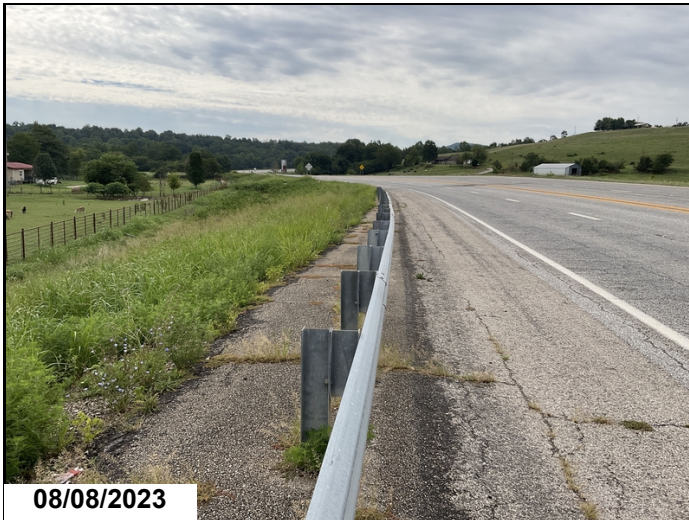
08/08/2023

The left ending approach railing has vehicle damage.

The left ending approach railing has vehicle damage.
Repaired since the last inspection

8/8/2023 WNR: The left ending approach railing has vehicle damage. Repaired since the last inspection

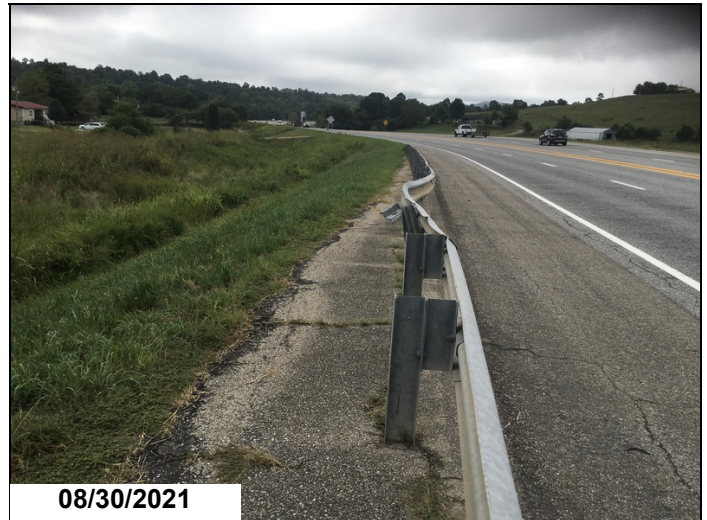
08/30/2021

The left ending approach railing has vehicle damage.

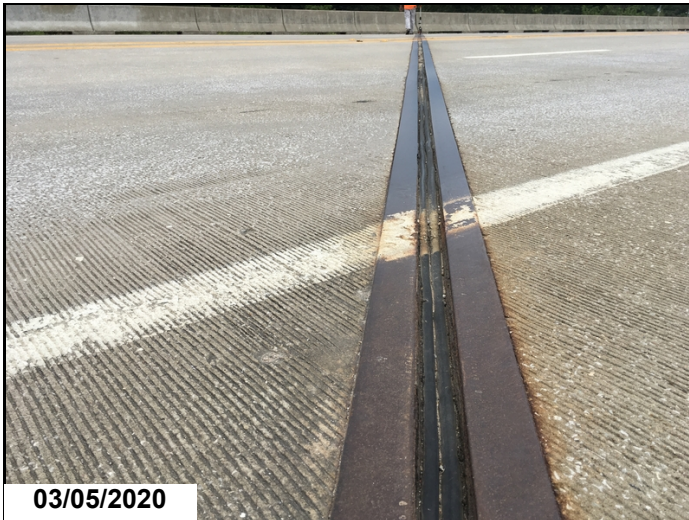
Deck- the expansion joints have leakage and loss of adhesion that is causing heavy corrosion of the beam ends and bearings.

Condition of joint seal #2. Typical of joint seal # 2,3.

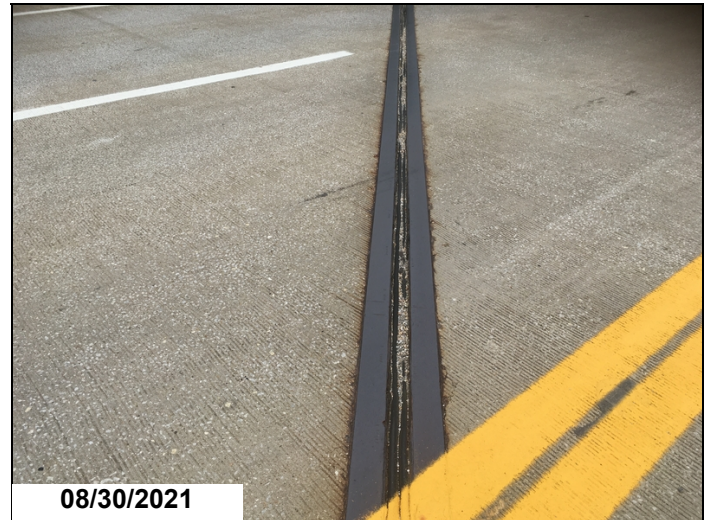
Seal condition at bent #1.

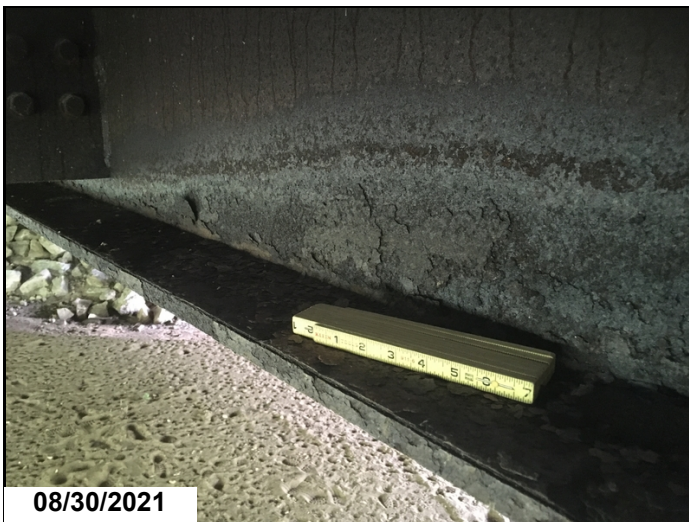
15' of Cs3 corrosion on beam #6 at the end of span #1.

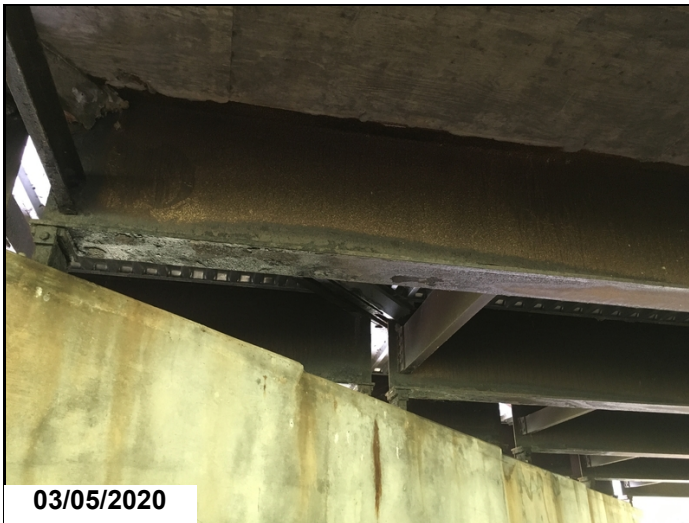
The beam ends, bottom flanges and bearings under the joint seal locations have corrosion due to leaking joint seals.

Typical bottom flange corrosion in span #1. Typical of many locations.

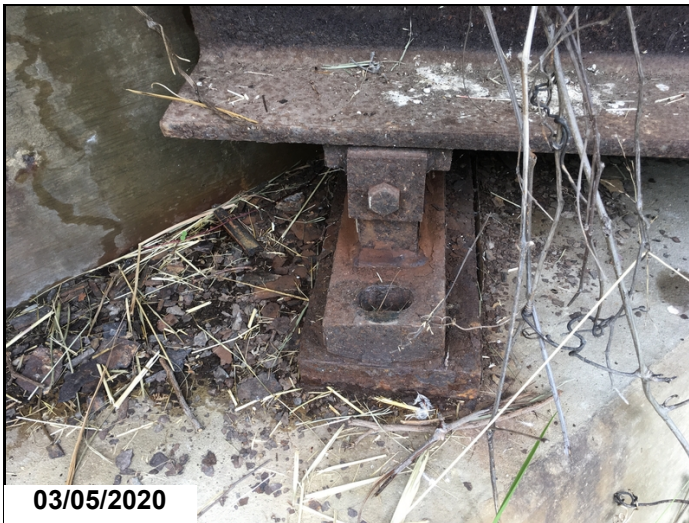
The exterior anchor bolt is missing on beam #10 at abutment #1.

Missing anchor bolt under beam #10.
