Asset #M1098(Routine)

US 62 Carroll over DITCH

Location: 0.4 miles West of SH 21

Team Lead: Benjamin Smith Inspection Date: 07/08/2024

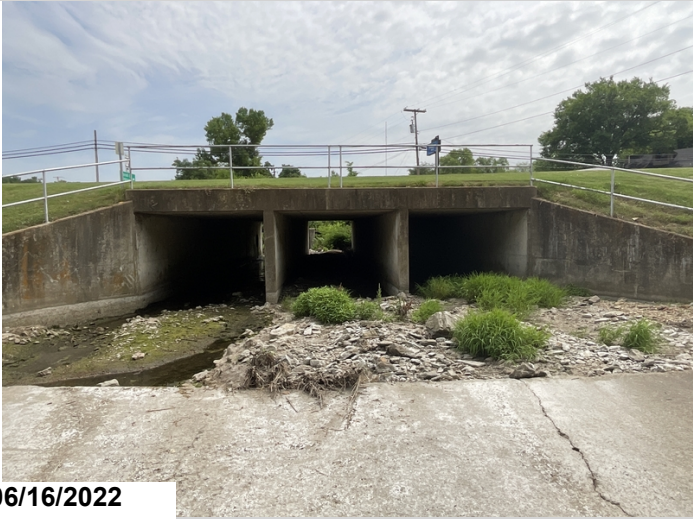
06/16/2022

Elevation with log left to right

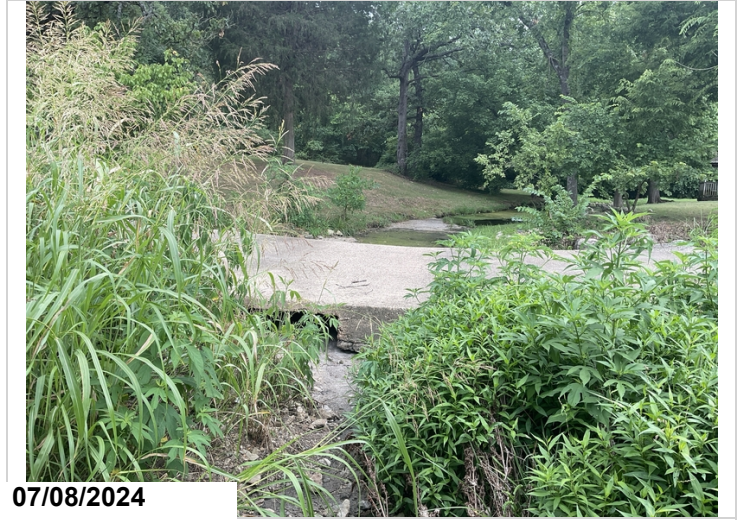
07/08/2024

The downstream channel is well vegetated. The visible portion of the channel bottom is solid rock. The downstream channel has a low water slab crossing.

Downstream channel view.

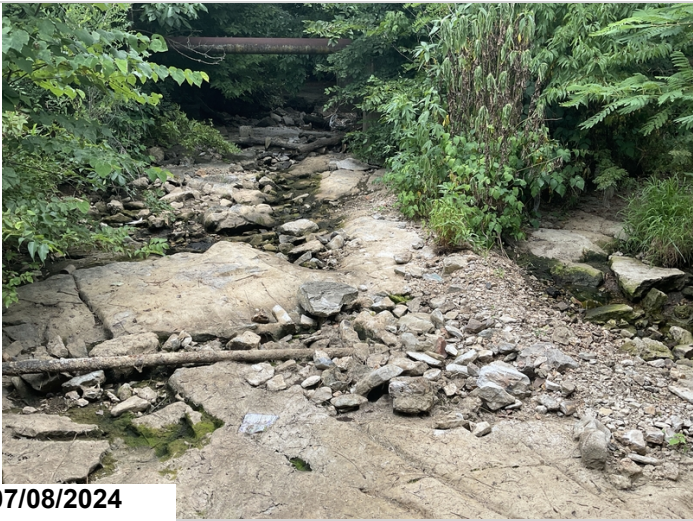
07/08/2024

61 - Channel/Channel Protection (7 - Bank protection is in need of minor repairs. River control devices and embankment protection have a little minor damage. Banks and/or channel have minor amounts of drift.)
The upstream channel is well vegetated. The visible portion of the channel bottom is solid rock. The upstream channel has an elevated utility crossing.

Upstream channel view.

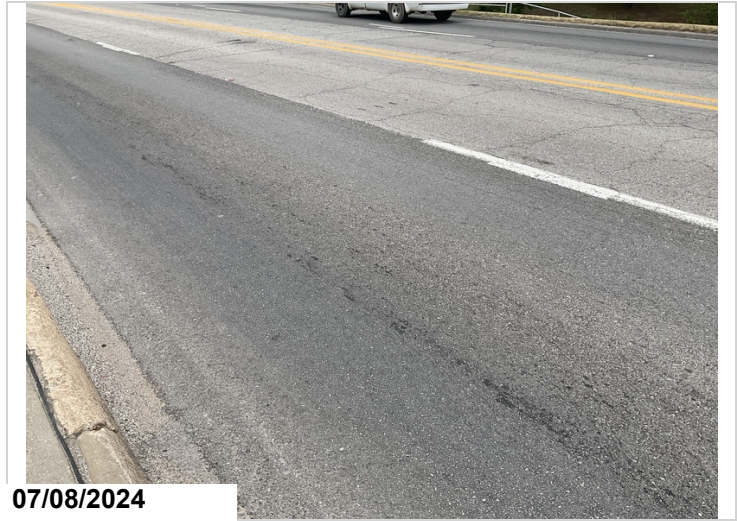
07/08/2024

Driving surface view.

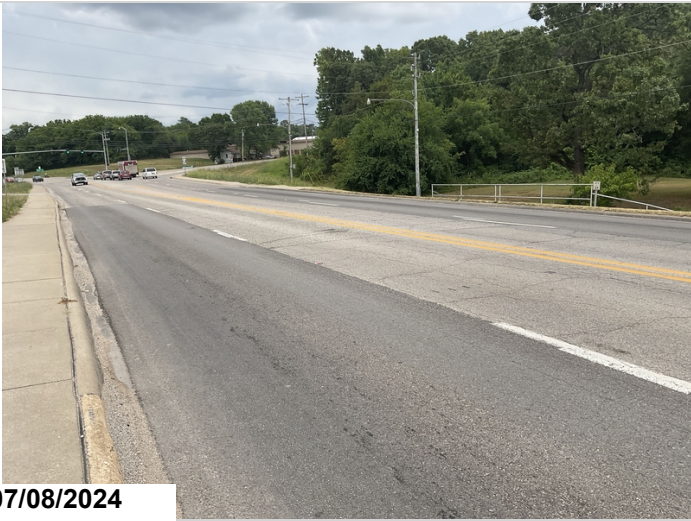
Approach view in direction of log mile.

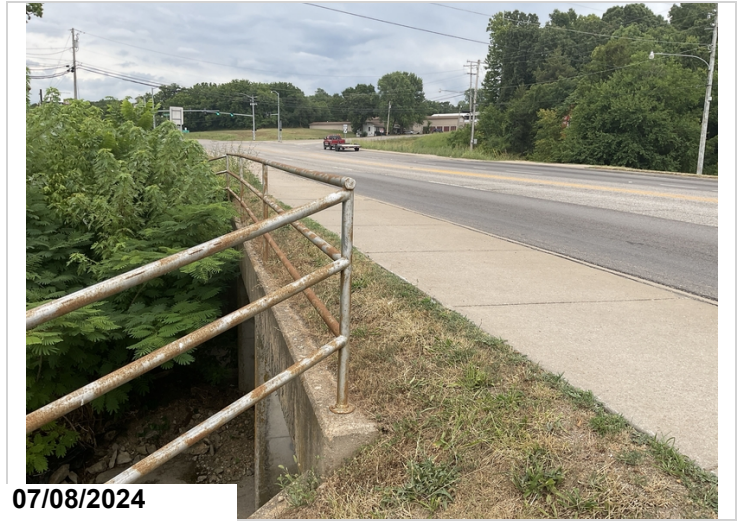
(330) The left side and right sides of the structure have welded metal pipe pedestrian hand railing.							
<p>Left hand railing- No deficiencies noted.</p> <p>Right hand rail- No deficiencies noted.</p>

Metal railing condition typical.
