Asset #M1099(Routine)

US 62 Carroll over DITCH

Location: 1.74 Miles East of SH 21

Team Lead: Benjamin Smith Inspection Date: 06/25/2024

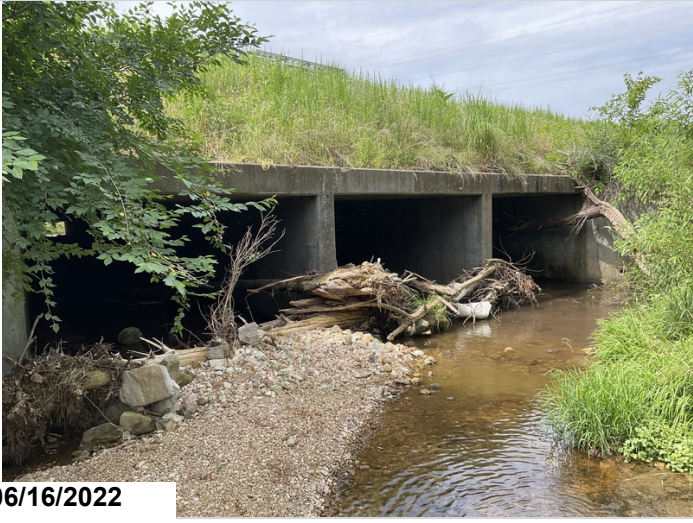
Elevation view.

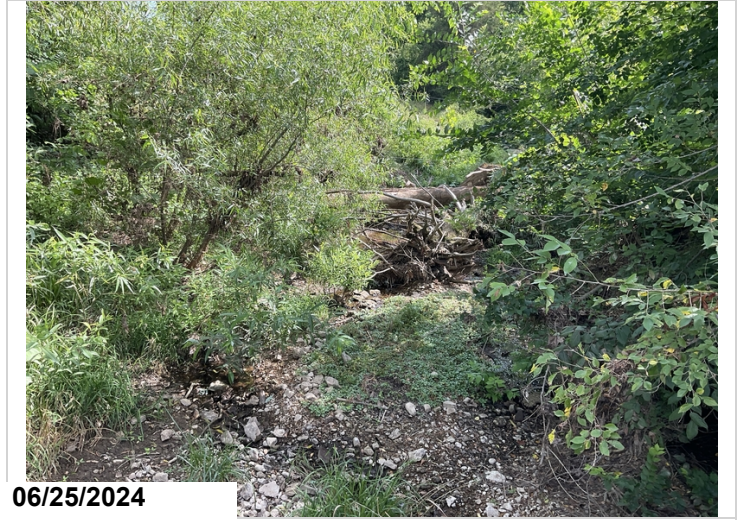
The upstream channel is well vegetated. The inlet end of the structure has a large drift accumulation.

Upstream channel view

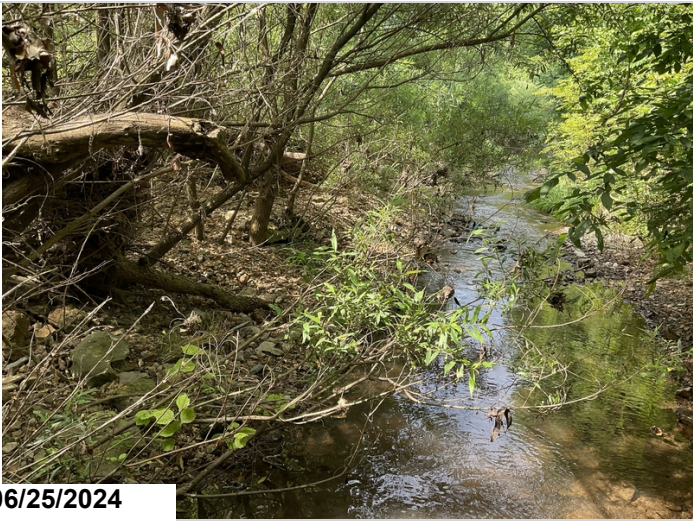
The downstream channel has aggradation with small trees growing in the channel. The channel banks are well vegetated.

Downstream channel view.

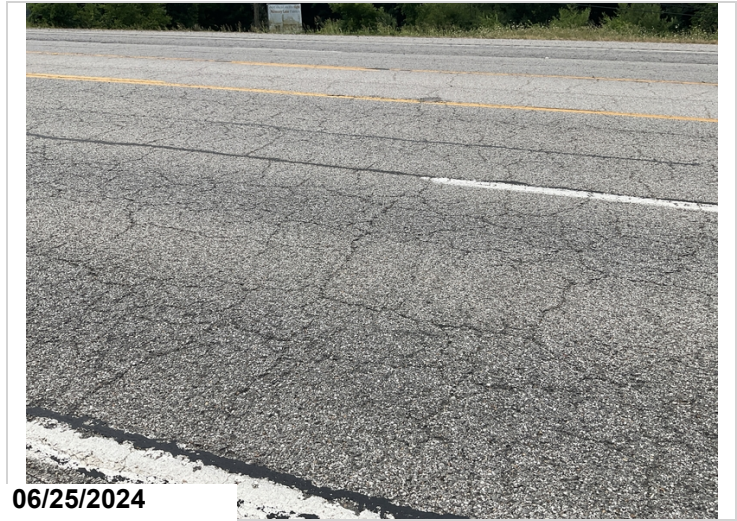
(241) Driving surface- has an asphalt overlay with unsealed cracking.
None of the original 1930 structure remains.

Driving surface view.

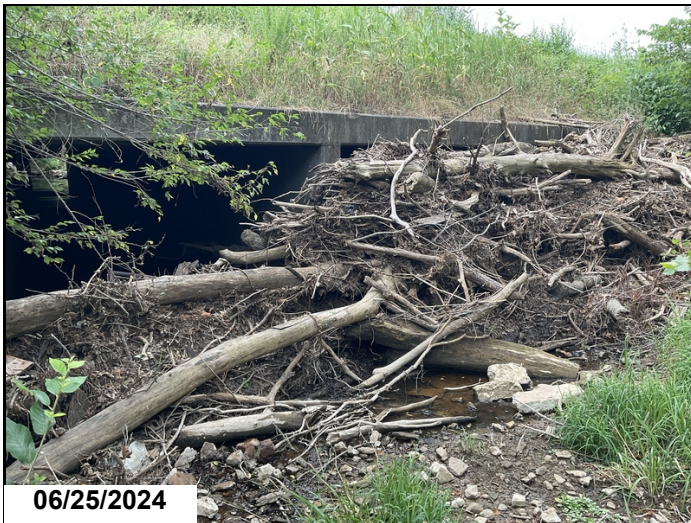
The inlet end has a large drift accumulation that is fully blocking barrels #1,2.

Drift accumulation across all three barrels.

Type of Work: Channel Work/Drift Removal

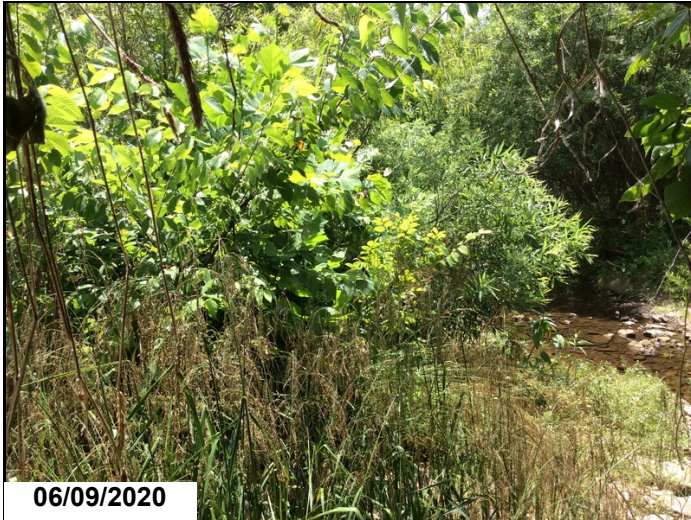
The channel has streambed accumulation and trees in the channel at barrels #1,2 at the outlet end.

Heavy growth of vegetation at outlet end of structure.

Type of Work: Channel Work/Drift Removal
