Asset #M1100(Routine)

US 62 Carroll over DITCH

Location: 2.07 Miles East of SH 21

Team Lead: Benjamin Smith Inspection Date: 06/25/2024

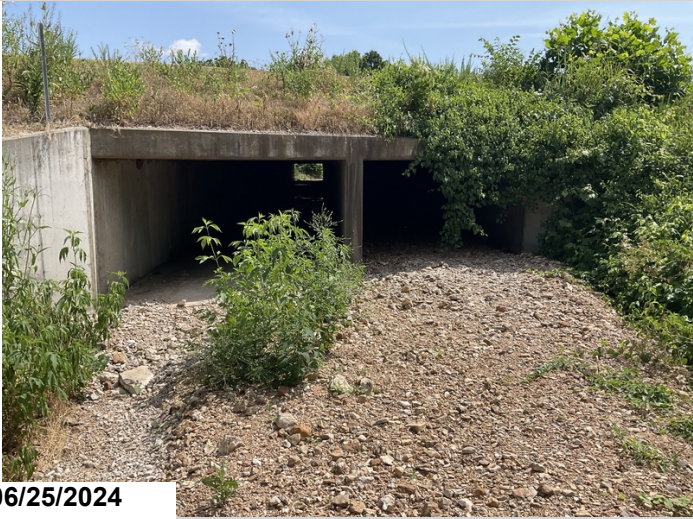
Elevation view.

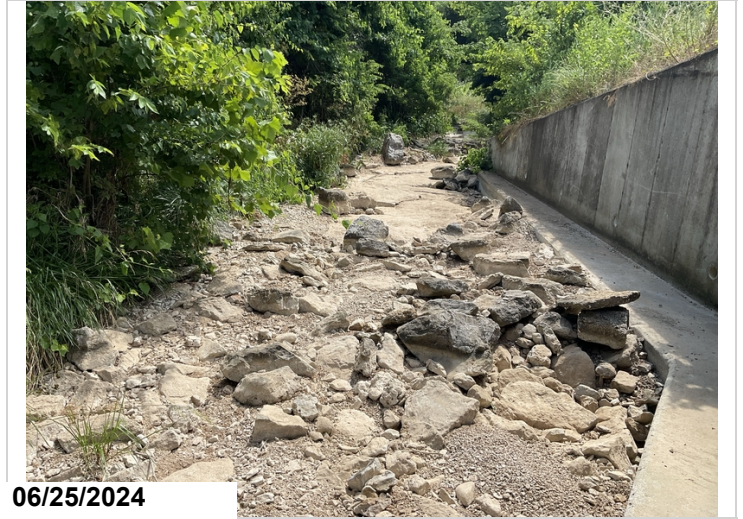
**61 - Channel/Channel Protection** (7 - Bank protection is in need of minor repairs. River control devices and embankment protection have a little minor damage. Banks and/or channel have minor amounts of drift.)  
The upstream channel banks are well vegetated. Exposed solid rock is visible in the upstream channel.

Upstream channel view.

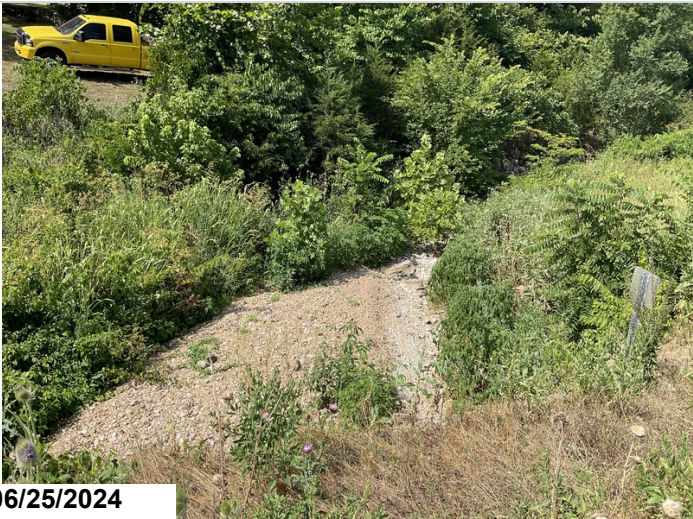
The downstream channel banks are well vegetated.

Downstream channel view.

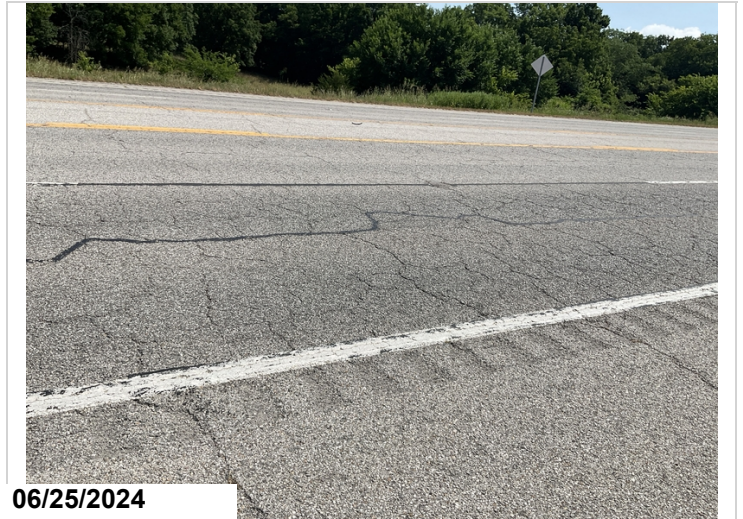
Driving surface view.

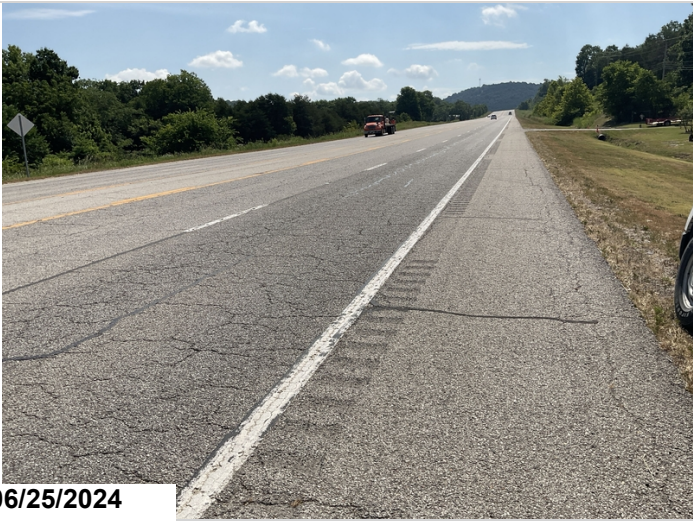
Approach view in direction of log mile.
