Asset #M1101(Routine)

US 62 Carroll over DITCH

Location: 3.18 Miles East of SH 21

Team Lead: Benjamin Smith Inspection Date: 06/25/2024

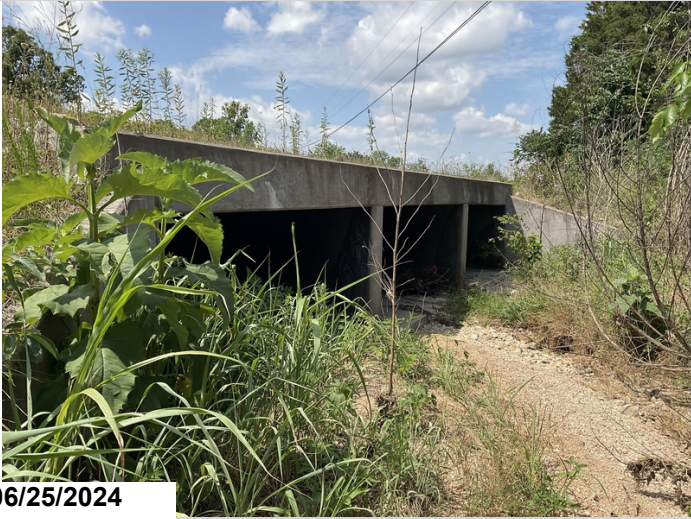
Elevation view.

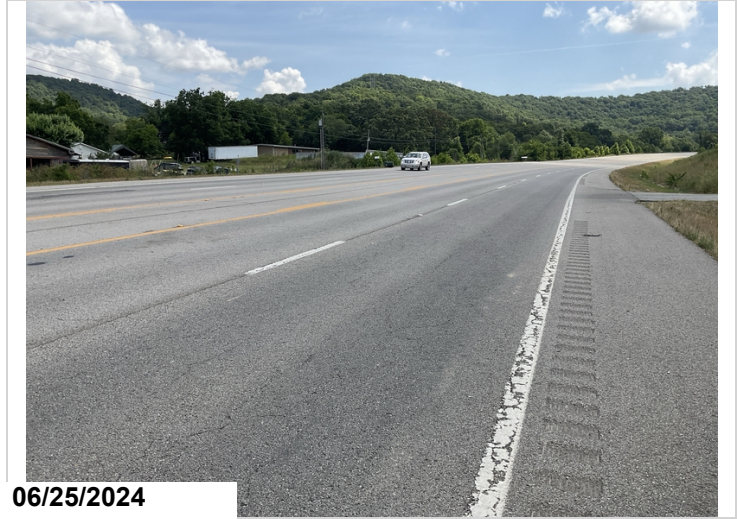
Approach view in direction of log mile.

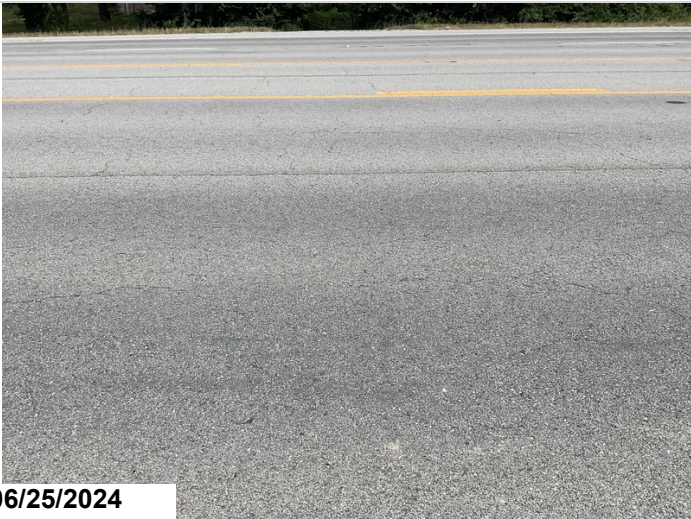
Driving surface view.

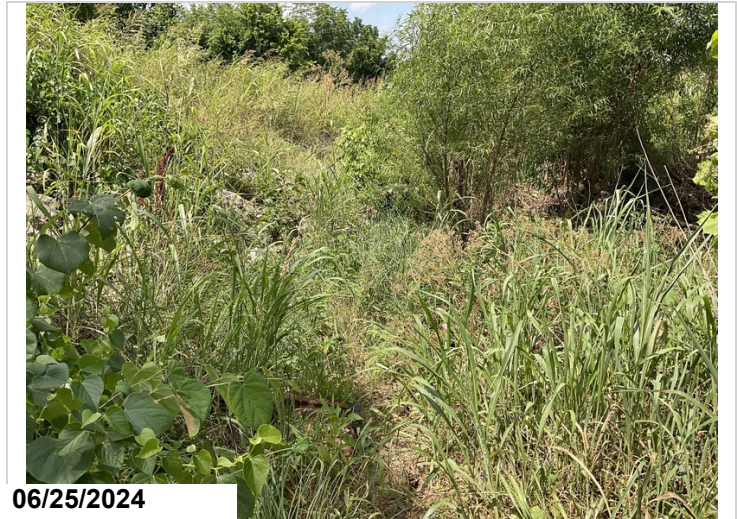
The downstream channel has rock channel protection on the left channel bank.

Downstream channel view.

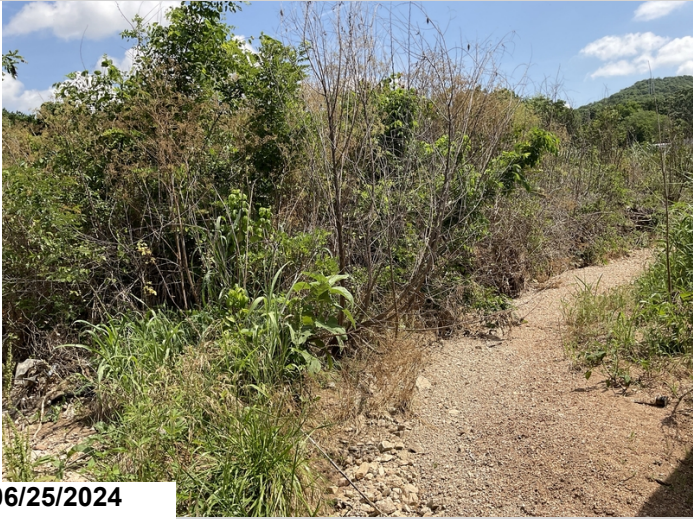
61 - Channel/Channel Protection (7 - Bank protection is in need of minor repairs. River control devices and embankment protection have a little minor damage. Banks and/or channel have minor amounts of drift.)
The upstream channel is well vegetated and has rock channel protection on the right hand side that is functioning as intended. The upstream channel has two separate creeks that converge near barrel #2.

Upstream channel view.
