Asset #X1656(Routine)

US 62 over Creek

Location: 6.85 miles West of the Boone Co line

Team Lead: Benjamin Smith Inspection Date: 08/21/2024

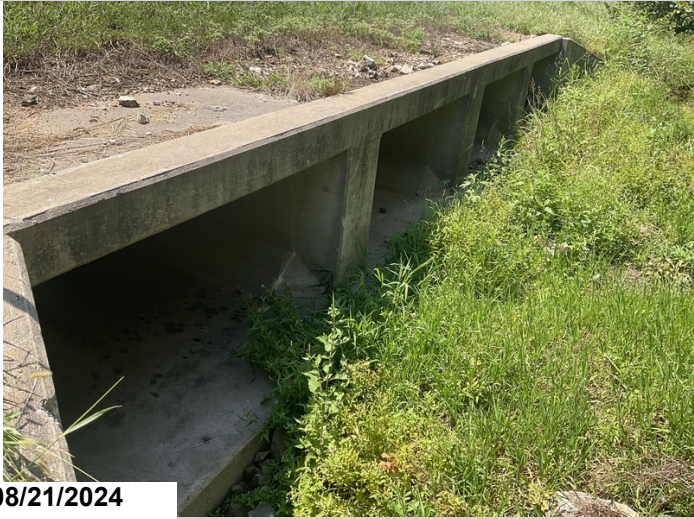
Elevation view.

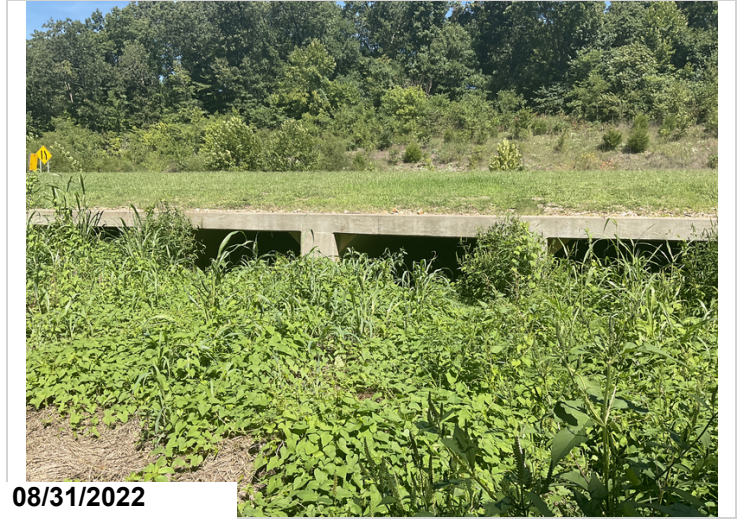
Alternate elevation view with log mile from left to right.

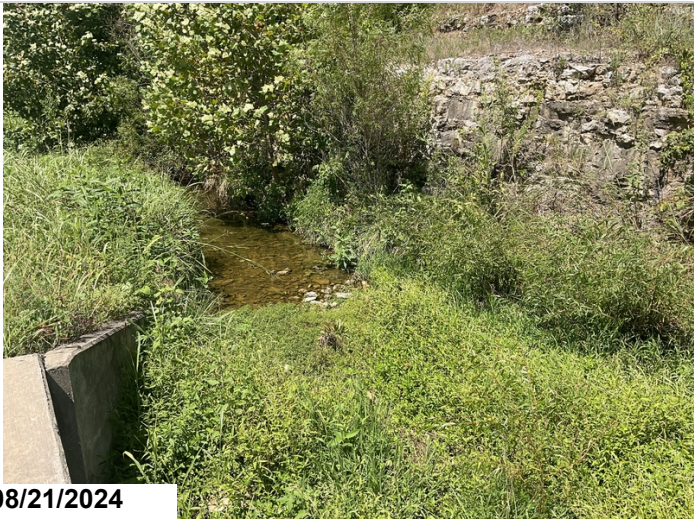
The upstream channel is well vegetated. The right upstream channel bank is a rock bluff.

Upstream channel view.

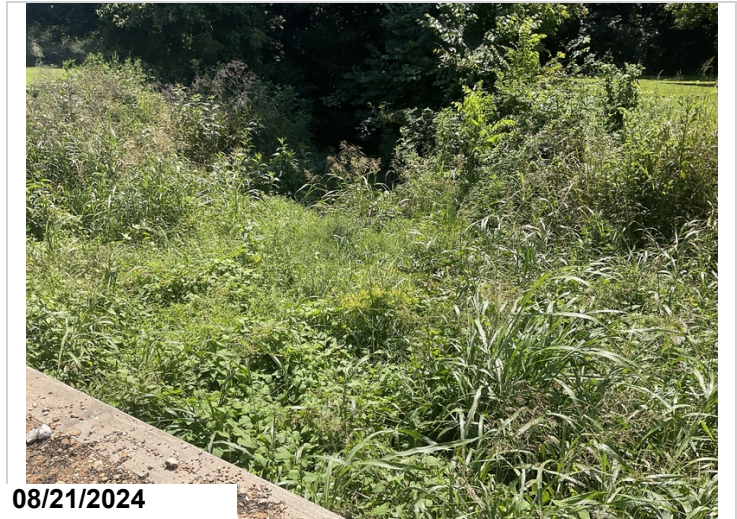
The downstream channel is well vegetated.

Downstream channel view.

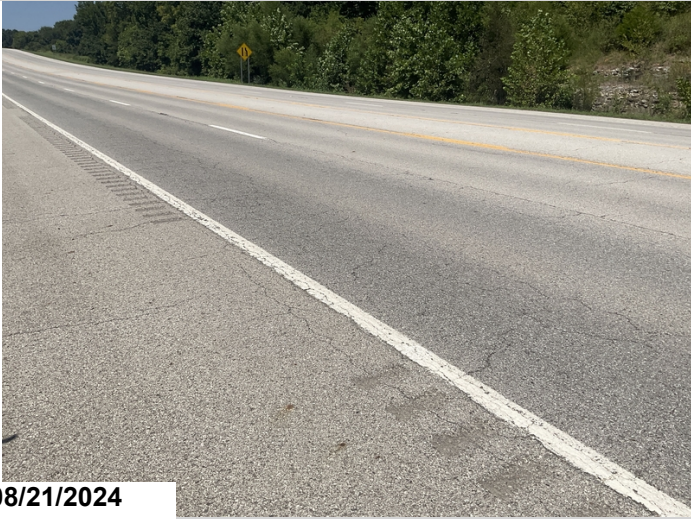
Driving surface view.

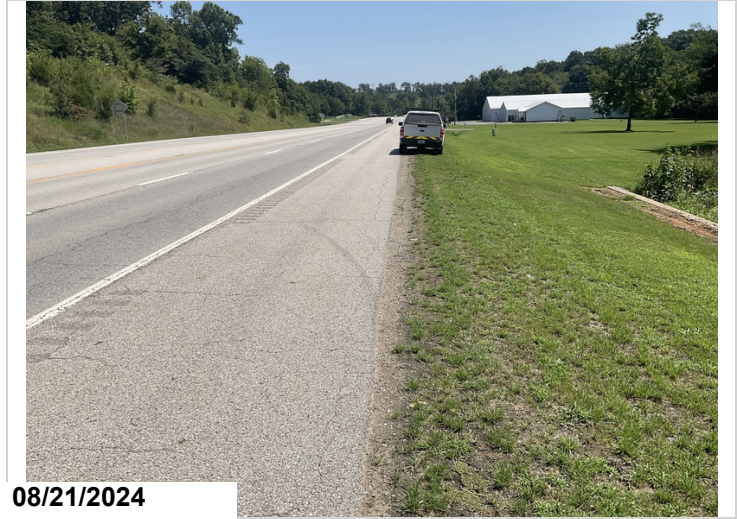
Approach view in direction of log mile.
