Asset #X1657(Routine)

US 62 Carroll over Creek

Location: 6.69mi W of Boone Co

Team Lead: Anthony Wood Inspection Date: 08/22/2024

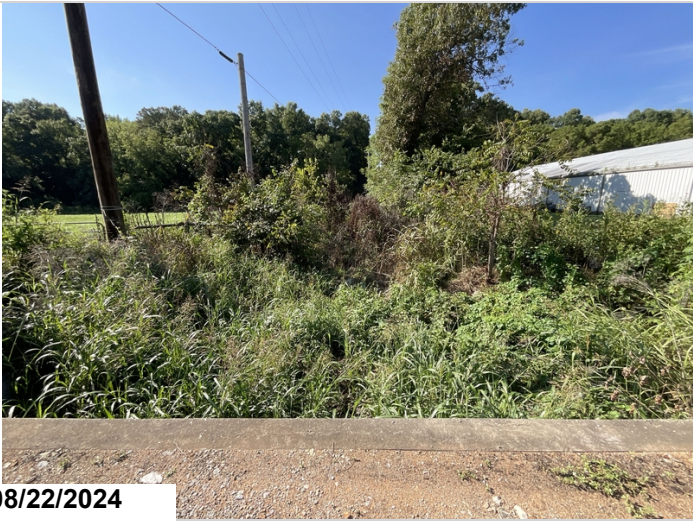
Channel, Right.

Overall, the channel is in very good condition.

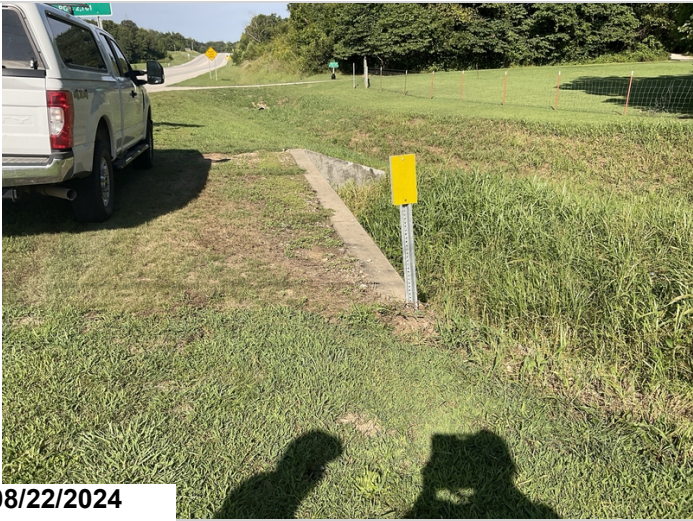
Log Mile Sign: Missing.

A-63 - Missing/Incorrect Log Mile Signage (Yes)

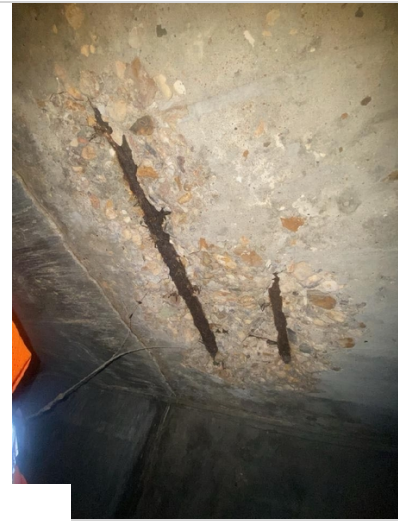
Barrel 3, Top: Spalling with exposed reinforcing steel with section loss. 1LF CS3

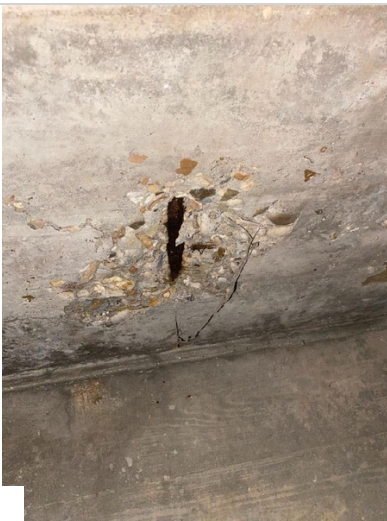
Barrel 3, Top: Spalling with exposed reinforcing steel with section loss. 1LF CS3

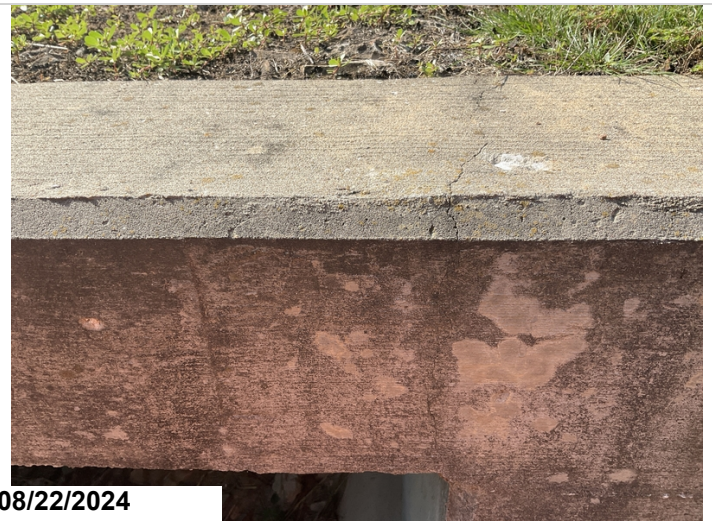
Barrel 3, Left, Head Wall: Cracking. 1LF CS2

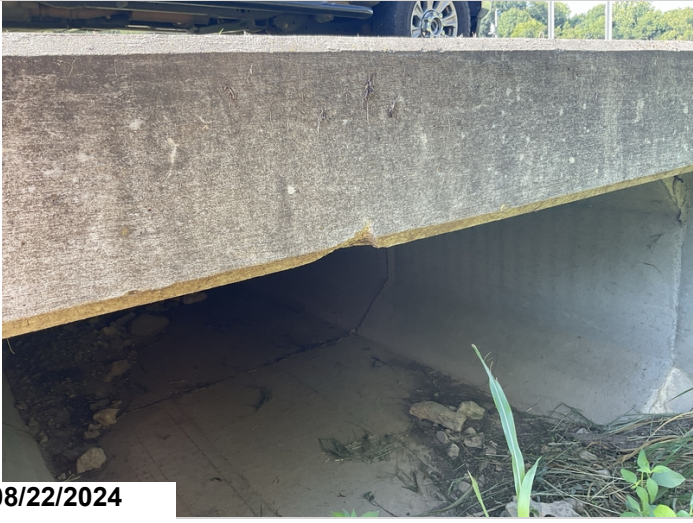
Barrel 2, Right, Head Wall: Spalling. 1LF CS2

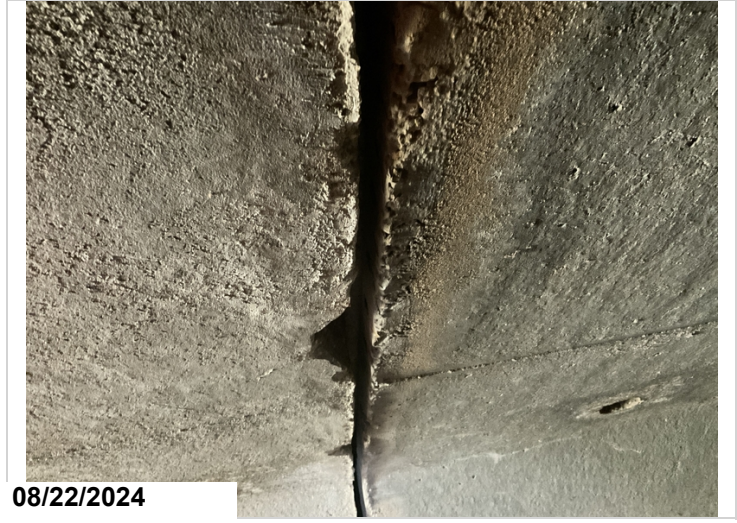
Barrel 2, Units 14, 17 & 18: Spalling. 3LF CS2

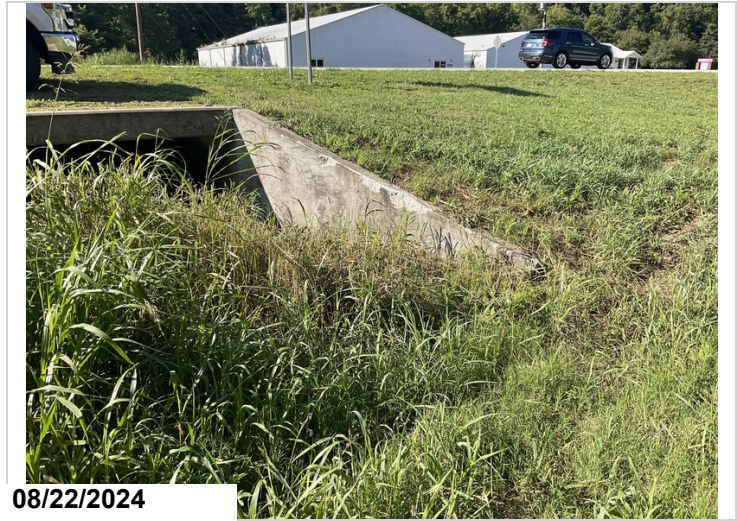
Barrel 1, Left, Wing Wall: Spalling.

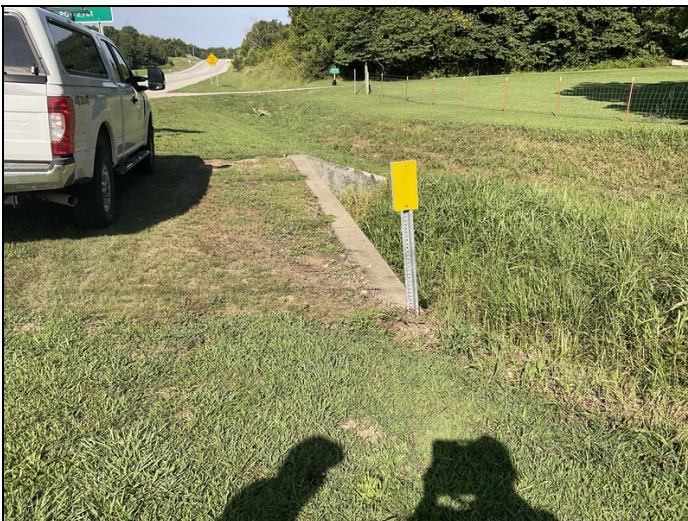
Log Mile Sign: Missing.
