Asset #M1108(Routine)
SH 392 Boone over DITCH
Location: 0.18 MI S JCT US 62

Team Lead: Nathan Rowland Inspection Date: 07/31/2023

Asset #M1108(Routine)

SH 392 Boone over DITCH

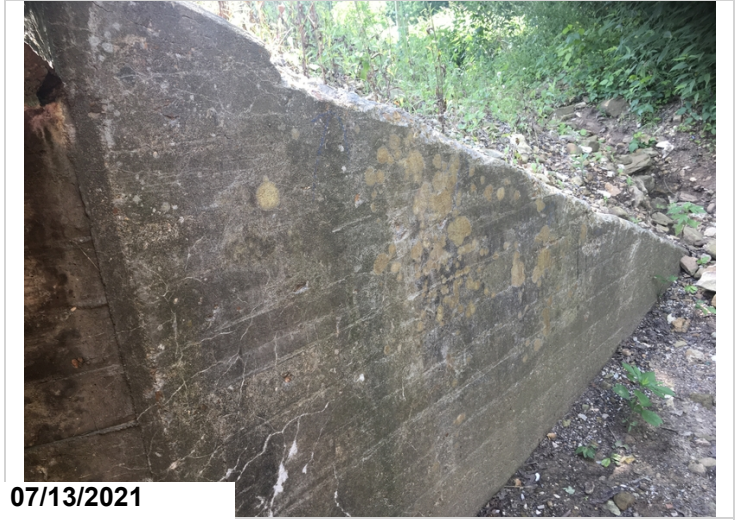
Right wing wall- has 6' of cs3 spalling with no rebar exposed along the top edge with 3' of efflorescence map cracking in the same footage.							
Both headwalls have map cracking with efflorescence and spalling with no rebar exposed.							
The wing walls are integral and are quantified with the structure.

Spalling with no rebar exposed in the top edge of the barrel #3 right wing.

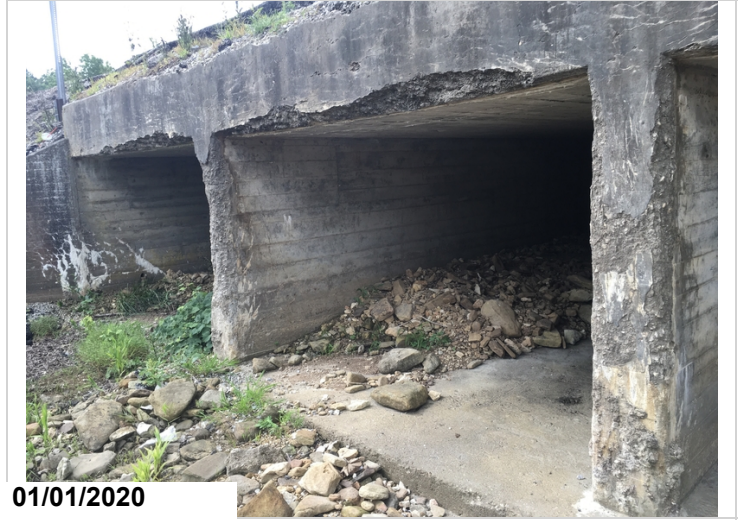
Barrel #2 has 4' of map cracking with efflorescence in the top slab at the outlet end.							
Barrel #2- has 18" of stream bed material build up for most of the width for the full length of the barrel. Division wall #2 has 4' of map cracking with efflorescence at the outlet end with 11' of vertical hairline cracks in the remaining portion of the wall.							
Barrel #3- has 6' of map cracking with efflorescence in the outlet end of the back wall with 4' of additional vertical hairline cracking in the remaining portion of the back wall. The top slab of barrel #3 has 2 small areas of spalling with exposed rebar and 6' of map cracking at the outlet end. The top slab also has 2' of spalling with exposed rebar 5' in from the inlet end. Barrel #3 has 18" of stream bed material build up for the full length and width of the barrel.							
Left wing wall- has 5' of cs3 efflorescence map cracking.

Concrete deterioration with map cracking and efflorescence at the outlet end of all 3 barrels.

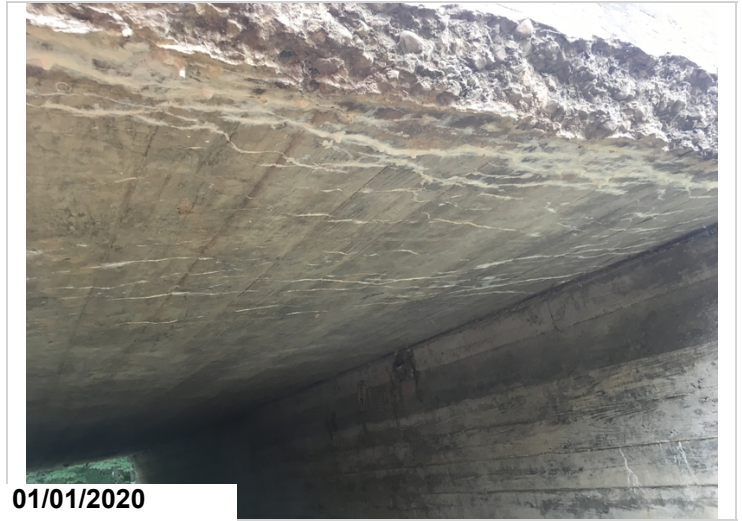
Top slab condition at the outlet end of barrel #3. Showing efflorescence map cracking. Typical of all 3 barrels.

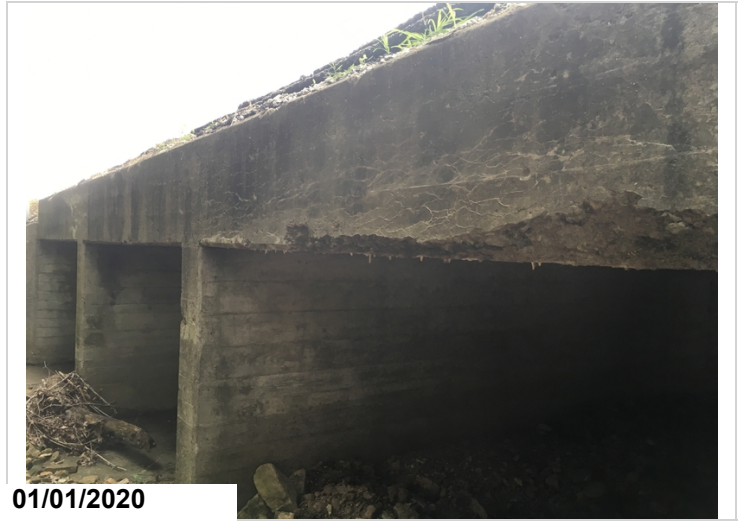
Concrete deterioration with map cracking and efflorescence on the right head wall.

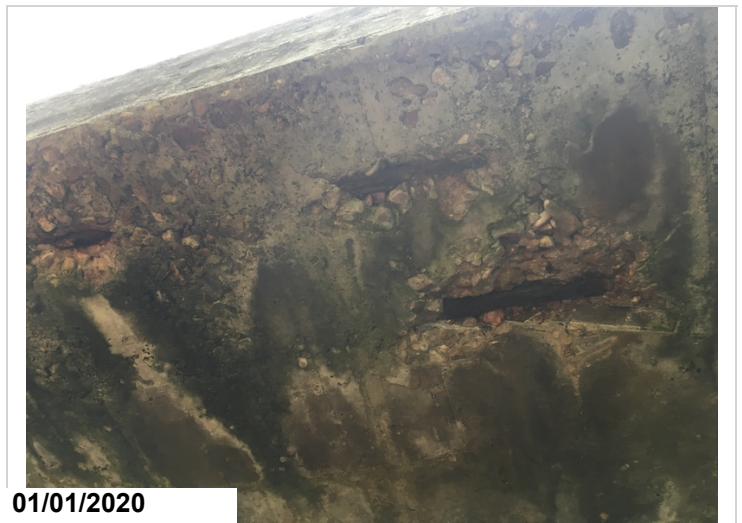
(241) 07-31-2023 WNR & DBM:							
Driving surface- has asphalt with map cracking.							
Barrel #1- has 2' of exposed rebar and shallow delaminations in the top slab at the inlet end with areas of delamination in the same footage. A 2' area of deep honeycombing exists in the back wall of barrel #1 near the bottom slab, the back wall has 17' total of honeycombing at the bottom of the back wall. The outlet end of the barrel #1 top slab has map cracking with efflorescence for 3' into the barrel. Division wall #1 on the barrel #1 side has a horizontal hairline crack for almost the entire length of the division wall, with 3' of map cracking with efflorescence at the outlet end. The barrel floor has minor build up along the division wall with 4' of cs2 abrasion that is visible.							
Left wing wall- has 7' of cs2 abrasion in the lower portion.							
Right wing wall- has 3' of cs2 abrasion in the lower portion. The last 2' of the wing is not visible due to dirt accumulation.

Spalling with rebar exposed at the inlet end of barrel #1 top slab.

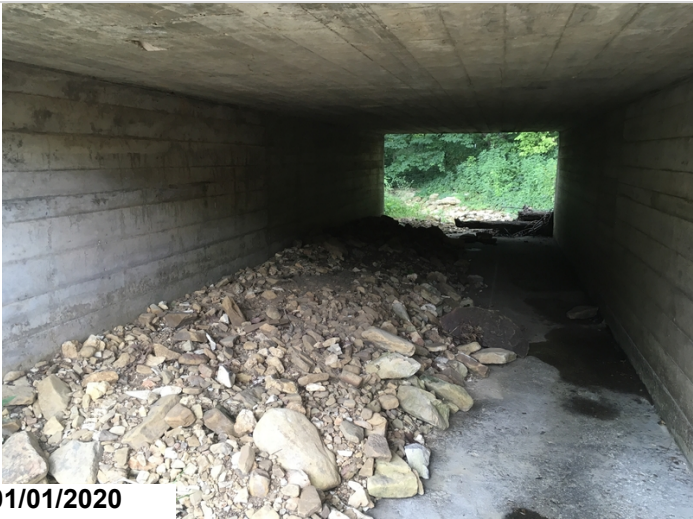
Minor amount of stream bed material build up in barrel #2.

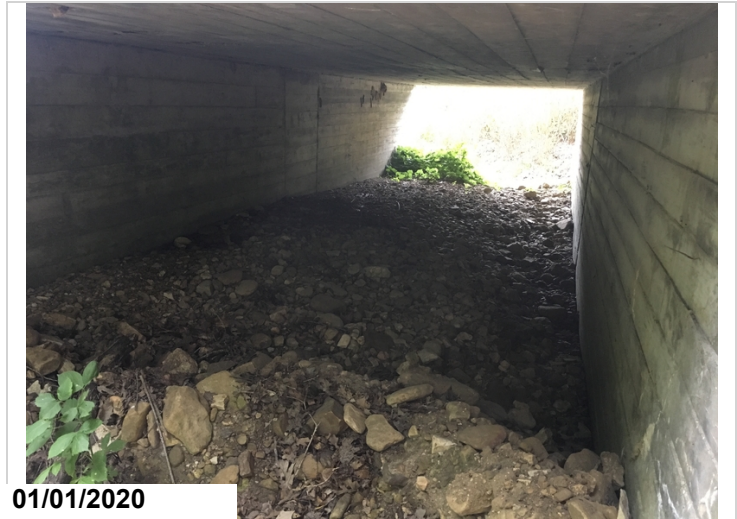
Stream bed material build up in barrel #3.

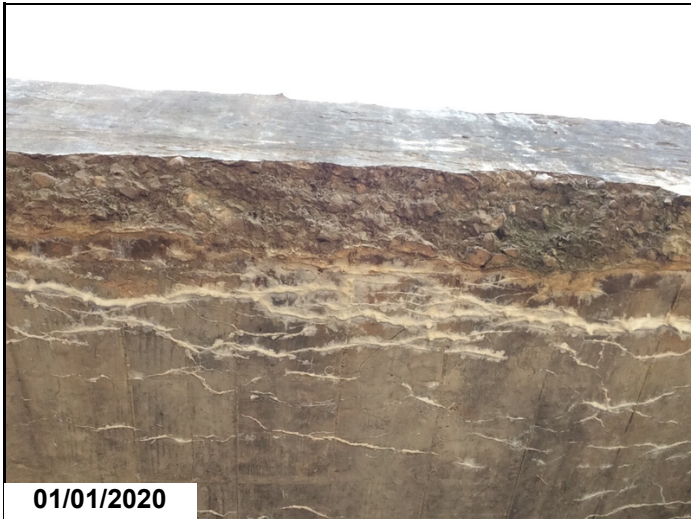
Barrels #2 and #3 have map cracking with efflorescence and spalling located in both head walls, the division wall and the top slab of the barrels at the outlet and inlet ends.

Efflorescence in the top slab

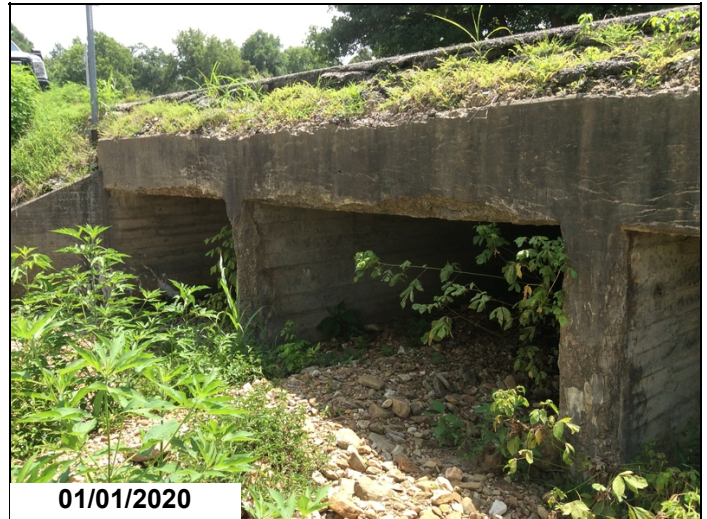
Barrel 2 and 3 soft deteriorated concrete located in head wall an interior wall of boxes outlet end

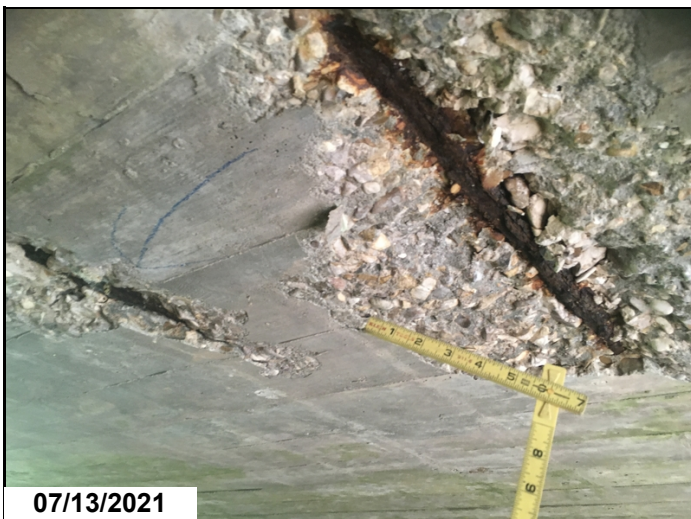
The top slab has areas of spalling with exposed rebar.

Spalling with rebar exposed in the top slab of barrel #3.

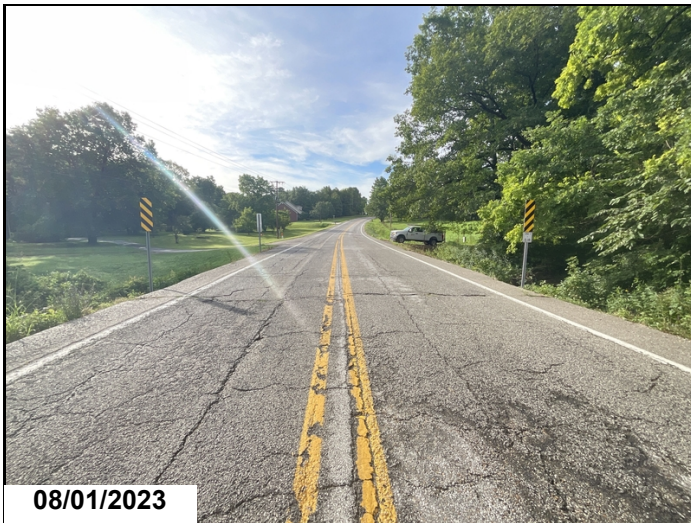
Inventory looking South

The Southwest Flareboard has been displaced.

Type of Work: Replace (General)
