Asset #M3562(Routine)

SH 392 Boone over DRY JORDAN

Location: 3.01 MI N of SH 7

Team Lead: Anthony Wood Inspection Date: 08/26/2024

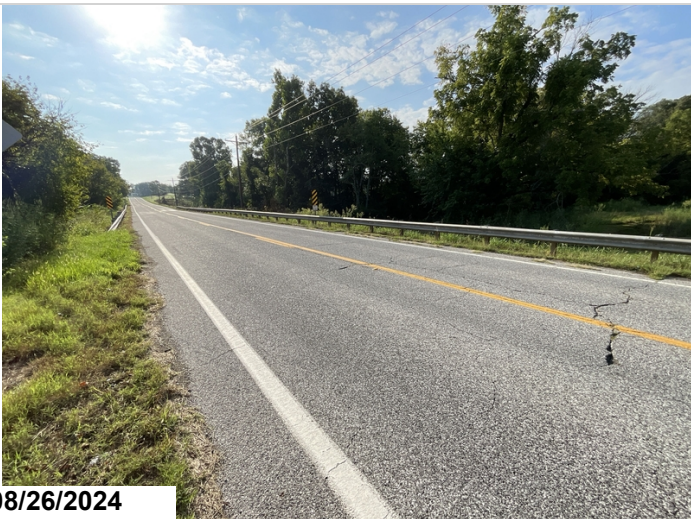
B.C.06 Bridge Railing Transitions Condition Rating (7 - GOOD - Some minor defects.)
Overall, the transition rail is in good condition with minor active corrosion in scattered locations.

Typical transition rail.

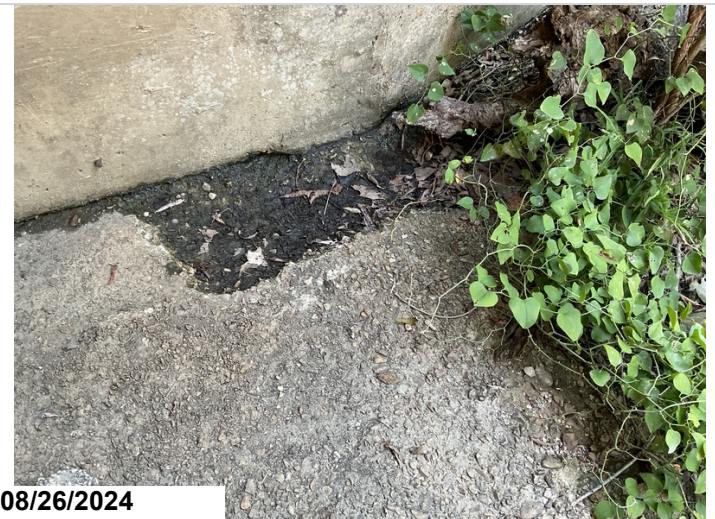
Barrel 5, Right, Floor: Spalling.

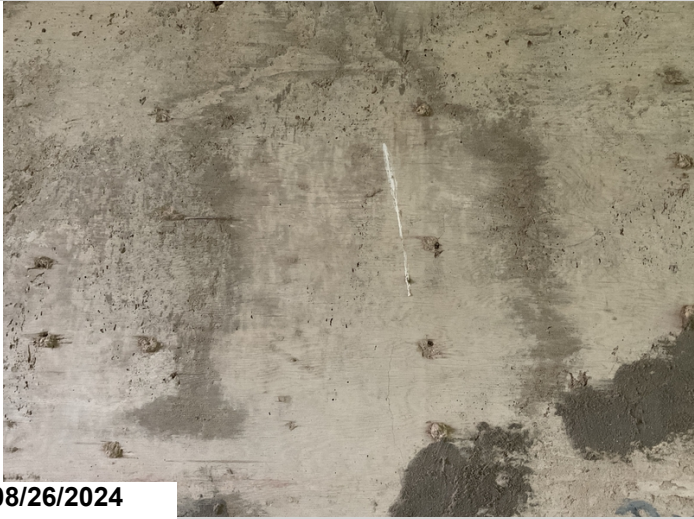
Barrel 1 - 5, Intermediate Walls: Hairline cracking.

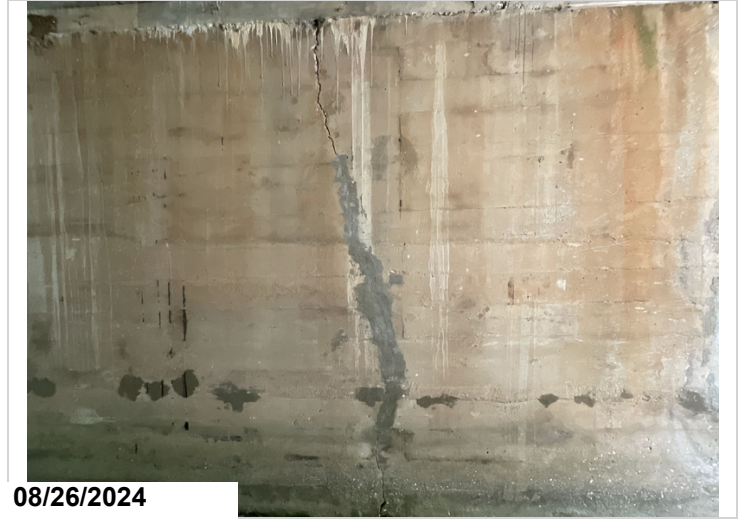
Barrel 5, Back Wall: Large open cracking. 1LF CS3

The back wall of barrels #1,5 both have a large vertical crack at the midsection.

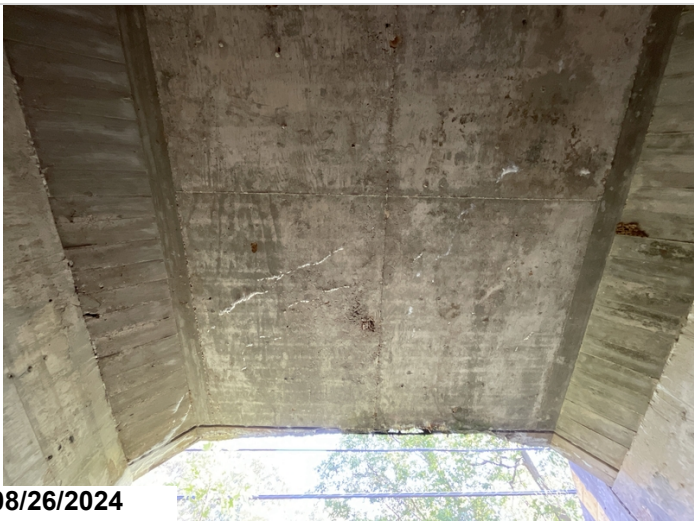
Barrel 5, Top: Cracking with efflorescence with build up. 6LF CS3

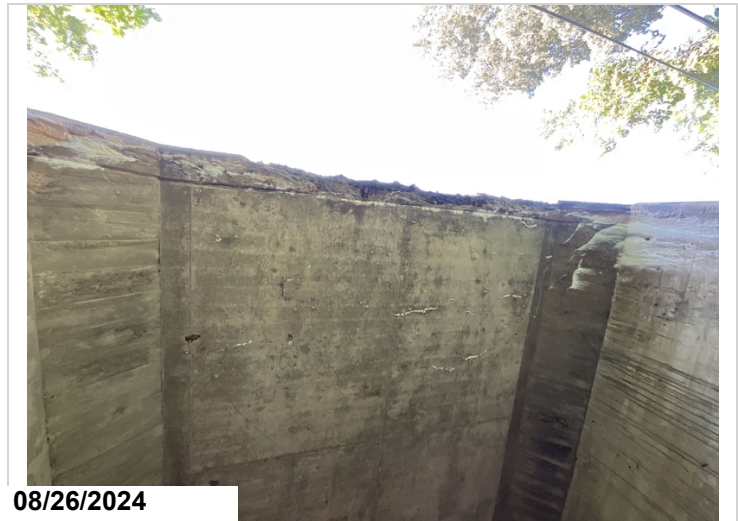
Barrel 4, Top: Cracking with efflorescence with build up. 6LF CS3

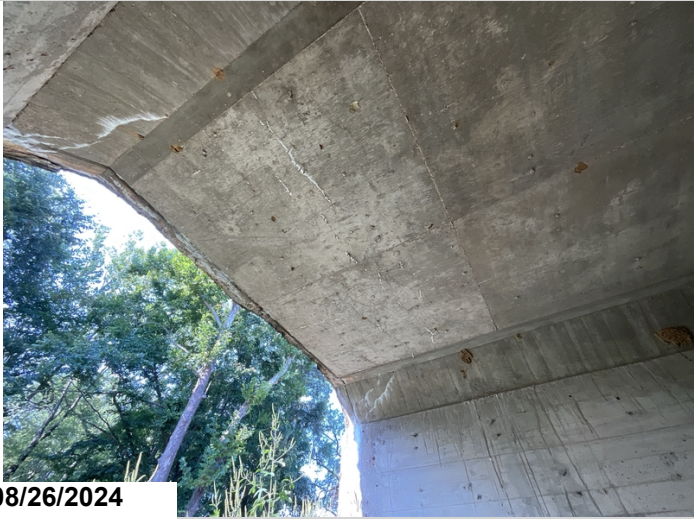
Barrel 2 & 3, Top: Cracking with efflorescence with build up. 12LF CS3

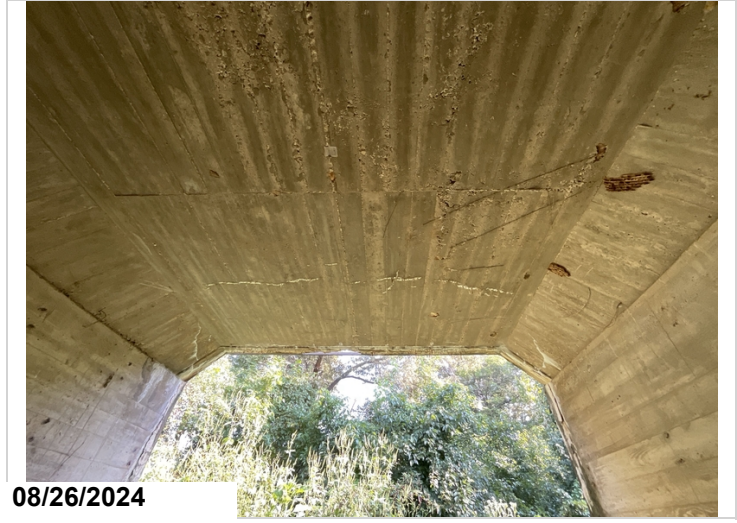
Barrel 2, Top: Cracking with efflorescence with build up. 6LF CS3

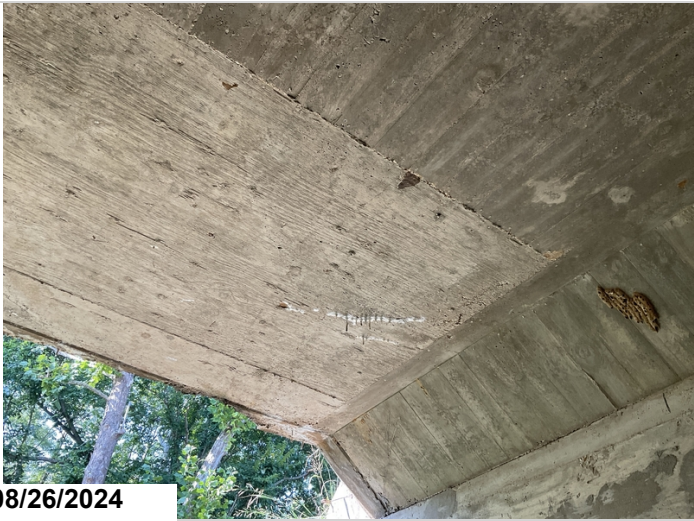
Barrel 1, Top: Cracking with efflorescence with build up. 6LF CS3

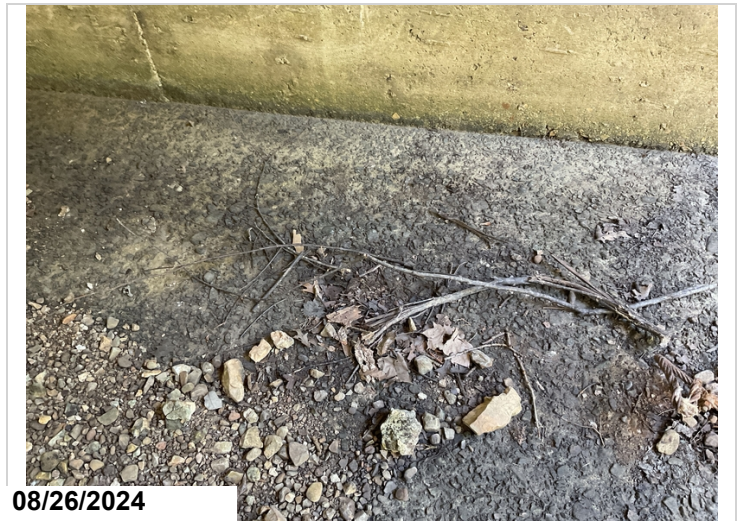
Barrel 1 - 5, Floor: Moderate abrasion.

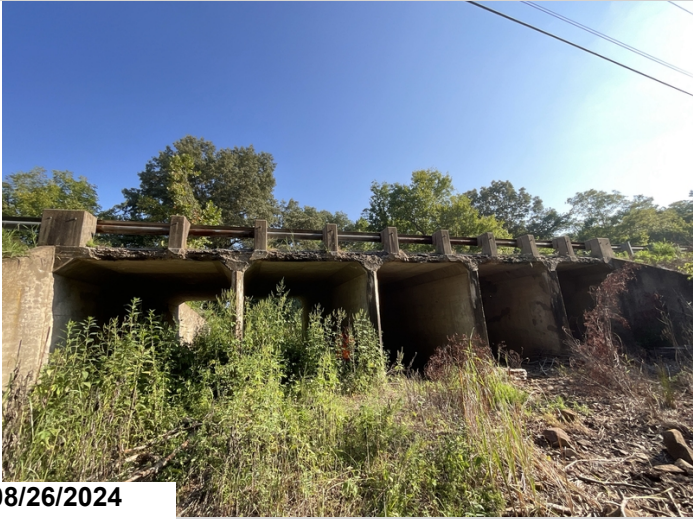
Barrels 1 - 5, Left & Right, Head Wall: Spalling with exposed reinforcing steel with section loss. 10LF CS3

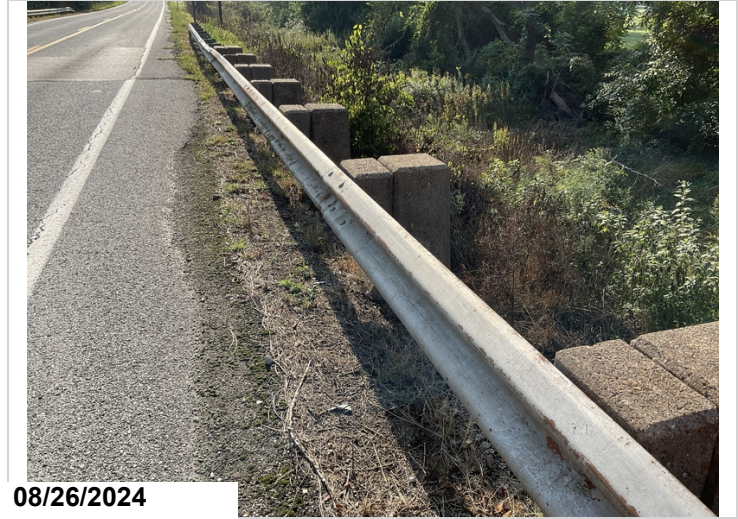
(330) The metal bridge railing consists of W-section railing attached to concrete posts. Left- the metal railing has general rusting on the front and back faces. Right- the metal railing has general rusting on the front and back faces. The right approach railing termination has minor distortion.

Left & Right, Rail: Minor active.

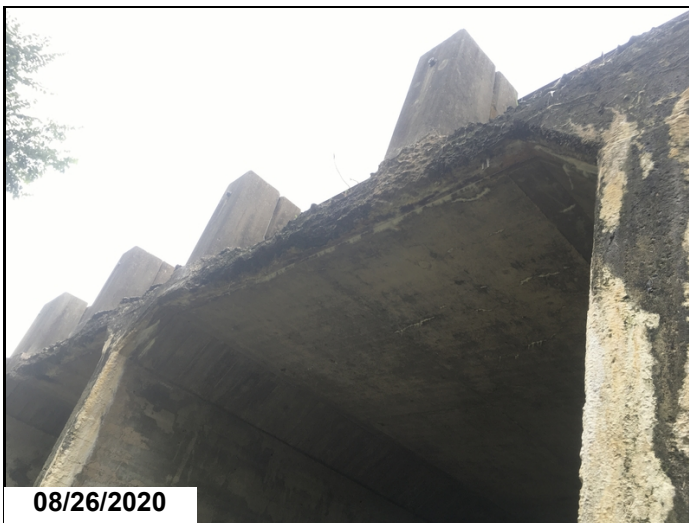
The left and right top slab edges have severe deterioration with spalling and rebar exposed.

Top slab deterioration and spalling typical of both sides of the structure.

Type of Work: Repair (General)

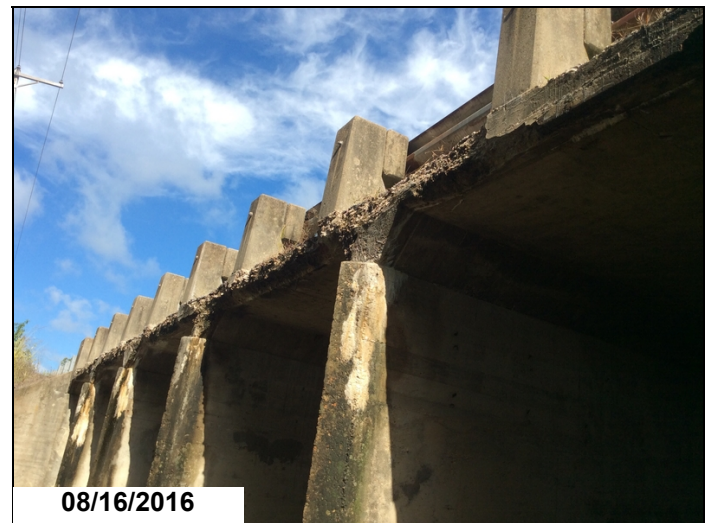
Overall condition of right side of structure.

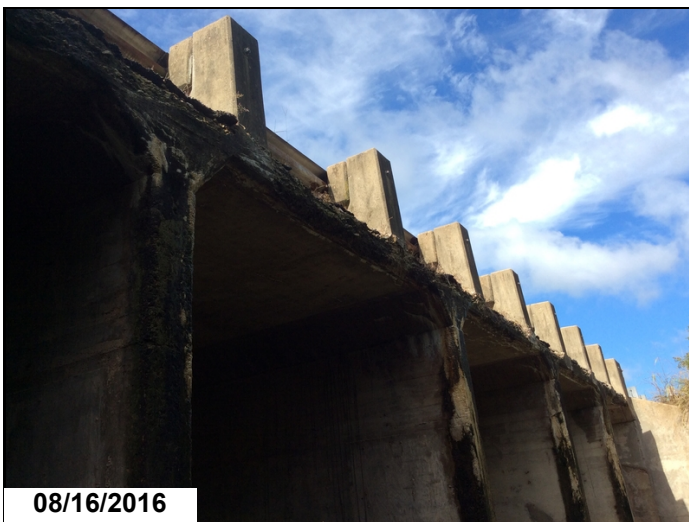
Overall condition of left side headwall of structure.

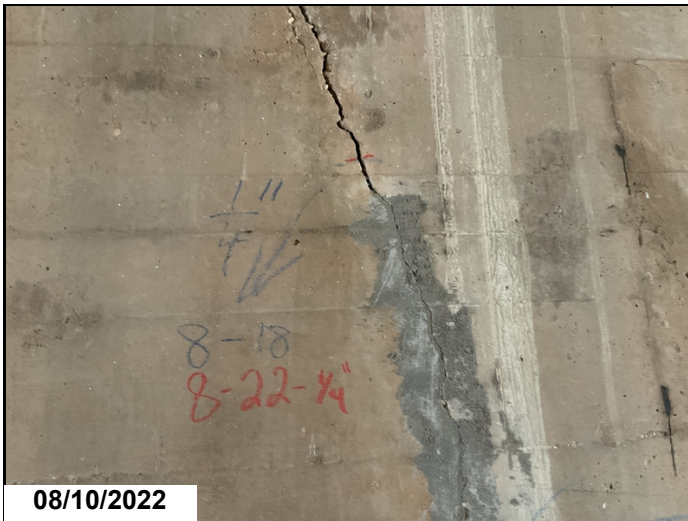
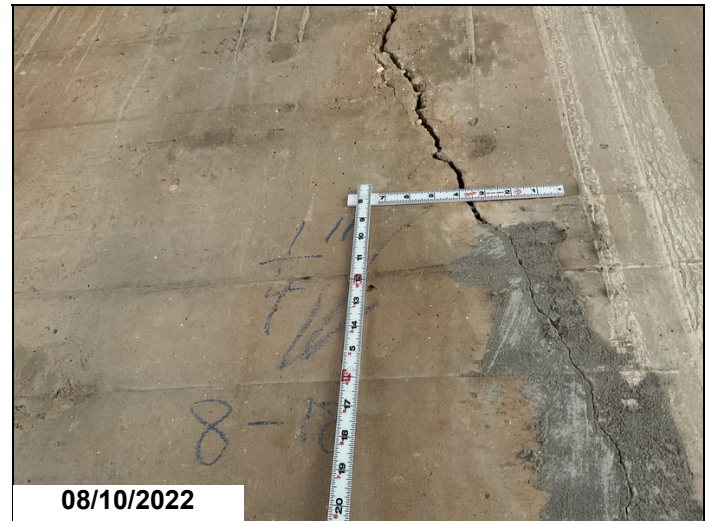
Barrel #5 vertical crack measurement 2022

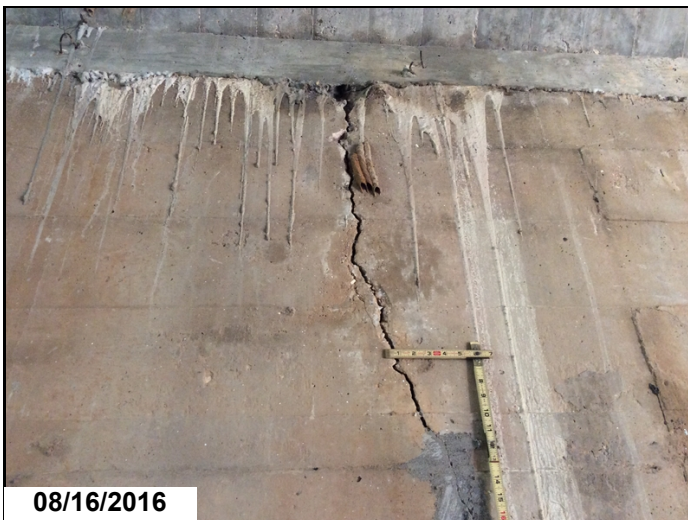
Crack in back wall of barrel #5 at mid section.

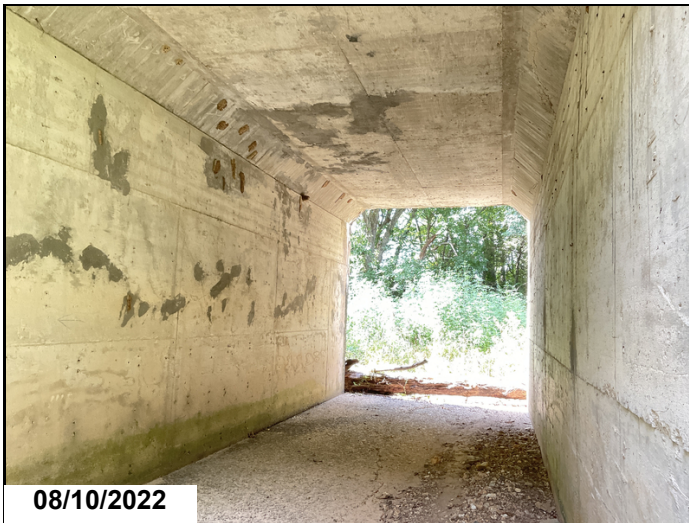
Barrel #4

The inlet end of barrels 2-5 have drift that is restricting the flow of water.

Type of Work: Channel Work/Drift Removal
