Asset #M3967(Routine)

SH 397 Boone over DRY JORDAN CREEK

Location: .5 MI N JCT SH 392

Team Lead: Nathan Rowland Inspection Date: 08/10/2022

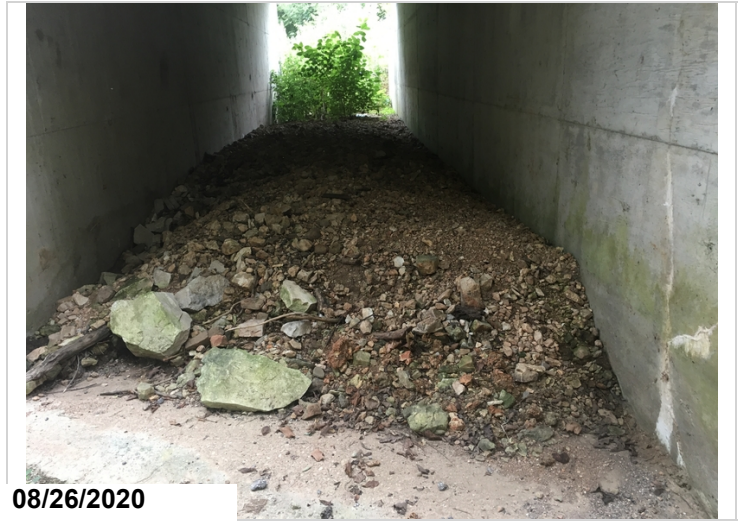
(241) 8/10/2022 WNR & DBM:							
<p>Barrel #1- has 18' of hairline vertical and horizontal cracking and 4' of cs2 efflorescence cracking. The upstream end of the division wall has 1' of cs3 delamination. The barrel floor has up to 24" of build up for the entire length and width. The right wing wall of barrel #1 showed no deficiencies. The left wing wall has 2" of separation (measurement taken from the bottom of the top slab). The left wing has 19' of diagonal cracks of which some have efflorescence and a large patched area that is fractured and spalling with steel exposed.</p> <p>Barrel #2- has 6' of hairline vertical cracking and 2' of exposed rebar at the inlet end. The barrel floor has 40' of cs2 abrasion.</p> <p>Barrel #3- has 3' of hairline vertical cracking and 1' of cs2 efflorescence cracking. It has 1' of delamination cs3. The barrel floor has 43' of cs2 abrasion. Barrel #3 has up to 18" of the bottom slab exposed at the outlet end.</p> <p>Barrel #4- has 4' of hairline vertical cracking and 1' of cs3 steel exposed with some section outlet end of wall #4. The barrel floor has 42' of cs2 abrasion. Barrel #4 has up to 14" vertical face of the bottom slab exposed for 7' at the inlet end.</p> <p>Barrel #5- has 7' of hairline vertical cracking and 1' of cs2 efflorescence cracking. It has 1' of exposed rebar in the top slab at the outlet end. The barrel floor has 39' of cs2 abrasion. The left wing wall of barrel #5 has 8' of diagonal cracking. The right wing wall has a large spall at the wingwall and barrel juncture and 9' of diagonal cracking. The right wing also has 2" of separation (measurement taken from the bottom of the top slab).</p> <p>The outlet ends of barrels 2-5 have the vertical face of the bottom slab exposed</p> <p>Both headwalls have large amounts of deterioration with efflorescence leaching.</p> <p>Left headwall- has areas of deterioration.</p> <p>Right headwall- has deterioration with exposed rebar over barrel #2.</p>

24" of stream bed material build up in barrel 1.

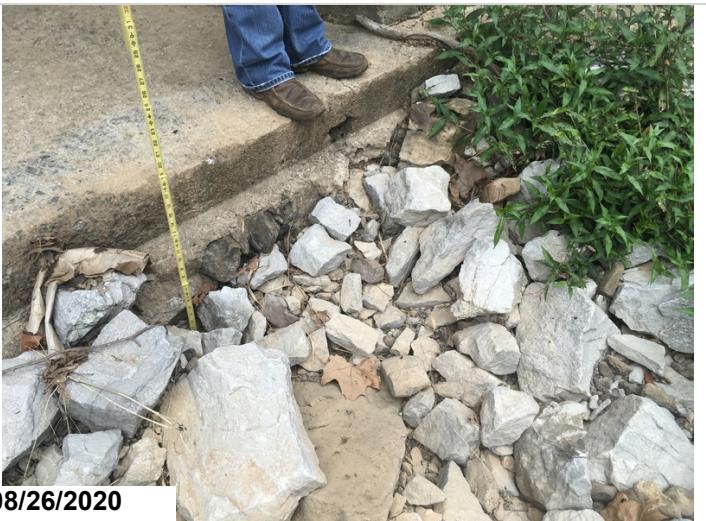
14" of the vertical face of the bottom slab exposed at the barrel 4 outlet. Typical of barrels 2-5.

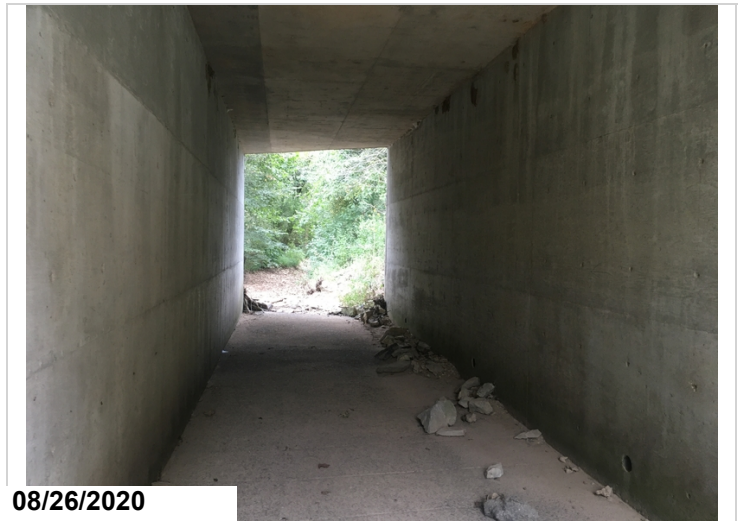
Typical barrel interior condition.

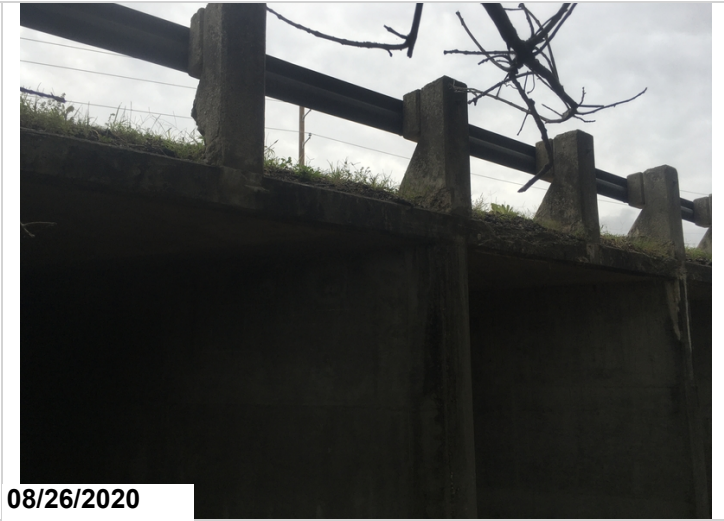
330	Metal Bridge Railing	LF	124	124	0	0	0
515	Steel Protective Coating	SF	372	372	0	0	0
(330) 8/10/2022 WNR & DBM:							
<p>The metal bridge railing consists of W-section railing attached to concrete posts.</p> <p>Left side- has deterioration on bridge rail posts #1, #10 &amp; #11, no rebar is exposed. No deficiencies noted on the metal railing.</p> <p>Right side- No deficiencies noted on the metal railing.</p>

The left end of the bridge railing showing spalling and delamination on the concrete posts.

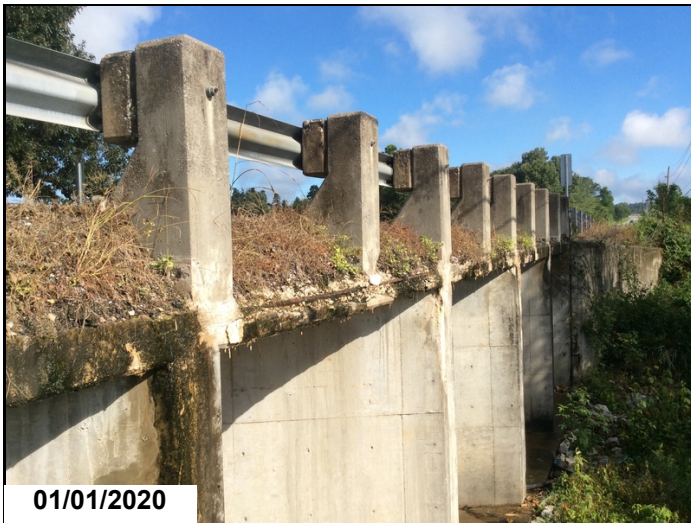
The right and left headwall has deterioration with exposed rebar over barrel #2.

Deterioration on the right edge of the top slab.

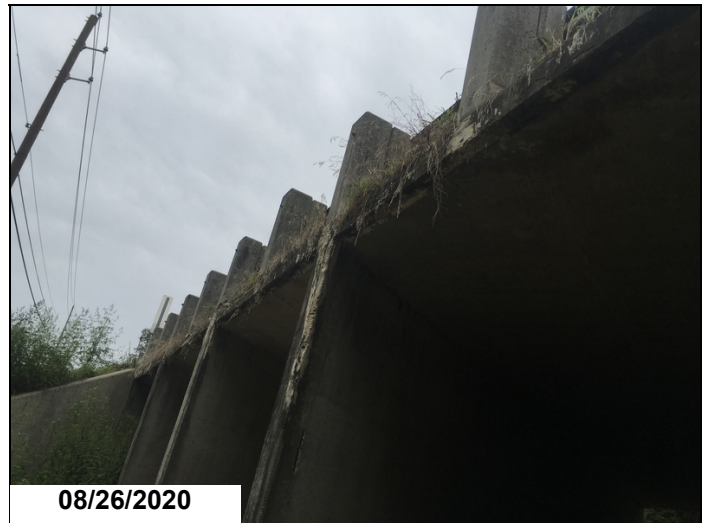
Efflorescence with concrete deterioration on the right edge of the top slab.

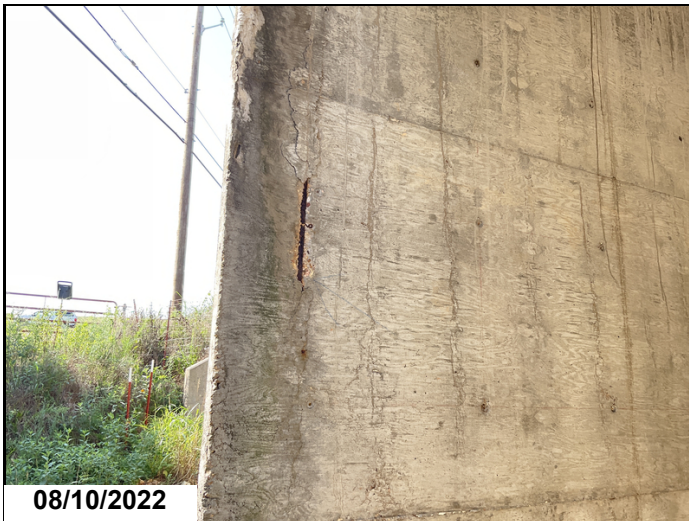
The division wall of barrel #2 & #4 and the top slab of barrel #5 have shallow spalls with rebar exposed.

Barrel #4 spalling with steel exposed on the outlet end of wall #4

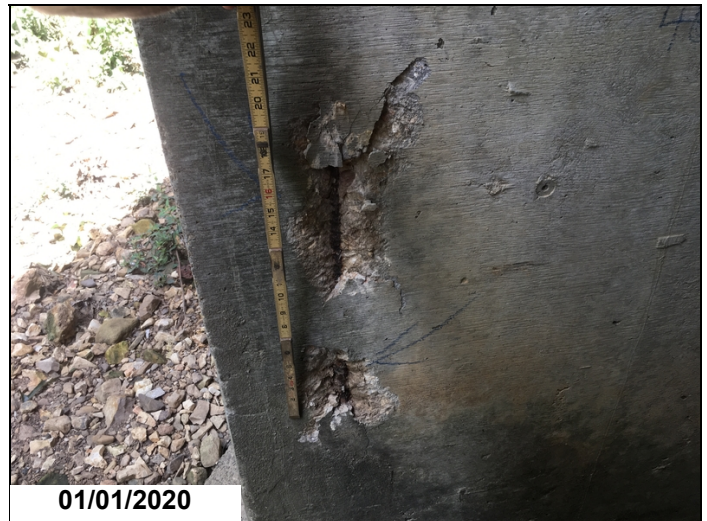
Barrel #2 has exposed rebar at the inlet end.

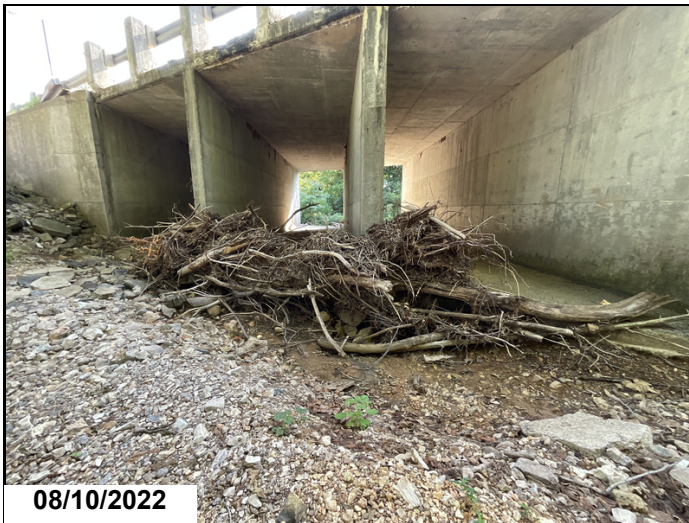
Barrels 3-5 have drift accumulation that is causing localized scour.

**Type of Work:** (Inactive) (Inactive) 1 - Clean
