Bridge 03627 Inspection Report

Route:14 Section:04 Log:10.66

Arnold Road ID:64x14x4xA, Arnold Log mile:10.617

SH 14 Searcy over BIG CREEK

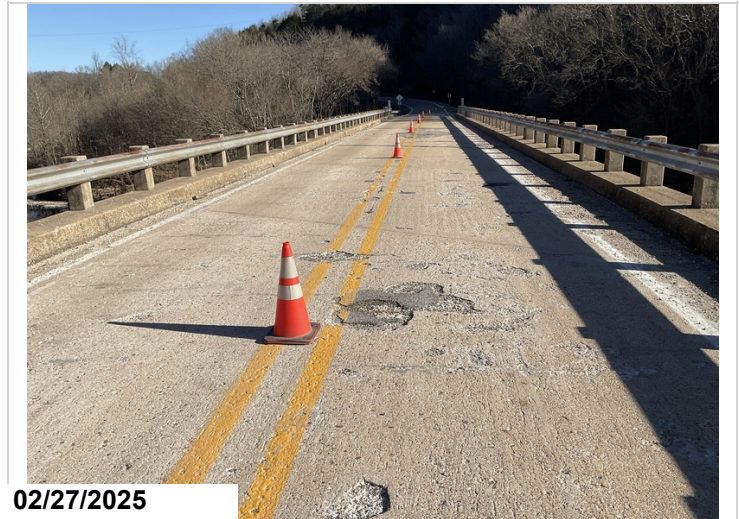
Overall the deck is in fair condition with large areas of spalling and delamination in the driving surface, the worst cases are in spans #2,3. The undersurface has some discoloration in the bays in span #3.

Driving surface view.

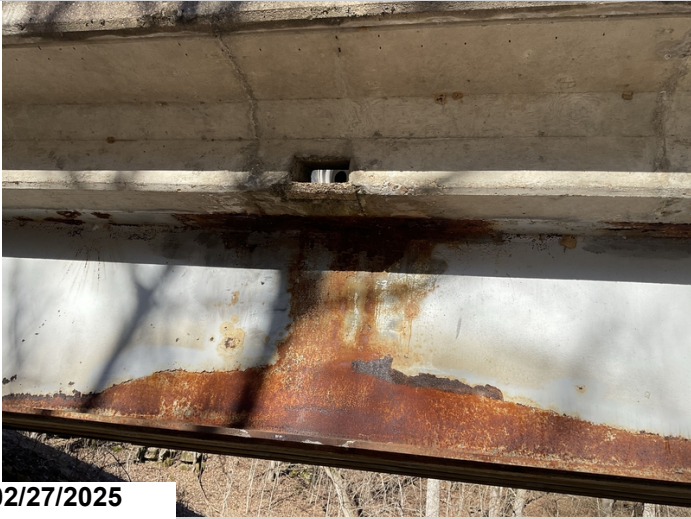
Area of cs3 corrosion on the exterior beams beneath the drain areas. Typically 3' long with up to 1/4" deep section loss.

The fascia beams have 3' areas of corrosion on the top and bottom flange beneath the drain holes along both sides of the structure.

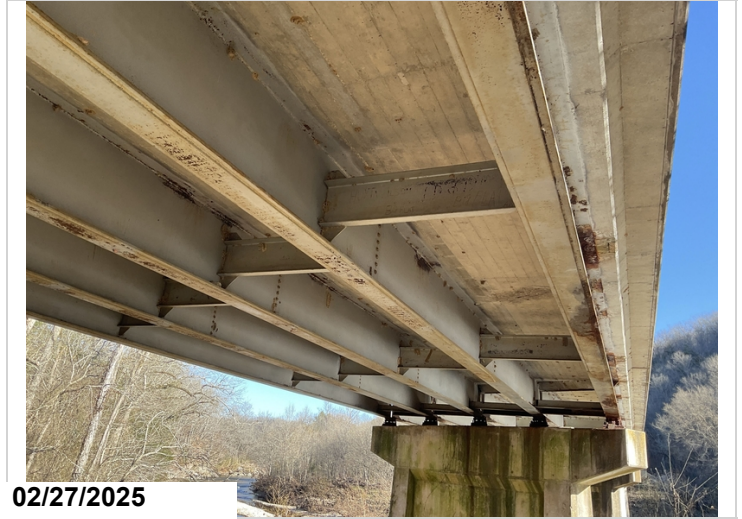
All spans have areas of delamination or spalling. Spans #2,3 have large areas of delamination and spalling with some discoloration noted on the undersurface.

Undersurface view.

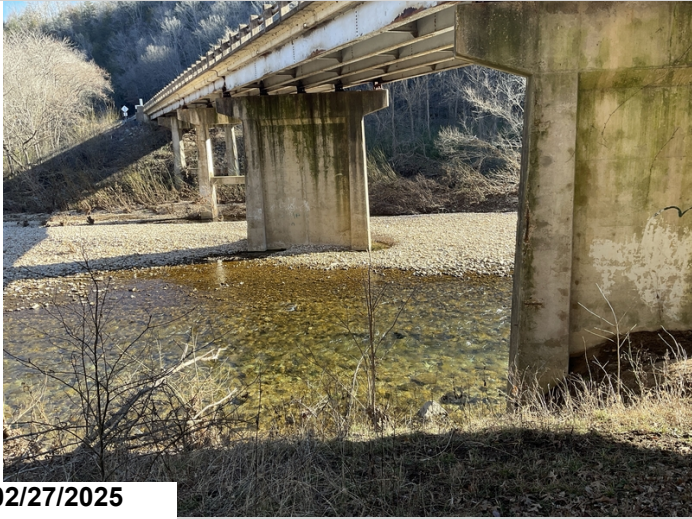
The channel beneath the structure flows mainly in spans #2,3. The columns near the channel have minor local scour with no footings exposed.

Channel beneath the structure.

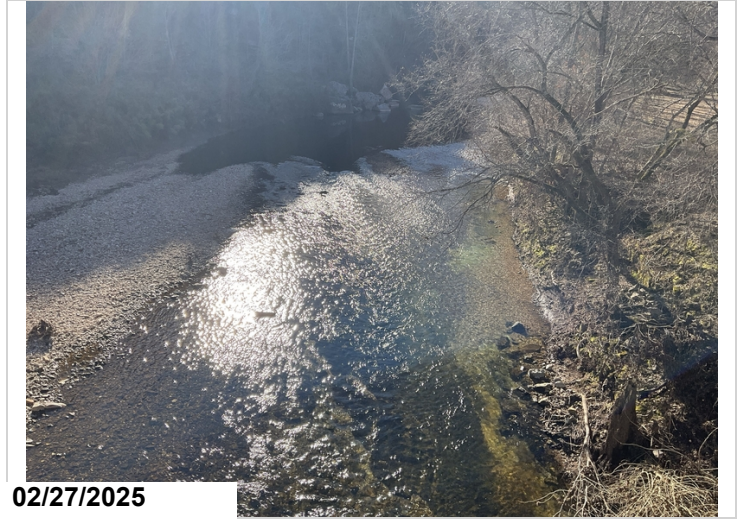
The upstream channel is mostly vegetated with areas of embankment erosion.

Upstream channel view.

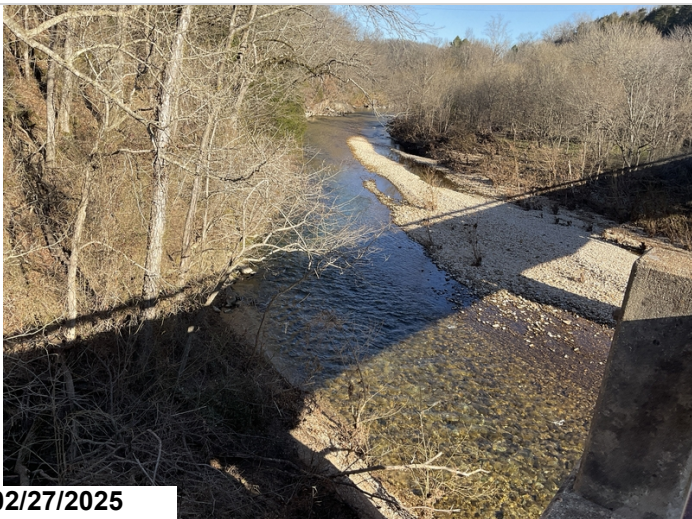
The downstream channel is vegetated.

Downstream channel view.

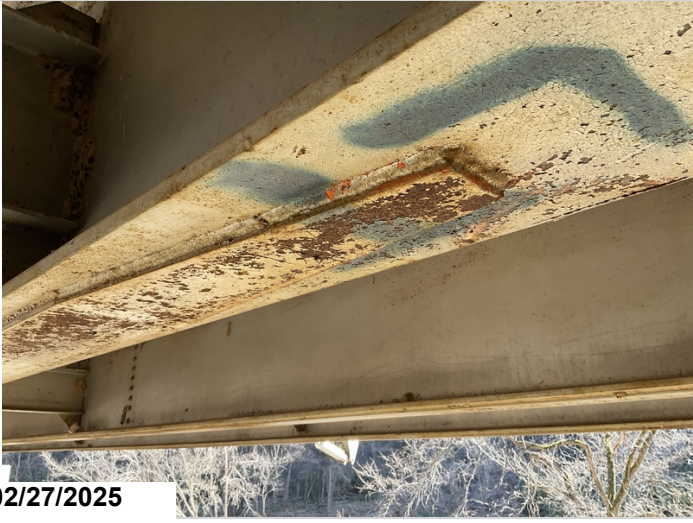
The bottom flanges of all beams have cover plates that are tapered and welded at the ends.

(107) 5 painted steel beam system. The protective coating total includes the diaphragms. The cover plates on the bottom flange are tapered and welded all the way around, this is an E detail.

Cover plate welding detail. This is an E detail.

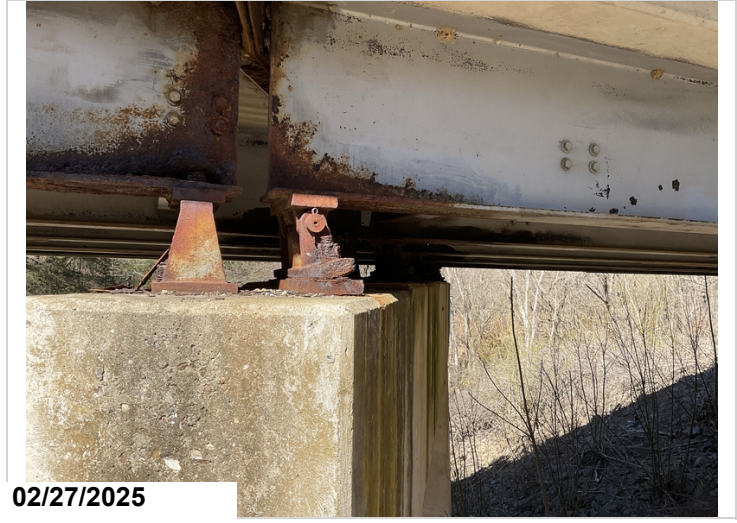
The moveable bearings at pier #4 span #5 are all tilted toward span #4.

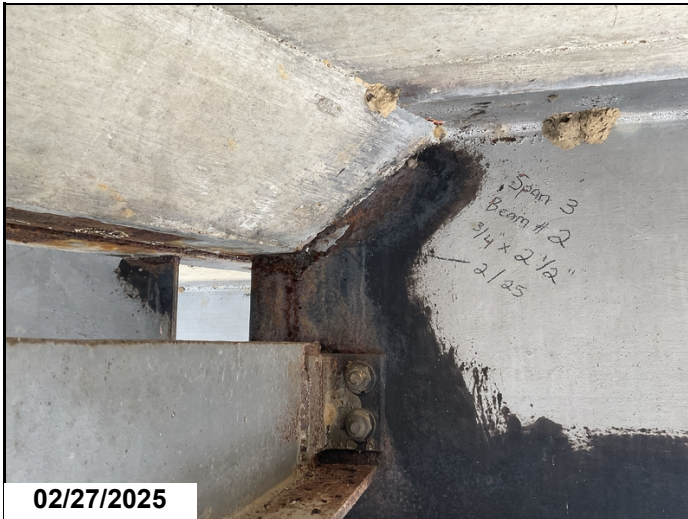
Beam #2 and beam #4 have a 3/4" tall by 4" long rust hole in the upper web at the beginning of span #3.

02/27/2025
3/4" tall by 4" long rust hole in the upper web of beam #2 at the beginning of span #3.

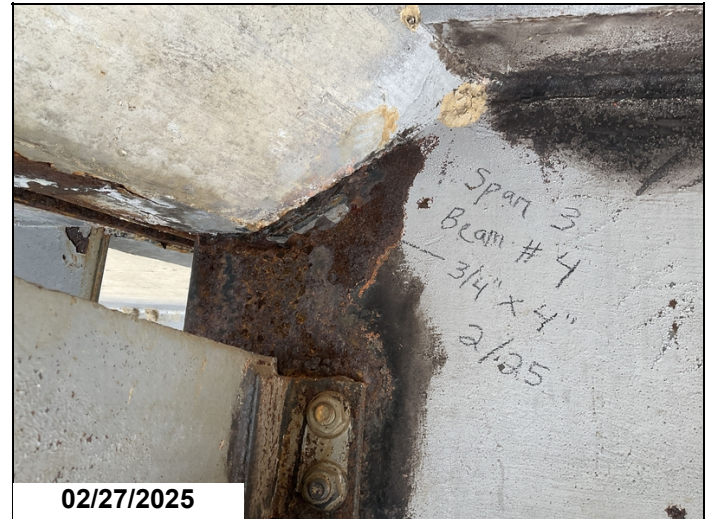
02/27/2025
3/4" tall by 4" long rust hole in the upper web of beam #4 at the beginning of span #3.

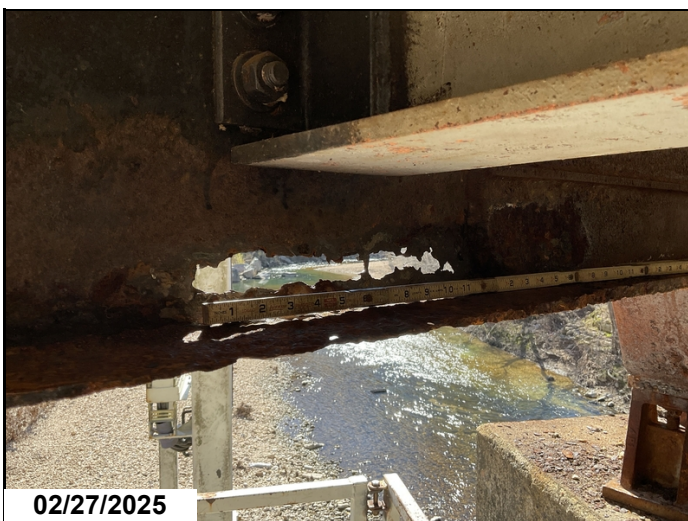
Beam #5 at the beginning of span #3 has a 12" by 1.5" rust hole in the lower web.

02/27/2025
12" by 1.5" tall rust hole in the lower web of the beginning of beam #5. 3' from the end of the beam.

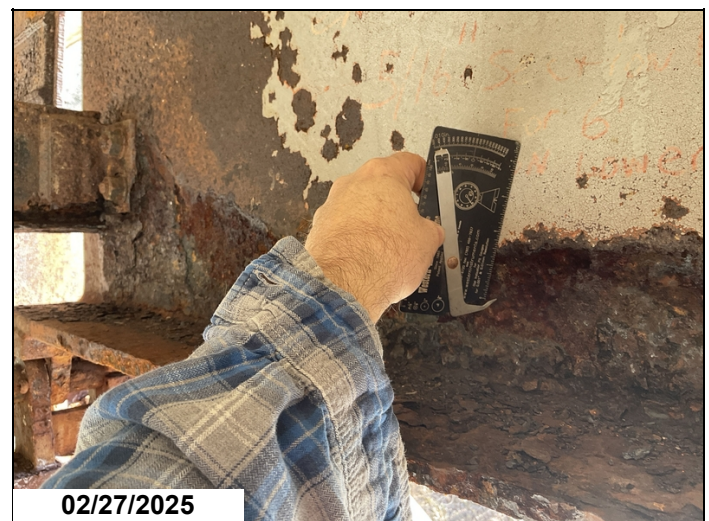
Beam #5 at the end of span #2 has up to 7/16" section loss on the lower web for 5' at the end of the span.

02/27/2025
Up to 7/16" section loss on the lower web for 5' at the end of beam #5 span #2.

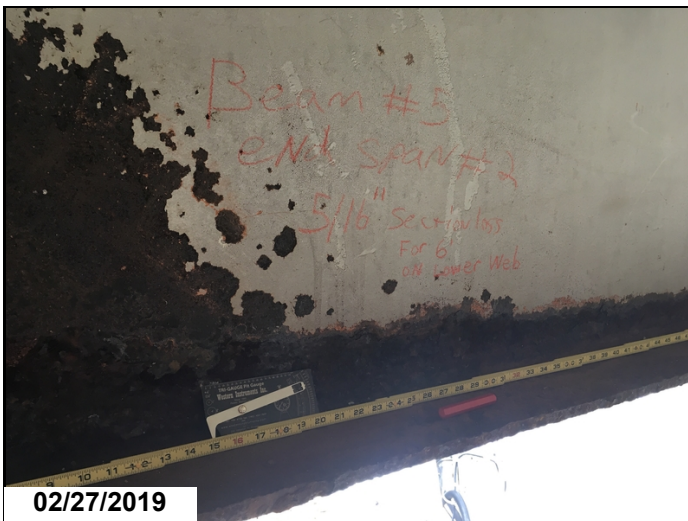
The lower portion of the web of beam #5 in span #2 has 5/16" deep section loss at the end the span for a length of 6'.

5/16" deep section loss on the lower web of beam #5 at the end of span #2 for a length of 6'.

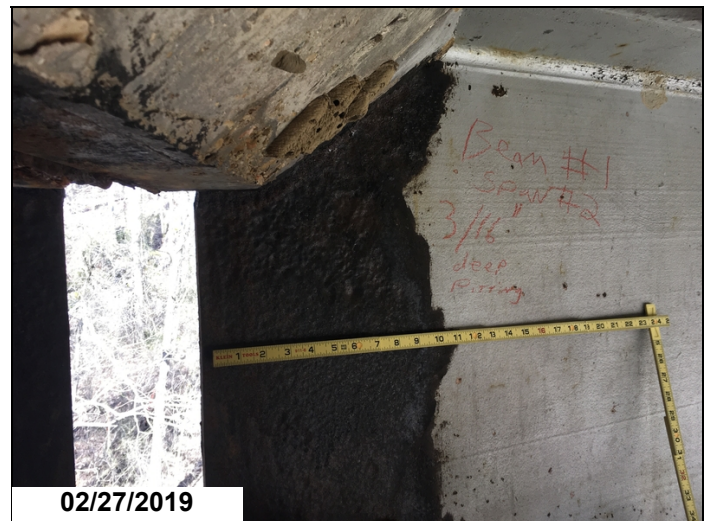
The web has pitting with 3/16 deep section loss on beam #1 of span #2. Typical also of beams 1,2,3 at the beginning of span #2.

(The original thickness of the web is 5/8").

Pitting with 3/16 deep section loss on beam #1 of span #2. Typical of beams 1,2,3 at the beginning of span #2. The original thickness of the web is 5/8".

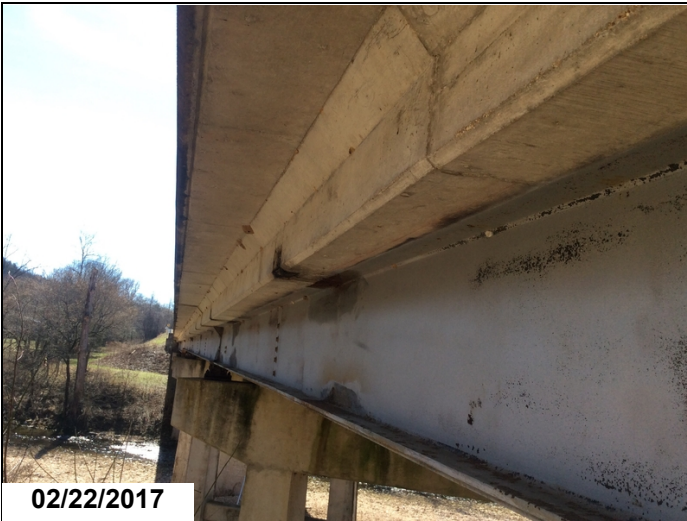
Corrosion beneath drains along the left and right sides of structure.

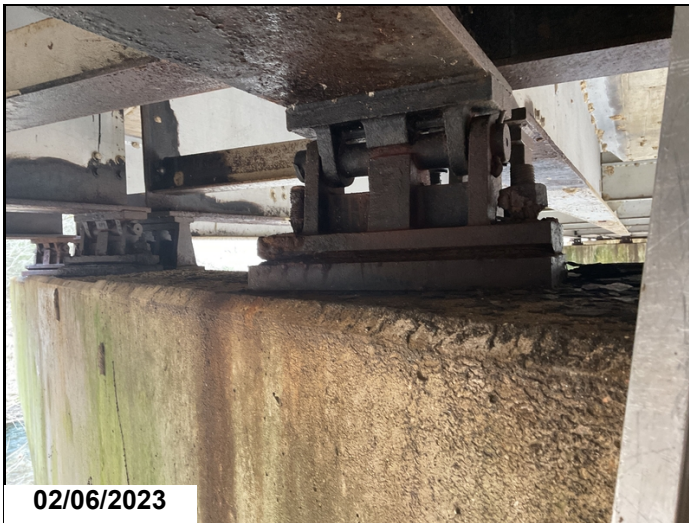
The bearings and anchor bolts have cs3 corrosion. Many of the anchor bolt studs have corrosion with loss of section.

Anchor bolt section loss and bearing corrosion over pier #1.
