## **Bridge 06670 Inspection Report**

## National Bridge Inventory Data Sheet

**US 62 Carroll over KINGS RIVER**

**Team Lead: Lacy Wiseman Inspection Date: 08/07/2025**

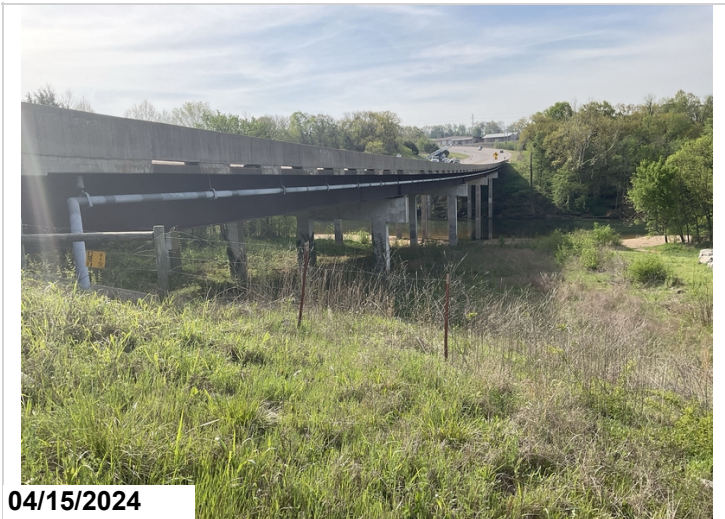
Elevation view. Log mile from left to right.

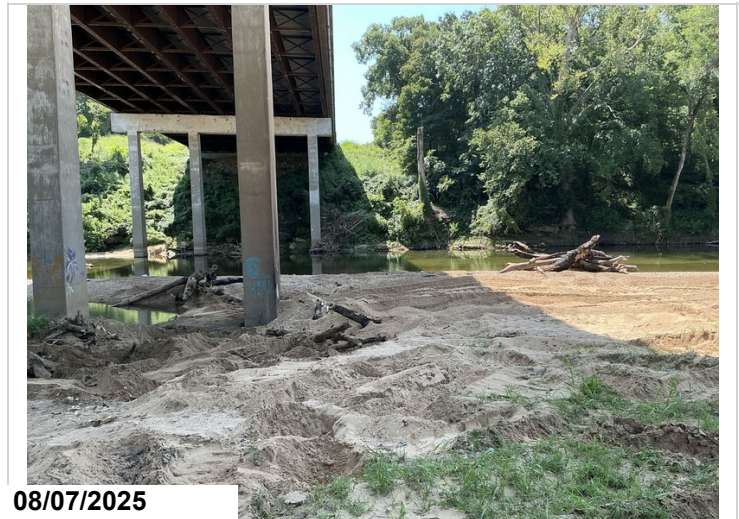
Remaining drift has been removed away from bent.

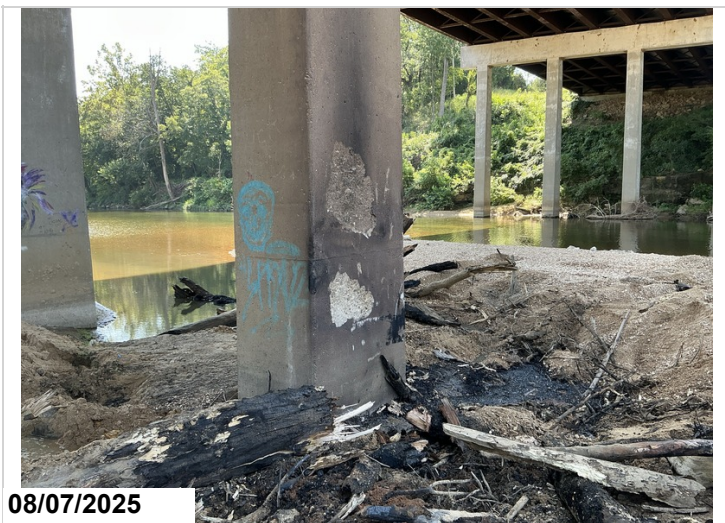
Special inspection August 2025 for drift pile being burnt at bent 3, column 4.

Special inspection August 2025 for drift pile being burnt at bent 3, column 4. spalling CS3 was noted on column 4 of bent 3.

Bent 3, column 4 spalling and discoloration due to drift pile being burnt.

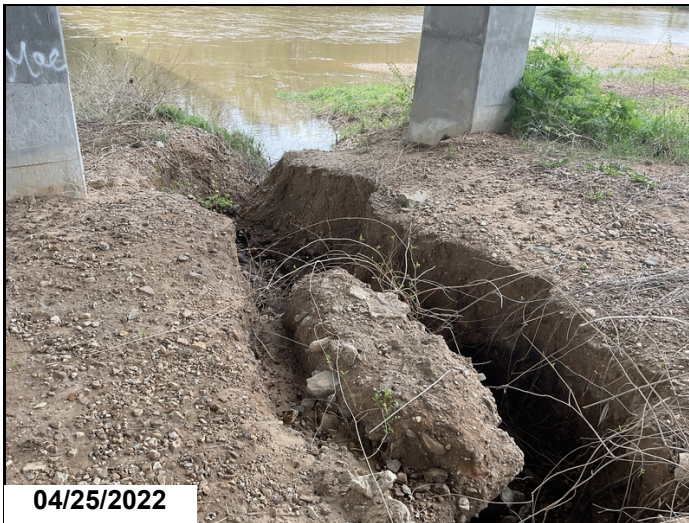
Bent #2 has a 4' ditch eroded between columns #3 and #4. No footings are exposed.

4' 8" deep ditch cut between columns #3 and #4 at bent #2. No footings are exposed.

Priority: D- Routine

Status: Monitor

Type of Work: Repair (General)

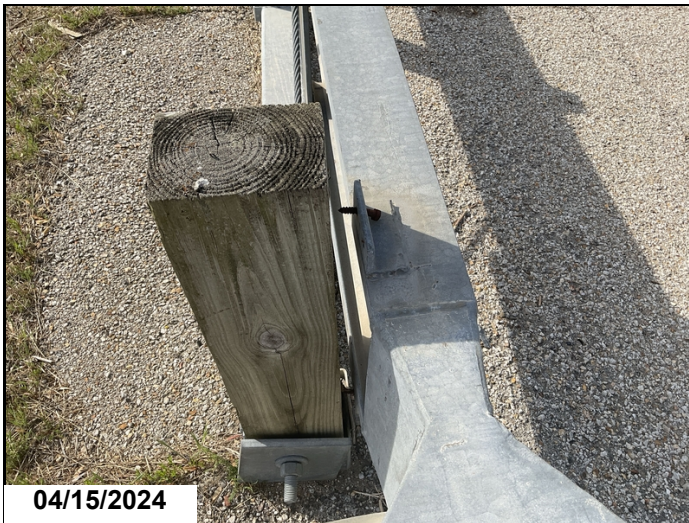
The left beginning and right ending approach railing termination is not connected to the wooden posts.

Left beginning end treatment is unattached to post.

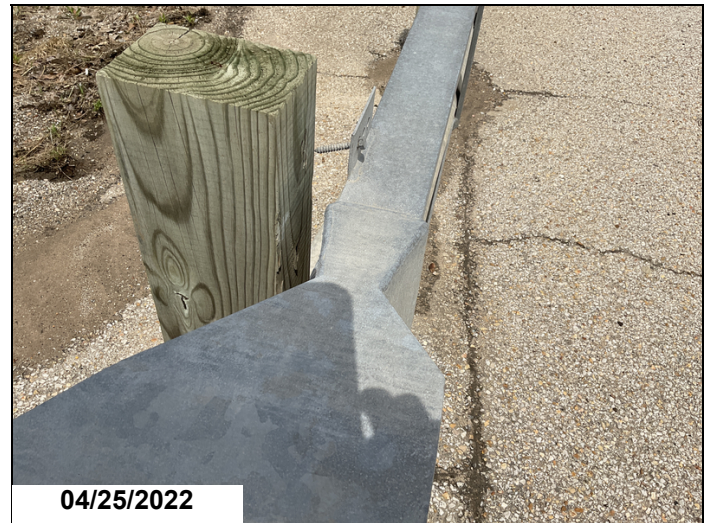
The right ending approach rail termination is not attached to the post.
