## **Bridge 06200 Inspection Report**

**Asset #06200**(Special)

**US 65 Searcy over BUFFALO RIVER**

**Team Lead:** Benjamin Smith **Inspection Date:** 06/02/2025

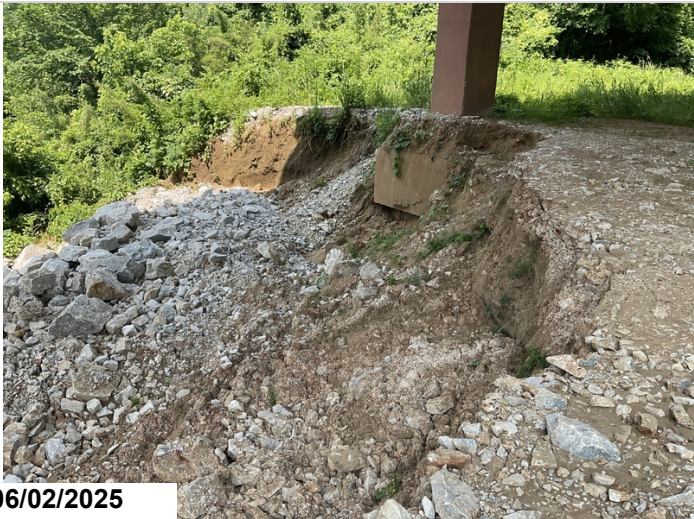
The pile cap and a 16" portion of the pile is exposed at bent #8 due to a large scour area from flooding in 2025.

View of scoured area at bent #8.

The bent #8 embankment has a large scoured area that has exposed 16" of the right H pile.

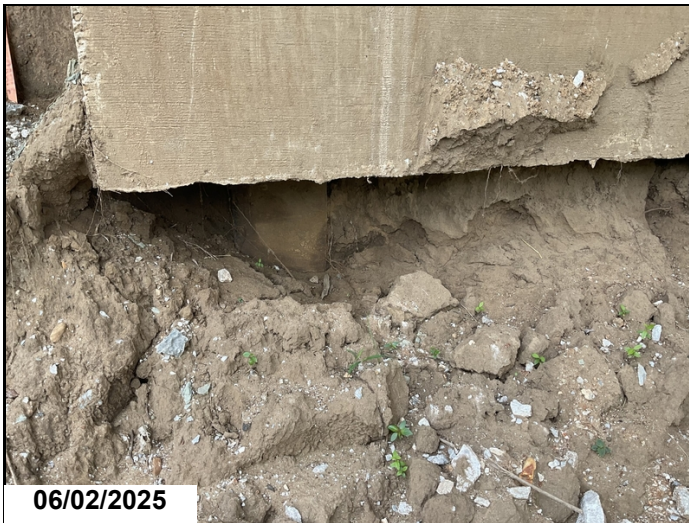
16" of the top of the H pile is exposed.

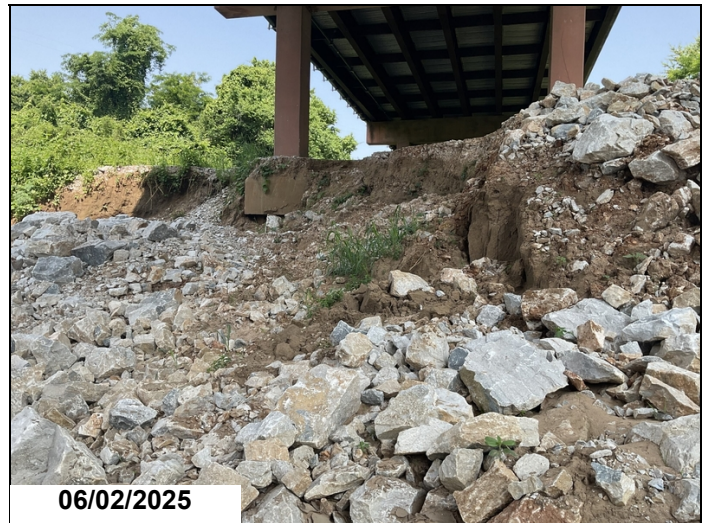
General view of the scoured area at bent #8.

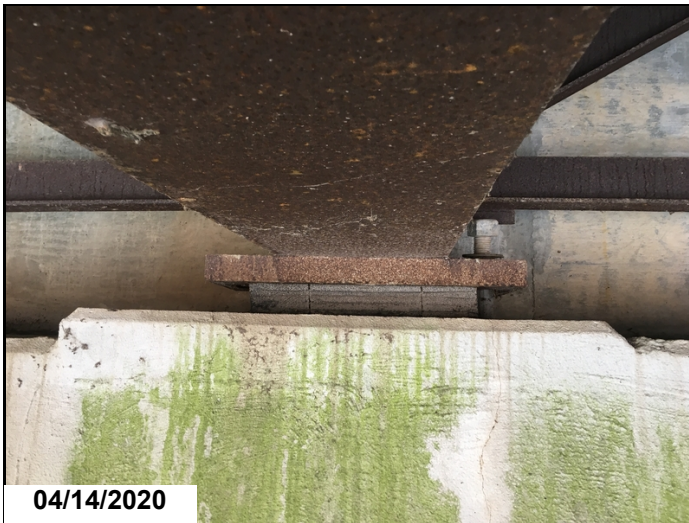
The left anchor bolt is sheared off at abutment #2 on beam #3.

Anchor bolt is sheared off at abutment #2 at beam #4.

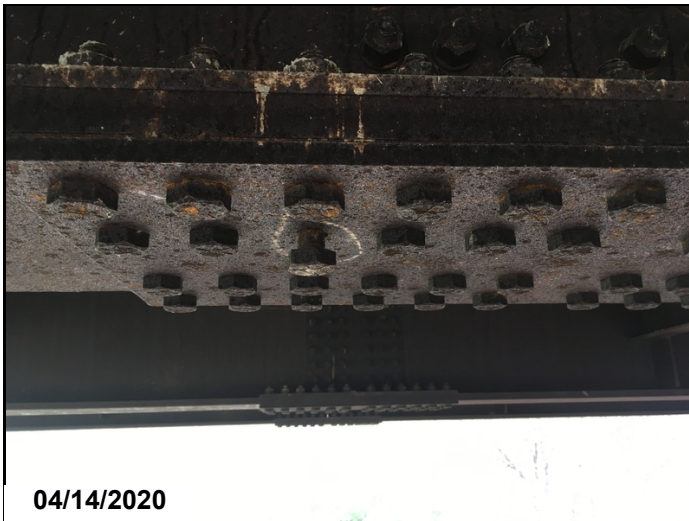
Loose bolts on the field splices at-  
Span #11- beam #4 at 2nd field splice  
Span #7- beam #3 at 2nd field splice  
Span #7- beam #1 at 2nd field splice  
Span #5- beam #1 at 1st field splice  
Span #4- beam #6 at 2nd field splice  
Span #3- beam #5 at 2nd field splice  
Span #3- beam #2 at 2nd field splice

Span #7 splice plate #2 at beam #3 has a loose bolt.

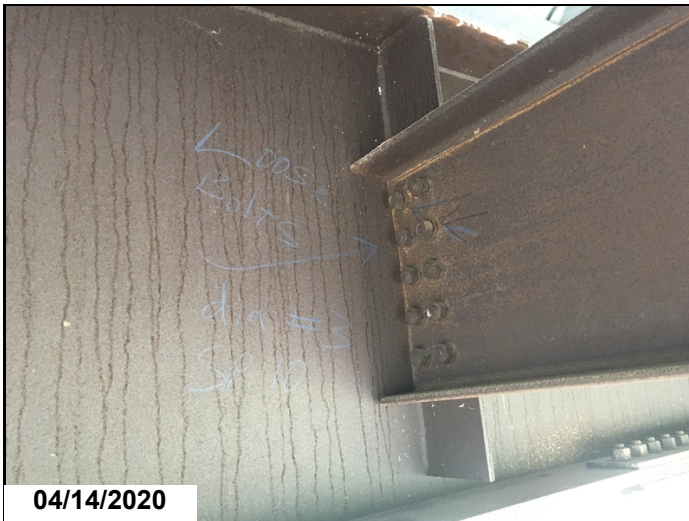
Loose bolts on the diaphragms at-  
Span #10- bay #4.  
Span #5- beam #3 has 2 bolts missing on the diaphragm  
Span #4- bay #4.  
Span #3- bay #2.  
Span #2- bay #5.  
Span #2- bay #5.  
Span #2 -bay #3.

Loose bolts on the diaphragm in span #9.

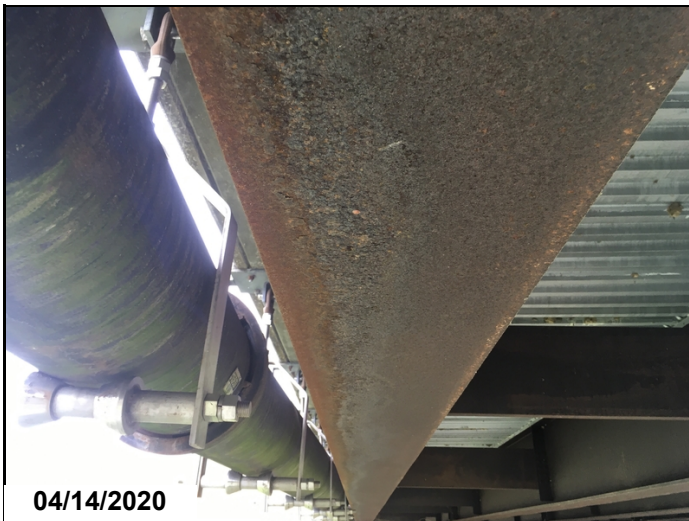
The bottom flange of beam #7 has areas of cs2 corrosion on the bottom flange in most spans.

Beam #7 in span #2 has cs3 corrosion on the lower connection of the field splice.

Beam #1 in span #11 has cs3 corrosion on the bottom flange near abutment #2.

Minor corrosion for the full length of the span on the bottom flange of beam #7 in span #4.
