Bridge 06750 Inspection Report

Asset #06750(Routine, Underwater type 2)

US 65 Searcy over BEAR CREEK

Team Lead: Benjamin Smith **Inspection Date:** 06/01/2022

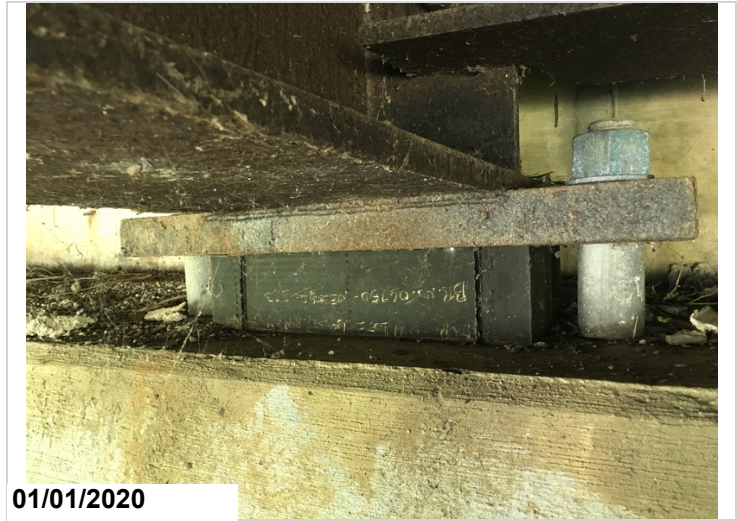
Bearing #3 at abutment #2. Showing minor corrosion with flaking rust.

The compression joint seals are leaking at both abutments causing corrosion on the beam ends and bearing sole plates at some locations.

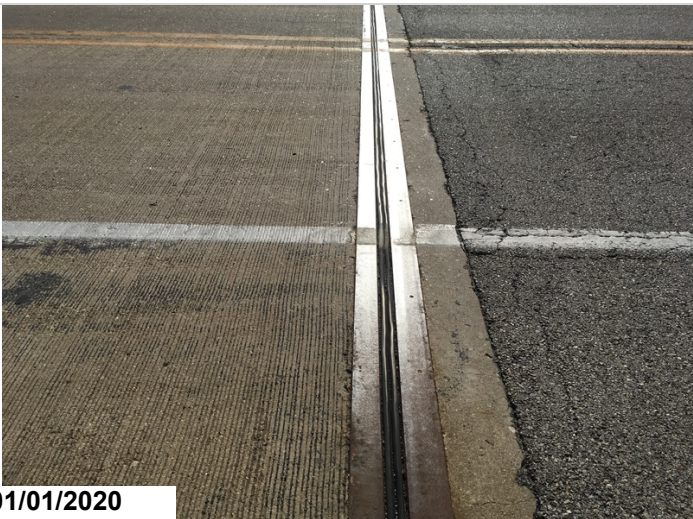
Condition of compression joint seal at abutment #2.

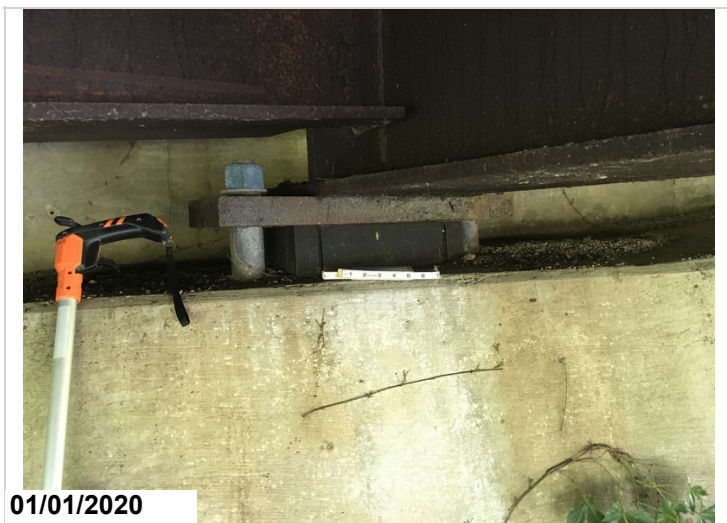
Bearing #4 at abutment #1 showing corrosion on the sole plate.

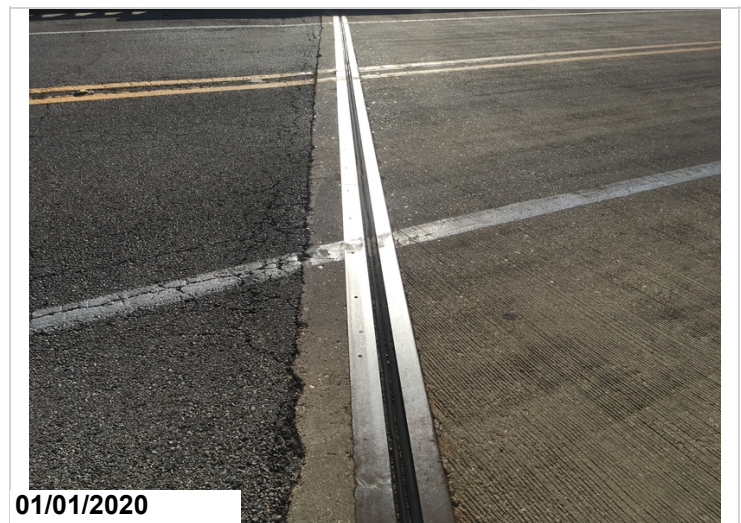
302	Compression Joint Seal	LF	88	0	44	44	0
2310	Leakage	LF	44	0	0	44	0
2320	Seal Adhesion	LF	26	0	26	0	0
2340	Seal Cracking	LF	18	0	18	0	0
<p>(302) Abutment #1 compression seal- has pack rust forming on the armoring plates that is causing adhesion loss and leakage, the seal has a few areas of cracking on the top edge.</p> <p>Abutment #2 compression joint seal- has pack rust forming on the armoring plates that is causing adhesion loss. The joint has 27' of leakage with some areas of cracking on the top edge.</p>							
303	Assembly Joint with Seal	LF	43	43	0	0	0

Condition of compression joint seal at abutment #1.

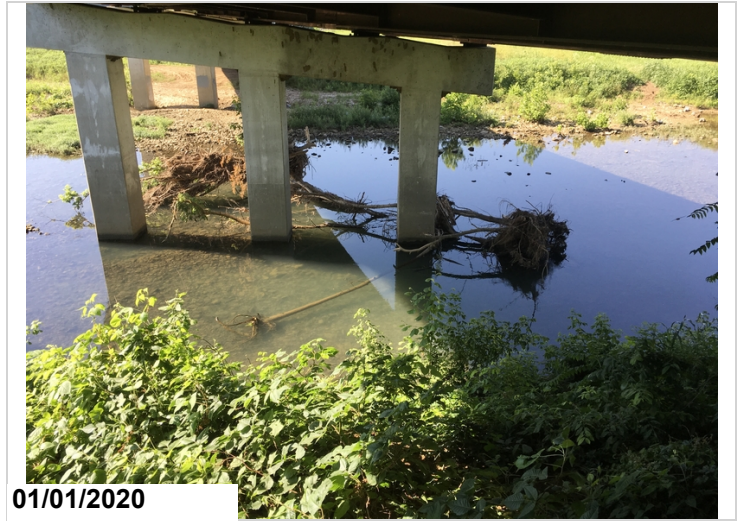
Minor drift accumulation on bent #1 is causing local scour at column #3.

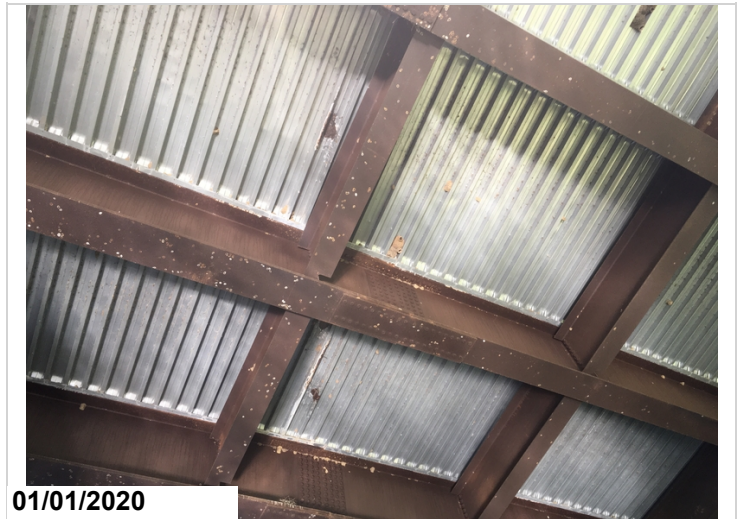
Corrosion in the sip forms in bays 2,3 in span #1 due to leaking construction joint seals. Typical of several locations

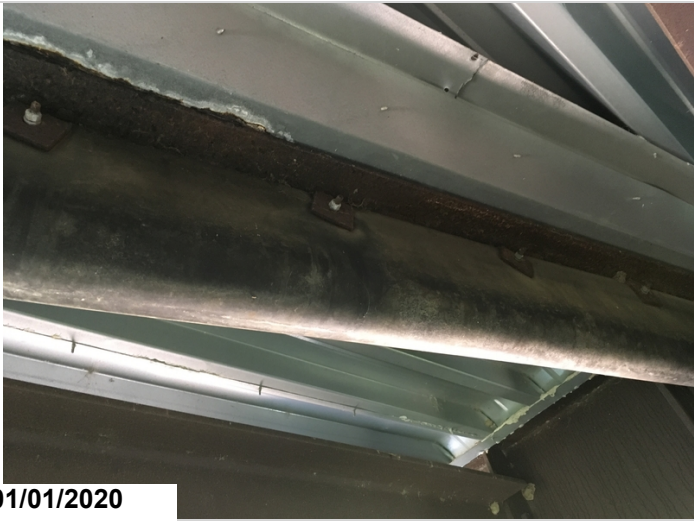
Neoprene trough condition at bent #3. No leaking was noted.

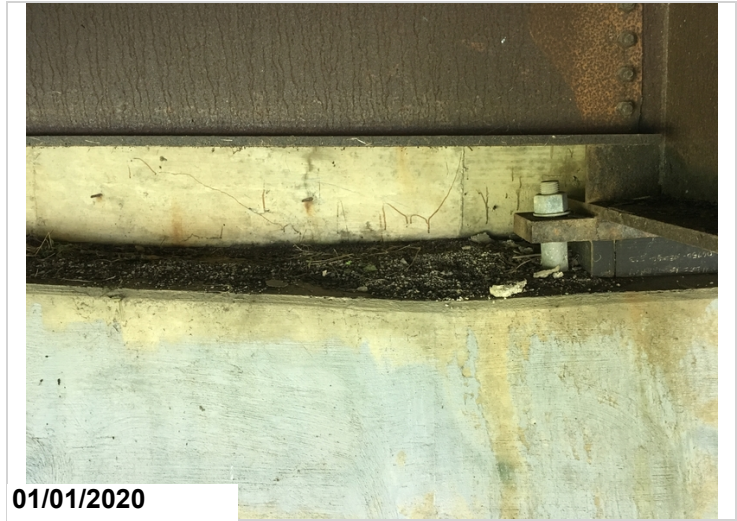
Debris build up on the abutment #2 bridge seat.

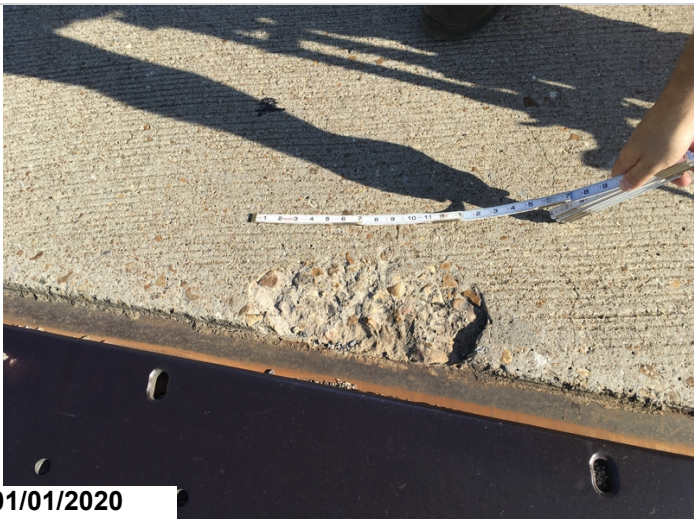
Spall in the left driving lane at the assembly joint seal.

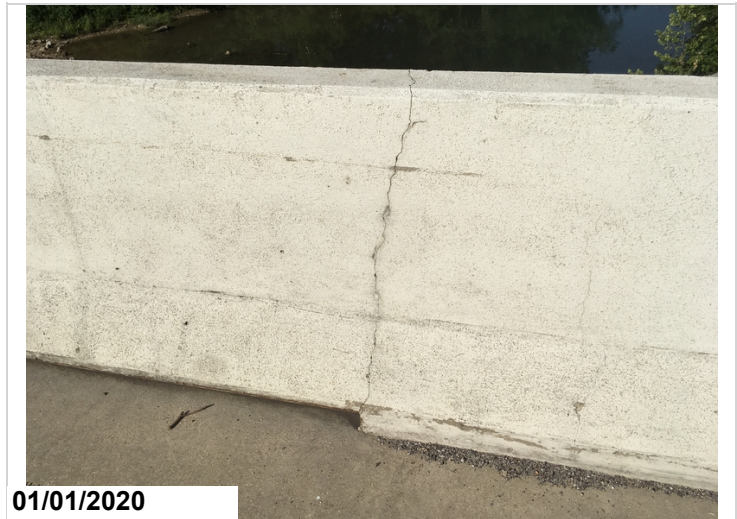
331	Reinforced Concrete Bridge Railing	LF	989	693	296	0	0
1130	Cracking (RC and Other)	LF	296	0	296	0	0
(331) The left parapet wall has 131' of hairline vertical cracks at random locations. The parapet wall grout coating has map cracking

Typical vertical crack in the parapet walls.

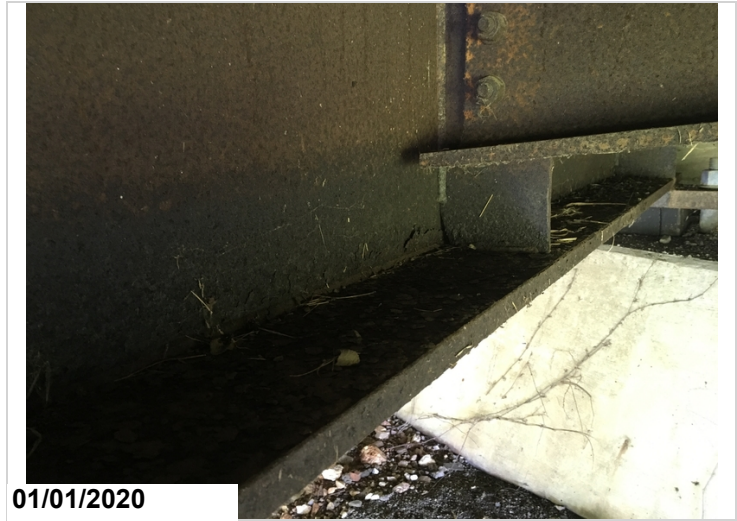
Corrosion with flaking rust on the bottom flange and lower web of beam #3 at abutment #1. Typical of several locations.

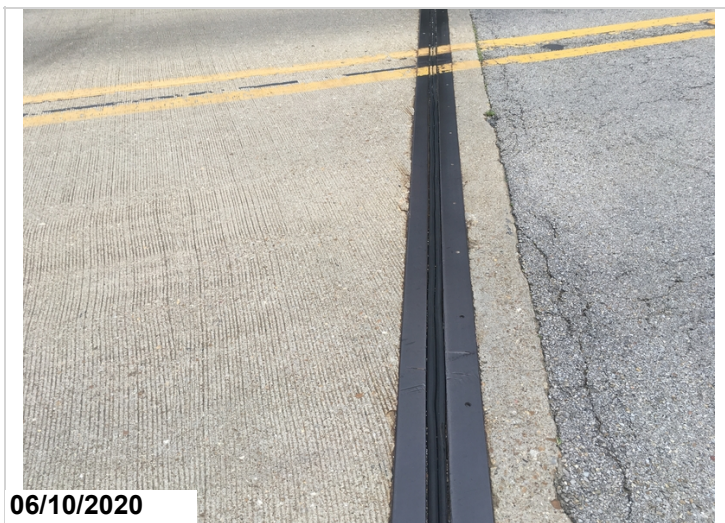
Joint seal condition at abutment 1.

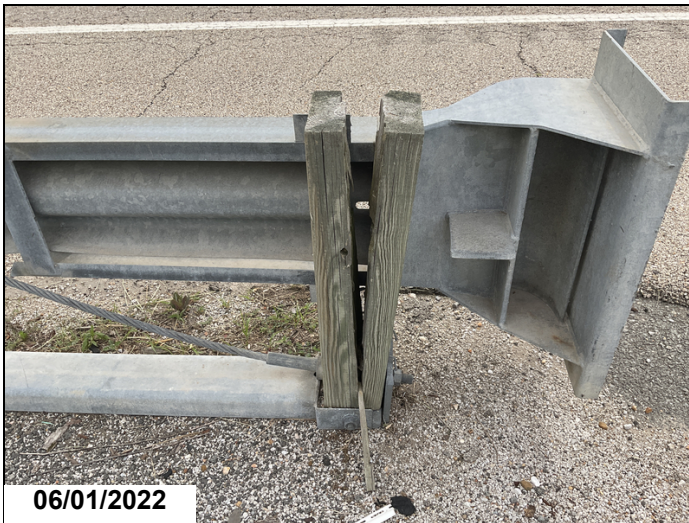
The right ending rail approach post termination is split and unattached.

Type of Work: Repair (General)
