Bridge 03345 Inspection Report

National Bridge Inventory Data Sheet

Team Lead: Benjamin Smith, Inspection Date: 05/29/2024

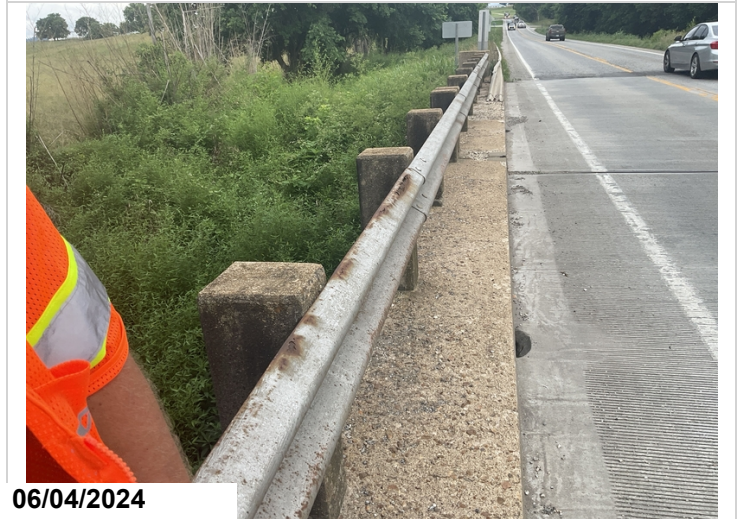
(330) Both left and right railing have areas that are down to primer throughout railing.							
Left side railing- has large areas of cs2 corrosion. Span #5 has minor vehicle damage.							
Right side railing- has 5' of cs3 corrosion in span #2. Some of the posts in span #4 have areas of cs3 spalling at the base of the posts. A portion of the span #5 and #6 railing has been replaced due to a traffic accident.

Cs3 corrosion on the right railing in span #2.

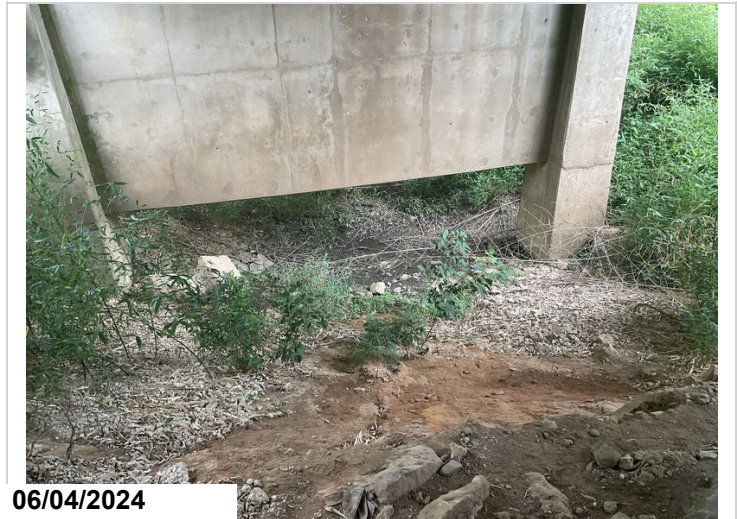
The channel beneath the structure is solid rock. A local scour was noted around the bent #1 columns. no footings are exposed. The abutment #1 slope has a large area of erosion at the toe of the slope.

Local scour around the bent #1 columns with embankment erosion at the toe of the abutment #1 slope.

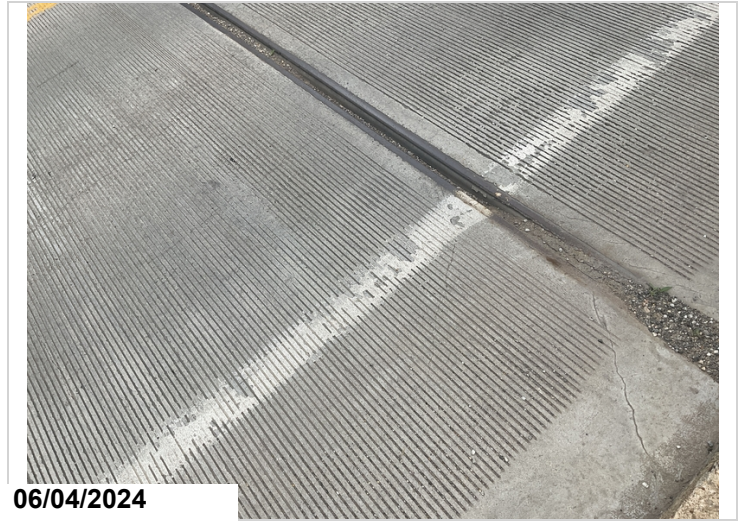
12' of deck cracking at the end of span #1.

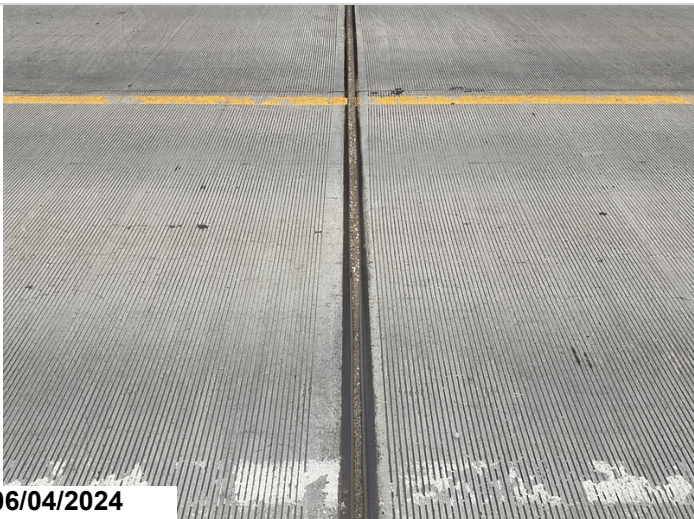
Strip seal condition over the bents. Loose debris impactation typical.

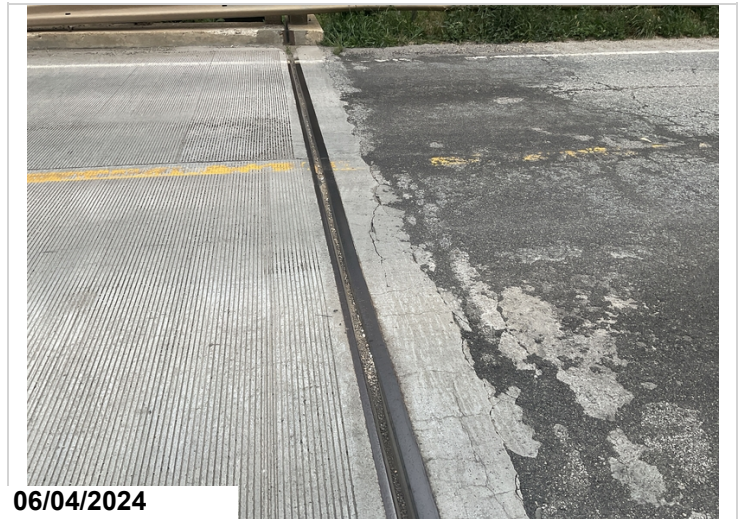
Abutment #2 seal condition.

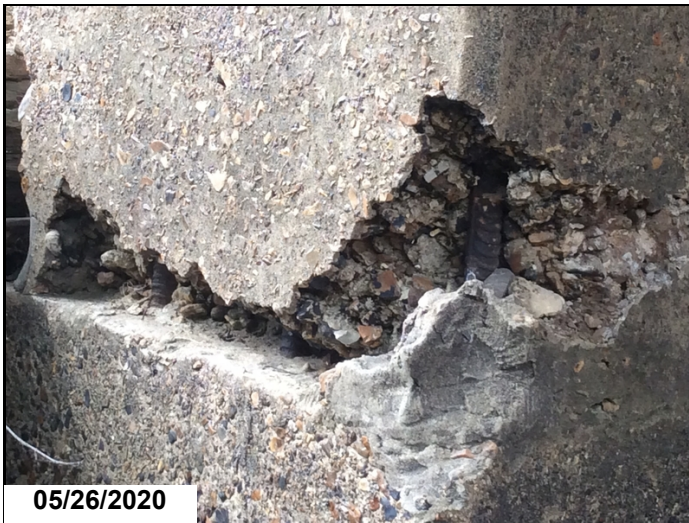
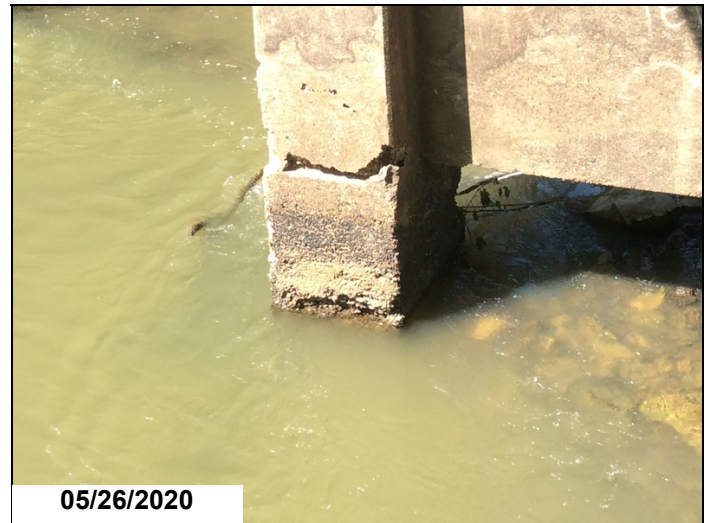
The substructure has small areas of cs3 rebar exposed and delamination in the pier caps. Bent #3 has cs3 abrasion with section loss.

The left and right columns of bent #3 have spalling and deterioration due to abrasion.

Bent 3 ahead side of right column 2 steel exposed.

Bent 3 column 2 ahead side side large areas of spalling with steel exposed.

Type of Work: Substructure Repair

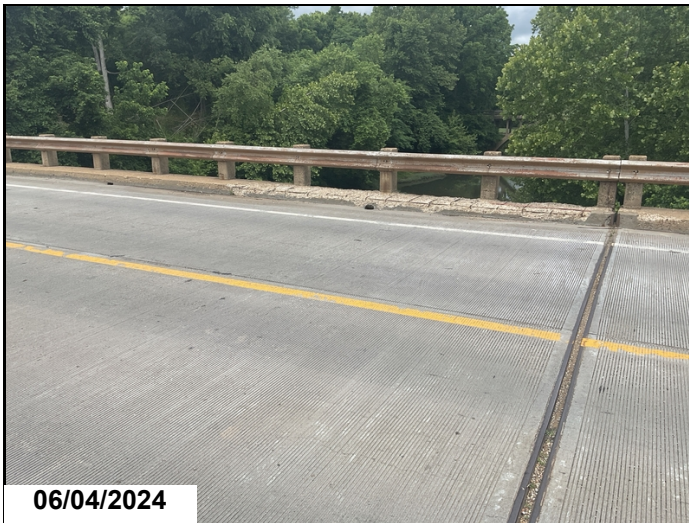
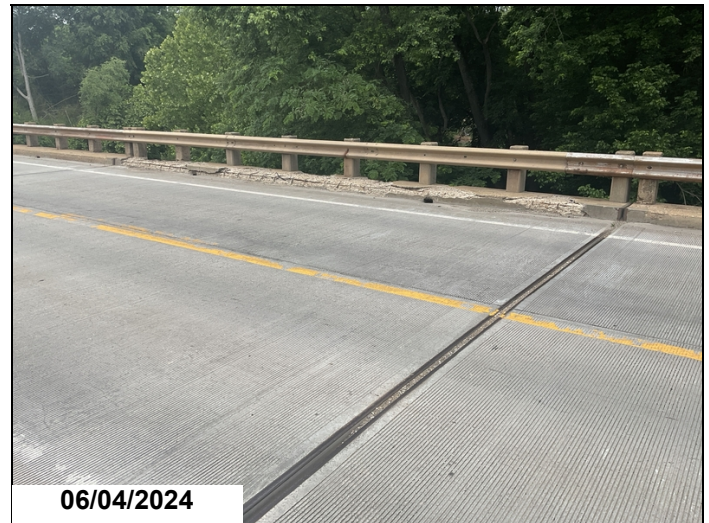
The driving surface of the deck has a hydro demolition with some short duration cracking in span #1. The curb sections have large areas of spalling with exposed rebar. The undersurface has full depth repairs with efflorescence cracking. The overhangs have large areas of spalling with exposed rebar.

The curb sections have large spalls with cs3 rebar exposed.

Left curb in span #3 showing spalling with exposed rebar.

Left curb in span #6 showing spalling with exposed rebar.

Type of Work: Repair (General)
