## **Bridge 06667 Inspection Report**

IDENTIFICATION	
(1) State Names	5 - Arkansas
(8) Structure Number	06667
(5) Inventory Route	1
(2) Highway Agency District	09 - District 09
(3) County Code	15 - Carroll County

Team Lead: Benjamin Smith, Inspection Date: 07/02/2024

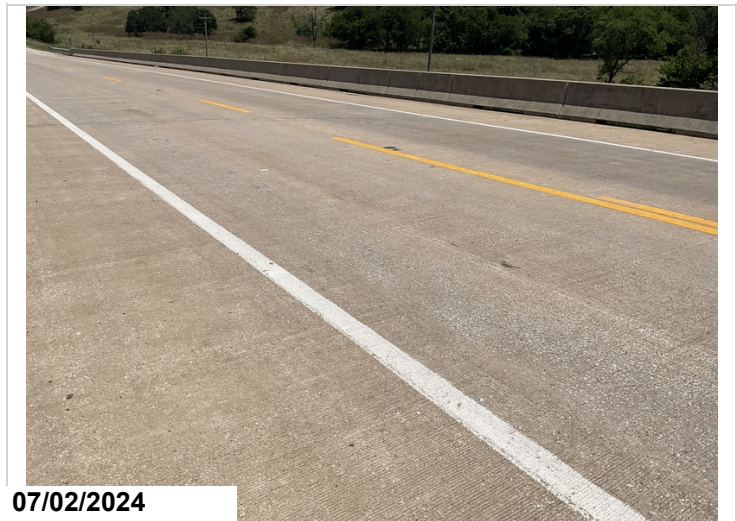
The driving surface has wear in the wheel paths with unsealed cs2 cracking. The undersurface has SIP forms in the bays. The overhangs have cs2 efflorescence.

The driving surface has unsealed cracking and wear in the wheel paths.

Driving surface view.

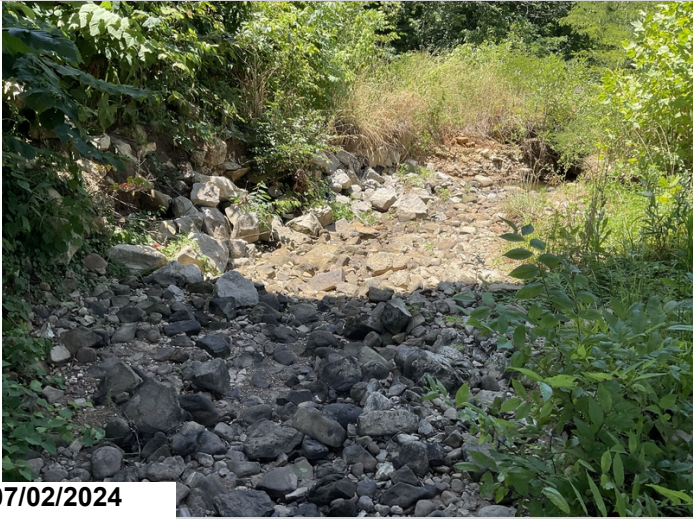
The downstream channel has embankment erosion. The channel banks are mostly vegetated.

Embankment erosion on the downstream channel.

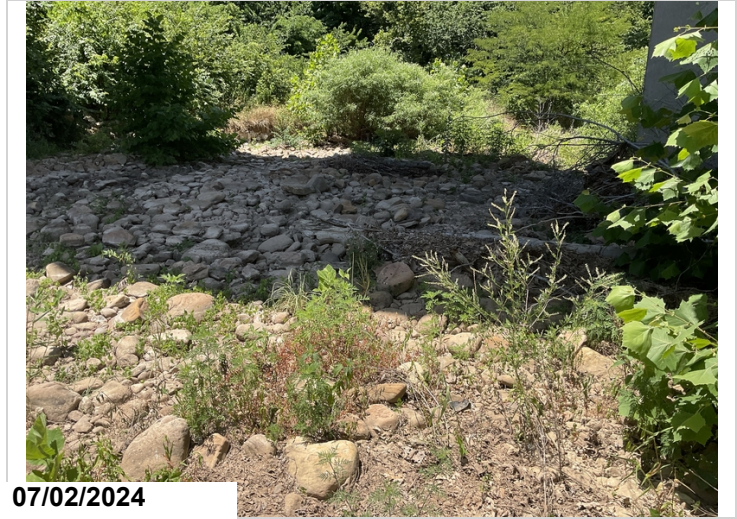
The channel beneath the structure has minor drift on pier #2. The lower portion of the abutment slopes have rip rap that is in place with no deficiencies. The channel is dry for most of the year.

Channel beneath the structure.

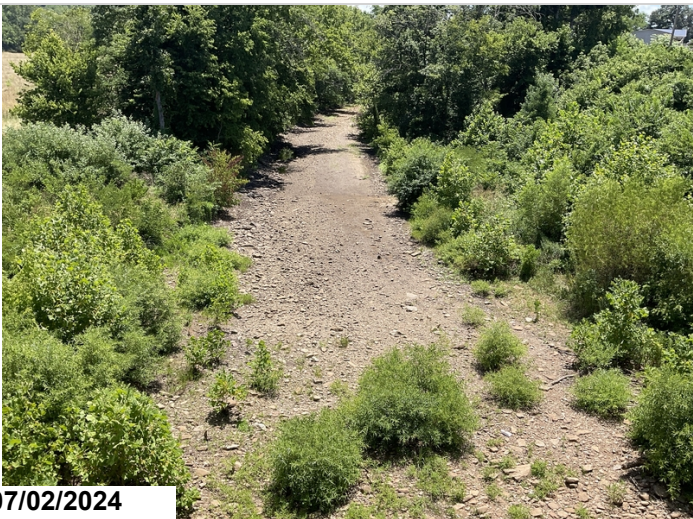
The upstream channel is well vegetated.

Upstream channel view.

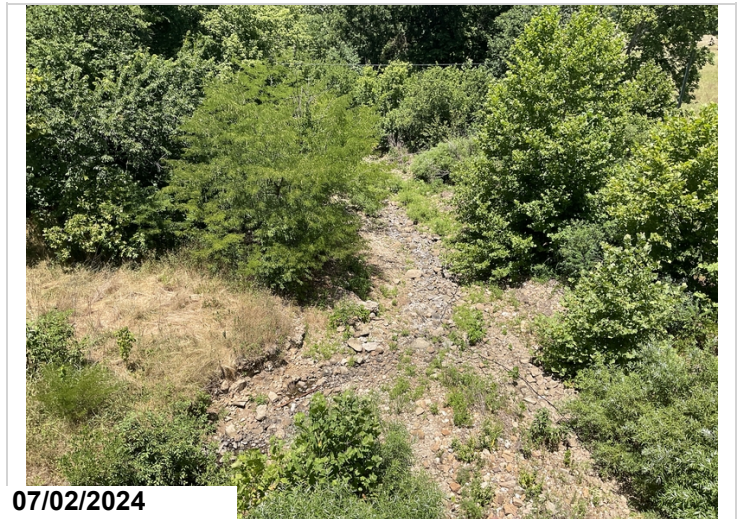
Downstream channel view.

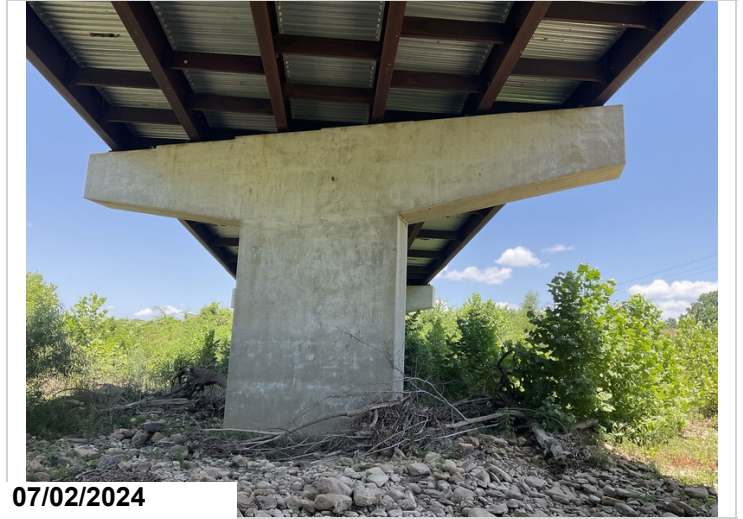
The abutments have cs3 delamination and spalling on the top of the back wall in the driving surface. The pier caps have shrinkage cracking.

Typical view of the piers.

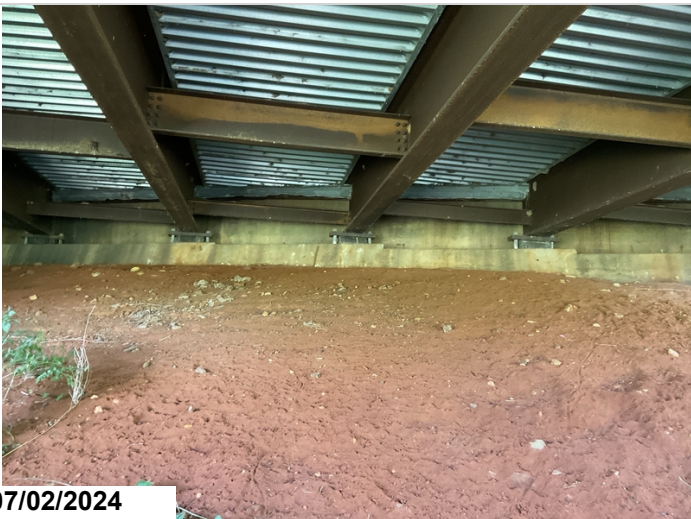
Typical abutment view.

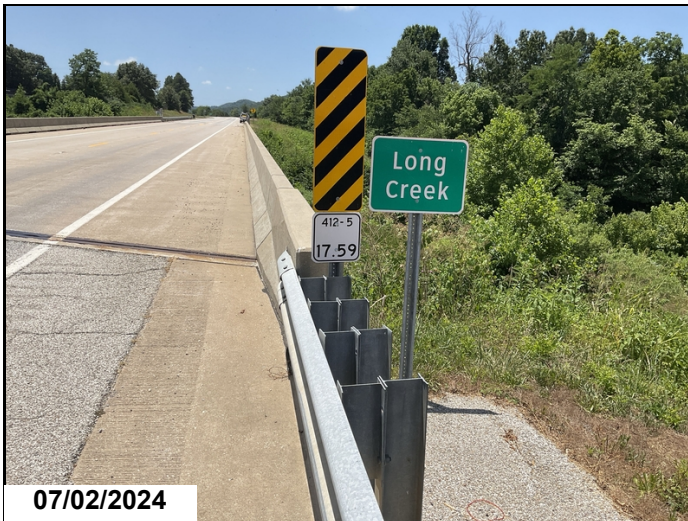
Log mile sign is incorrect. Should read 17.59

Replaced log mile sign to reflect proper log mile.

It was noted during the routine inspection that the log mile sign has been replaced and reads correctly. BDS 2024
