## Bridge 06668 Inspection Report

Asset #06668(Routine, Underwater type 2)

US 412 S-5 Carroll over LONG CREEK

Team Lead: Benjamin Smith Inspection Date: 08/13/2024

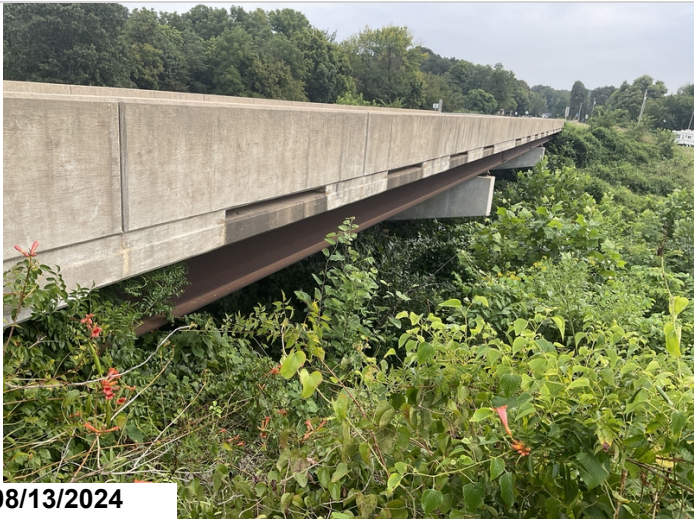
Elevation view.

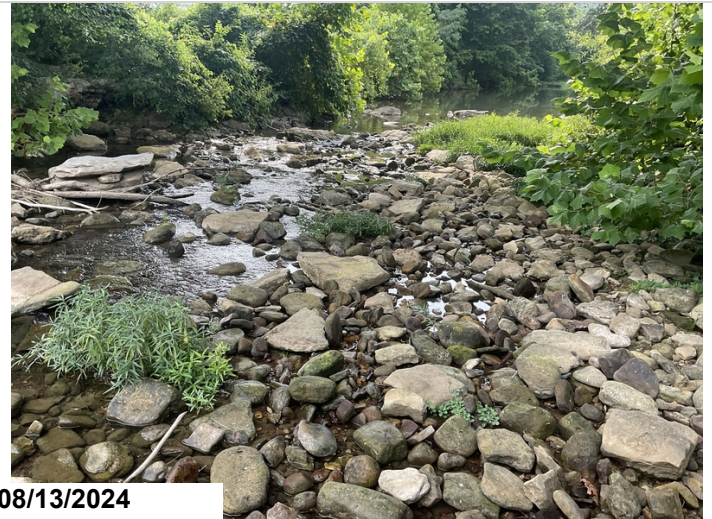
Channel beneath the structure.

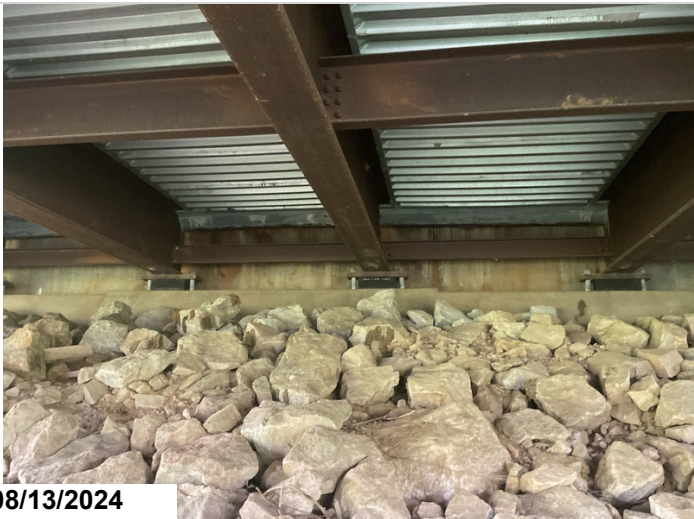
General view of abutment #1.

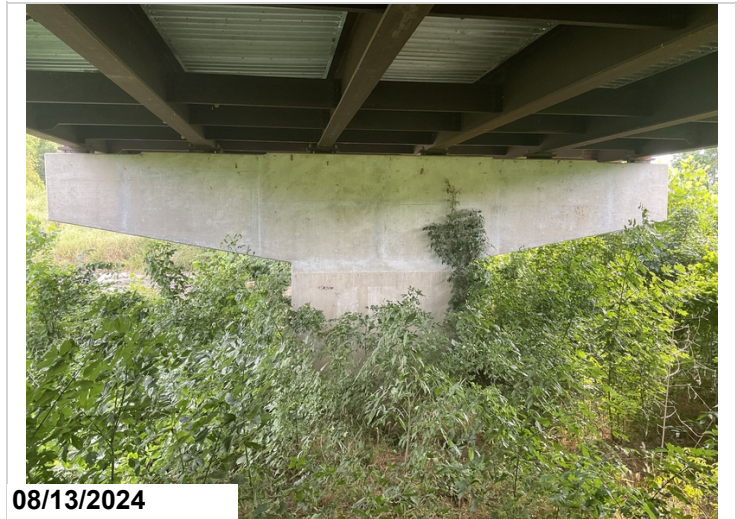
General view of pier #1.

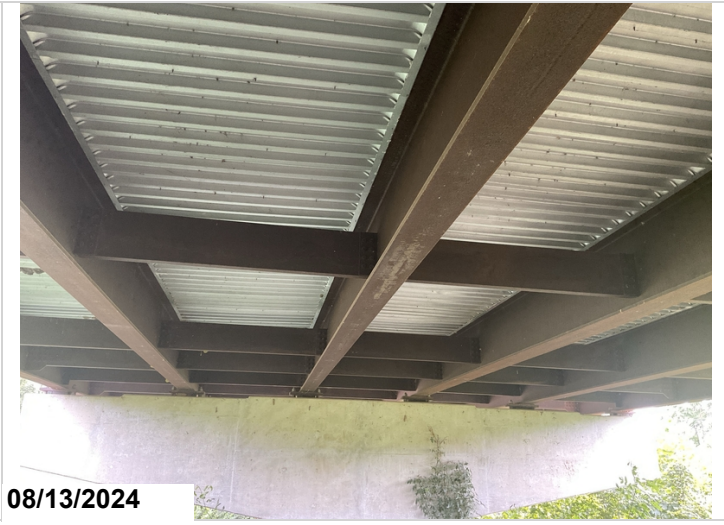
Undersurface view.

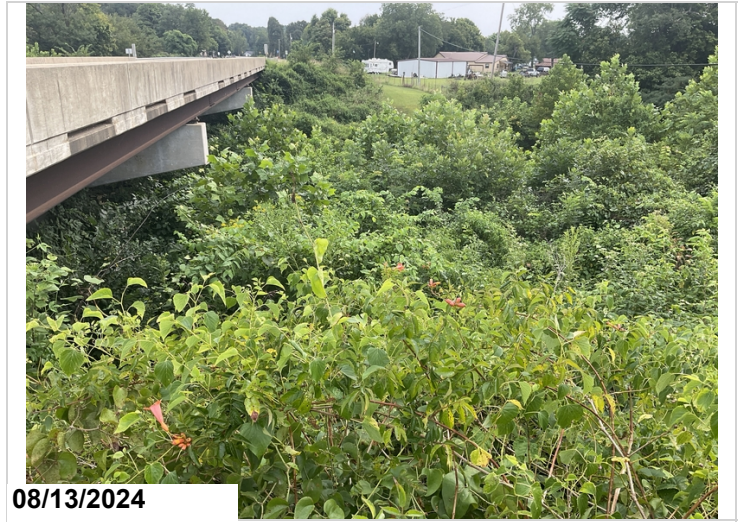
Both sides and underneath the structure have a heavy growth of vegetation.

Brush along the side and underneath the structure.

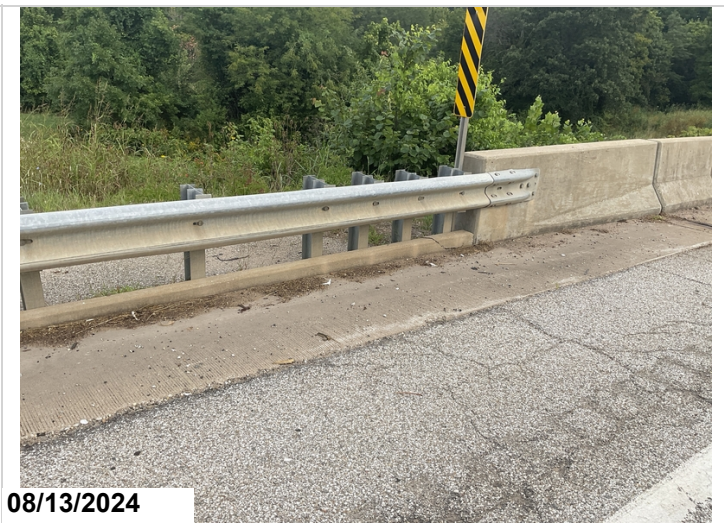
Transition area.

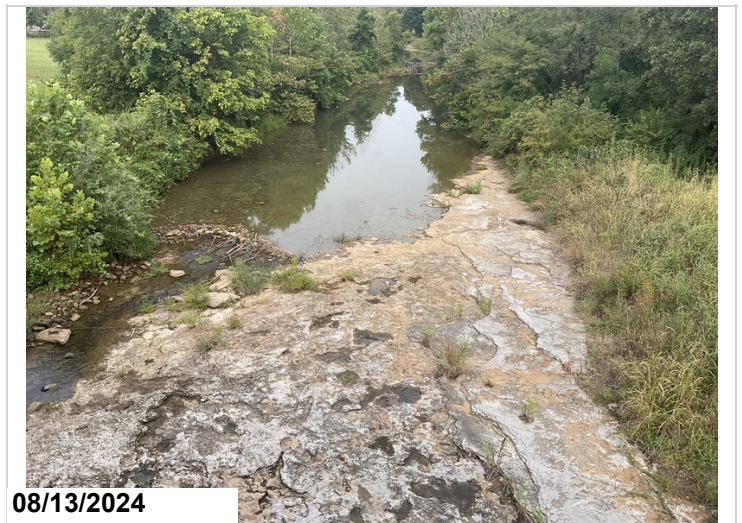
The upstream channel banks are well vegetated. The channel bottom has large areas of exposed solid rock.

Upstream channel view.

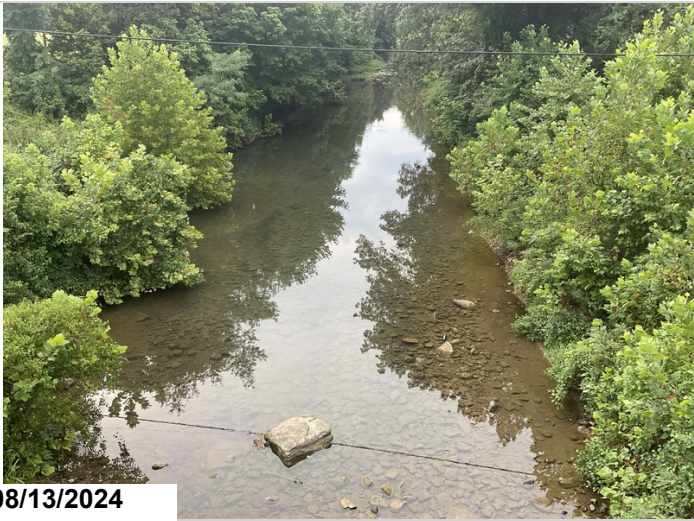
The downstream channel banks are well vegetated.

Downstream channel view.

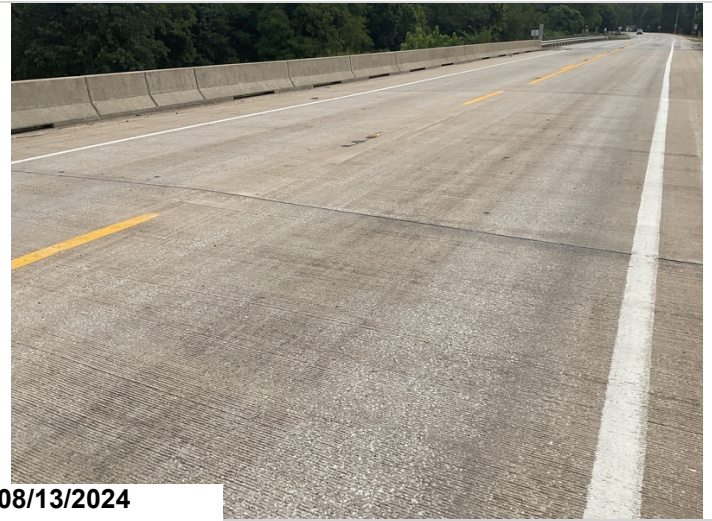
The driving surface has wear in the wheel paths with unsealed longitudinal cracking. The deck edges have cs2 cracking along the joint seal armoring plates.

Driving surface view.

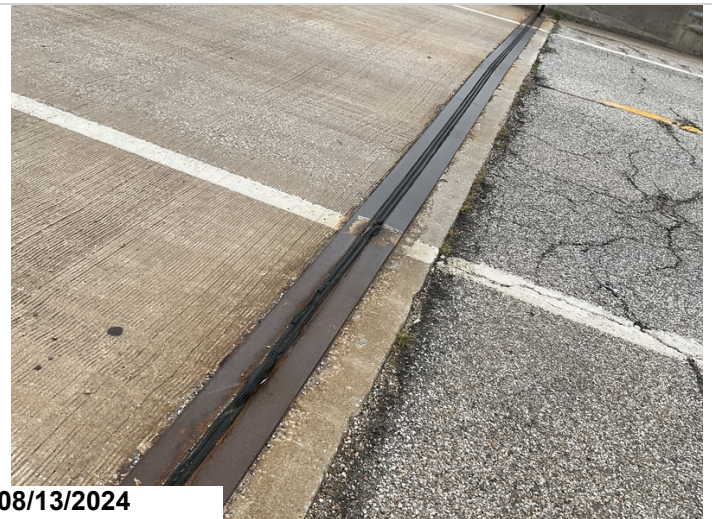
The compression joint material is cracking at both abutments. The joint seals have damage in the gutter lines.

Abutment #1 seal condition.

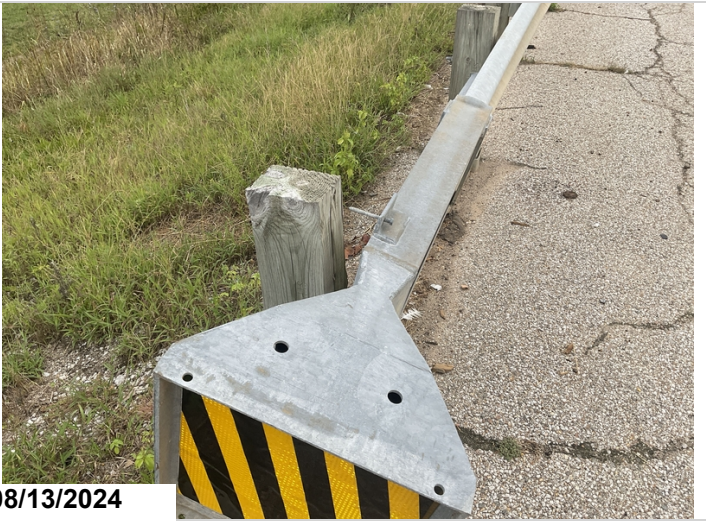
The left beginning end treatment is detached from the post.

The right beginning and right ending approach railing end treatment is not attached to the post. The left beginning approach rail end treatment is detached from the post.

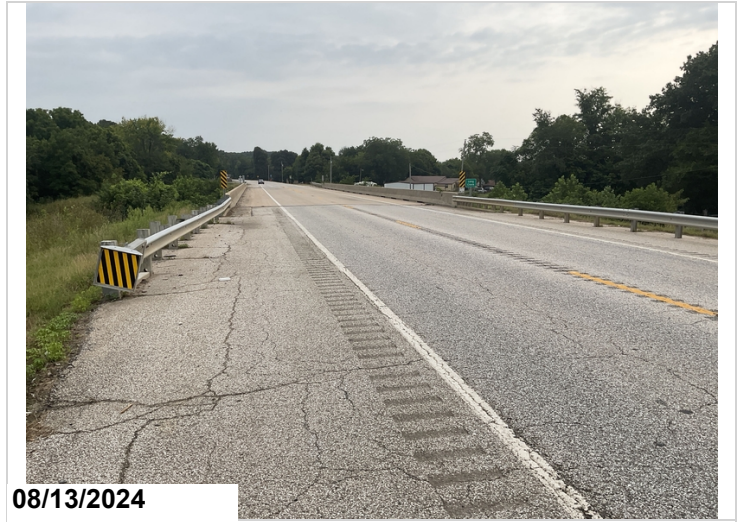
Approach view in direction of log mile.

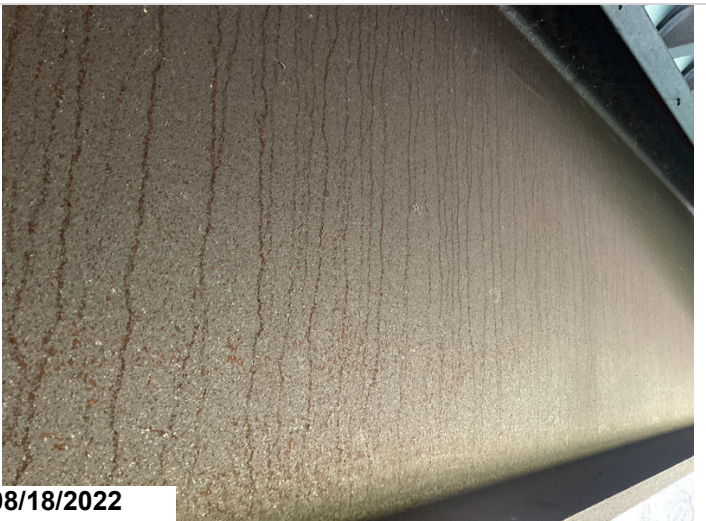
Typical view of the weathering steel protective coating condition.

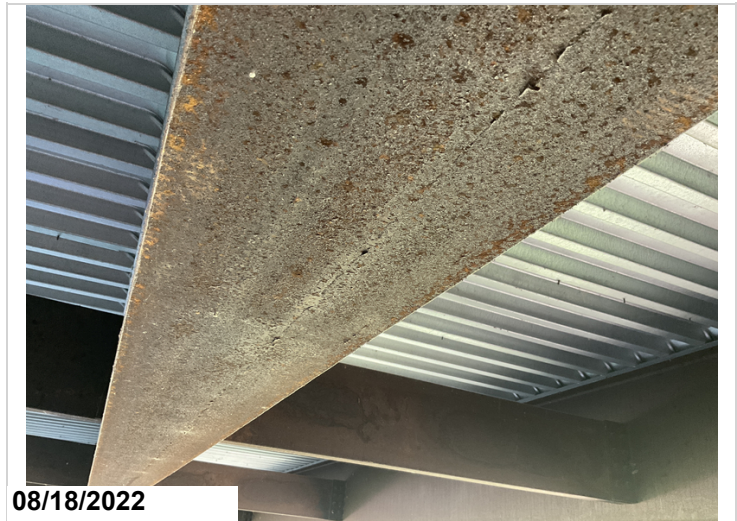
Superficial factory defect on the bottom flange of beam #3 in span #1. Typical.

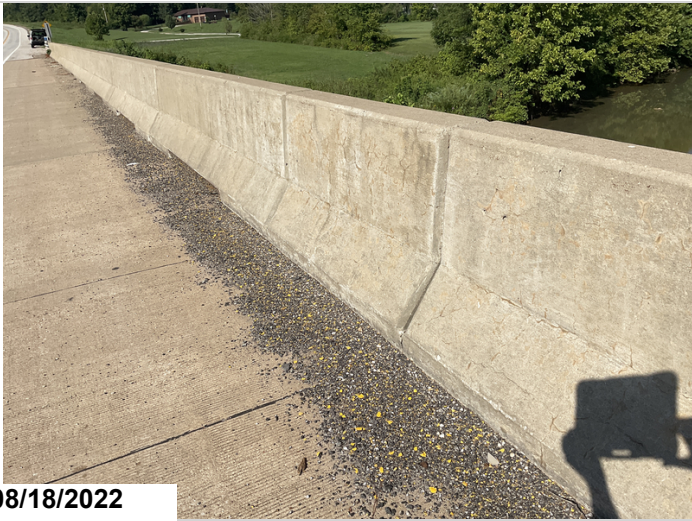
Map cracking in the left parapet wall.

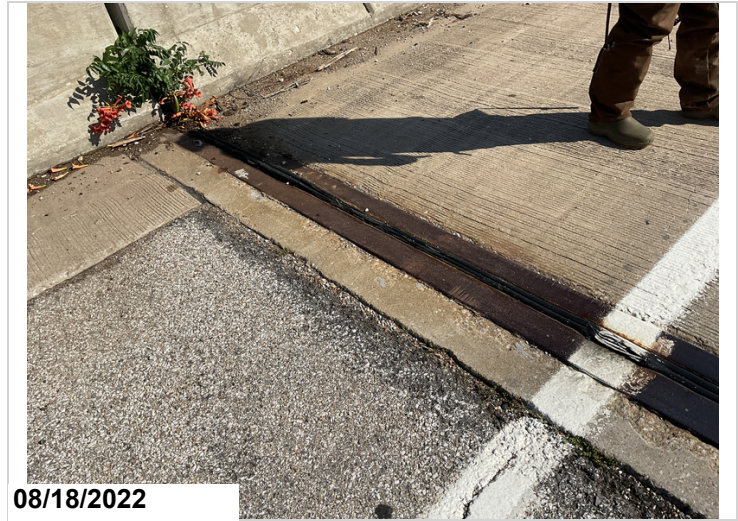
Seal damage at abutment #1.

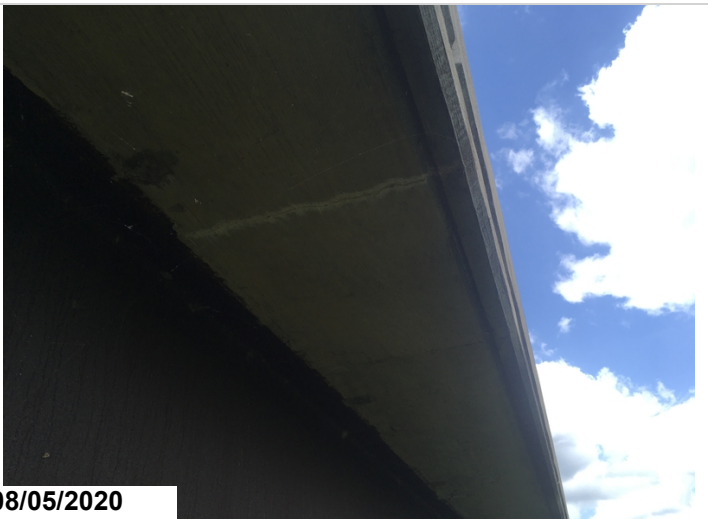
The undersurface has cs2 efflorescence in the overhangs.

Efflorescence cracking in the deck overhangs.

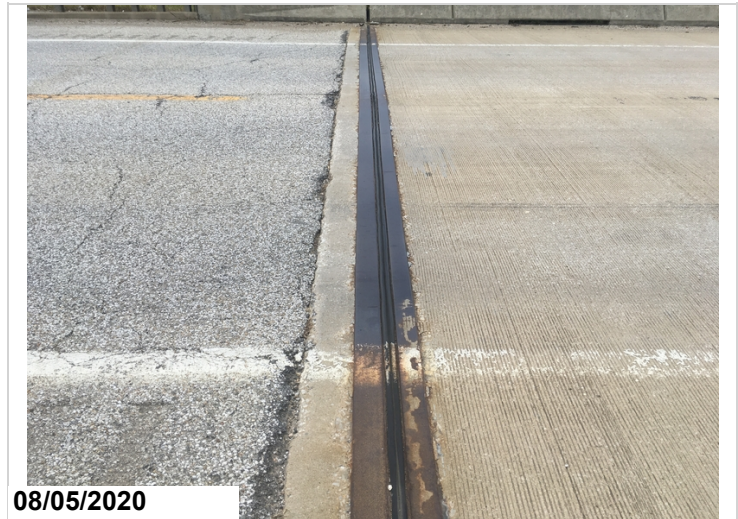
Joint seal condition at abutment 1.

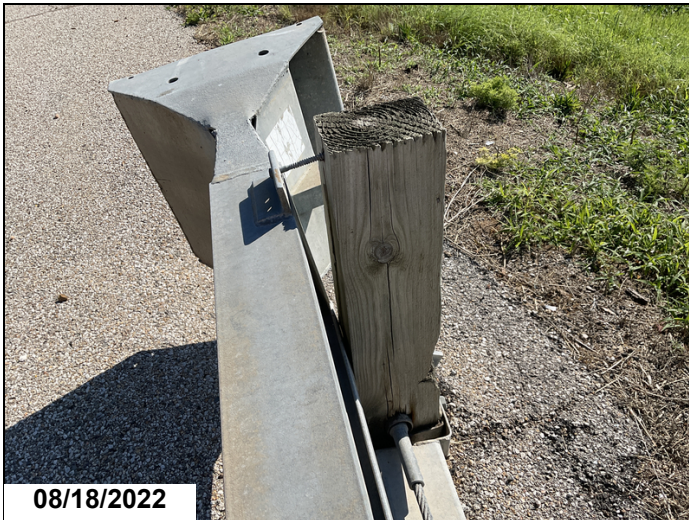
The right ending approach railing end treatment is not attached to the post.

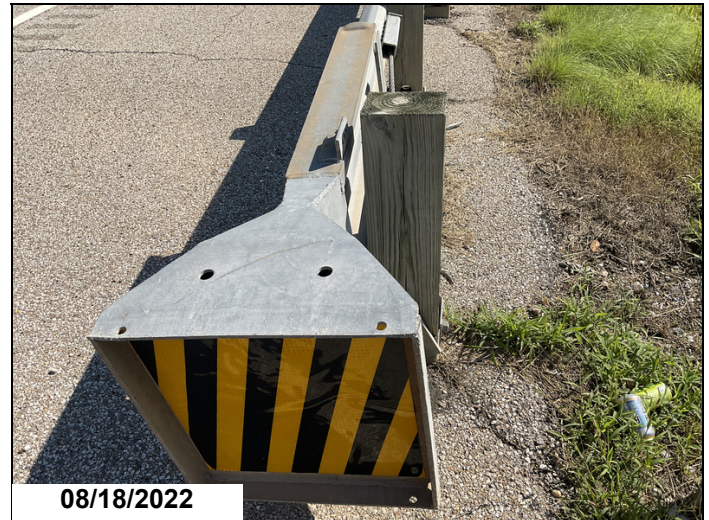
The right beginning approach railing end treatment is not attached to the post.

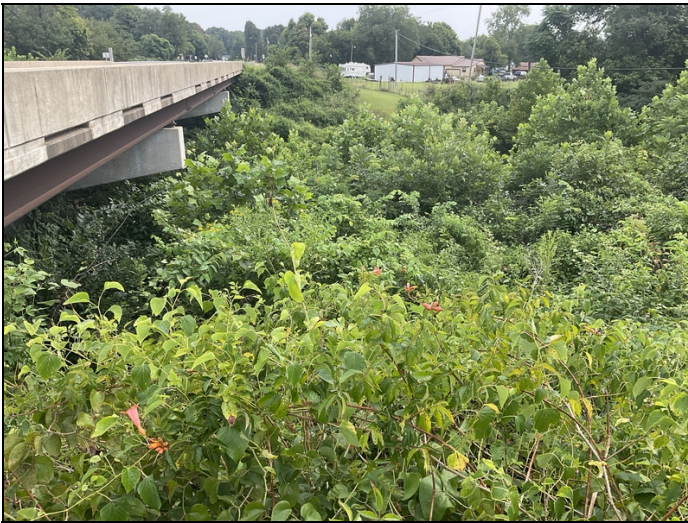
Both sides and underneath the structure have a heavy growth of vegetation.

Brush along the side and underneath the structure.
