Bridge 06787 Inspection Report

Asset #06787 (Routine, Underwater type 2)

US 412 S4 Madison over ONION CREEK

Team Lead: Anthony Wood Inspection Date: 05/20/2025

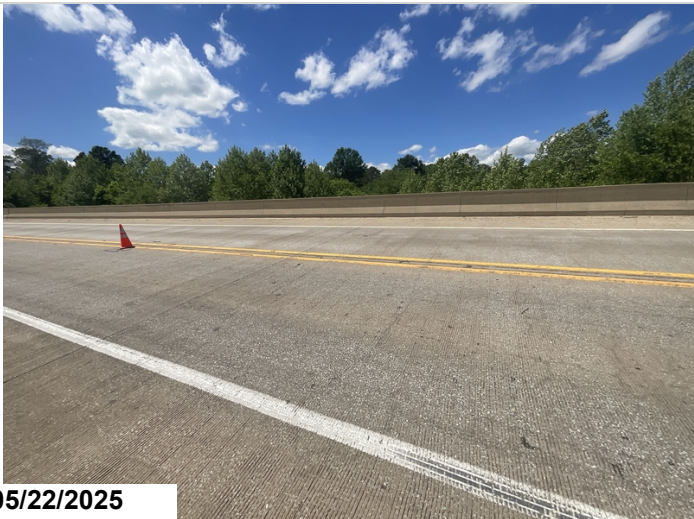
Overall, the deck is in good condition with cracking and abrasion.

Typical deck.

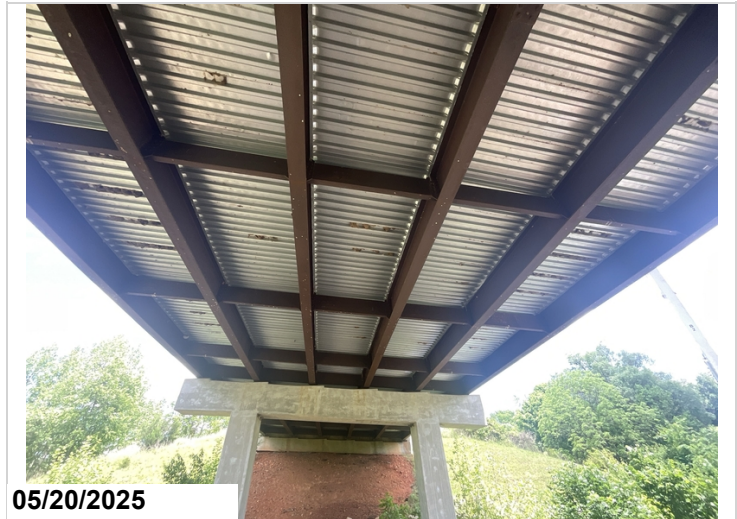
Typical undersurface.

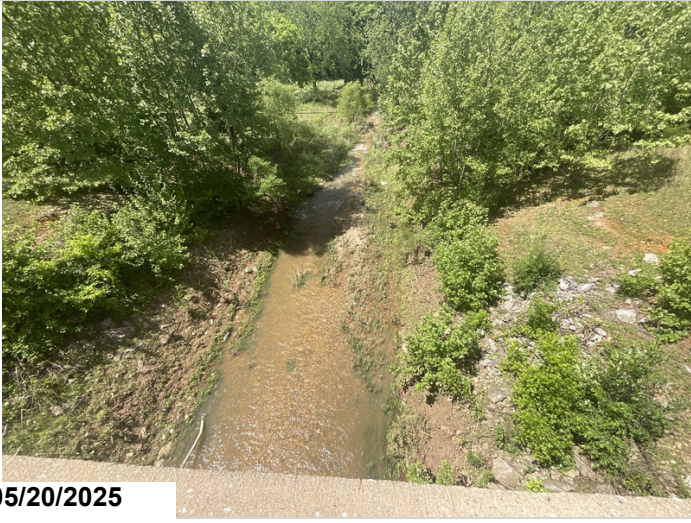
Channel, Left.

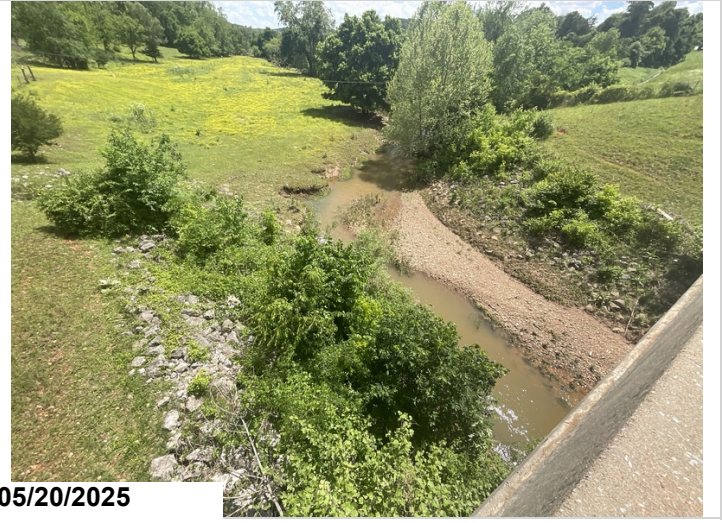
Channel, Right.

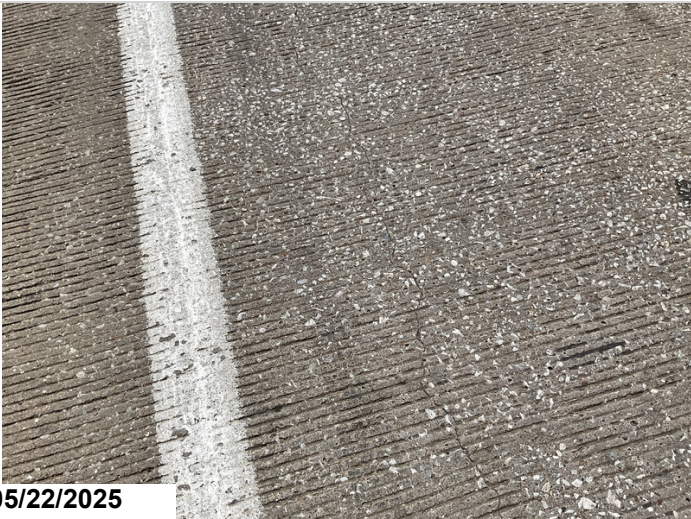
Spans 1 - 3 have minor cracking.

Spans 1 - 3: Transverse and longitudinal cracking.

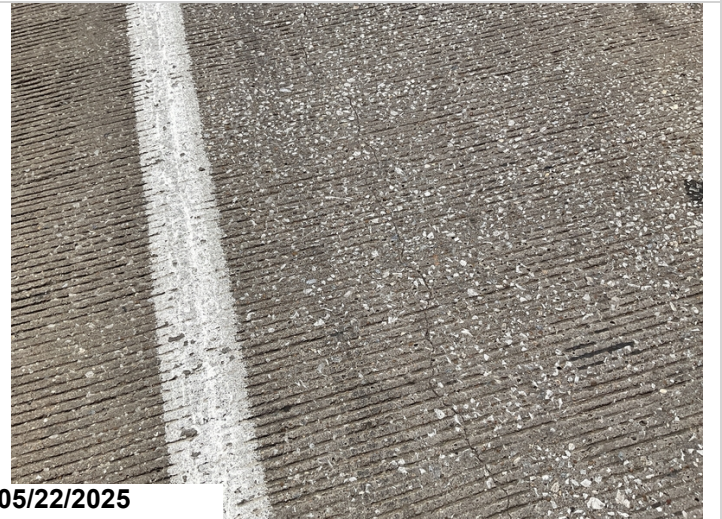
Spans 1 - 3 have minor cracking.

Spans 1 - 3: Transverse and longitudinal cracking.

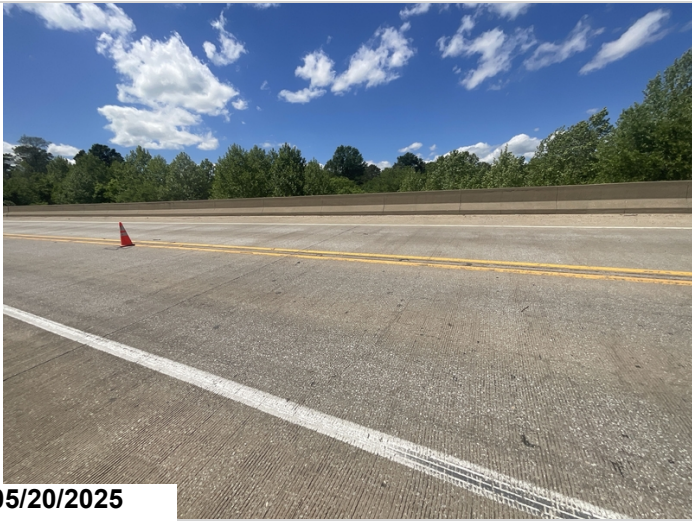
Overall, the bridge rail is in satisfactory condition with cracking.

Typical bridge rail.

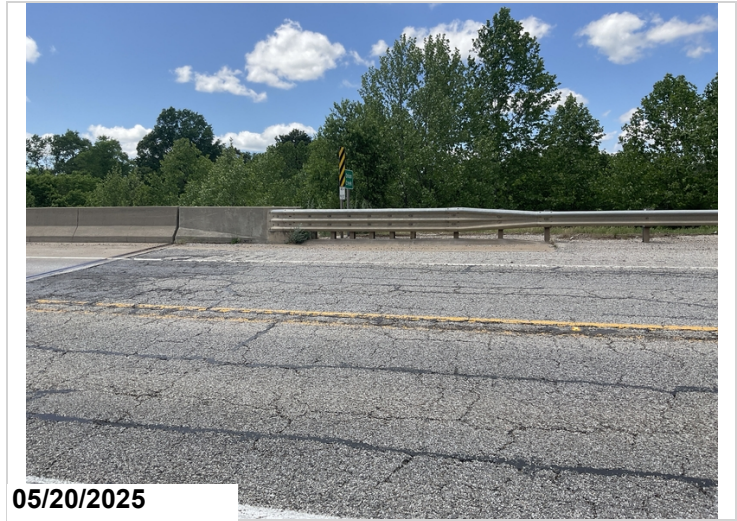
Overall, the transition rail is in excellent condition.

Typical transition.

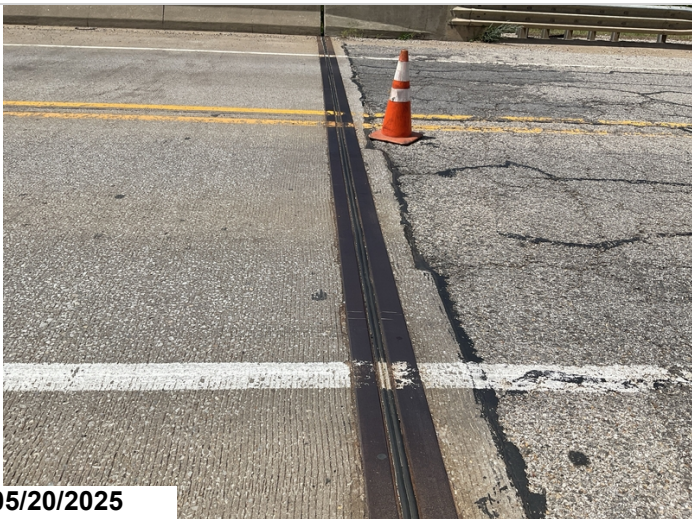
Overall, the joints are in good condition with minor debris impaction in the gutter lines.

Typical joints.

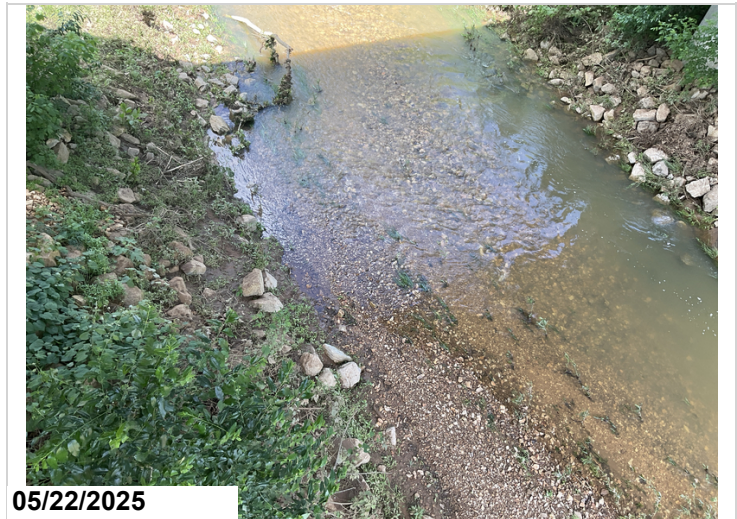
Overall, the channel protection is in satisfactory condition with areas of displaced rock at abutment 2.

Areas of displaced rock in the channel beneath structure.

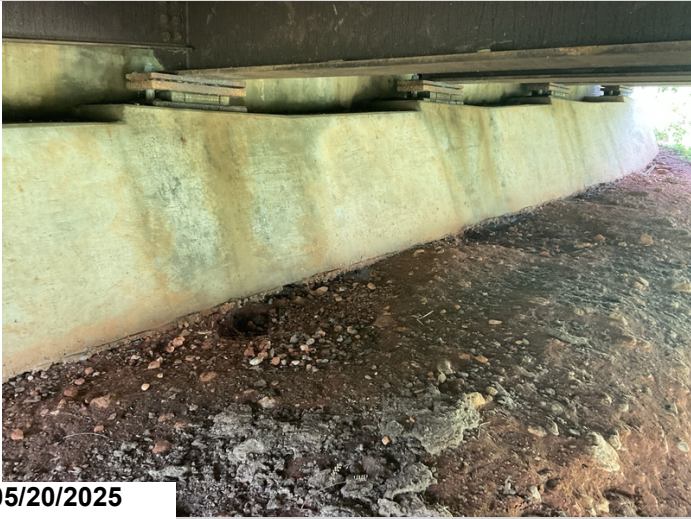
Overall, the scour condition is good with minor erosion at abutments 1 & 2.

Abutment 1: Minor erosion.

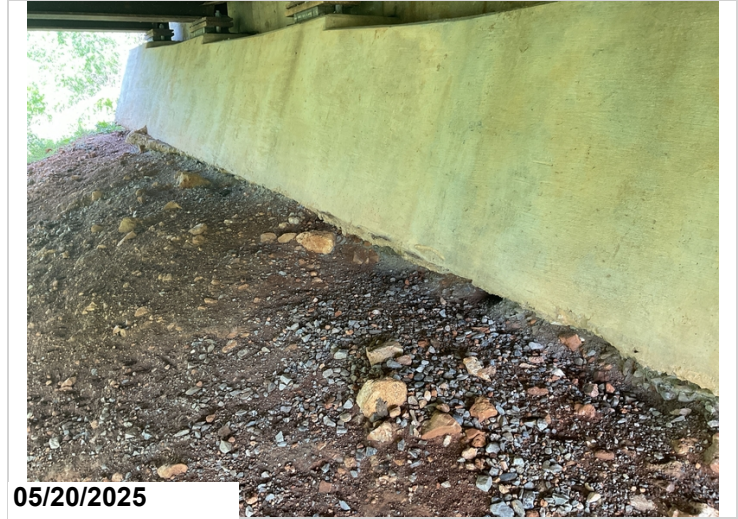
Abutment 2: Minor erosion.

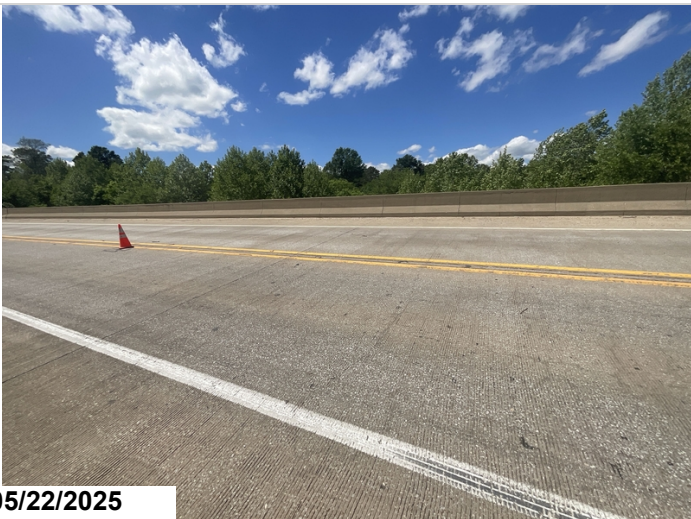
Spans 1 - 3: Abrasion in the wheel paths. 1160SF CS2

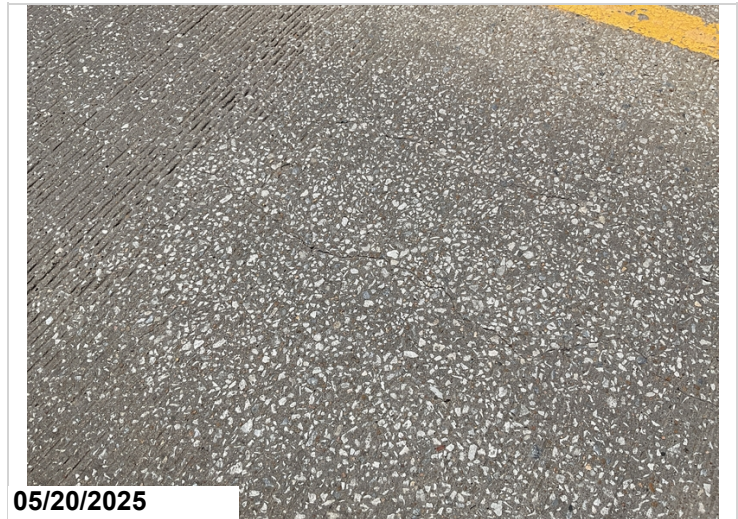
Span 3: Cracking. 412SF CS2

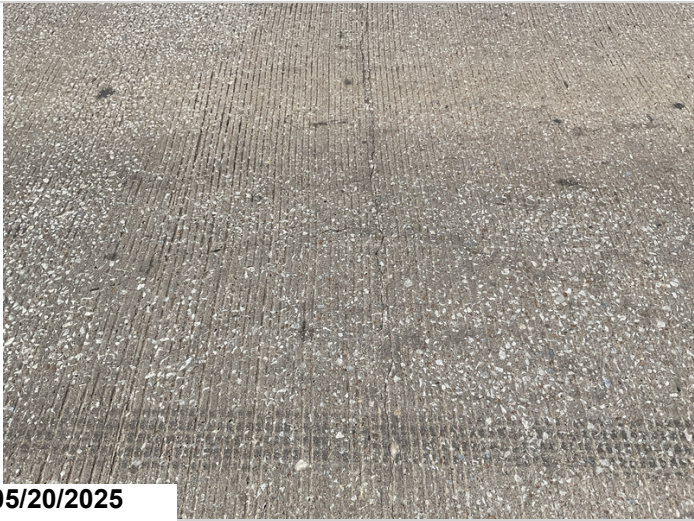
Span 2: Cracking. 564SF CS2

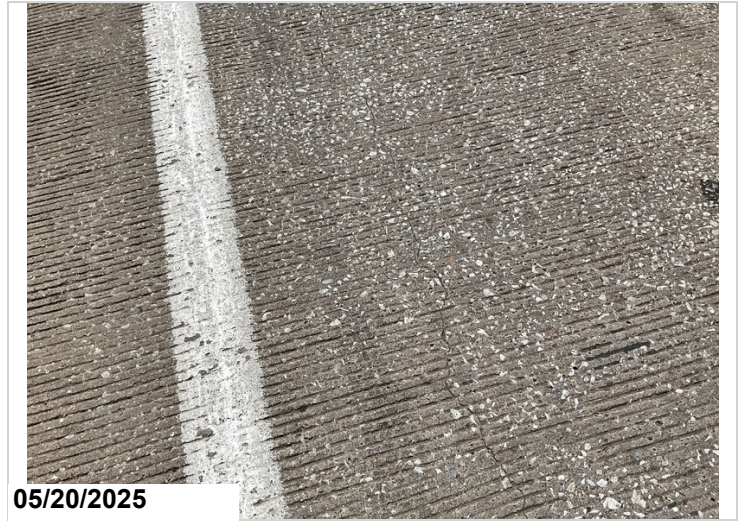
Span 1: Cracking. 280SF CS2

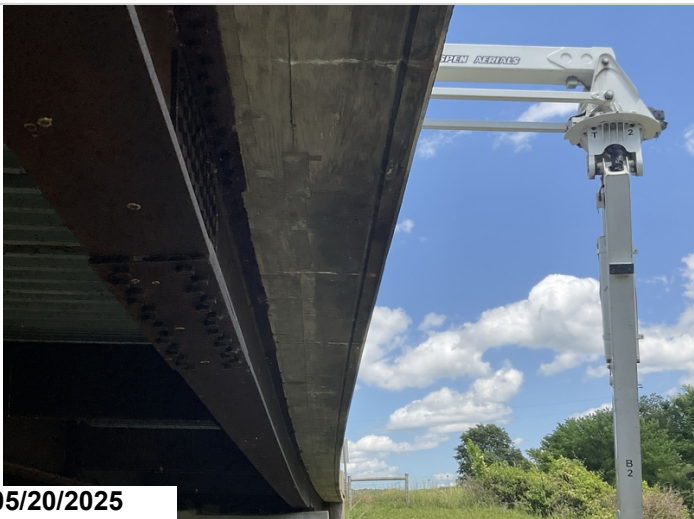
Spans 1 - 3, Right, Overhang: Cracking with efflorescence with build up. 30SF CS3

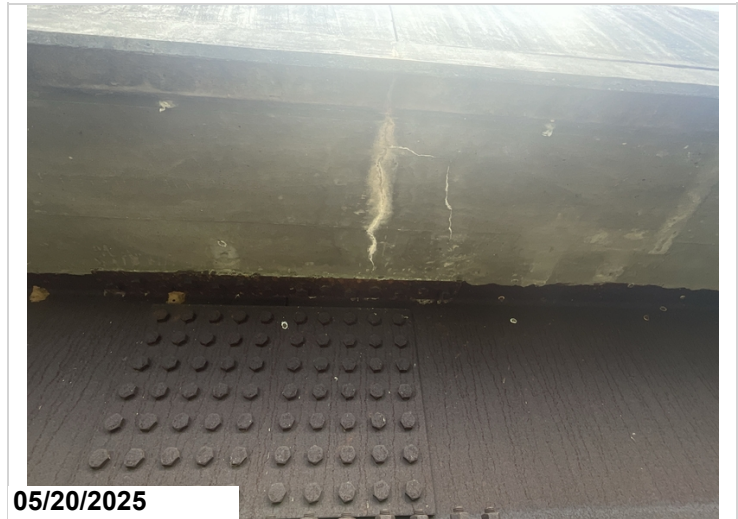
Spans 1 - 3, Left, Overhang: Cracking with efflorescence with build up. 44SF CS3

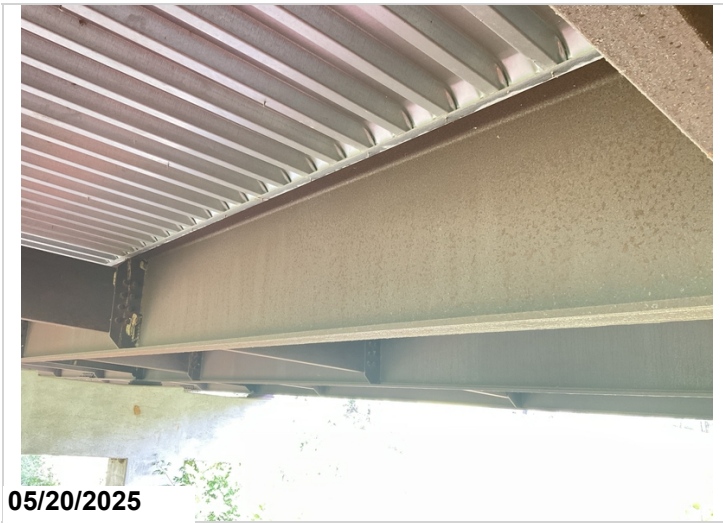
Overall, the superstructure is in good condition with a minor active corrosion.

Typical girders.

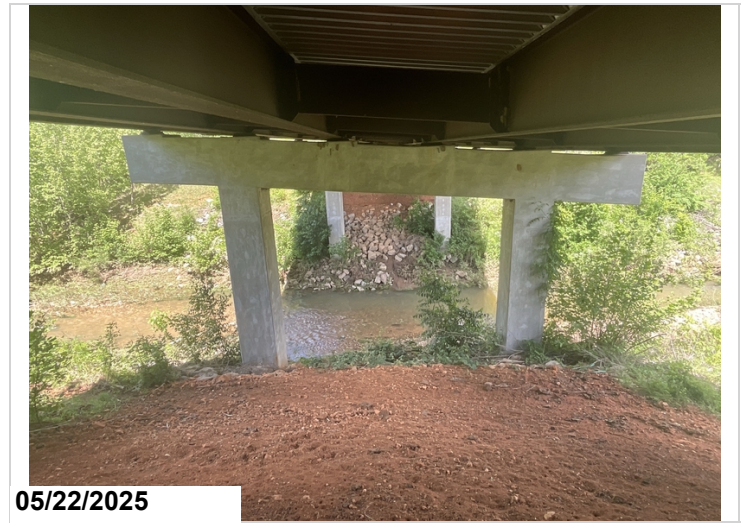
Typical intermediate bent.

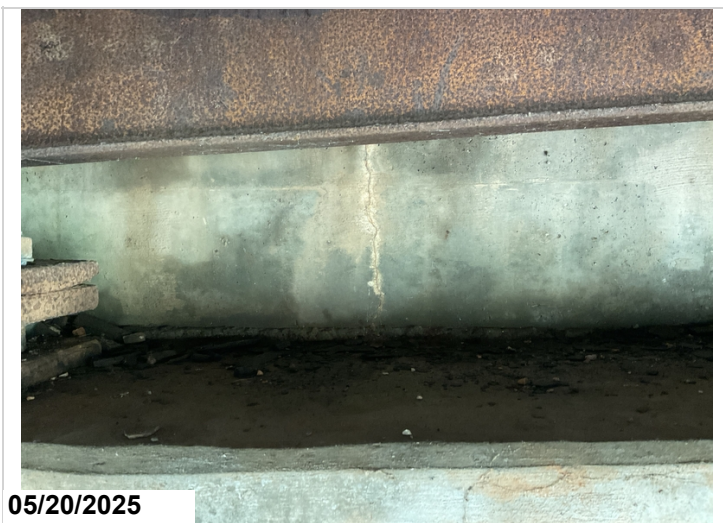
(215) Abutment 1 & 2: Cracking with efflorescence. 3LF CS2							
234	Reinforced Concrete Pier Cap	LF	82	82	0	0	0
302	Compression Joint Seal	LF	86	74	0	12	0
2350	Debris Impaction	LF	12	0	0	12	0

Abutment 1 & 2: Cracking with efflorescence. 3LF CS2

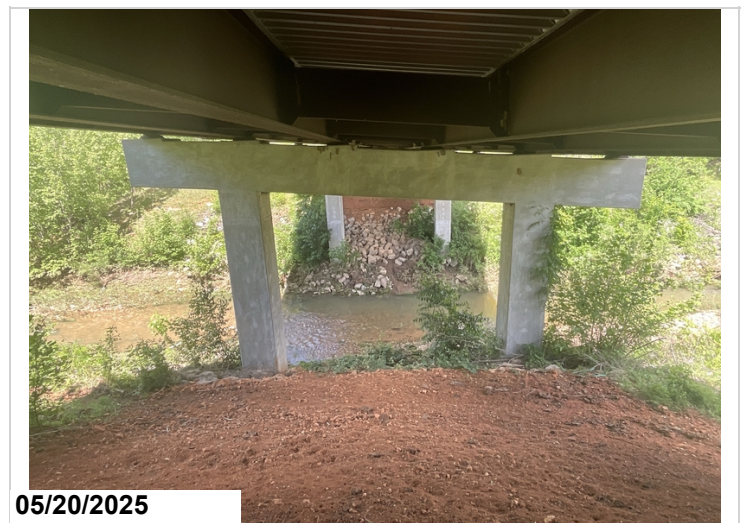
Typical intermediate bent.

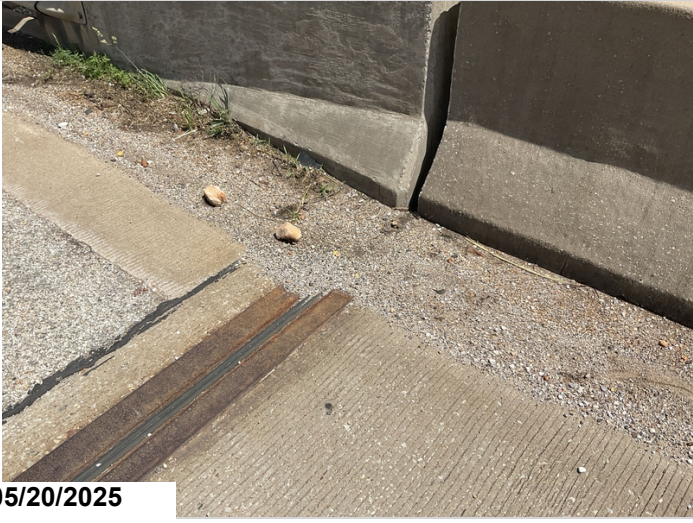
Abutment 1 & 2, Gutter Lines: Debris impact. 12LF CS2

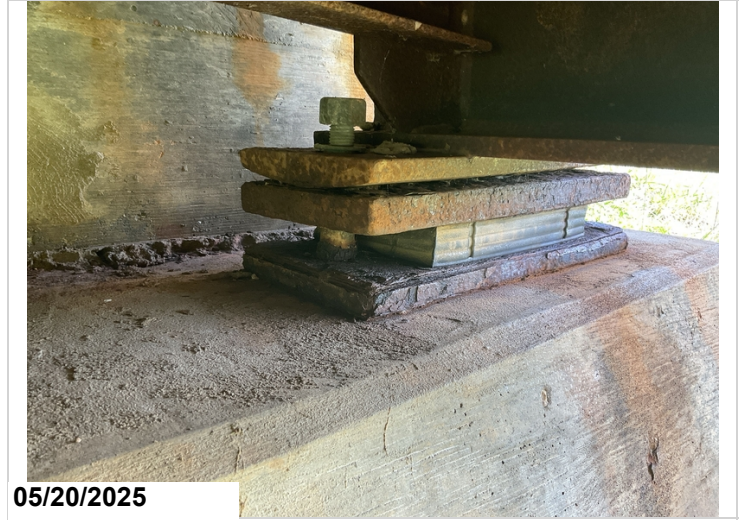
Abutments 1 & 2, Girders 1 - 6: Active corrosion with flaking rust.

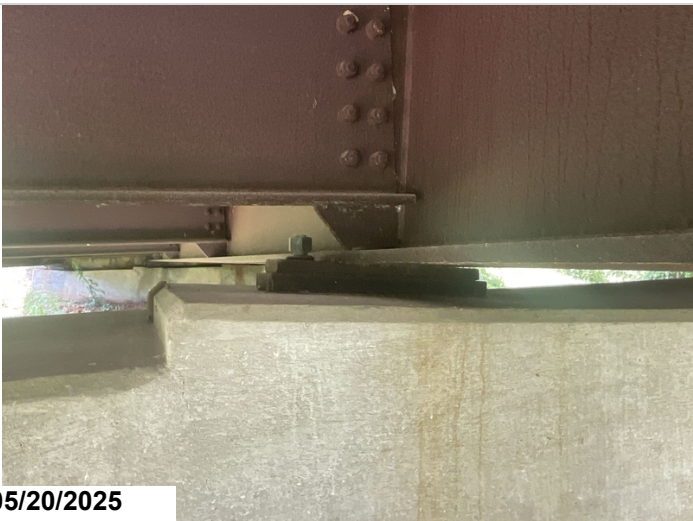
Overall, the bearings are in good condition.

Typical view of bearings

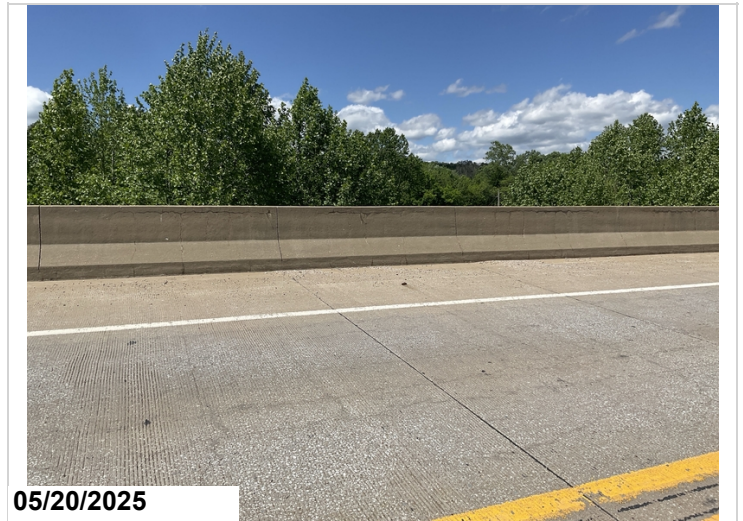
Span 1 - 3, Left & Right: Cracking. 234LF CS2

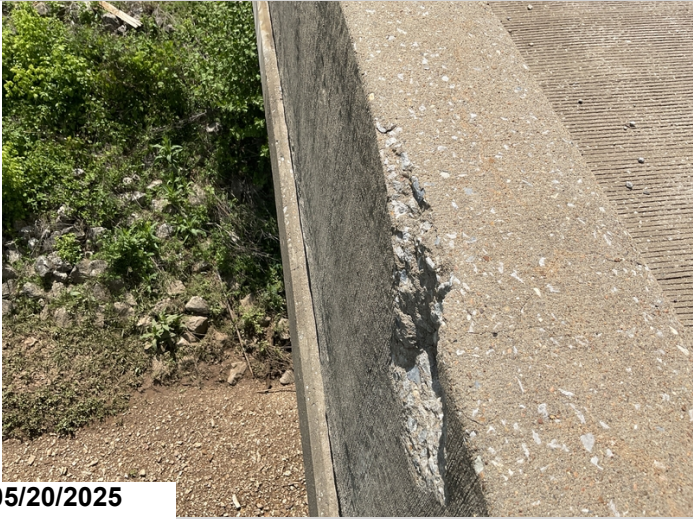
Span 2, Right: Spalling. 1LF CS3

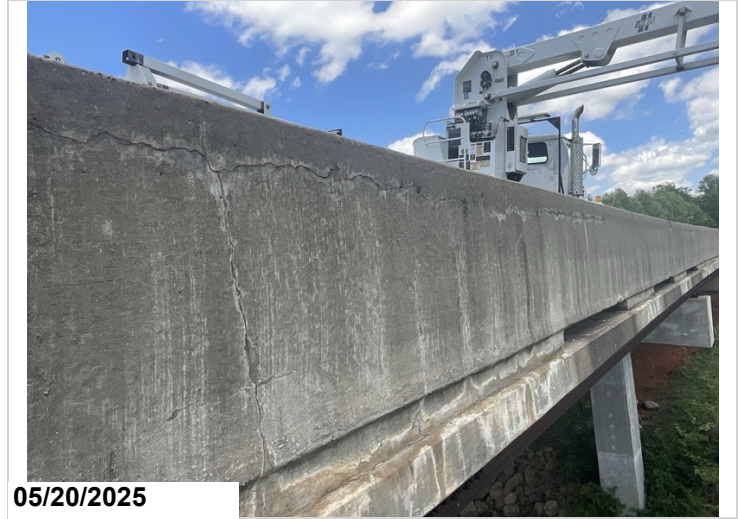
Span 2, right. Parapet wall cracking.

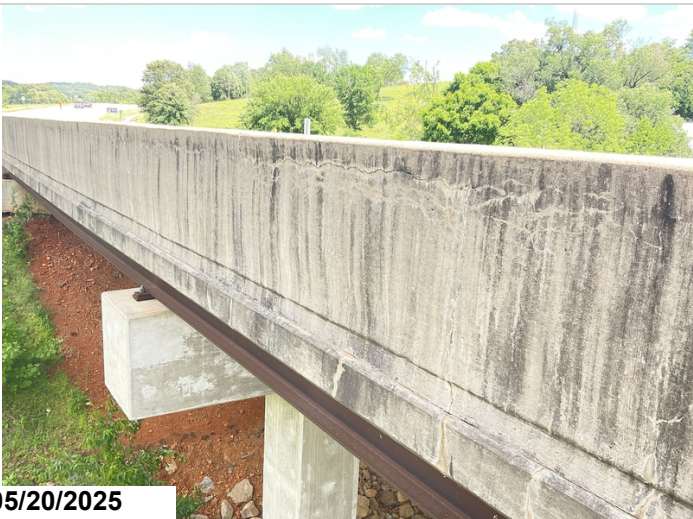
Span 2, left. Parapet wall horizontal cracking.

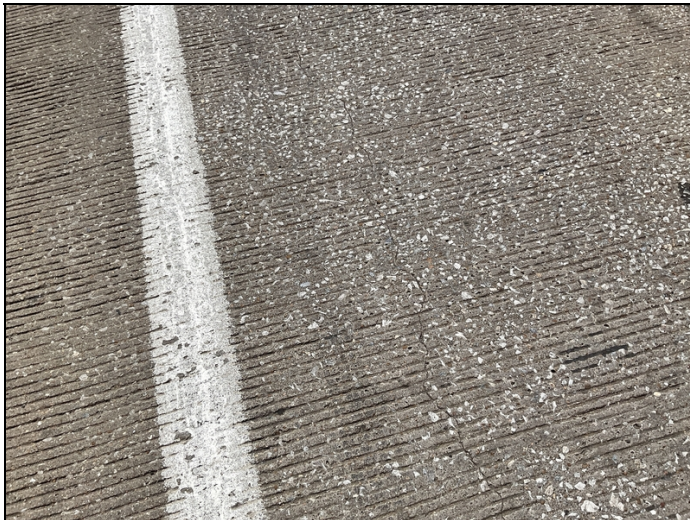
Spans 1 - 3 have minor cracking.

Spans 1 - 3: Transverse and longitudinal cracking.

A-54 - Sealable Deck Cracks (Yes)

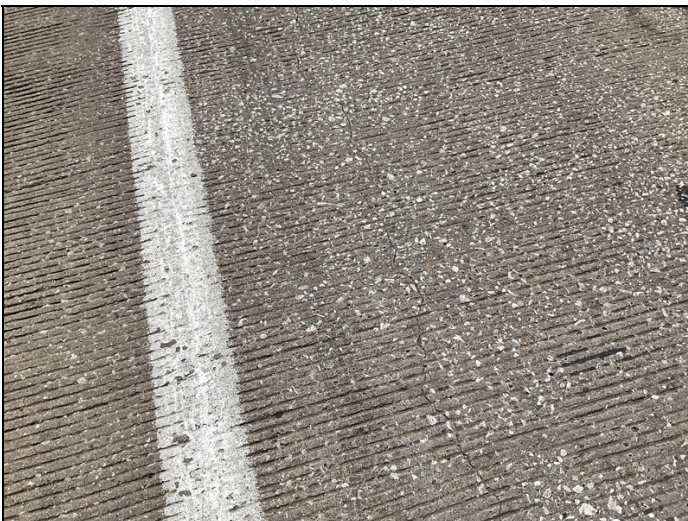
Spans 1 - 3 have minor cracking.

Spans 1 - 3: Transverse and longitudinal cracking.

A-61 - Polymer Overlay Advised (Yes)
