## Bridge 06788 Inspection Report

**US 412 Madison Co. over KINGS RIVER**

**Location: 1.7 Mi W Jct SH 21**

**Team Lead:** Nathan Rowland **Inspection Date:** 01/31/2024

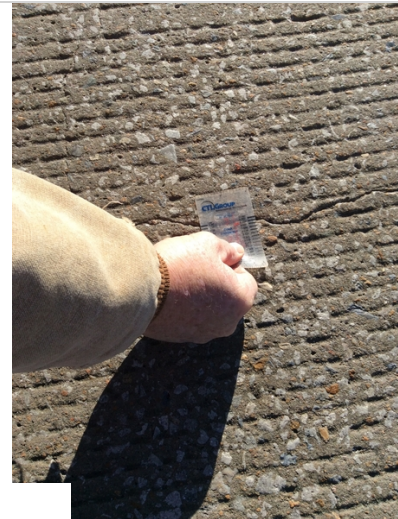
(12) -The driving surface of all spans have moderate width transverse and full length sealable longitudinal cracks. -Undersurface of the overhangs have transverse cracking with efflorescence on approximately 10' spacing.							
107	Steel Open Girder/Beam	LF	2519	2519	0	0	0
515	Steel Protective Coating	SF	28145	28145	0	0	0

Deck cracking

Transverse and longitudinal cracking in multiple locations ranging from hairline to medium-sized cracking.

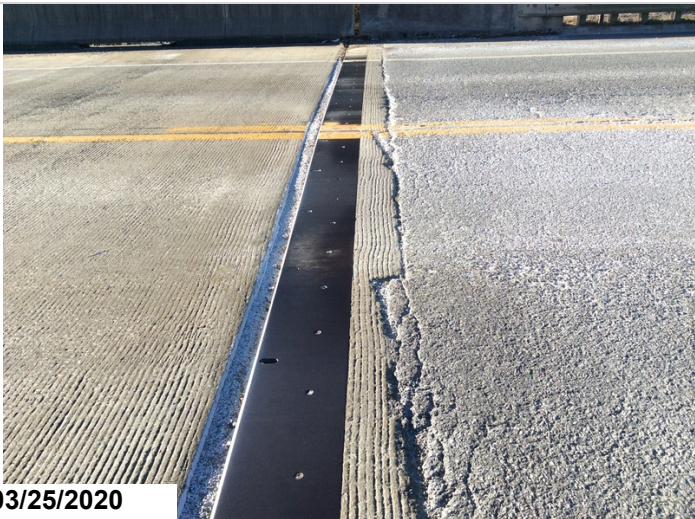
(215) -Abutment #1 has damage to the top of backwall that appears to be from mechanical grinding. -The top of abutment backwalls have a few transverse cracks in random locations visible from the driving surface.							
234	Reinforced Concrete Pier Cap	LF	164	154	10	0	0
1130	Cracking (RC and Other)	LF	10	0	10	0	0

Abutment #1 has damage to the top of backwalls that appear to be from mechanical grinding.

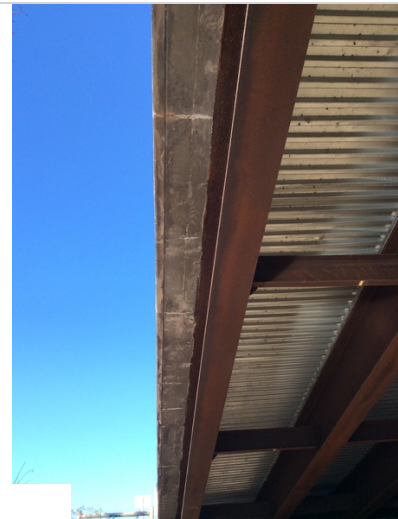
Transverse cracking in undersurface of deck

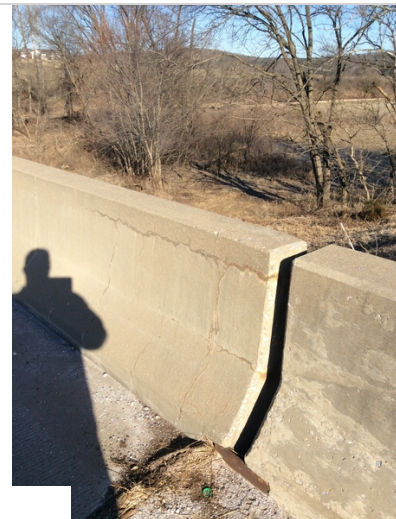
General cracking

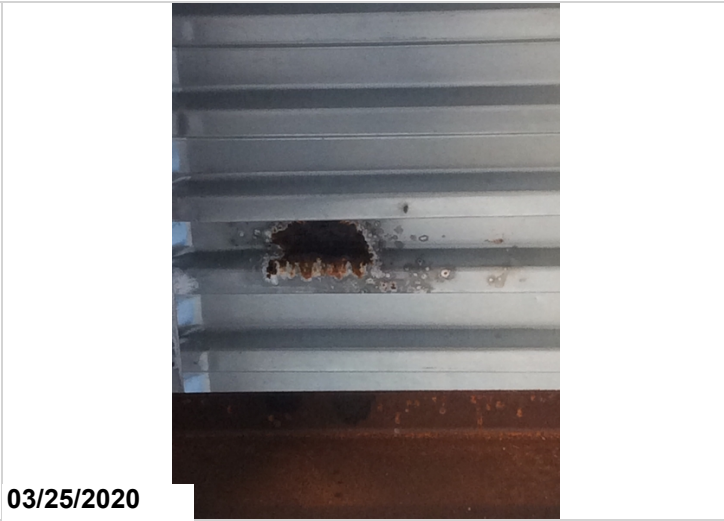
Span 5 has corrosion in span 5 bays 2 and 4.

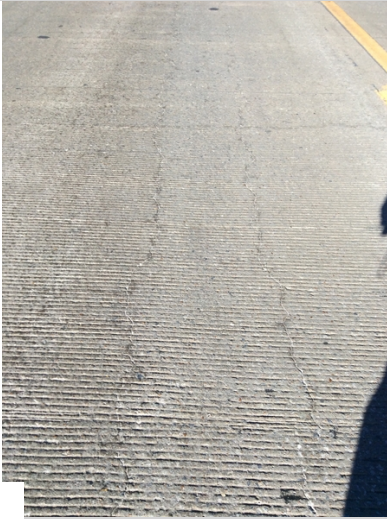
General view of cracking

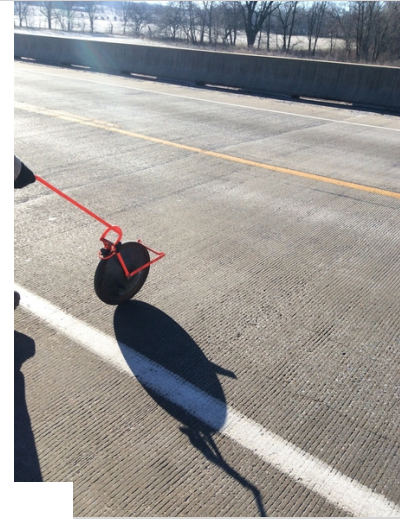
Wheel rolling cracks

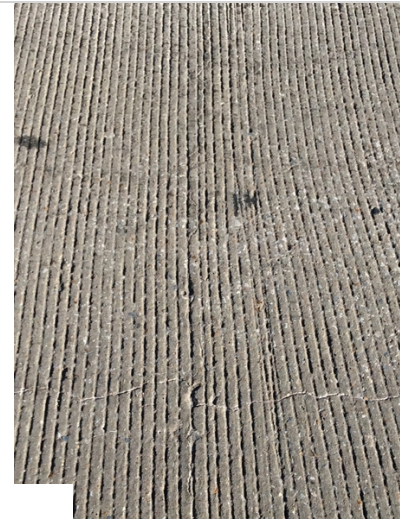
Transverse and longitudinal cracks

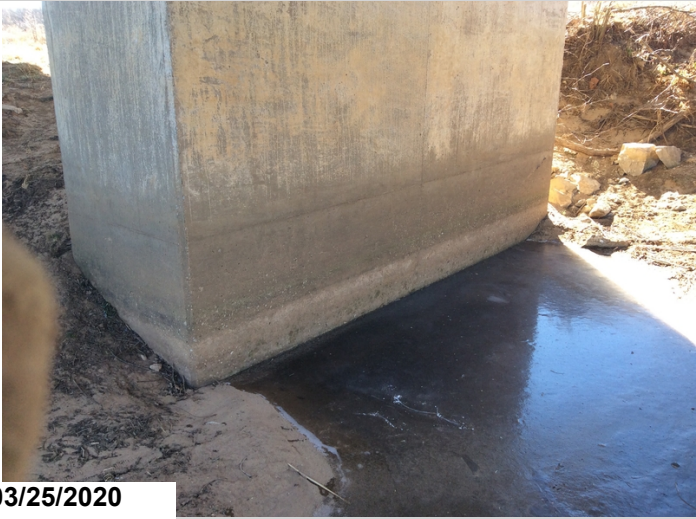
Bent 2 footings has cover

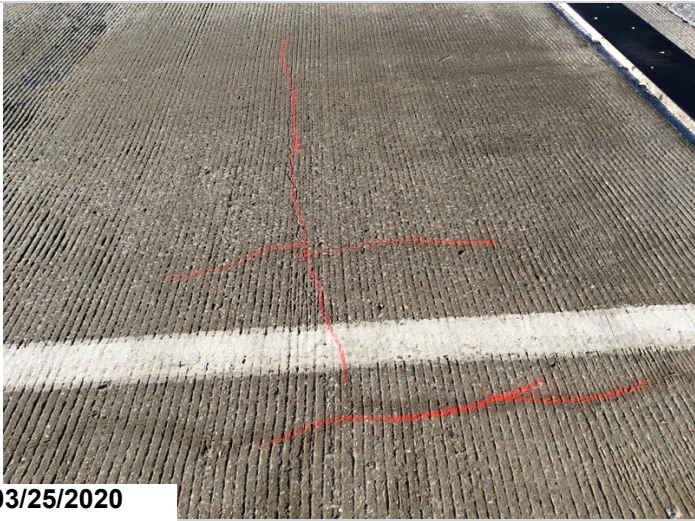
Span #1, Left lane-Transverse and longitudinal cracking.

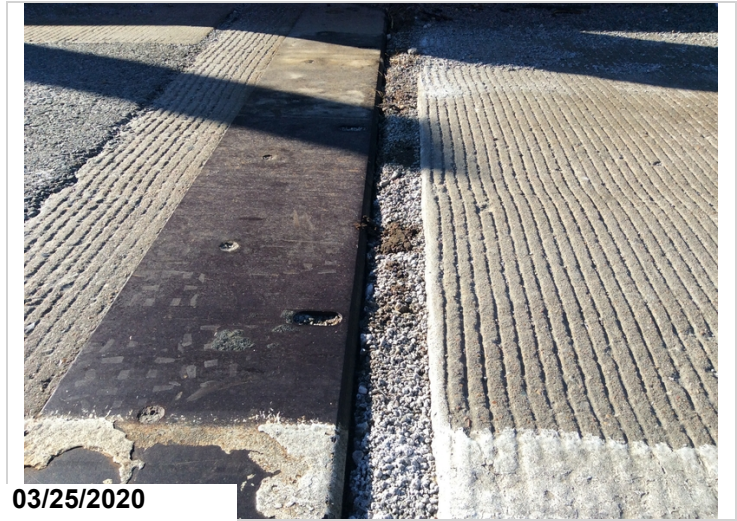
(305) -The sliding plate expansion joints have moderate debris impaction the full length of joints that appear to be from recent snow and ice removal operations.							
310	Elastomeric Bearing	EA	36	36	0	0	0
515	Steel Protective Coating	SF	108	108	0	0	0

Abutment #2-Debris impact in expansion joint.

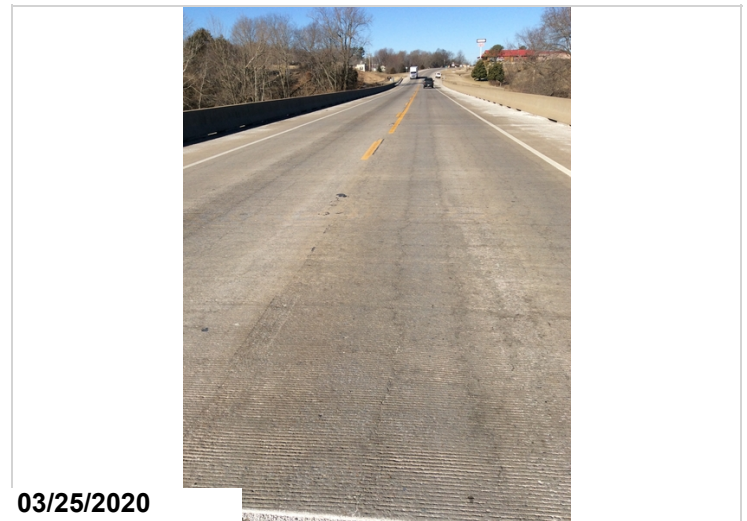
Longitudinal cracking

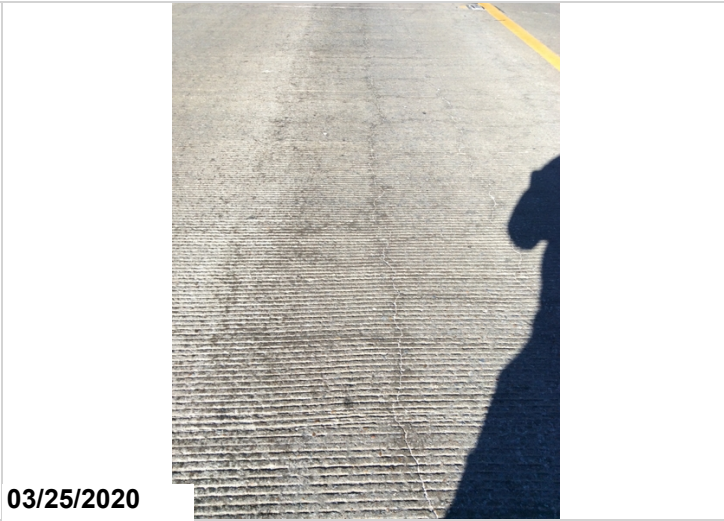
General deck cracking

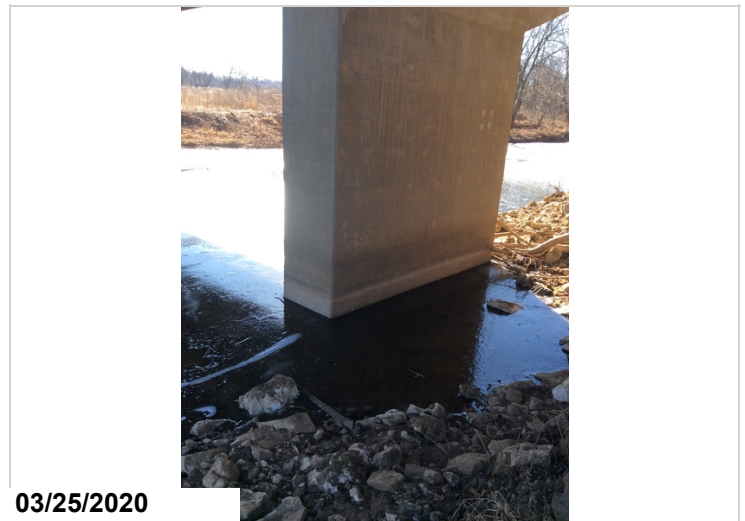
Bent one footing has cover

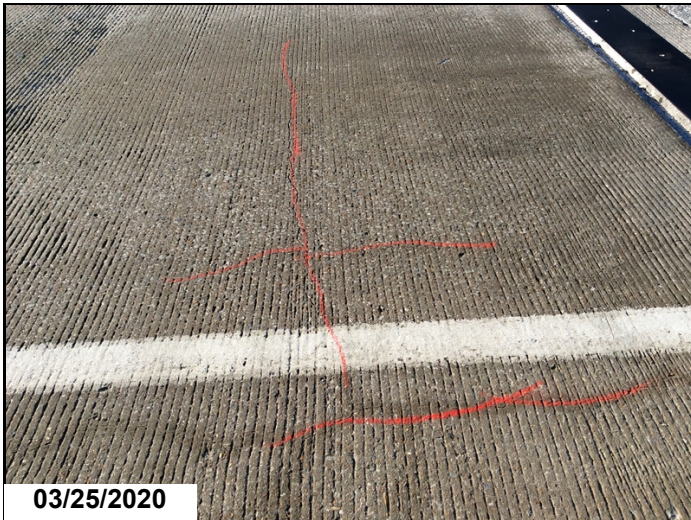
Deck - The driving surface of the deck has numerous moderate width longitudinal and transverse cracks in all spans. The longitudinal cracks are full length of structure and appear to be over the girders.

Span #1, Left lane-Transverse and longitudinal cracking.

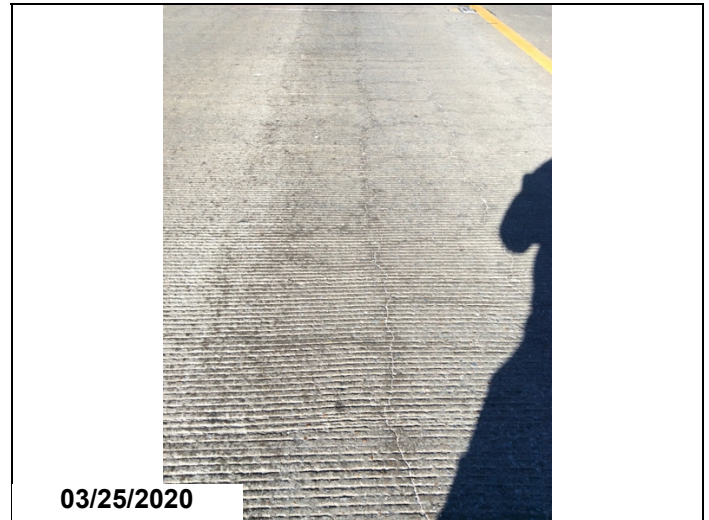
Longitudinal and transverse deck cracking.

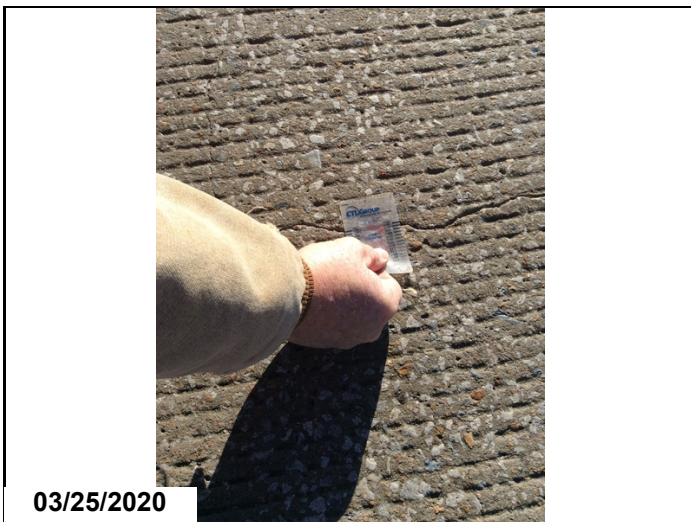
Moderate width deck cracking.

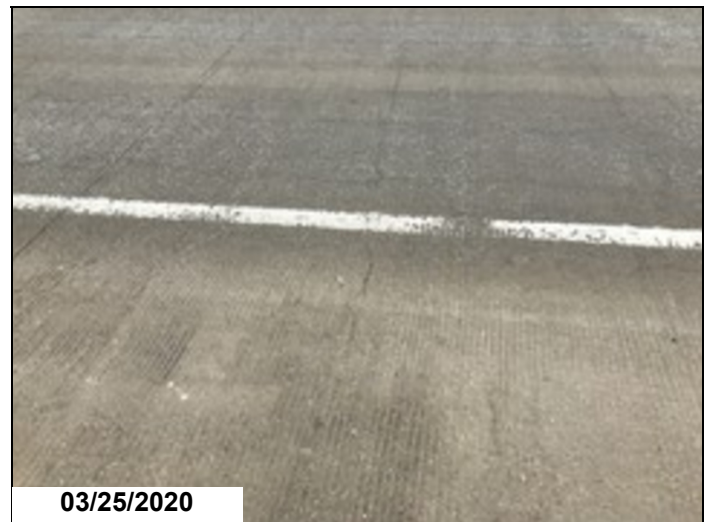
Deck surface typical transverse cracking.

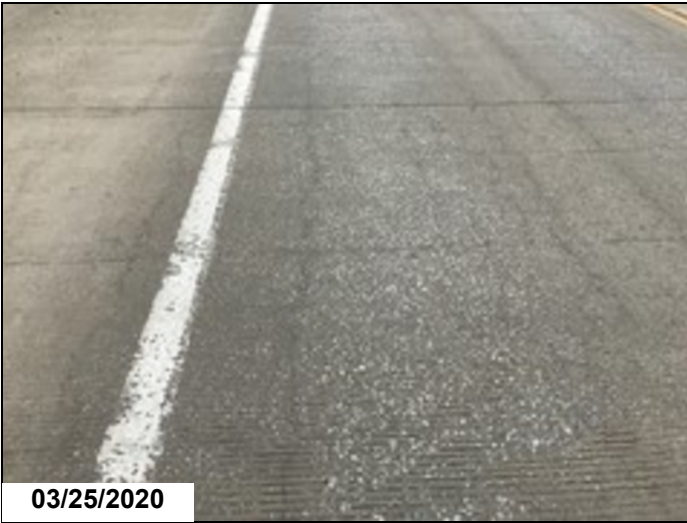
Deck surface Typical full-length longitudinal cracking

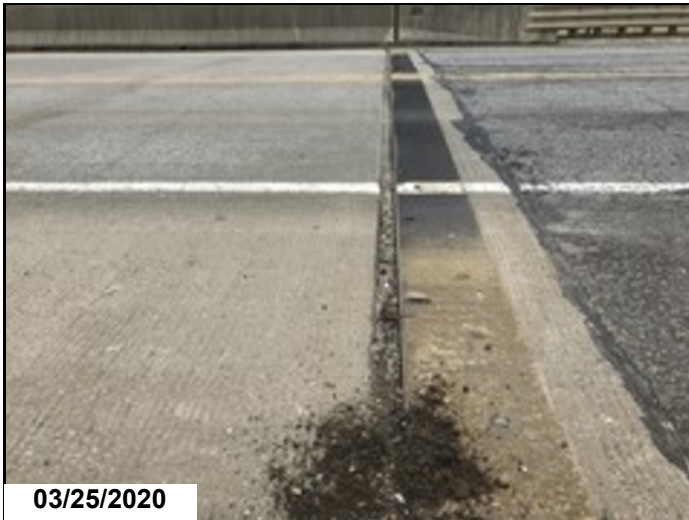
Expansion joint assemblies - The sliding plate expansion joint assemblies at both bridge ends have heavy debris accumulation that appears to be from recent ice and snow removal activities.

Abutment #1 joint material has heavy debris impactation.

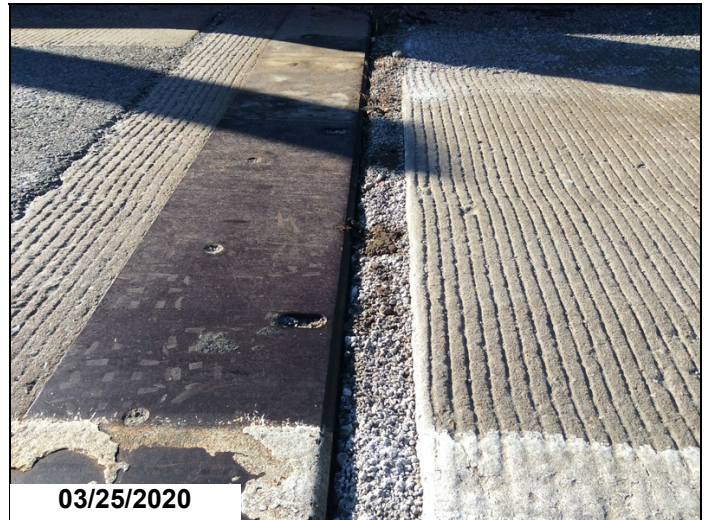
Debris accumulation.
