## Bridge 06578 Inspection Report

Asset #06578(Routine, Underwater type 2)

US 412 S-5 Carroll over DRY FORK BR

Team Lead: Benjamin Smith Inspection Date: 05/28/2026

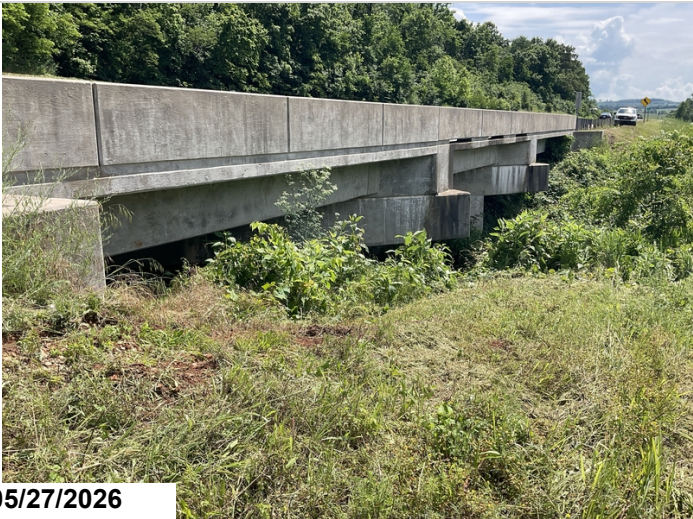
Elevation view.

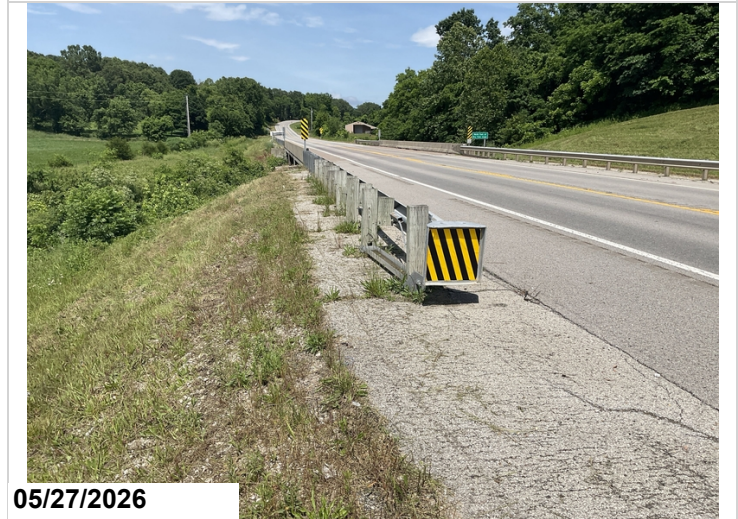
Approach rail termination.

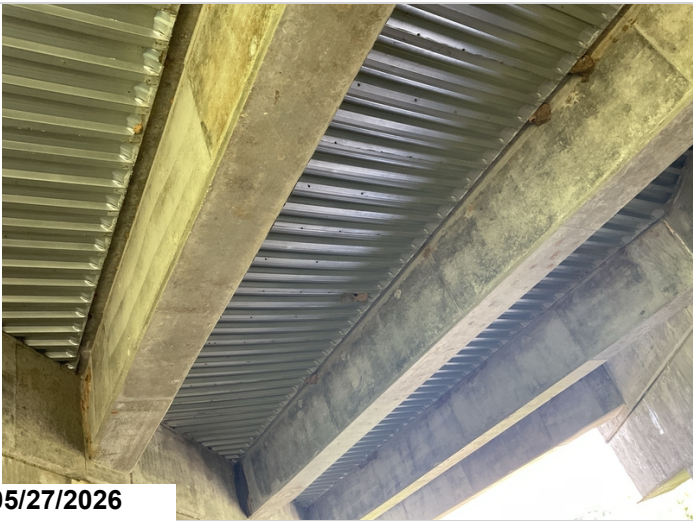
| ELEMENTS | DESCRIPTION | UNITS | TOTAL | CS1 | CS2 | CS3 | CS4 |
|---|---|---|---|---|---|---|---|
| Under surface- the under surface has metal sip forms in all bays. | | | | | | | |

Undersurface view.

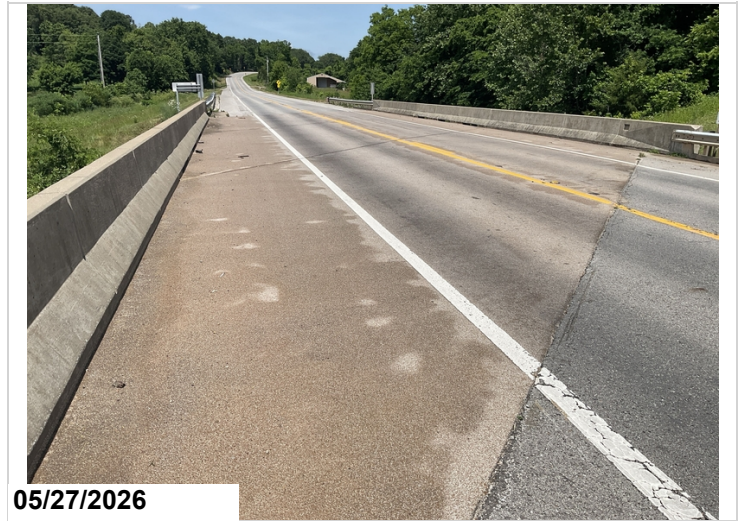
| ELEMENTS | DESCRIPTION | UNITS | TOTAL | CS1 | CS2 | CS3 | CS4 |
|---|---|---|---|---|---|---|---|
| (12) Driving surface- has a polymer overlay. The left lane of span #2 has 3' of spalling CS3 in the polymer. | | | | | | | |

Driving surface view.

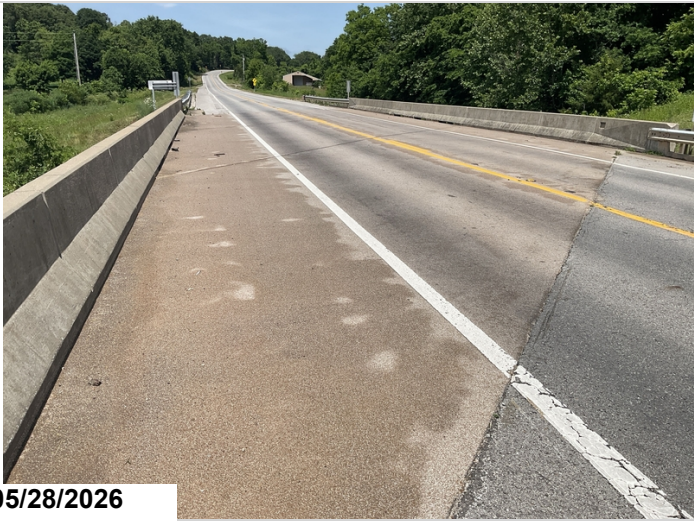
| ELEMENTS | DESCRIPTION | UNITS | TOTAL | CS1 | CS2 | CS3 | CS4 |
|---|---|---|---|---|---|---|---|
| <p>(331) Left side parapet wall- has 23' of horizontal and vertical cracking CS2 at random locations.</p> <p>Right side parapet wall- has 41' of vertical, and map cracking. Sections #5,6,7 have map cracking CS3 for their full length. The beginning right parapet section has 1' of spalling CS3 with no rebar exposed on the top edge.</p> <p>Approach railing-</p> <p>The upper connection is loose on the left beginning approach railing.</p> <p>Transitions- are gradually stiffened.</p> | | | | | | | |

Left and right parapet condition.

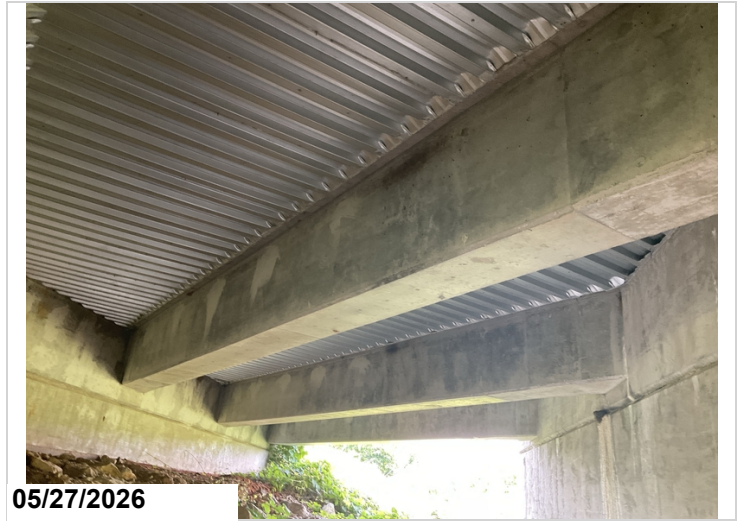
Overall the superstructure is in good condition with hairline flexure cracking and small areas of efflorescence CS2.

General superstructure view.

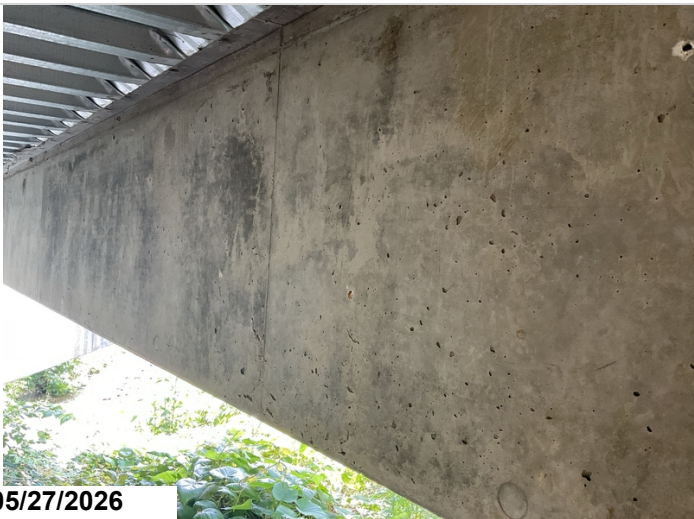
| ELEMENTS | DESCRIPTION | UNITS | TOTAL | CS1 | CS2 | CS3 | CS4 |
|---|---|---|---|---|---|---|---|
| Span #1-<br>Tee beam #1- has very minor vertical hairline flexure cracking.<br>Tee beam #2- has 1' of vertical efflorescence CS2.<br>Tee beam #3- has very minor vertical hairline flexure cracking.<br>Tee beam #4- has very minor vertical hairline flexure cracking.<br>Tee beam #5- has very minor vertical hairline flexure cracking. | | | | | | | |

Typical tee beam condition.

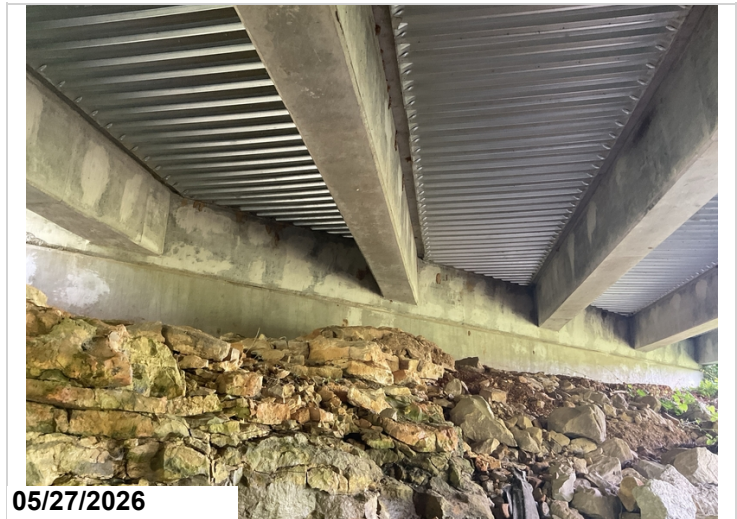
| ELEMENTS | DESCRIPTION | UNITS | TOTAL | CS1 | CS2 | CS3 | CS4 |
|---|---|---|---|---|---|---|---|
| <p>(215) Abutment #1- has 13' of vertical and horizontal hairline shrinkage cracks with 1' of spalling CS3 with no rebar exposed at the right end of the abutment. The right side of the abutment is cast on solid rock. The rip rap is in place and functioning as intended. The base of the abutment has a concrete embankment settlement repair along the right side.</p> <p>Abutment #2- has 7' of vertical and horizontal hairline shrinkage cracks. The rip rap is in place and functioning as intended.</p> | | | | | | | |

General view of abutment #1.

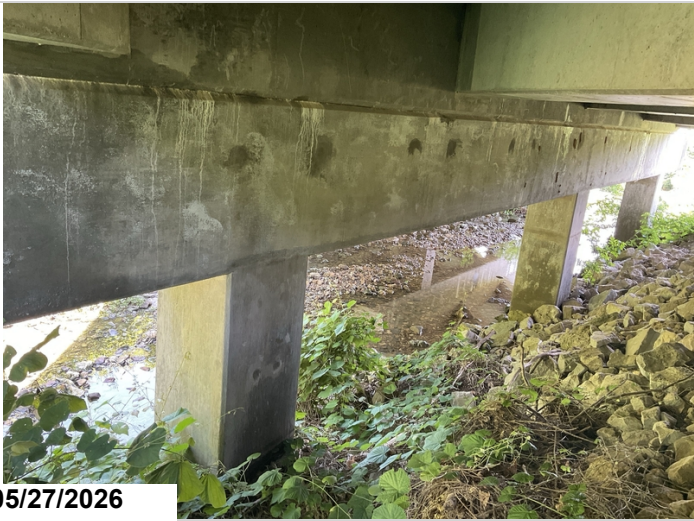
Typical bent view.

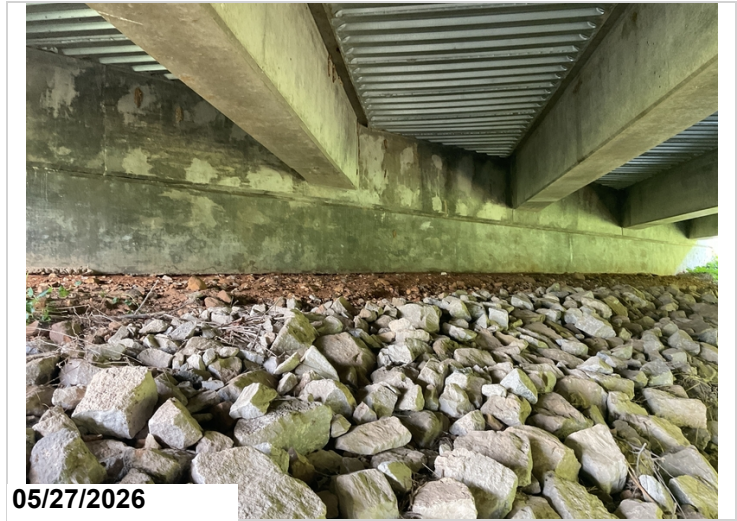
General view of abutment #2.

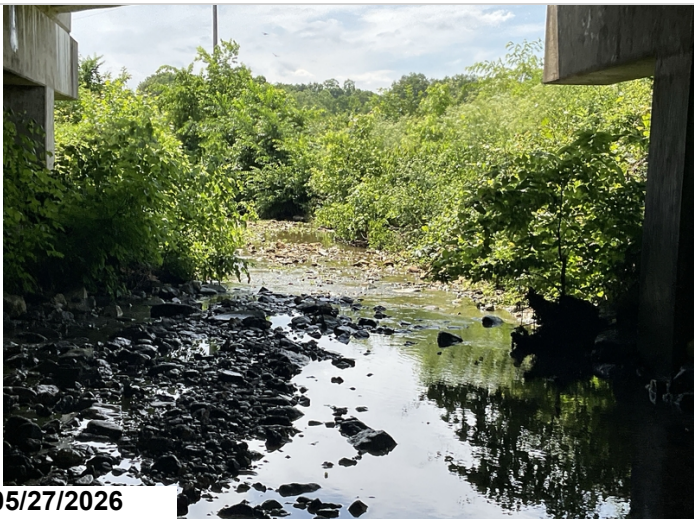
The downstream channel is well vegetated. The alignment is satisfactory.

Downstream channel view.

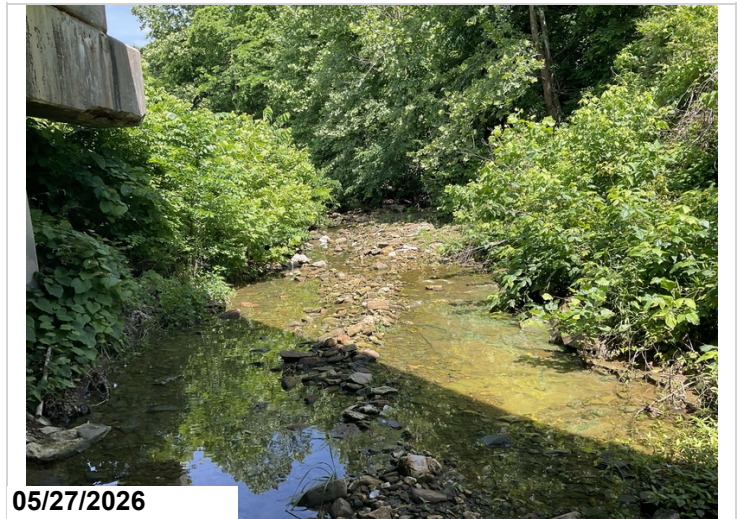
The upstream channel is well vegetated. The alignment is satisfactory.

Upstream channel view.

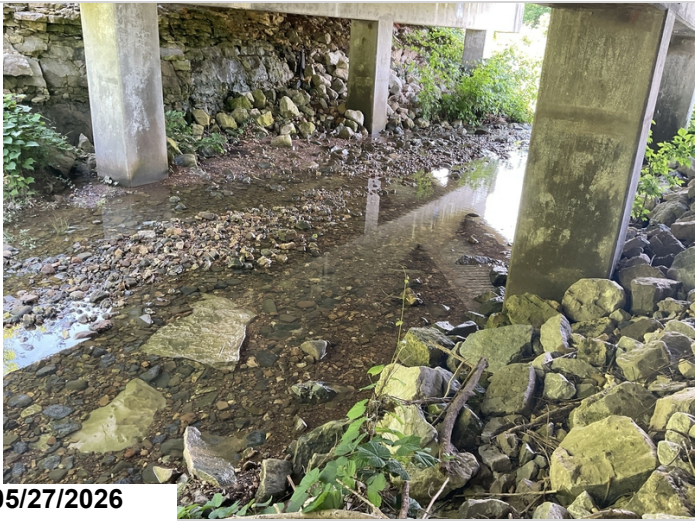
The channel beneath the structure flows mainly in span #2. No scour noted.

Channel beneath the structure.

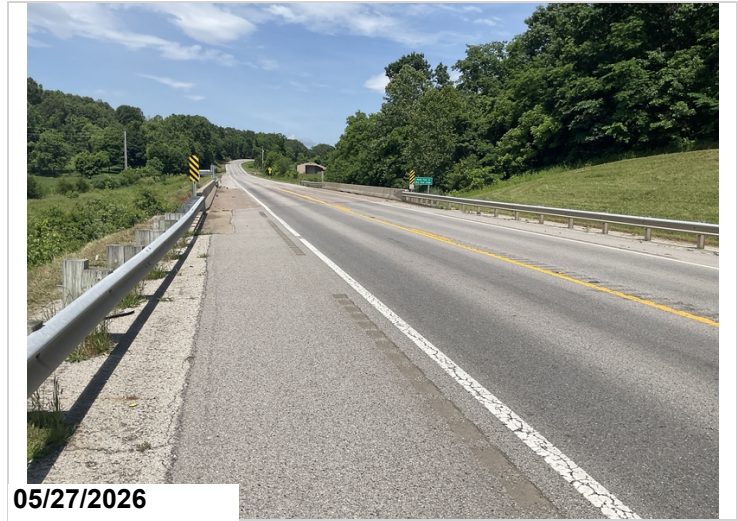
Approach view in direction of log mile.

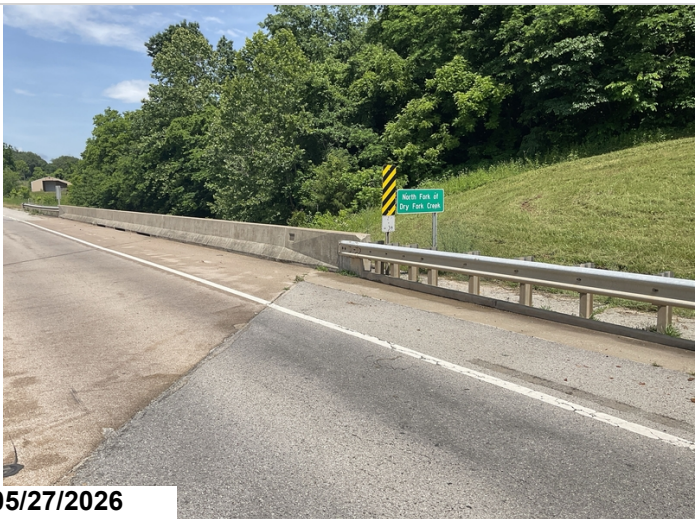
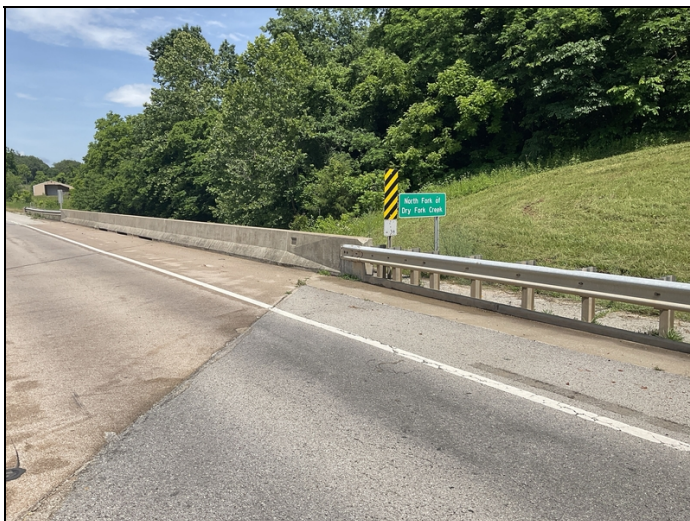
Illegible log mile signs.

**A-63 - Missing/Incorrect Log Mile Signage (Yes)**

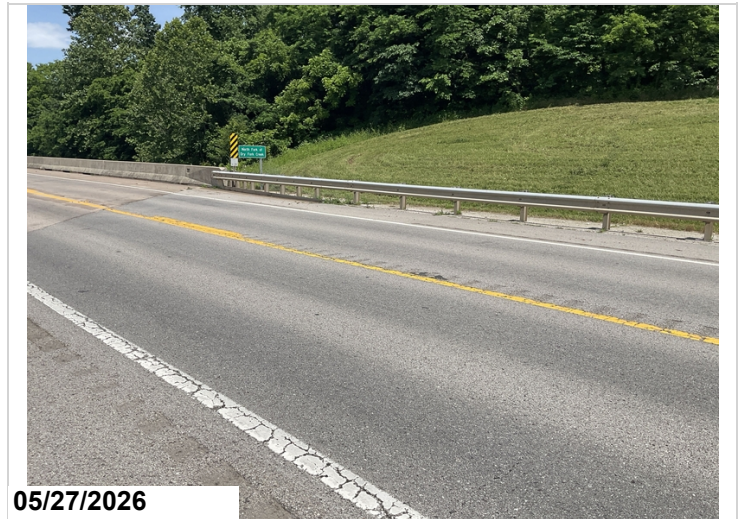
Transition area.

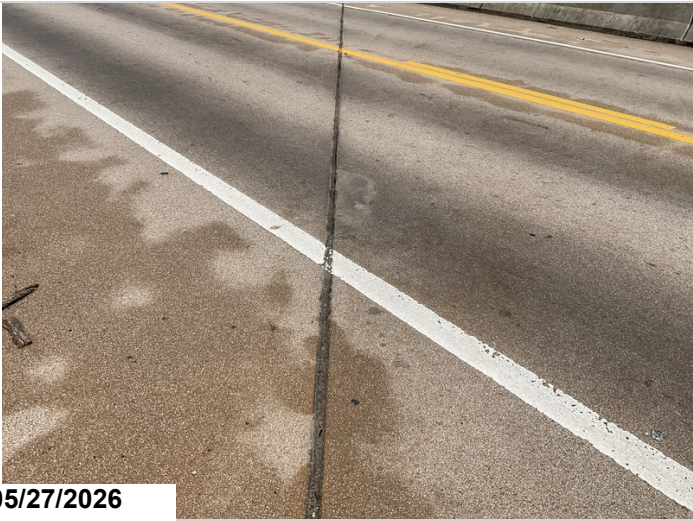
| ELEMENTS | DESCRIPTION | UNITS | TOTAL | CS1 | CS2 | CS3 | CS4 |
|---|---|---|---|---|---|---|---|
| Construction joint seals- The first pourable construction joint seal has 24' of adhesion loss with leakage CS2. The second pourable construction joint seal has 25' of adhesion loss with leakage CS2. | | | | | | | |

Bent #1 construction joint condition.

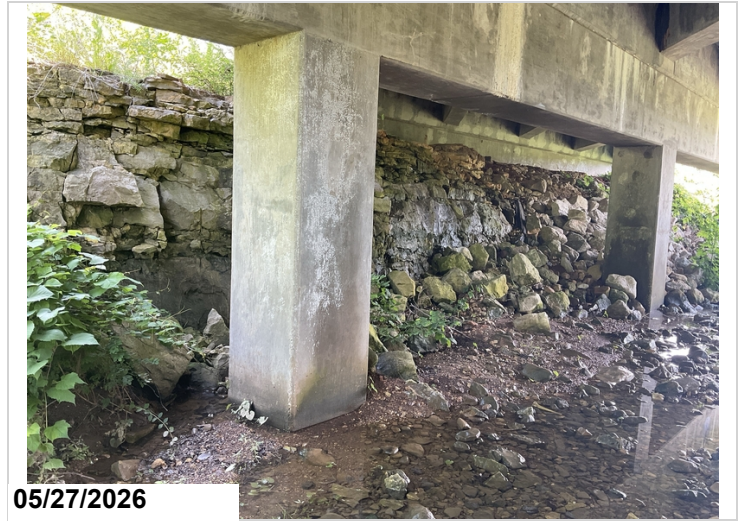
Rip rap and exposed rock at the abutment #1 embankment.

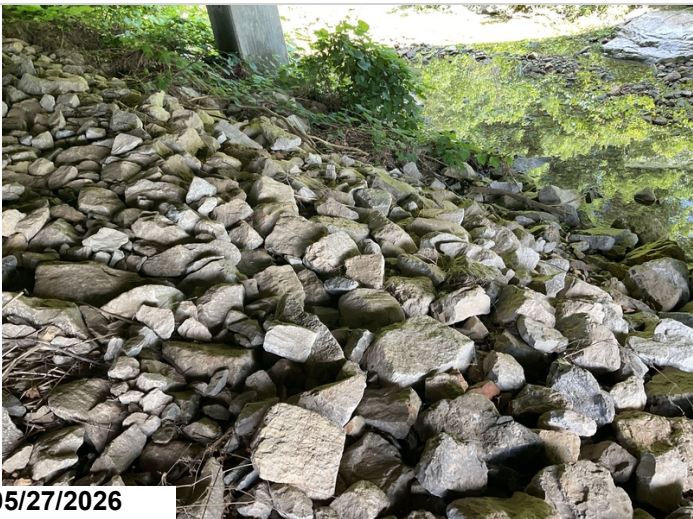
Abutment #2 rip rap.

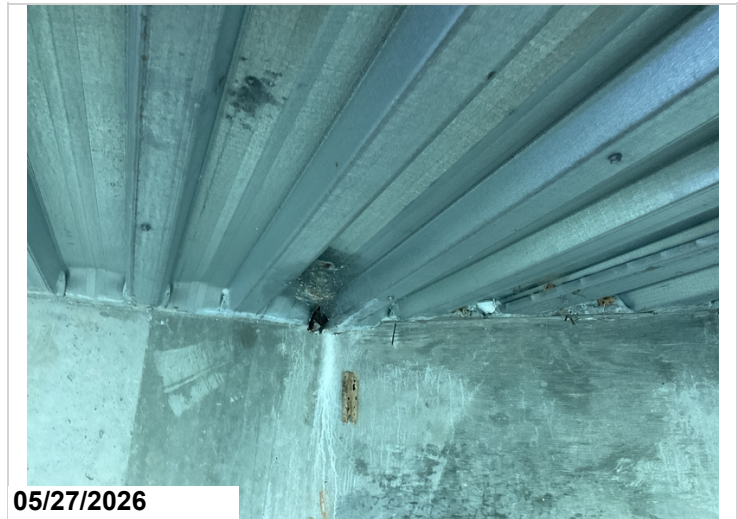
| ELEMENTS | DESCRIPTION | UNITS | TOTAL | CS1 | CS2 | CS3 | CS4 |
|---|---|---|---|---|---|---|---|
| Span #3-<br>Minor corrosion was noted in the sip forms at bays #1,4 at abutment #2.<br>Left overhang- no deficiencies noted.<br>Right overhang- no deficiencies noted. | | | | | | | |

Sip corrosion in bay #4 at abutment #2.

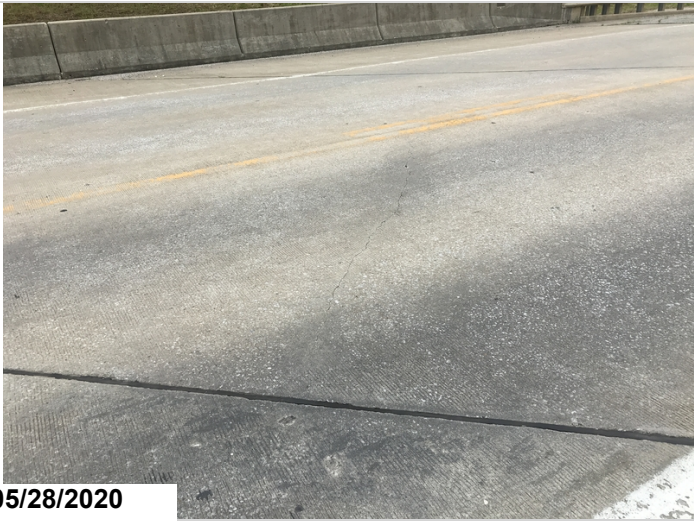
Typical diagonal cracking in span #2.

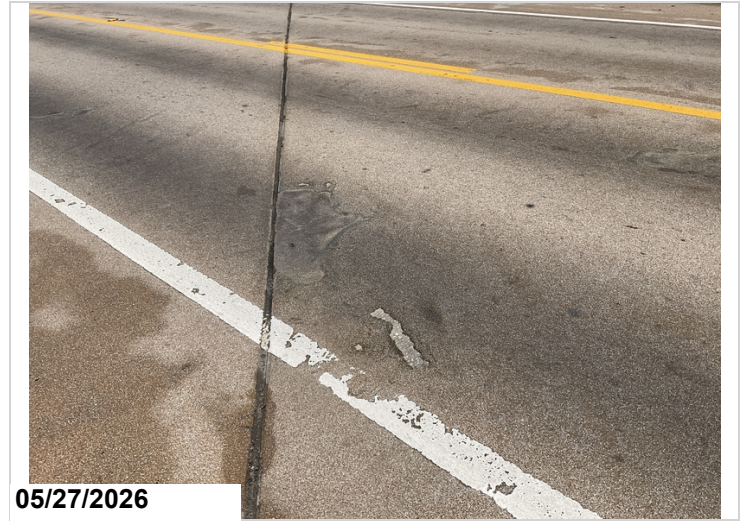
| ELEMENTS | DESCRIPTION | UNITS | TOTAL | CS1 | CS2 | CS3 | CS4 |
|---|---|---|---|---|---|---|---|
| (510-12) The left lane of span #2 has 3' of spalling CS3 in the polymer overlay. | | | | | | | |

Spalling CS3 in the left lane polymer overlay.

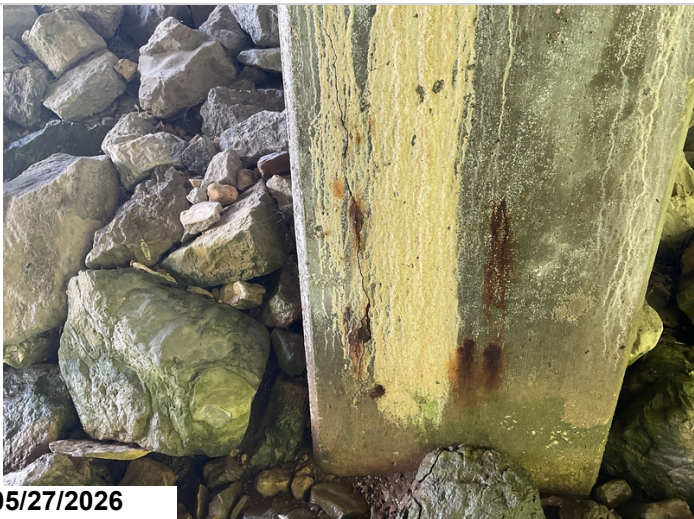
| ELEMENTS | DESCRIPTION | UNITS | TOTAL | CS1 | CS2 | CS3 | CS4 |
|---|---|---|---|---|---|---|---|
| <p>(205) Bent #1 columns-<br/>Column #1- no deficiencies noted.<br/>Column #2- has abrasion CS2 on the lower portion.<br/>Column #3- no deficiencies noted.<br/>The footings have cover.</p> <p>Bent #2 columns-<br/>Column #1- no deficiencies noted<br/>Column #2- has a vertical delamination CS3 on the span #2 side.<br/>Column #3- no deficiencies noted.<br/>The footings have cover.</p> | | | | | | | |

Delamination CS3 on column #2 of bent #2.

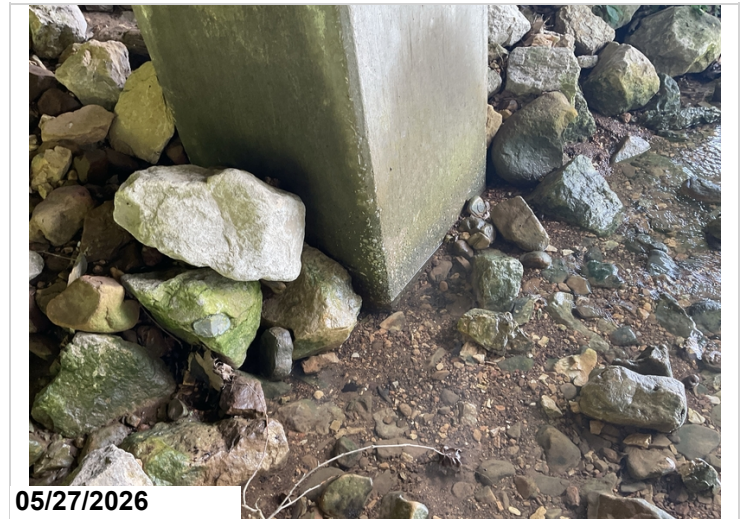
Abrasion CS2 on column #2 of bent #1.

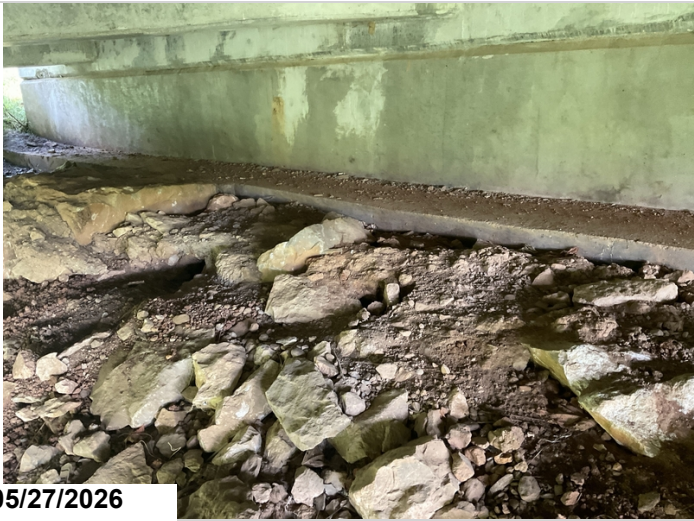
Embankment settlement repair along the right side of abutment #1.

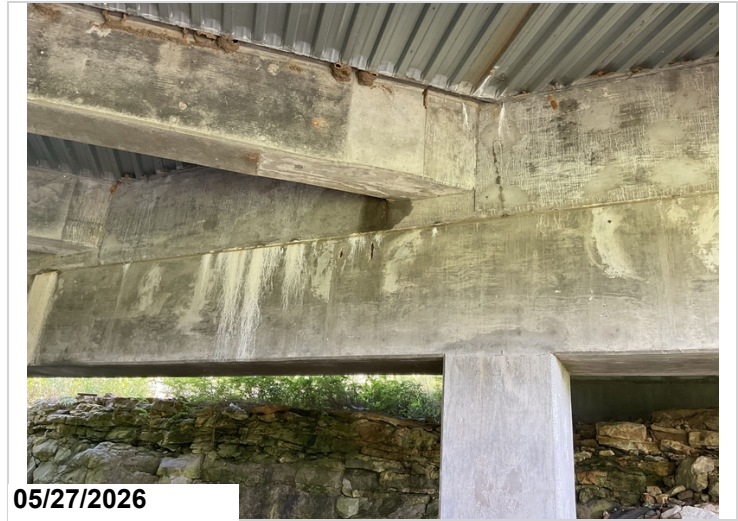
Efflorescence leaching on the bent #2 cap.

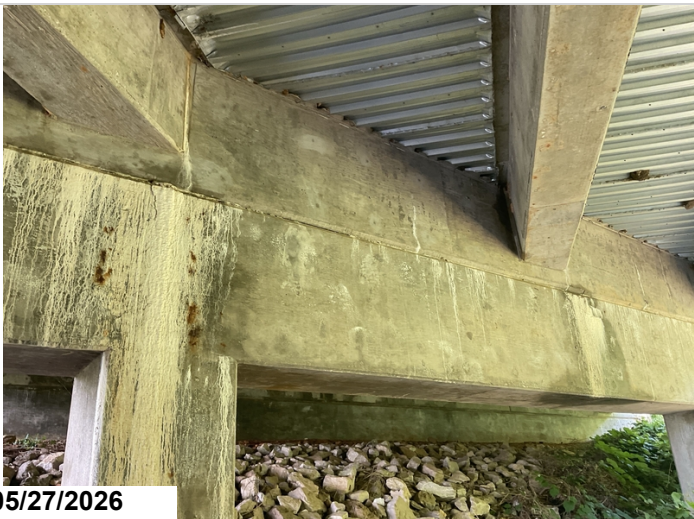
| ELEMENTS | DESCRIPTION | UNITS | TOTAL | CS1 | CS2 | CS3 | CS4 |
|---|---|---|---|---|---|---|---|
| <p>(234) Pier cap #1- has 7' of vertical hairline shrinkage cracks. The left end of the cap on the span #1 side has 2' of delamination CS3 and 1' of spalling with exposed rebar CS3. The span #2 side of the cap has 2' of spalling with shallow exposed rebar CS3 at the midsection. The vertical face of the cap has 3' of efflorescence CS2 with efflorescence CS3 leaching build up due to construction joint seal leakage.</p> <p>Pier cap #2- has 6' of efflorescence CS2. The underside of the cap has 1' of delamination CS3 between columns #1,2. The underside of the right cantilever has 5' of spalling with rebar CS3 exposed, 3' of delamination CS3. The vertical face of the cap has efflorescence CS2 and CS3 leaching build up due to construction joint seal leakage.</p> | | | | | | | |

Efflorescence cracking CS2 with efflorescence CS3 leaching build up.

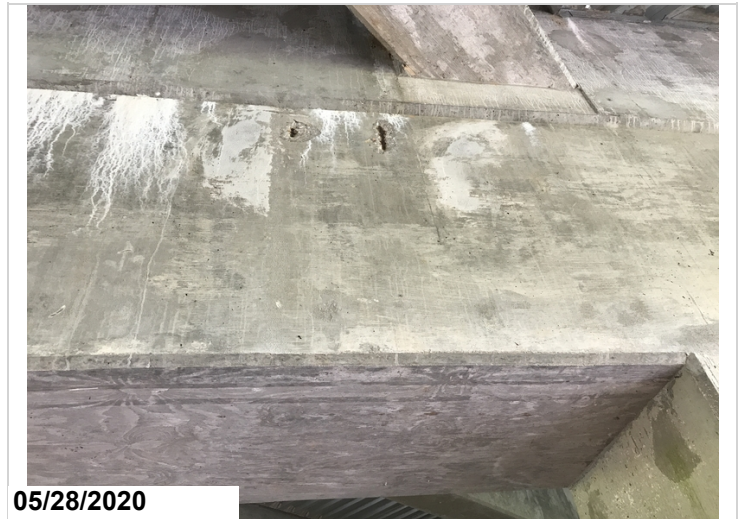
Bent #1 cap ahead side has minor spalls with rebar exposed.

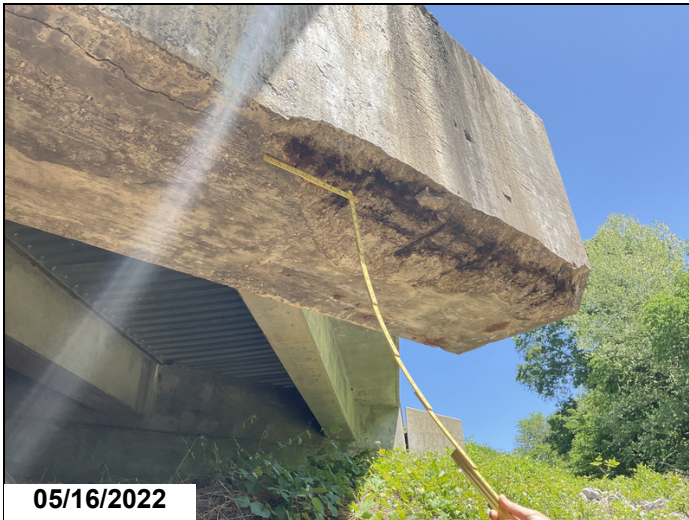
**05/16/2022**

The left end of the bent #1 cap has a 2' delamination and small spalls with exposed rebar at the left and at the mid section of the span #2 side. The bent #2 cap has a large spall with rebar exposed under the right cantilever.

Spalling with rebar exposed on the under surface of the right cantilever of bent #2.

**Type of Work:** Repair (General)

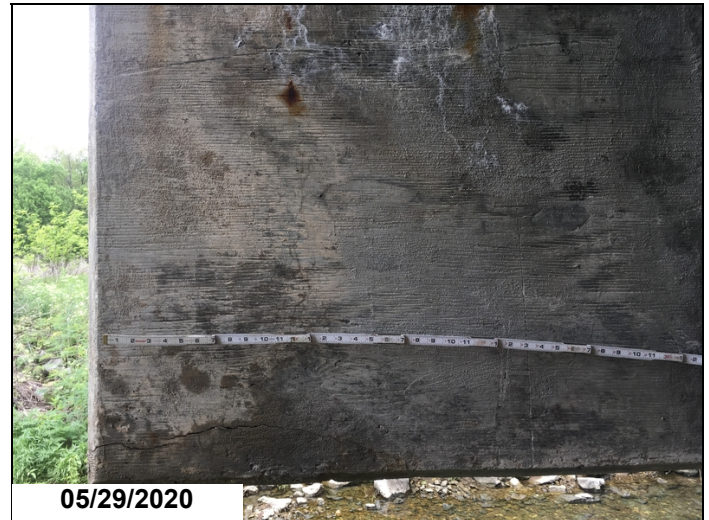
**05/29/2020**

Delamination at the left cap end of bent #1.
