## Bridge 06639 Inspection Report

Route:412 Section:03 Log:12.15

**US 412 Madison Co. over HOLMAN CREEK & SH 23**

**Team Lead: Anthony Wood Inspection Date: 08/06/2025**

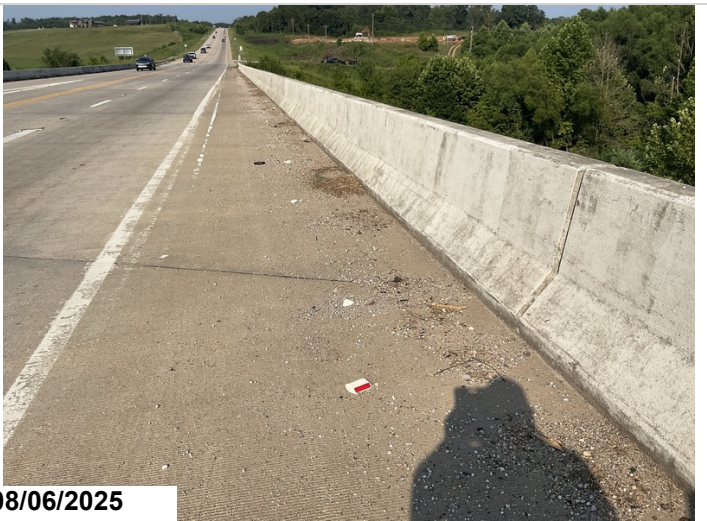
Deck washing needed.

| Type of Maintenance | Is Recommended? |
|---|---|
| A-55 - Deck Washing Needed | Yes |

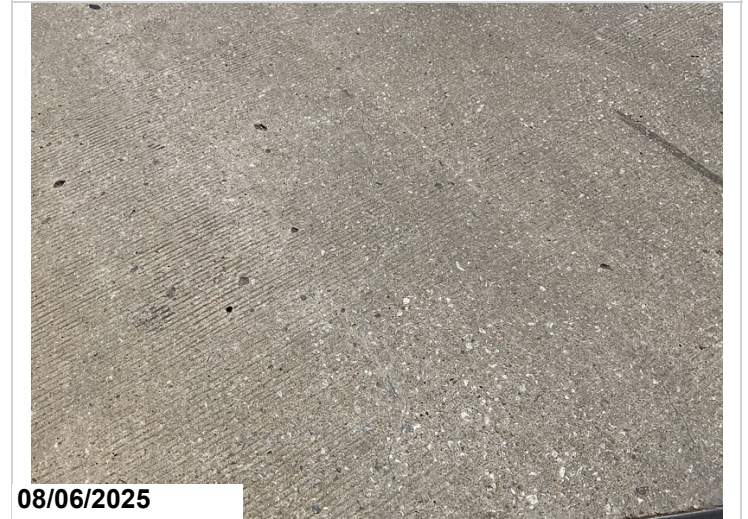
Spans 1 - 5: Sealed cracks.

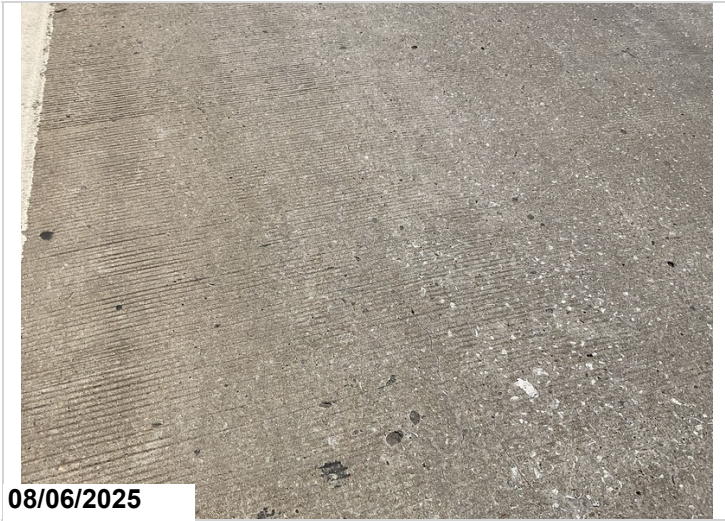
| ELEMENTS | DESCRIPTION | UNITS | TOTAL | CS1 | CS2 | CS3 | CS4 |
|---|---|---|---|---|---|---|---|
| 1130 | Cracking (RC and Other) | SF | 724 | 0 | 724 | 0 | 0 |

Spans 1 - 5: Minor cracking. 724SF CS2

| Type of Maintenance | Is Recommended? |
|---|---|
| A-54 - Sealable Deck Cracks | Yes |

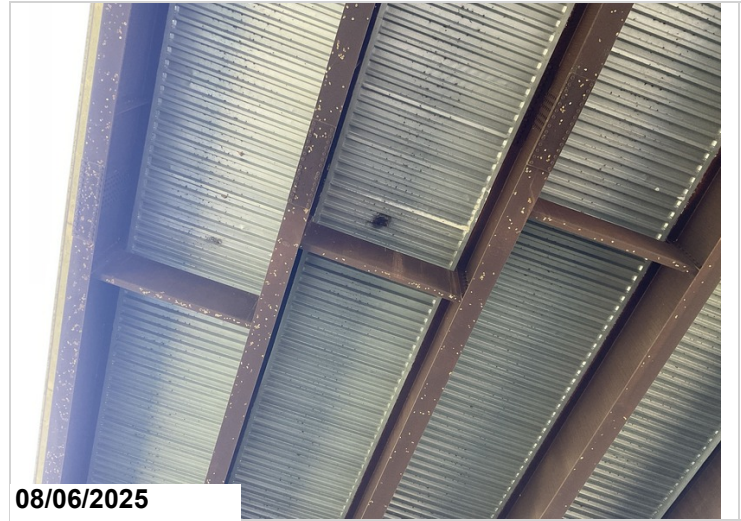
Span 3, Bays 1 & 2: Minor active corrosion in SIP forms.

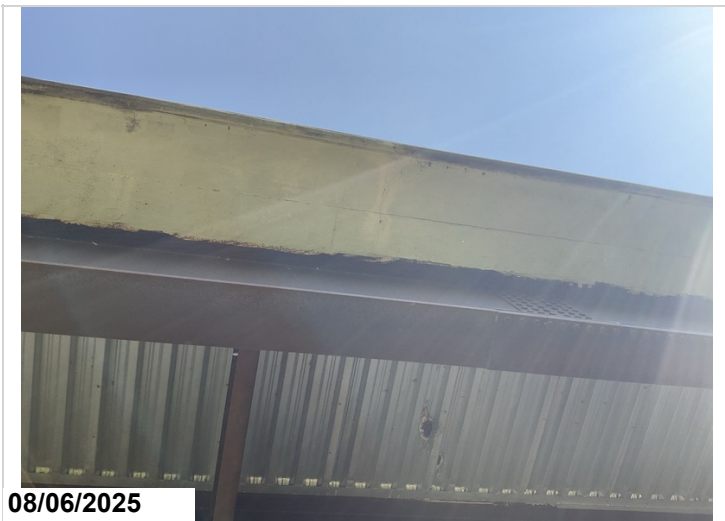
| ELEMENTS | DESCRIPTION | UNITS | TOTAL | CS1 | CS2 | CS3 | CS4 |
|---|---|---|---|---|---|---|---|
| 1120 | Efflorescence/Rust Staining | SF | 90 | 0 | 90 | 0 | 0 |

Spans 1 - 5, Left & Right, Overhangs: Minor cracking. 90SF CS2

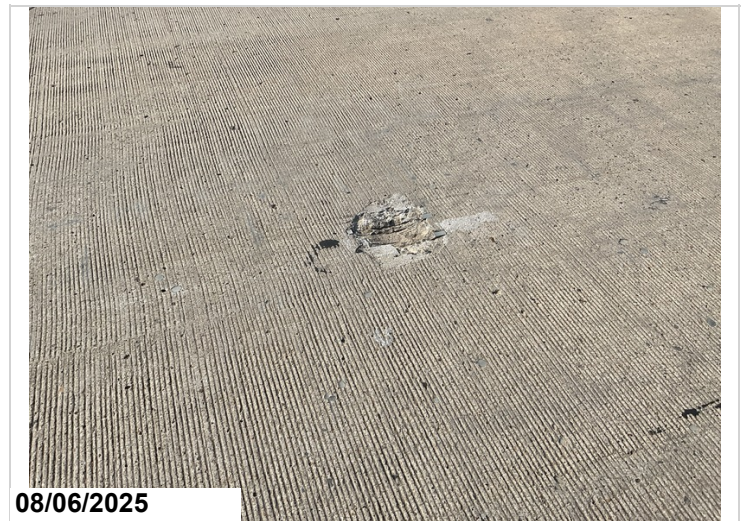
| ELEMENTS | DESCRIPTION | UNITS | TOTAL | CS1 | CS2 | CS3 | CS4 |
|---|---|---|---|---|---|---|---|
| 1080 | Delamination/Spall/Patched Area | SF | 12 | 0 | 0 | 12 | 0 |

Spans 1 & 3 - 5: Spalling where plowable delineators have been removed. 12SF CS3

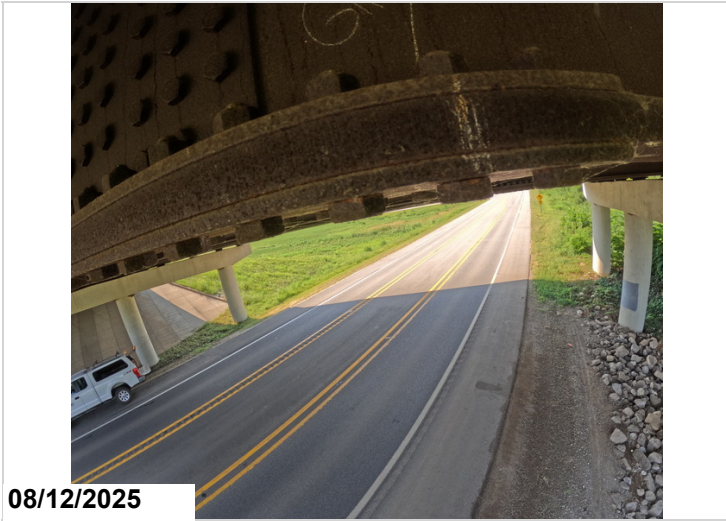
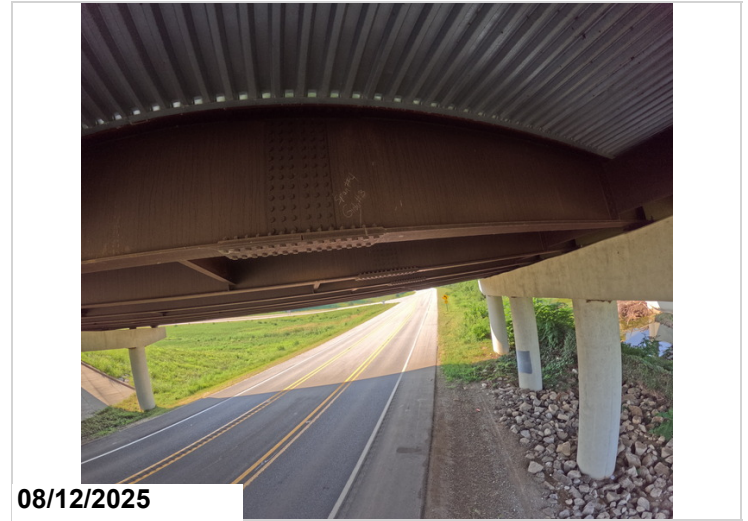
Span 4, Girder 3, Flange: Loose bolt.

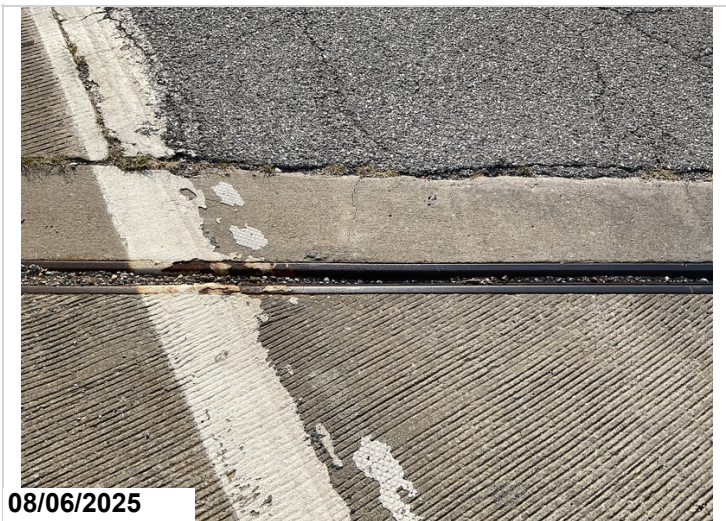
Overall, the substructure is in good condition with minor cracking in the top of the backwalls.

Abutment 1 & 2, Top of Back Wall: Cracking. 45LF CS2

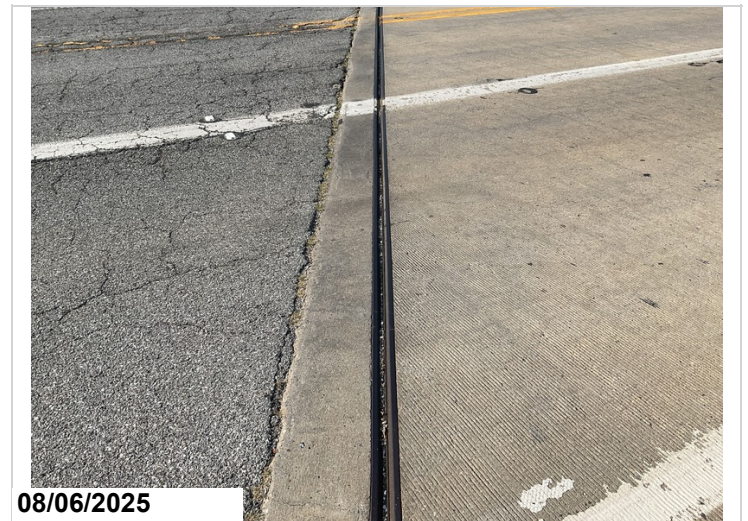
Abutment 2: Minor debris impaction. 98LF CS2

| Type of Maintenance | Is Recommended? |
|---|---|
| A-56 - Joint Cleaning/Flushing Needed | Yes |

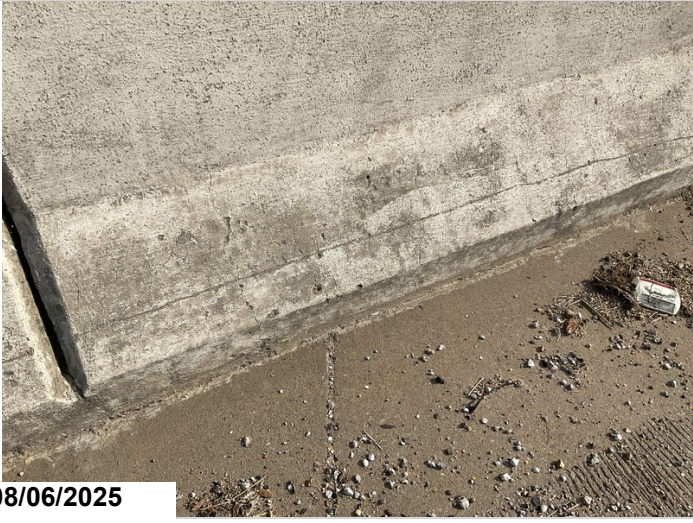
Spans 1 - 5, Left & Right: Minor cracking. 234LF CS2

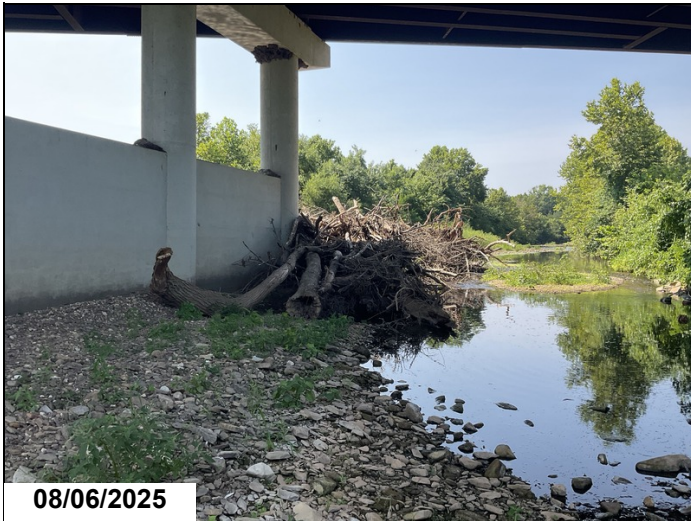
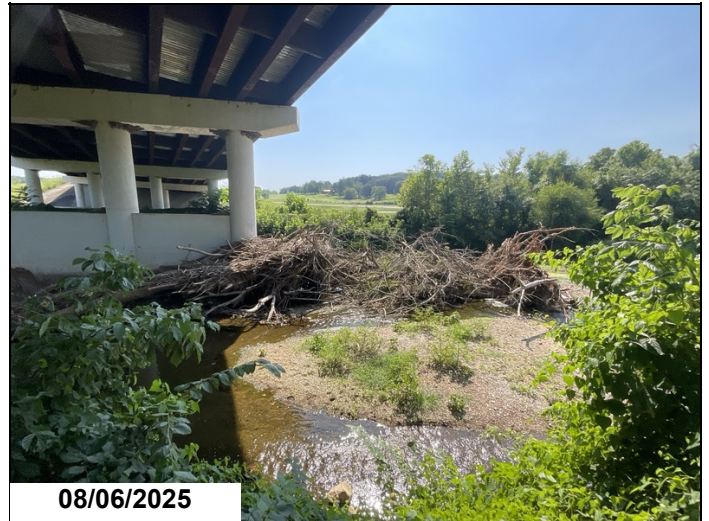
Bent 2: Large trees and brush restricting the channel.

Bent 2: Large trees and brush in channel.

**Type of Work:** Channel Work/Drift Removal

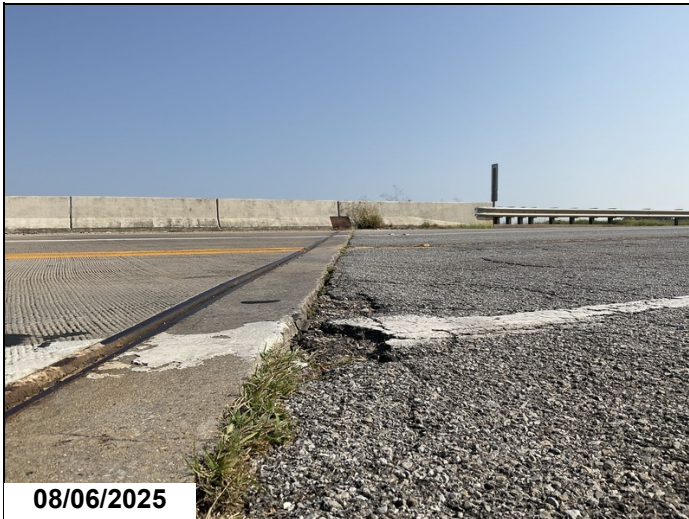
Approach 1 & 2, Left & Right Lanes: Settlement up to 4"D for 3'L.

Approach 1 & 2: Up to 4" of settlement for 3'.

**Type of Work:** Approach Leveling/Maintenance

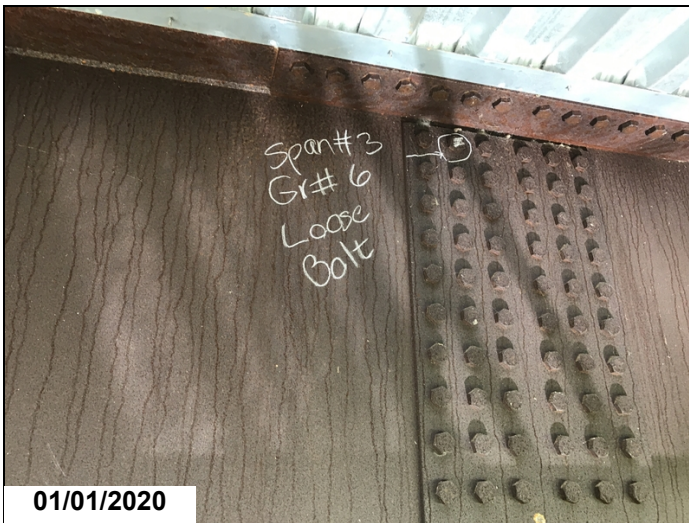
01/01/2020  
-Span #3 girder #6 has a loose bolt in the web of splice connection.

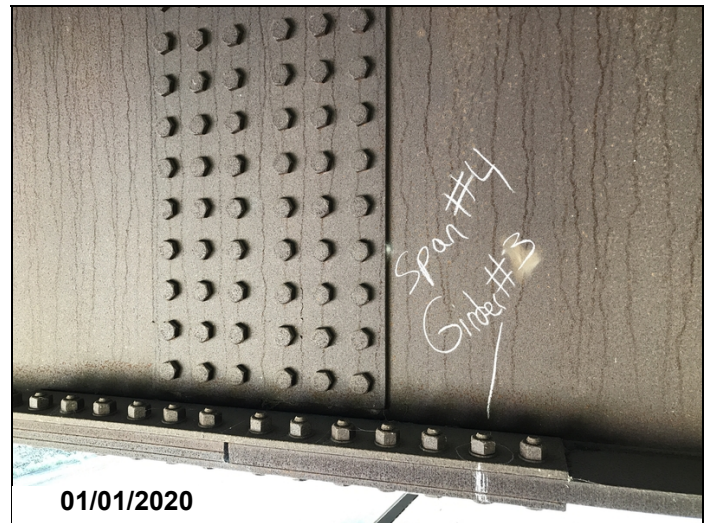
01/01/2020  
Span #4 girder #3 at loose bolt in the bottom flange of splice.

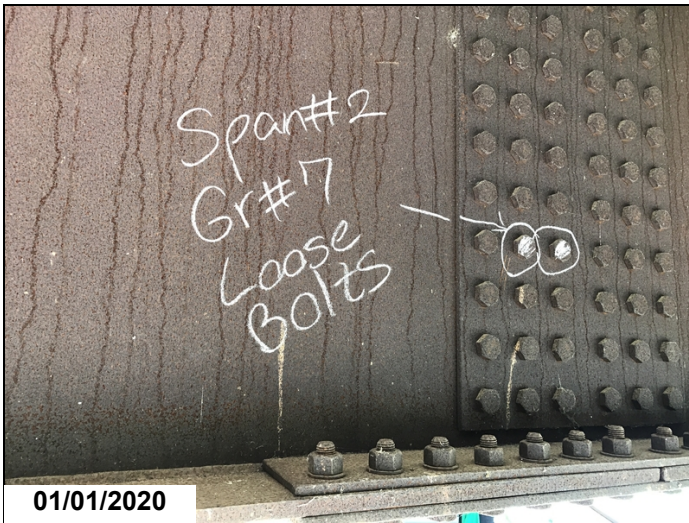
Span #2 girder #7 has 2 loose bolts. In the web of splice connection.

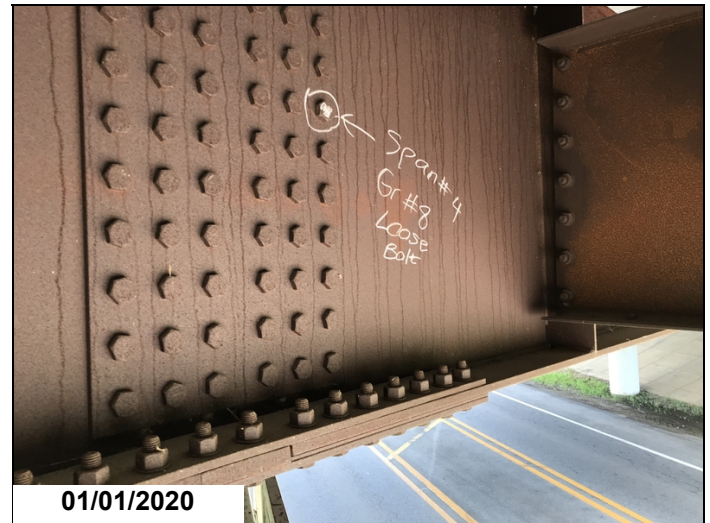
Span #4 girder #8 loose bolt in the web of the bolted splice connection.

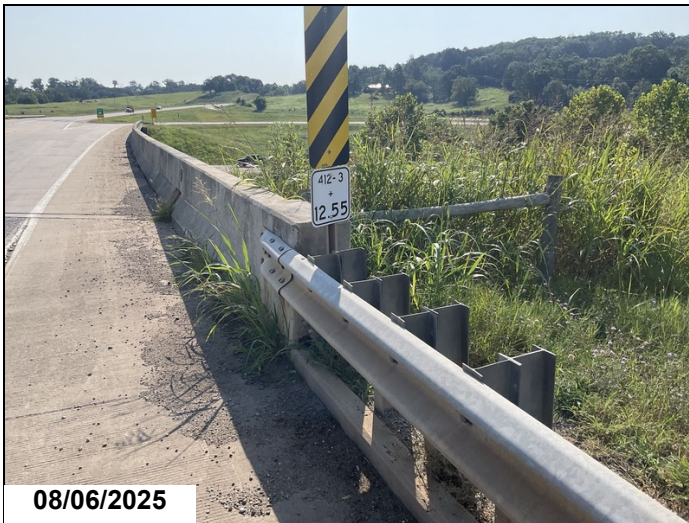
Log mile signs are not legible and need to be replaced.

Log mile signs in place and legible.

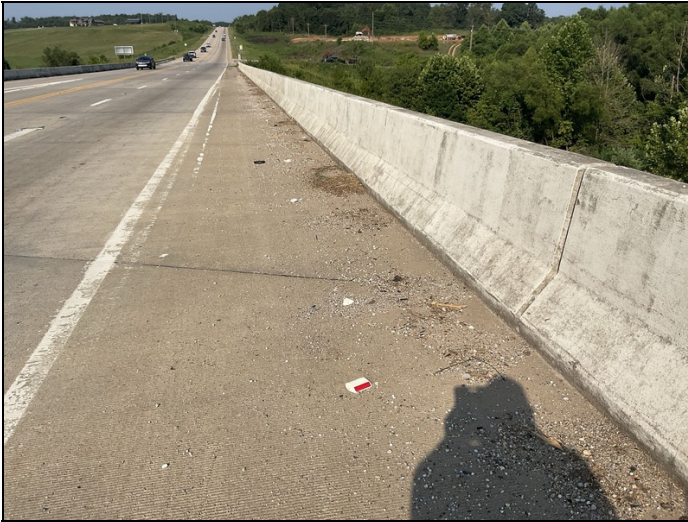
Deck washing needed.

**A-55 - Deck Washing Needed (Yes)**
