Bridge #03046(Routine, Underwater type 2)

US 49/sec-7/L-7.91 over Caney Creek

Team Lead: Myron Futrell Inspection Date: May 07, 2020

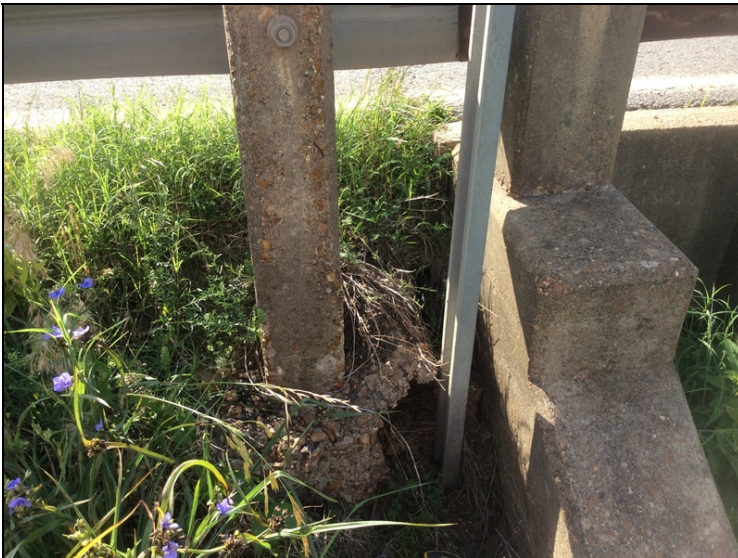
Abutment #1 right and left shoulder and abutment #2 left shoulder at bridge is eroded up to one foot deep behind head wall.

Abutment #1 right shoulder at bridge is eroded one foot deep behind head wall.

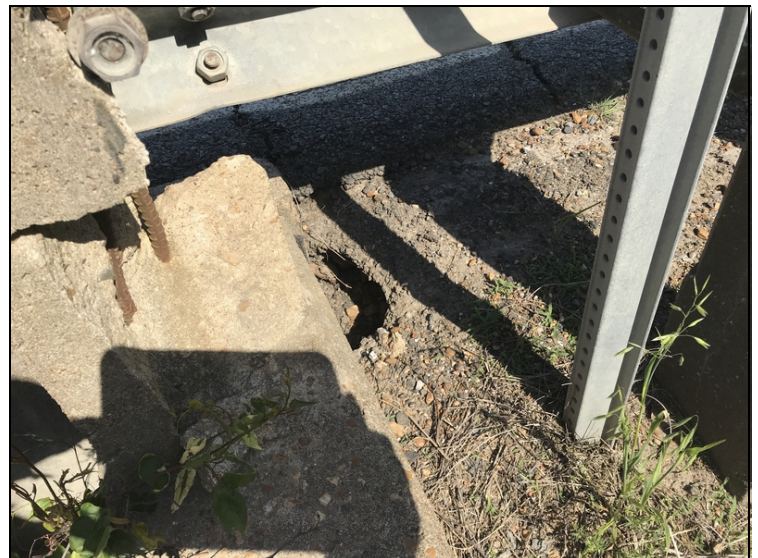
Minor erosion at abutment #1 left side.

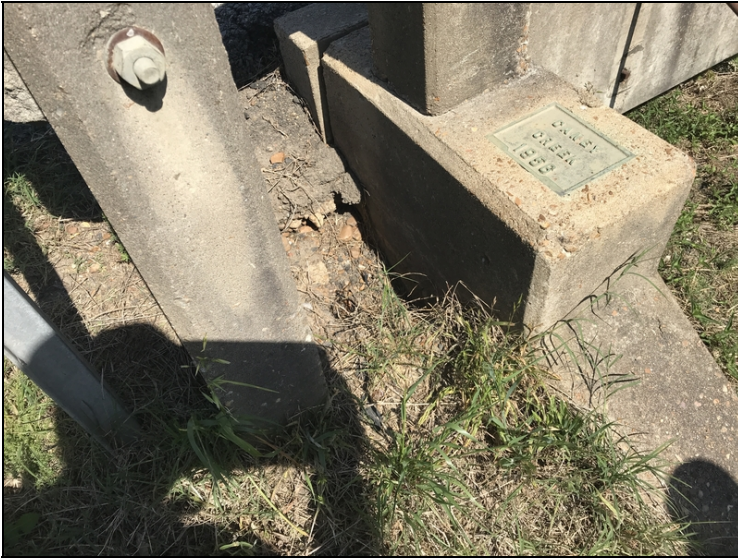
Erosion at abutment #2 left side.

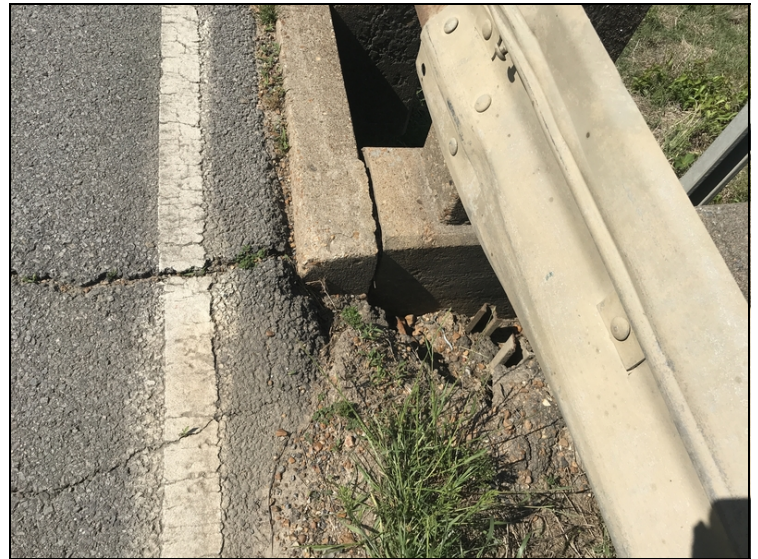
Erosion at abutment #1 right side.

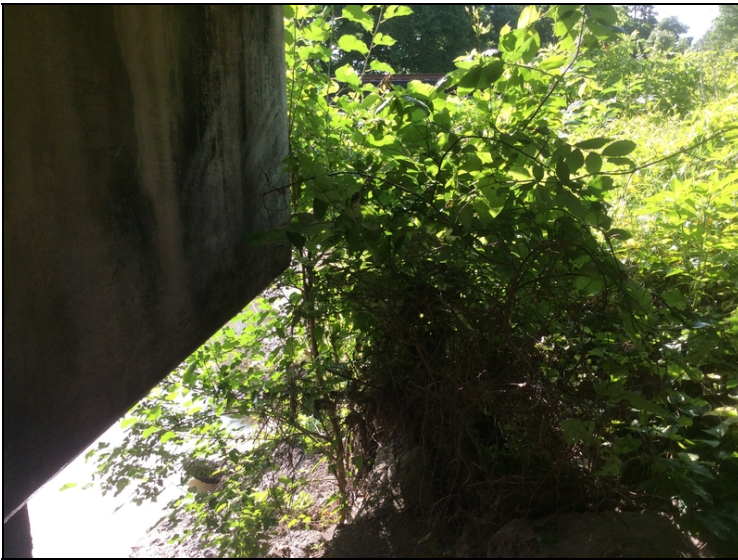
Small trees and vegetation are growing beside and under bridge.

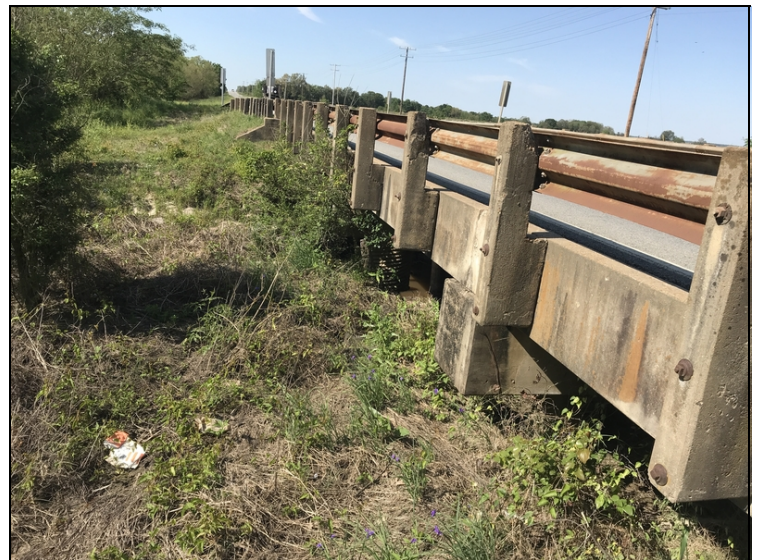
Trees and vegetation growing beside and under bridge.

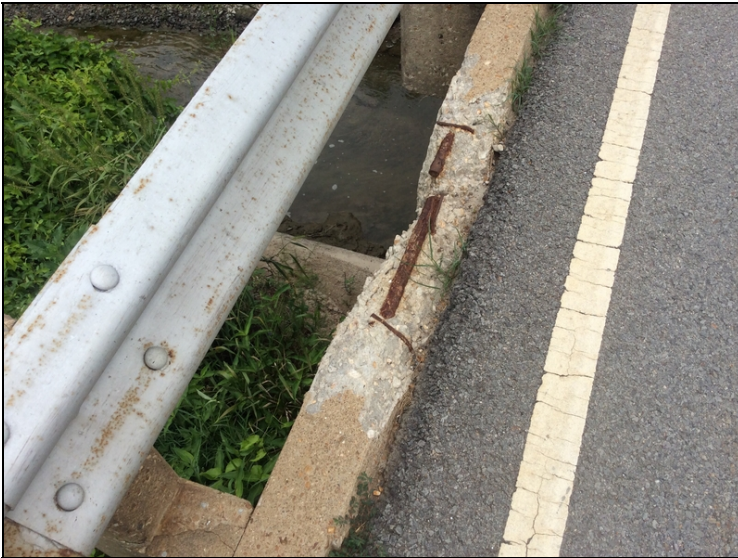
Bent #3 left curb has 4' spall with exposed rebar with 5% section loss.

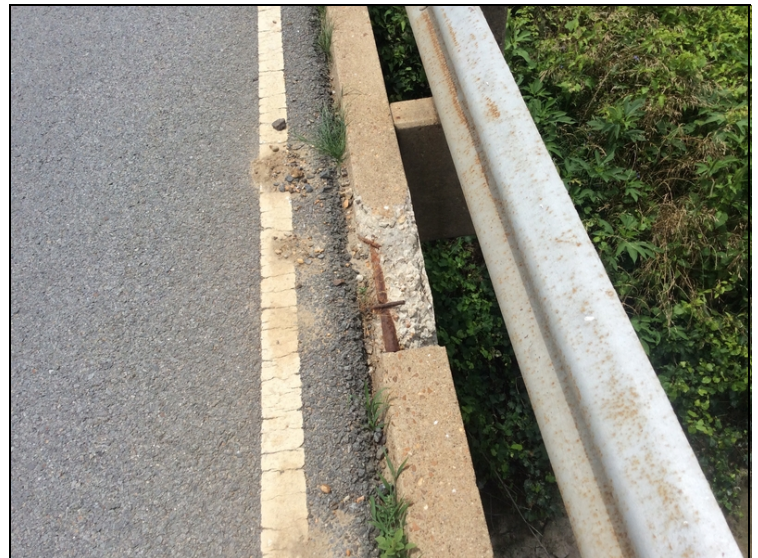
Right curb over bent #4

Bent #4 right curb has 3' spall with exposed rebar with 5% section loss.

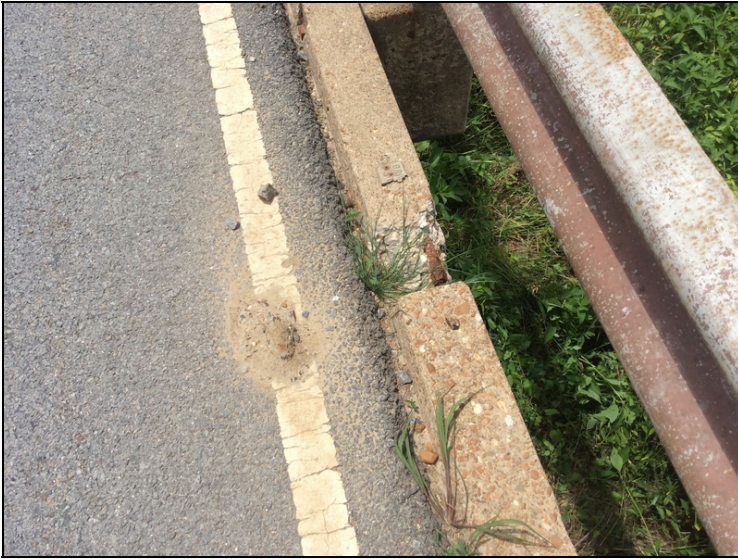
Right curb over bent #2

Bent #2 right curb has 1' spall with exposed rebar with 5% section loss.

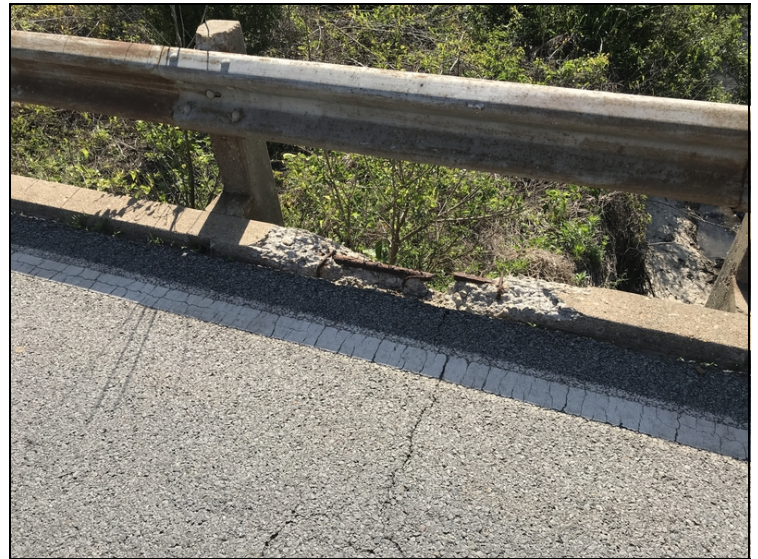
Left curb spalled at bent #3.

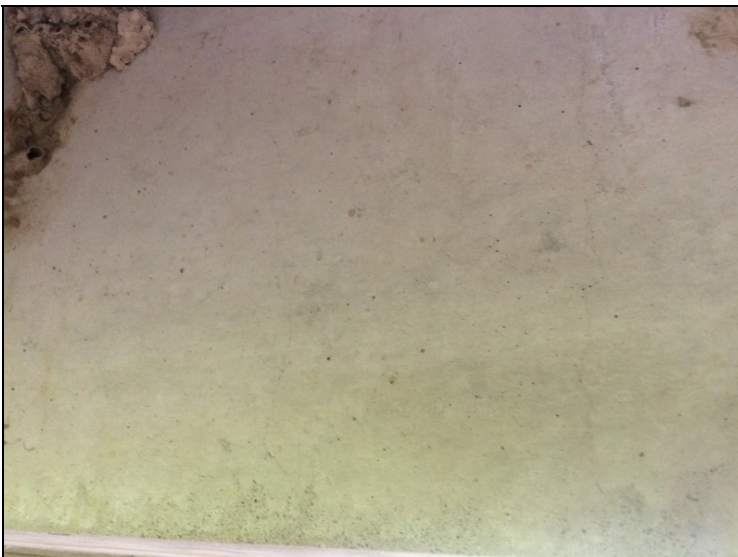
Typical vertical flexure cracks

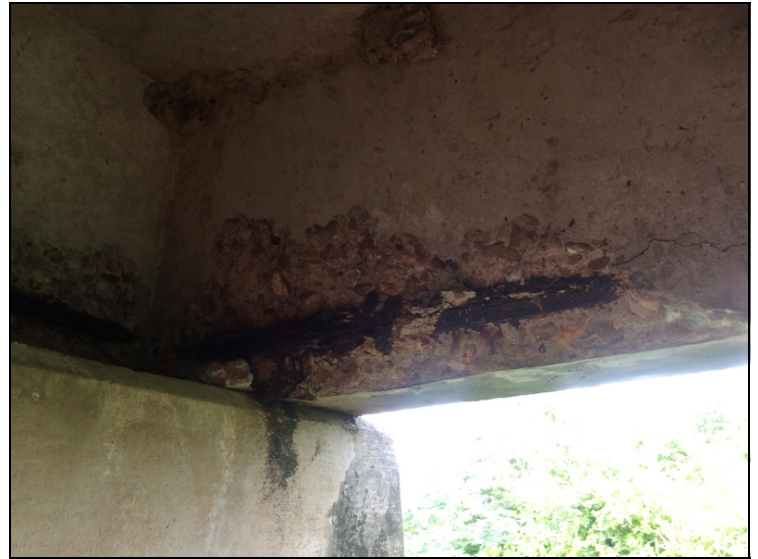
Span #2 girder #7 right leg at bent #3

Span #2 girder #6 right leg has 6" spall with no exposed rebar.
Span #2 girder #7 left leg at 3/4 span has a two foot delamination with rust staining, and at half span has a three foot long spall with exposed rebar with 20% section loss.
Span #2 girder #7 right leg is cracked for 12' with two foot long delamination and a one foot spall at bent #3 with exposed rebar with 20% section loss.
Span #3 girder #1 left leg has hairline cracks on sides on stem and bottom for first foot with light efflorescence.
Span #3 girder #1 right leg first half of span is cracked on sides of stem and bottom with light to moderate efflorescence the second half is cracked with rust staining and two foot delamination at bent #4.
Span #3 girder #2 left leg near center has one foot crack with delamination.
Span #3 girder #6 right leg is spalled for eight feet in center rebar exposed with 20% section loss.
Span #3 girder #7 right leg has a one foot area near center with six inch spall with exposed rebar with 15% section loss and cracks.

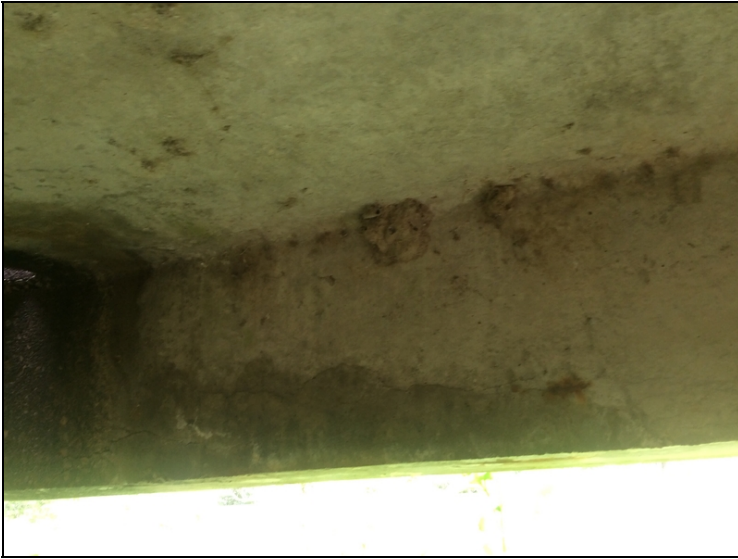
Span #2 unit #1 left and right leg cracked with efflorescence last half of span.

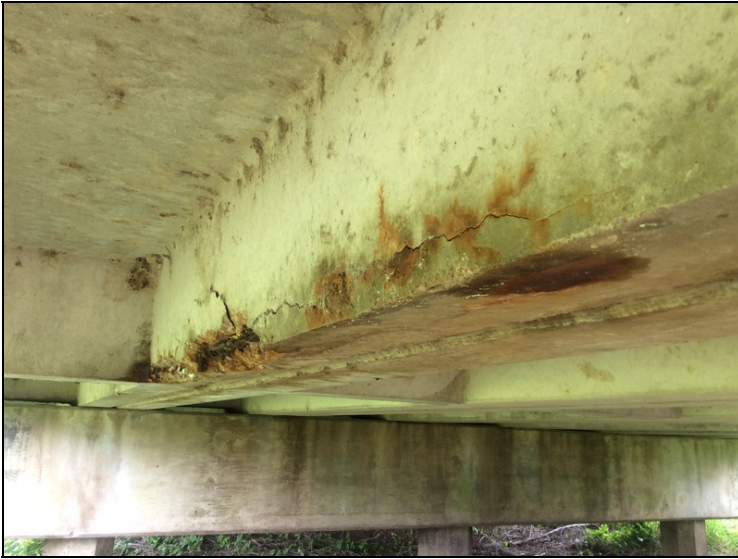
Span #2 girder #7 left leg mid span 4' spall with exposed rebar large section loss. Remaining section of last half of span left leg cracked with rust stains.

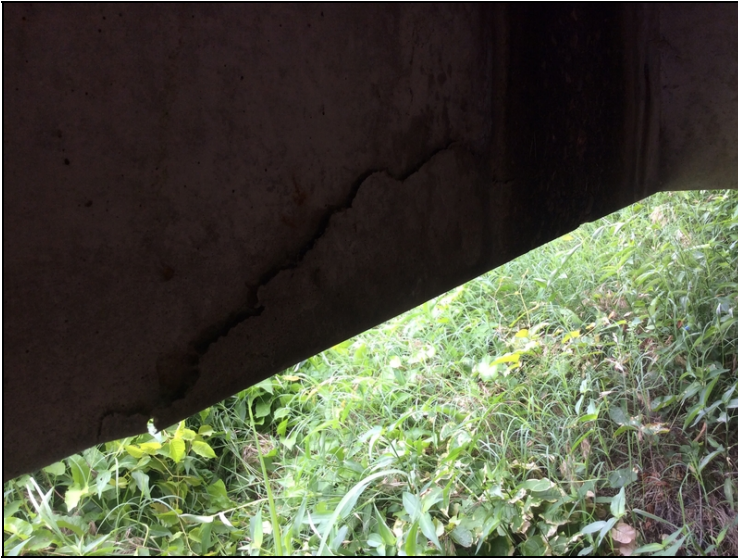
Span #3 girder #7 left leg cracked for 2' with rust staining.
Span #4 unit #1 left leg at 1/4 span has one foot spall with exposed rebar with 20% section loss.

Span #4 unit #1 left leg 2' delamination.

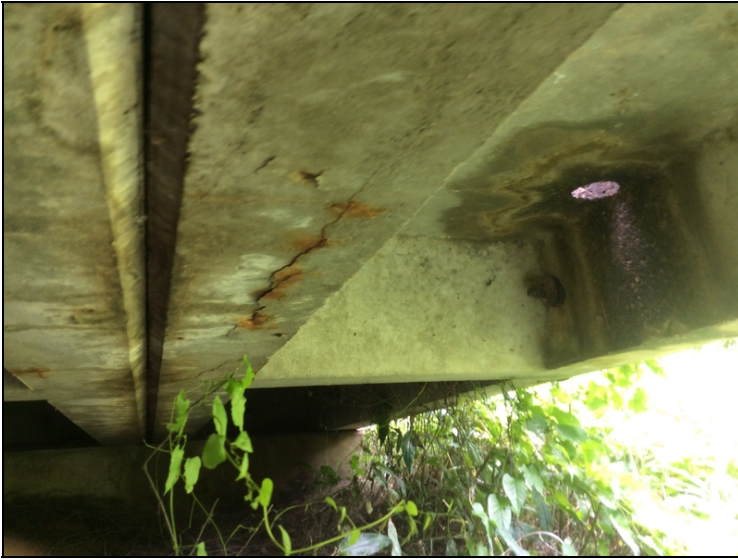
Span #1 girder #1 left leg second half of span is cracked with a six inch piece of rebar exposed at bent #2 with 30% section loss
Span #1 girder #1 right leg is cracked and delaminated second half of span with rust staining.
Span #1 unit #2 left leg cracked for 4' with rust staining, right leg has 6" spall with exposed secondary rebar.
Span #1 girder #6 right leg is cracked and delaminated first half of span with rust staining.
Span #1 girder #7 left leg is cracked in center span for three feet with rust staining.
Span #2 girder #1 both legs second half of span are cracked on sides and bottom of stems with three feet of delaminations and light efflorescence with rust staining.
Span #2 girder #2 left leg is cracked and delaminated for fifteen feet with rust staining and a five foot spall with rebar exposed at bent #3 with 20% section loss. Leg also has light efflorescence on side at bent #3 for three feet.

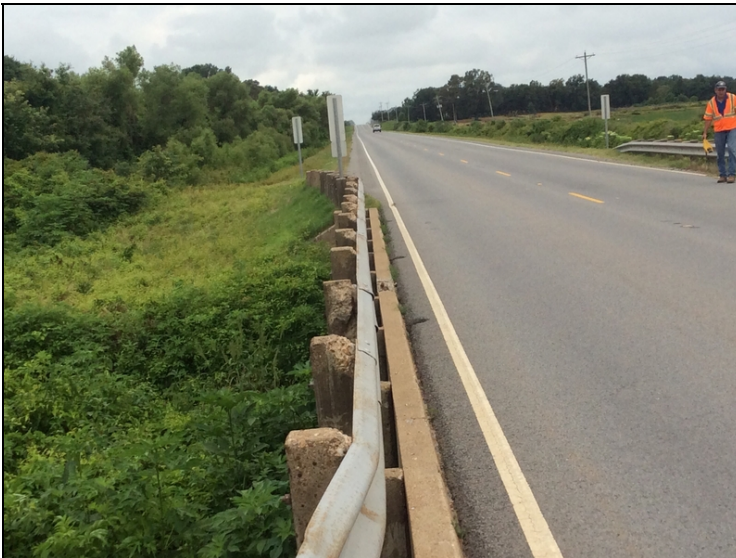
Bridge rail left side tops of all posts

All rail posts on left side have small spalls on tops.

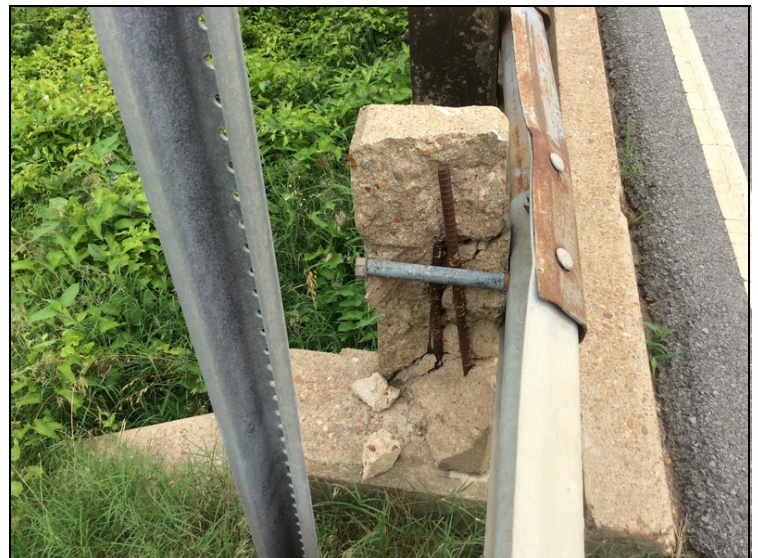
Abutment #1 left side 1st post.

Abutment #1 left side, first post is broken.

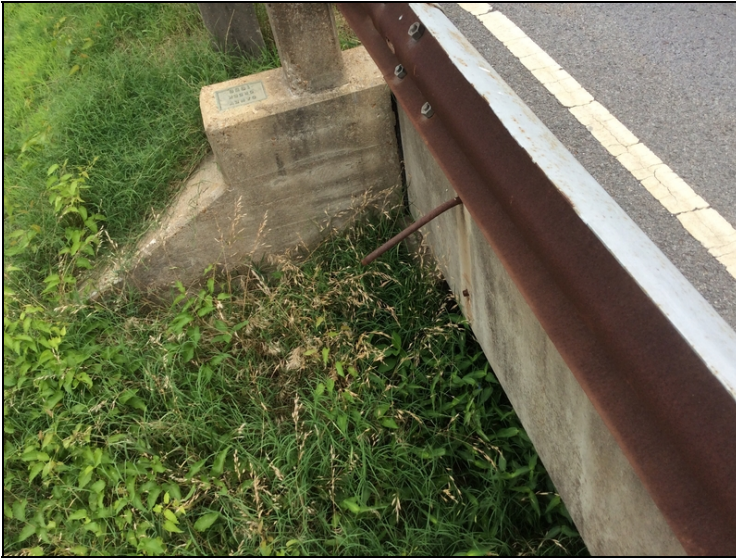
Next to last rail post on left side at abutment #2 is missing.

Span #3 left side next to last post gone.

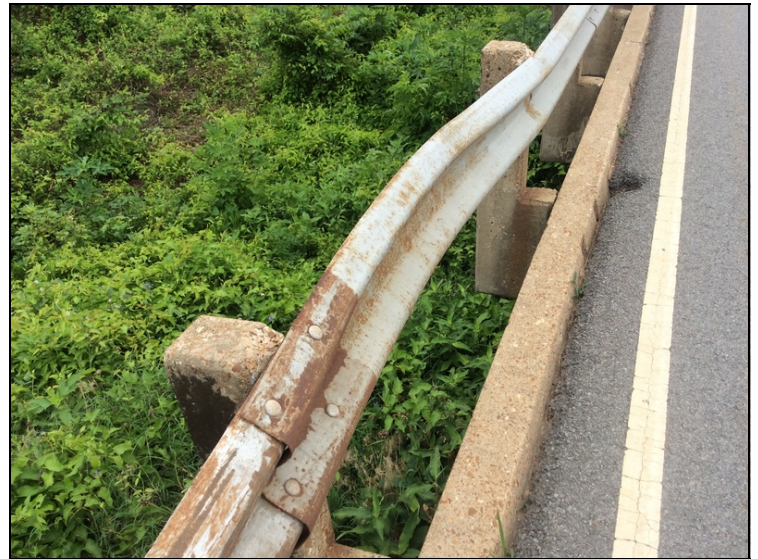
Span #1 left side beginning of bridge has six feet of collision damage with rail bent outward and end post broken and spalled with exposed rebar.

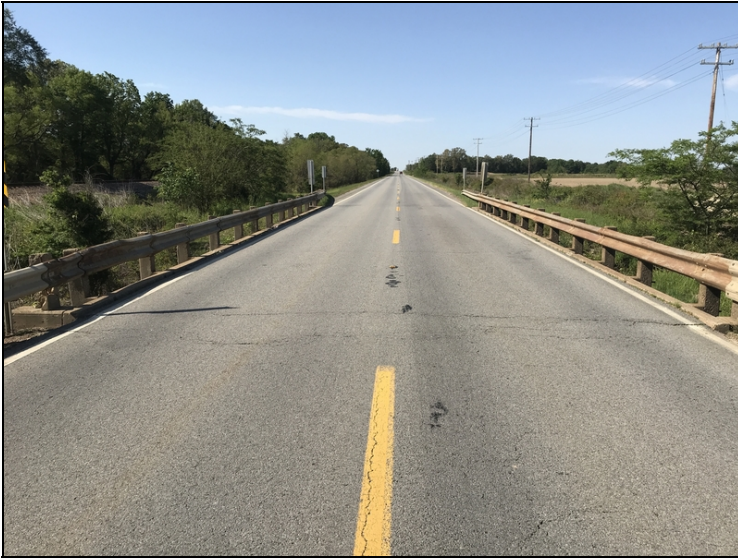
Span #1 left rail damage and 1st post broken.
