Bridge #03047 (Routine, Underwater type 2)

US 49/sec-7/L-7.60 over Caney Creek

Location: 1.50 MI S JCT OF SH 269

Team Lead: Myron Futrell **Inspection Date:** May 07, 2020

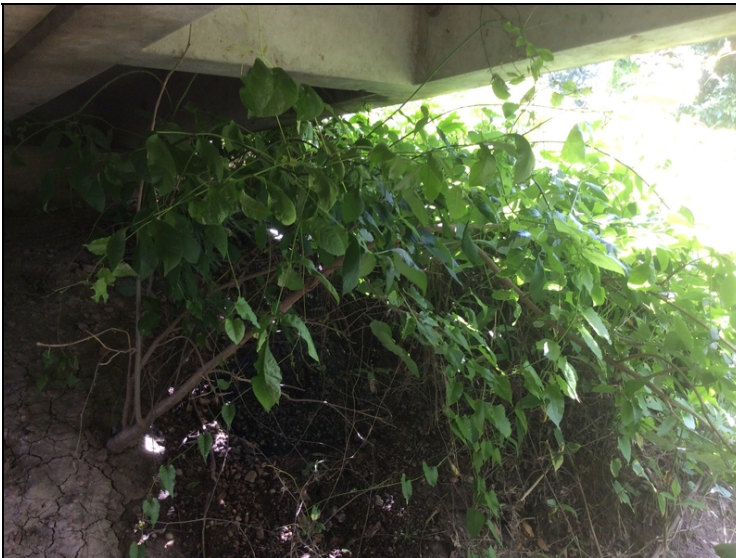
Small trees and vegetation are growing under and beside bridge.

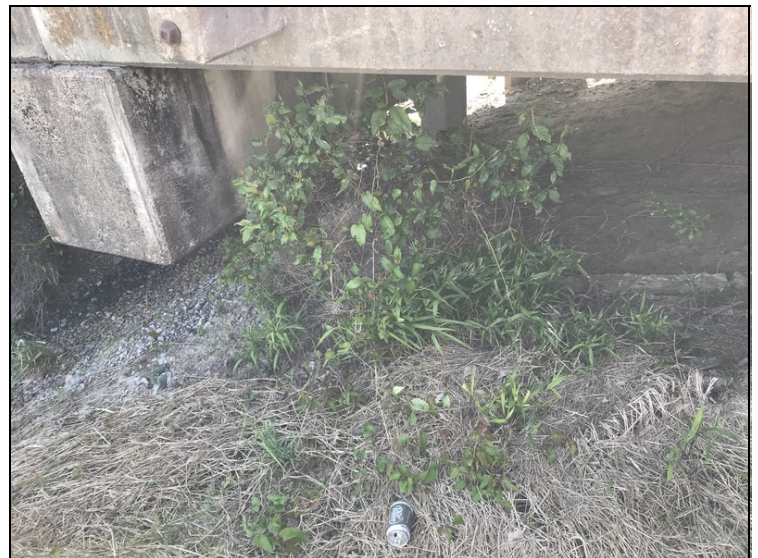
Small trees and vegetation growing beside and under bridge.

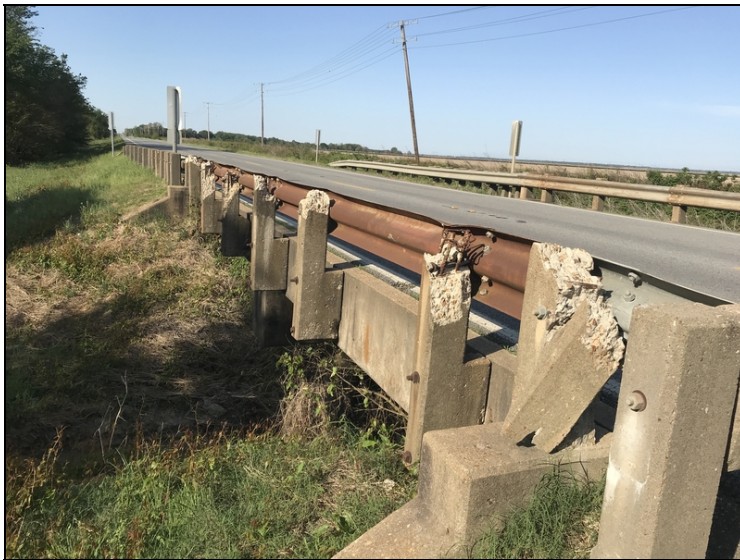
All left side rail posts are spalled with exposed rebar with no section loss.

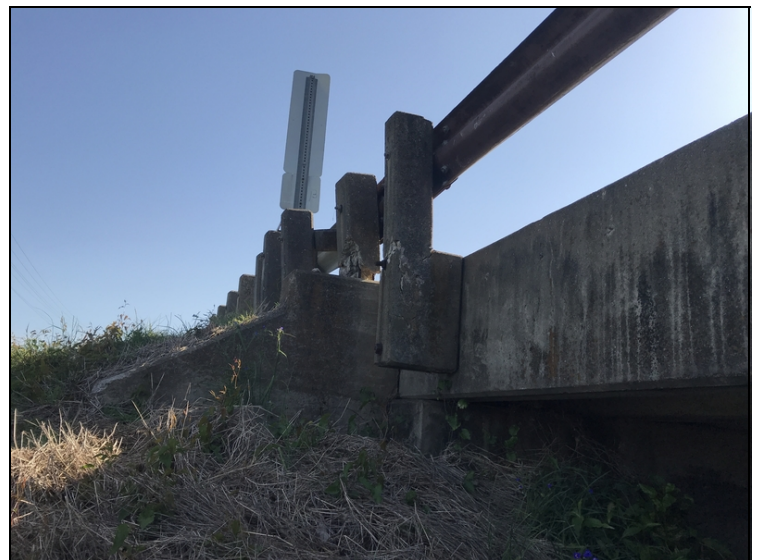
1st and 2nd rail posts on right side broken at bottom.

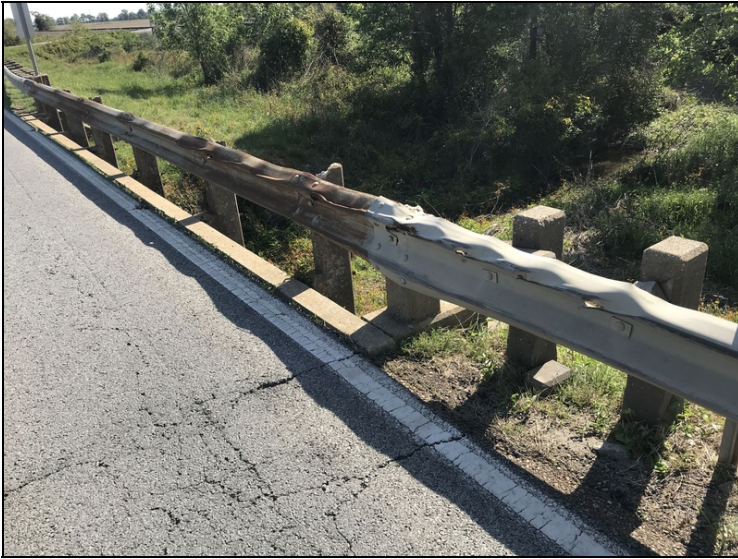
Left rail damage at abutment #2

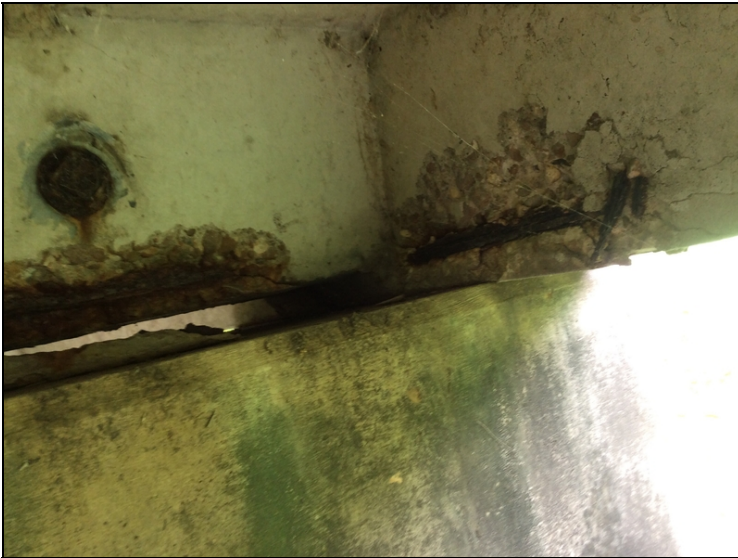
Span #2 unit #1 at bent #2

Span #2 unit #1 bent #2 diaphragm has two foot spall with exposed rebar with 20% section loss.

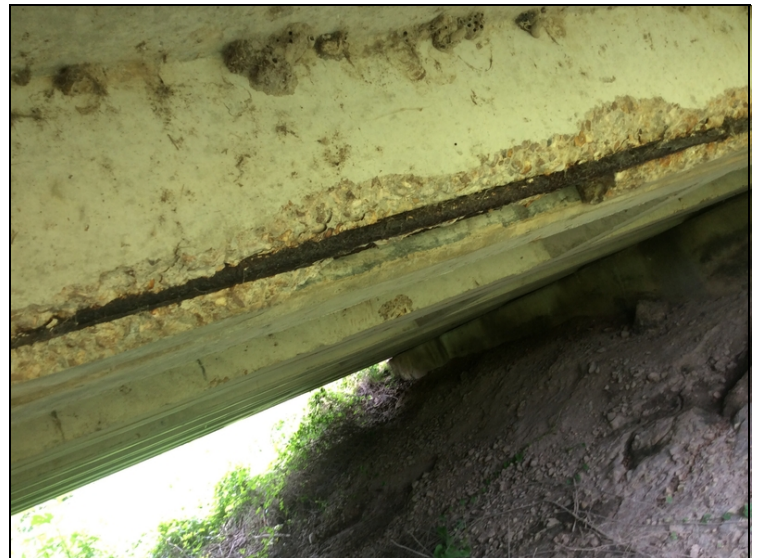
Span #2 unit #7 left leg has six foot spall in first half of span with exposed rebar with 20% section loss and three feet of cracks and delamination around spall.

Span #2 unit #7 left leg.

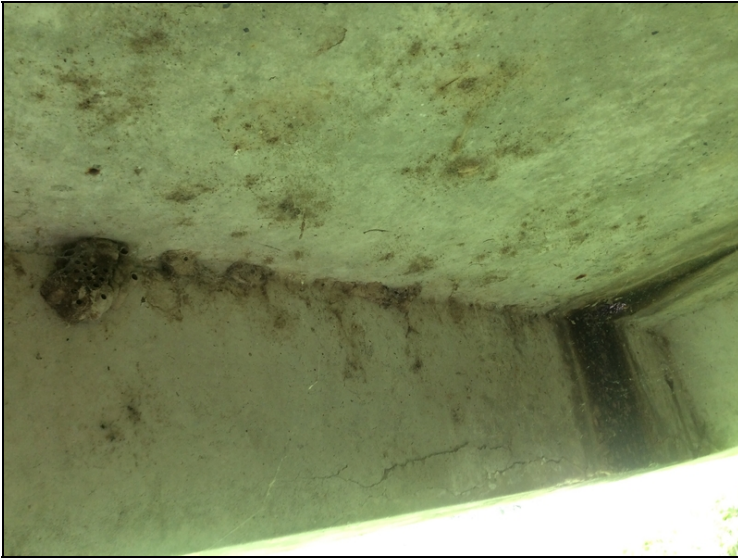
Span #2 unit #1 left leg is cracked and delaminated first half of span with two foot delamination and a one foot spall with exposed rebar at bent #2 with 20% section loss.

Span #2 unit #1 left leg 3' delamination

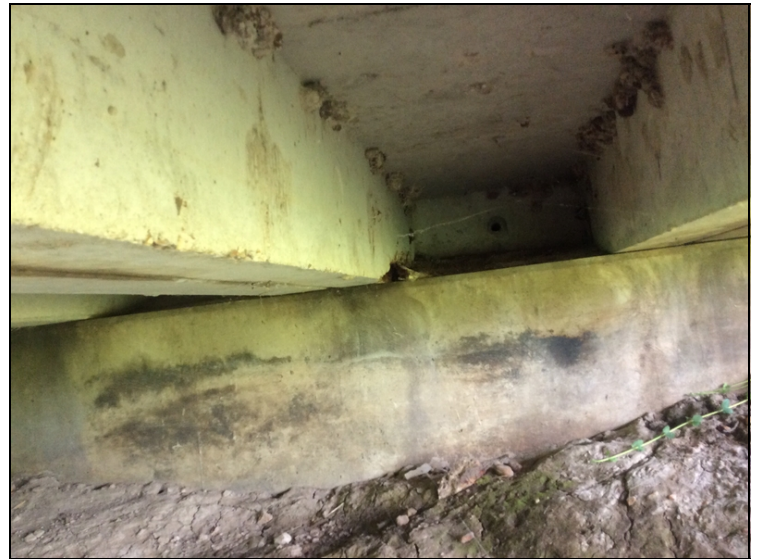
Span #2 unit #6 left leg has two foot spall at bent #3 with exposed rebar with 20% section loss, right leg has 4' of cracking.

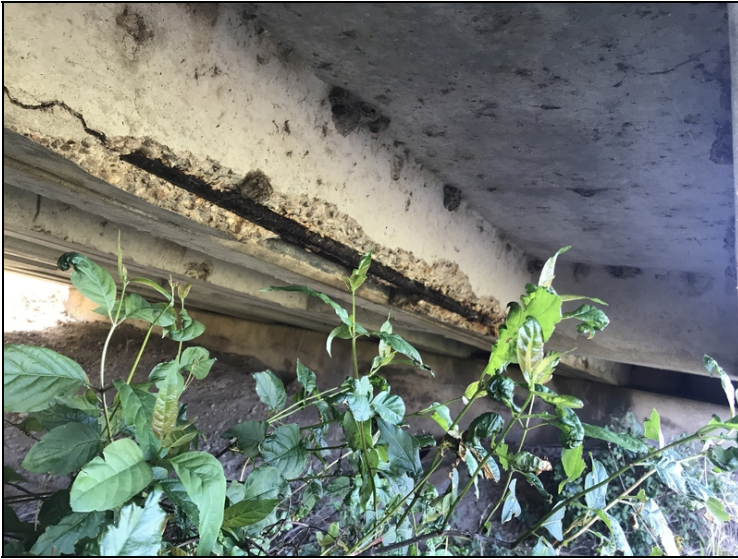
Span #2 girder #7 cracked and spalled full length with 6' of exposed rebar with 10% section loss.

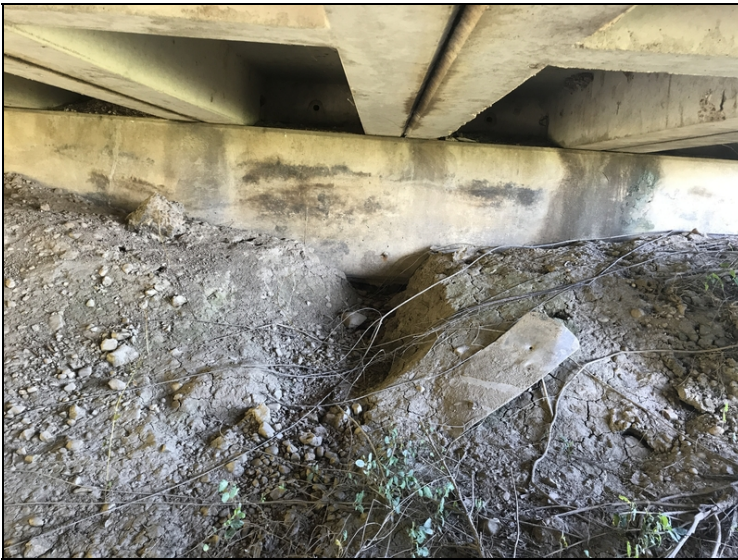
Abutment #2 cap undermined for 1' up to 4" six feet from right end.

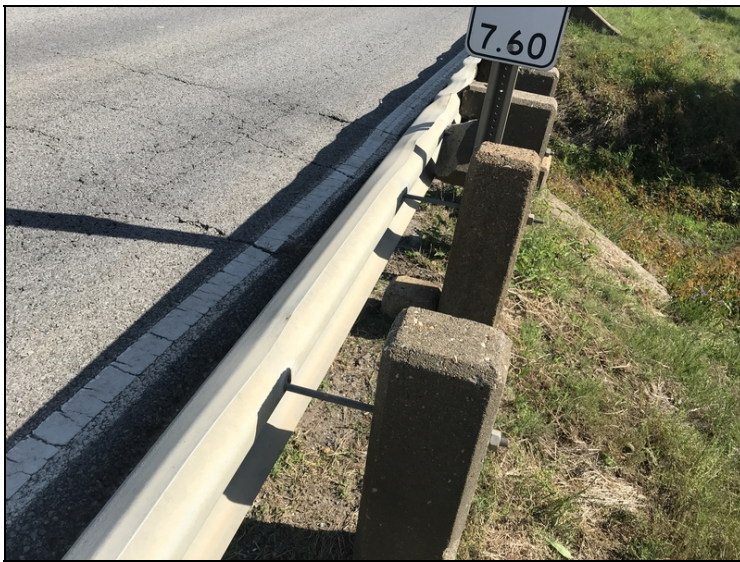
Left approach rail at abutment #2 has 2 missing and 1 broken spacers.

5/7/2020-Left approach rail at abutment #2 has 2 missing and 1 broken spacers.

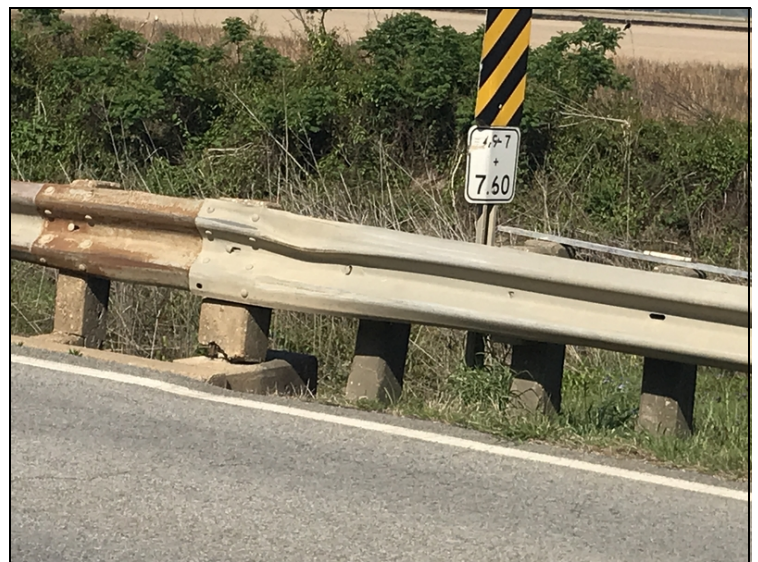
Abutment #1 right approach rail has 3' of minor collision damage at bridge end.
Left approach rail at abutment #2 has 2 missing and 1 broken spacers.

Abutment #1, right side, approach rail damage.
