Asset #00461 (Routine)

SH 35 S-5 LM 15.92 over BLAKEY CREEK

Team Lead: Lee Swan, Inspection Date: 05/19/2022

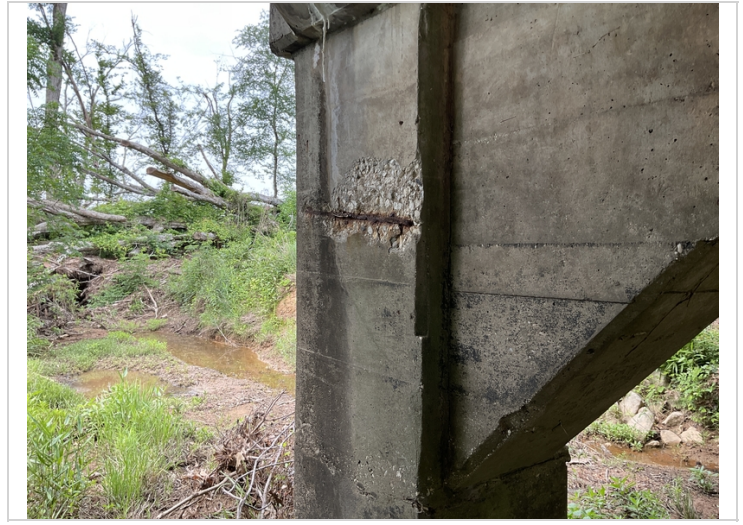
(205) Column 1 has efflorescence with build up. Column 2 has a large spall with exposed rebar with section loss.							
210	Reinforced Concrete Pier Wall	LF	14	7	0	7	0
1090	Exposed Rebar	LF	7	0	0	7	0

Column 2 exposed rebar

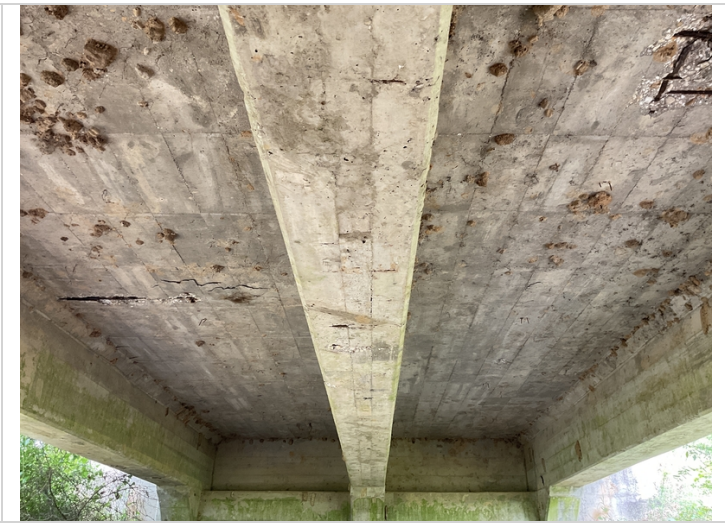
Typical soffit

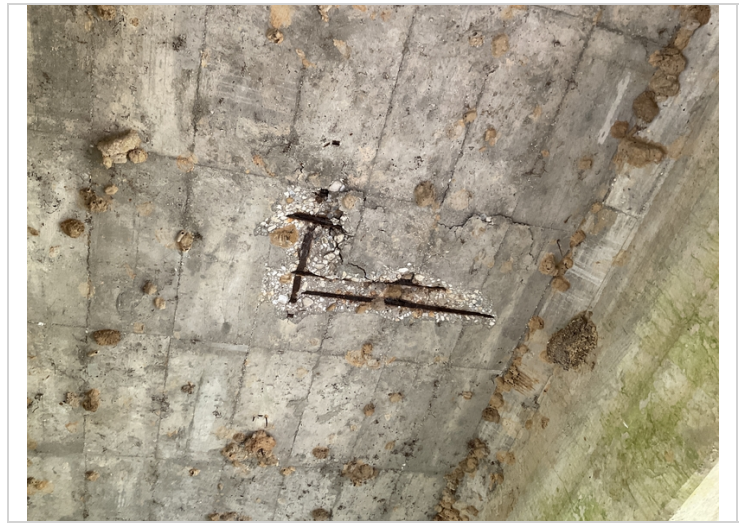
Span 1 bay

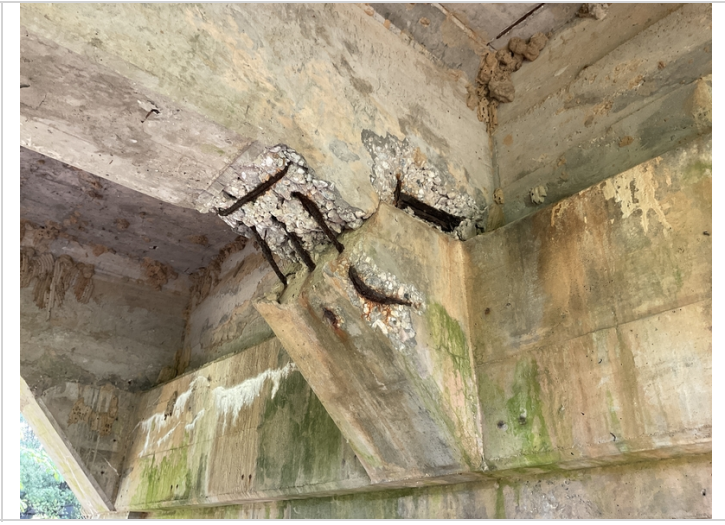
G 2 span 1 has cracks and spalls with exposed steel

Bent 2 girder 2

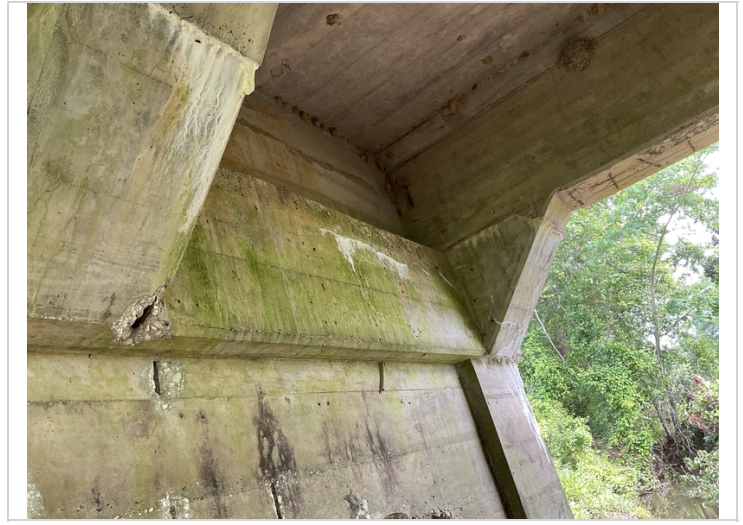
(234) The bent 2 cap has cracks with efflorescence.							
301	Pourable Joint Seal	LF	20	0	0	20	0
2350	Debris Impaction	LF	20	0	0	20	0
(301) The pourable joint seal is impacted by the wearing surface.							
331	Reinforced Concrete Bridge Railing	LF	126	126	0	0	0

Bent 2 efflorescence in cap

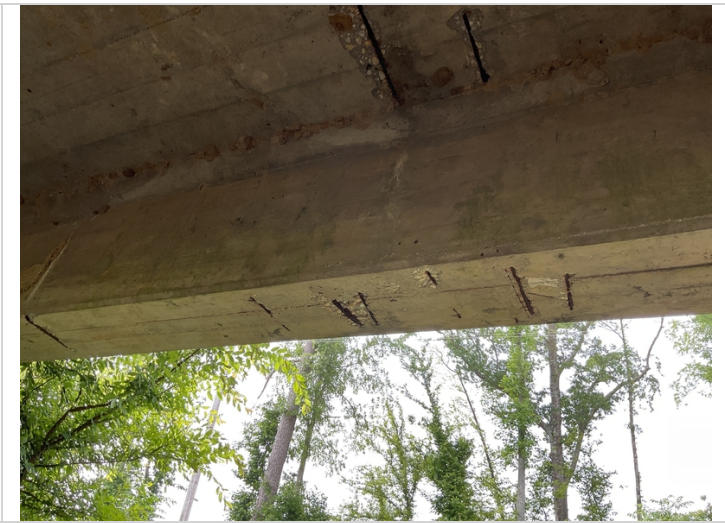
(110) Spalls with exposed rebar with section loss in both spans. Scattered small cracks with efflorescence.							
205	Reinforced Concrete Column	EA	2	0	0	2	0
1090	Exposed Rebar	EA	1	0	0	1	0
1120	Efflorescence/Rust Staining	EA	1	0	0	1	0

Span 2 girde 3, exposed rebar

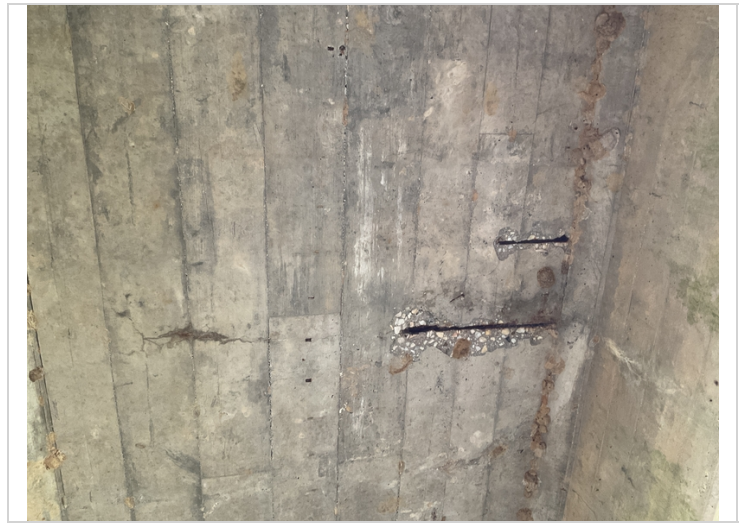
Span 2 bay 2, exposed rebar in soffit

Added 5/19/2022 RLS- spalls with exposed rebar in soffit both bays both spans.

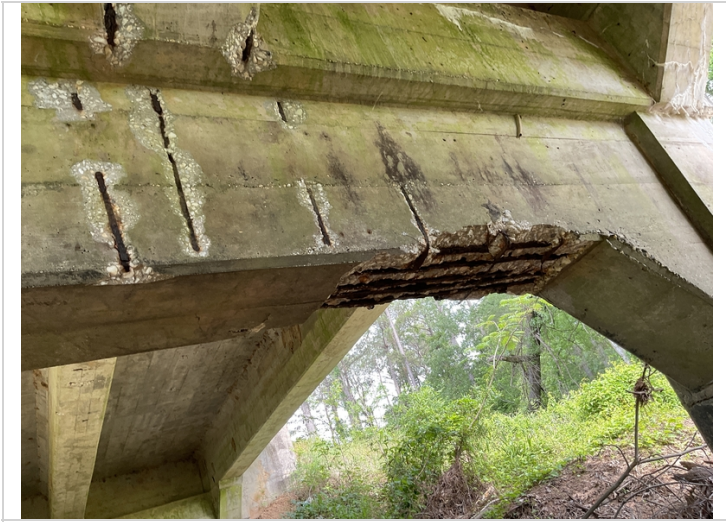
(210) The pier wall below the bent 2 cap has large spalls with exposed rebar with section loss.							
215	Reinforced Concrete Abutment	LF	46	46	0	0	0
(215) No notable defects.							
234	Reinforced Concrete Pier Cap	LF	23	16	7	0	0
1120	Efflorescence/Rust Staining	LF	7	0	7	0	0

Bent 2 pier wall, exposed rebar

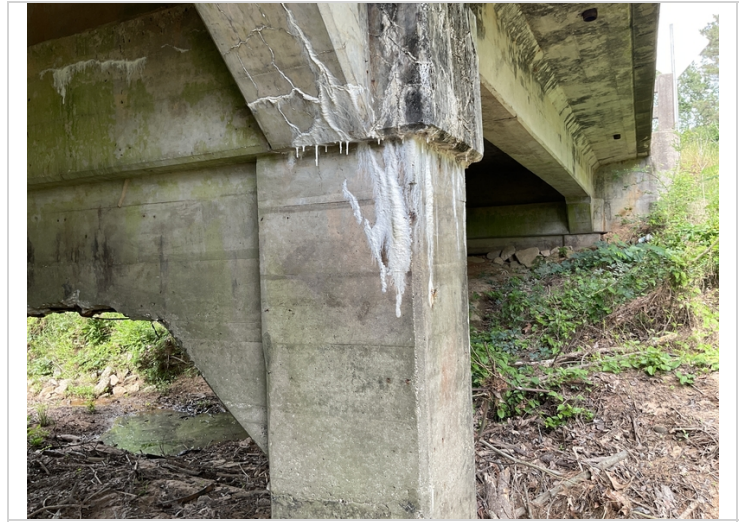
Bent 2 column 1, build up of efflorescence

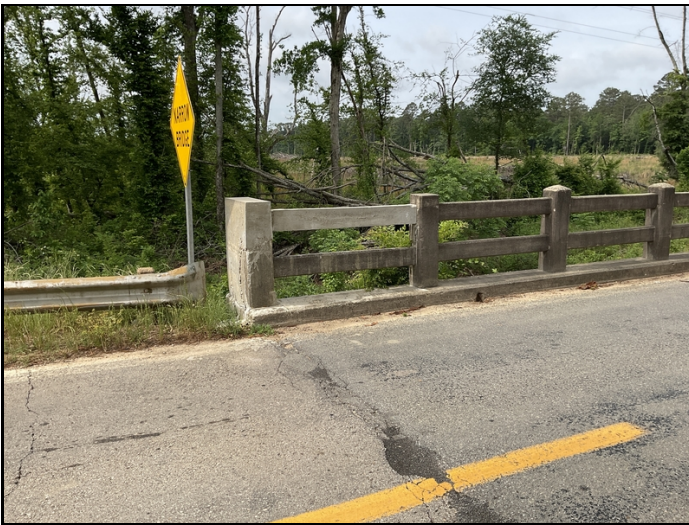
5/19/2022-RLS-Bridge post and rail have been repaired.

Repaired bridge railing.

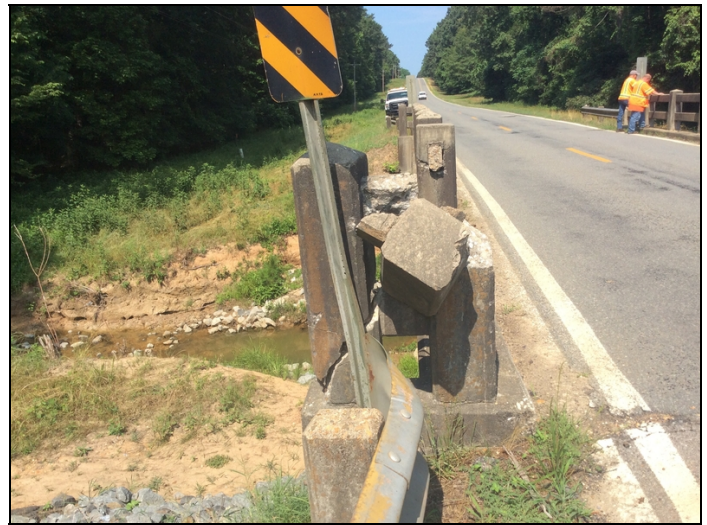
Bridge End Post and top concrete rail @ BR End Rt. collision damage, top of end post broke and top rail is missing.

Abutment 2 Rt. BR end post & top rail in last section before the BR end post, has collision damage.

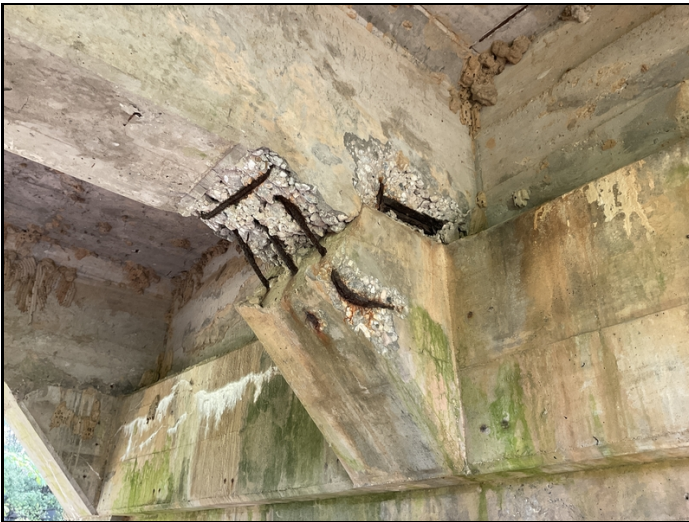
Span 1 Girder 2 @ bent 2 back, spall @ haunch with exposed steel with pack rust and section loss. 05/30/2018 JPR -- Little or no change since last inspection.

Bent 2 girder 2

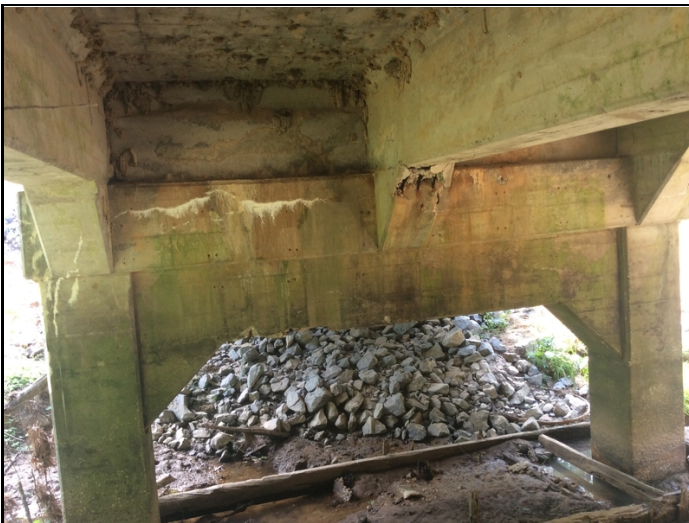
Bent 2 haunch below & back of bent 2 girder 2 has a spall with exposed steel with some section loss. Also bent 2 cap has some cracking with efflorescence on back face of the cap.

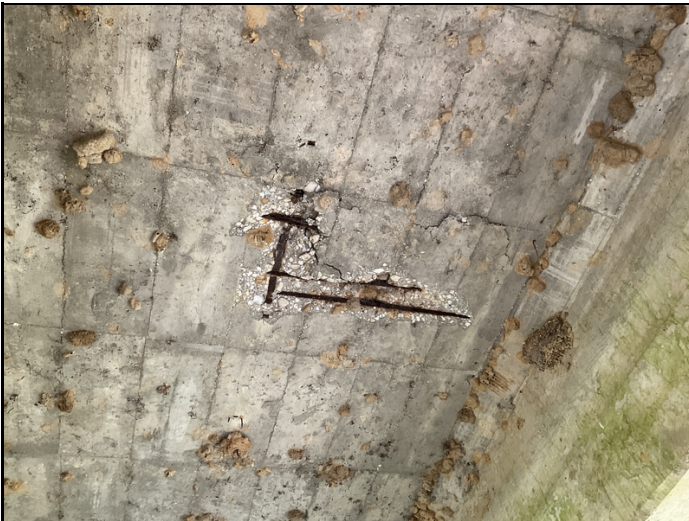
Span 1 bay

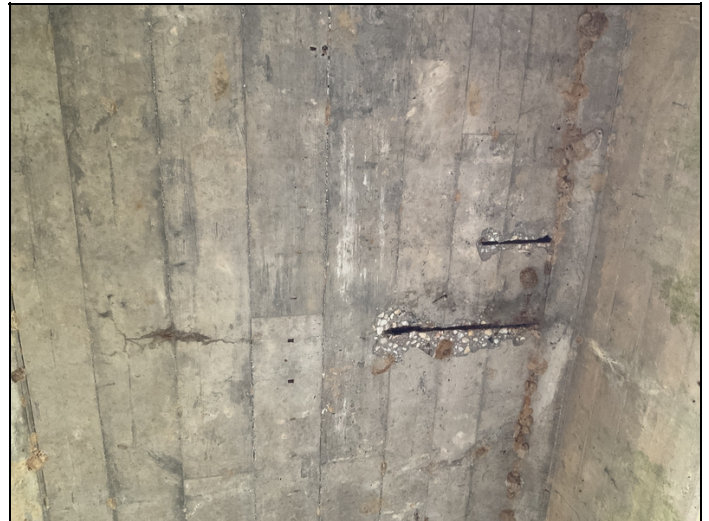
Span 2 bay 2, exposed rebar in soffit

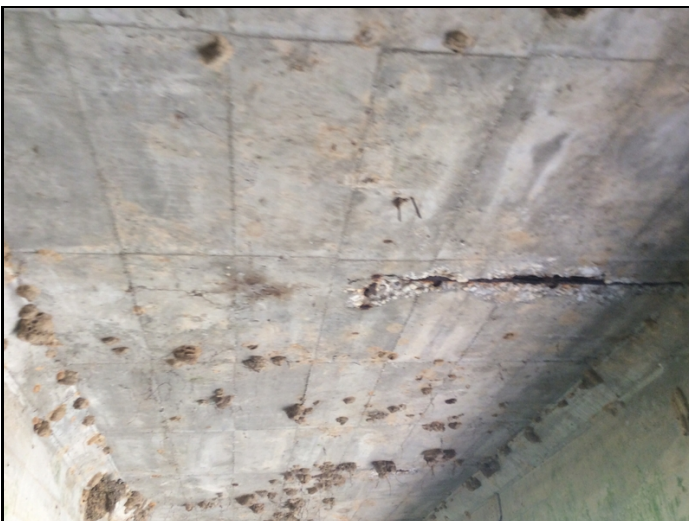
Span 1, mid-span between girders 2 & 3 there is a spall on Soffit of deck with exposed steel with section loss.

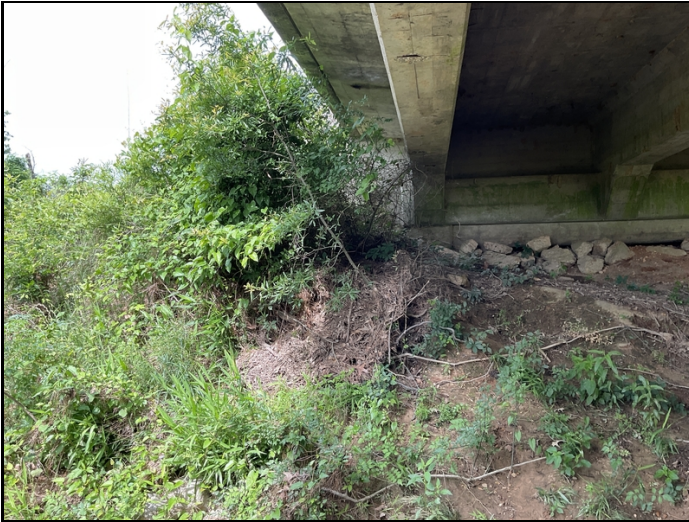
Small trees growing next to and under bridge.

Span 1 right side.

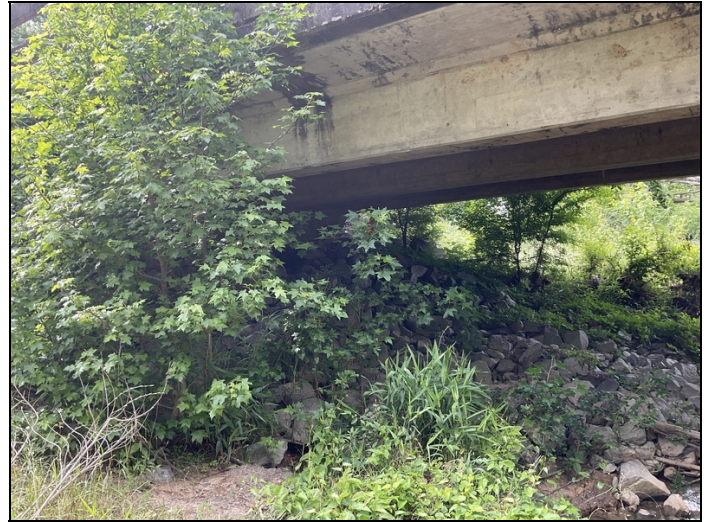
Span 2 vegetation
