Asset #03415(Routine)

SH35 Sec5 Lm 12.42 over BIG CREEK

Location: 4.86 MI W JCT SH 15

Team Lead: Rickie Bratton, Inspection Date: 05/18/2020

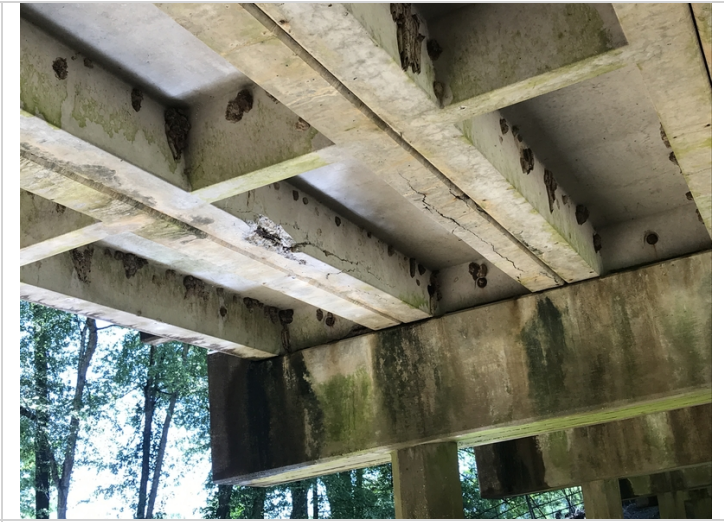
Span 2 unit 2, cracked and spalled with exposed rebar

Channel units have exposed rebar

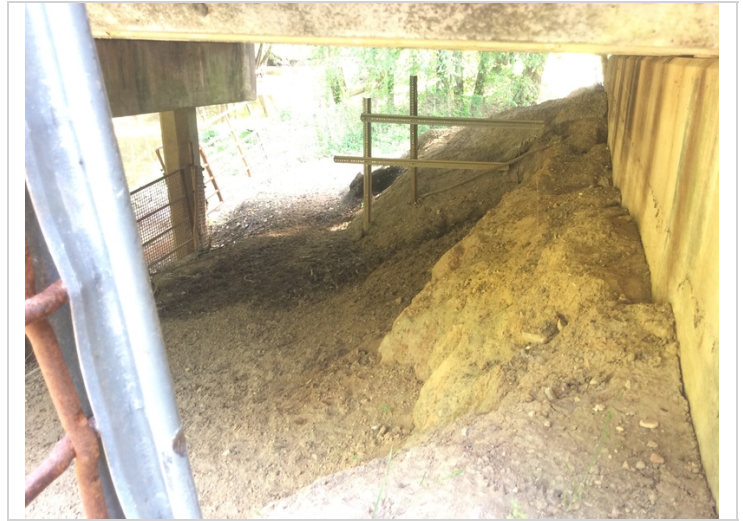
ELEMENTS	DESCRIPTION	UNITS	TOTAL				
				CS1	CS2	CS3	CS4
215	Reinforced Concrete Abutment	LF	50	0	50	0	0
6000	Scour	LF	50	0	50	0	0
(215) Abutment 2 slope is eroded by a farm animal crossing under the structure along the slope and over bank area. Some scouring of opposite stream bank.							
227	Reinforced Concrete Pile	EA	15	0	15	0	0
1190	Abrasion/Wear (PSC/RC)	EA	15	0	15	0	0
234	Reinforced Concrete Pier Cap	LF	125	122	0	3	0
1080	Delamination/Spall/Patched Area	LF	3	0	0	3	0

Comment: Cattle trail crosses from one pasture to another under the structure along the bank and slope of abutment 2. This traffic and flooding have eroded the slope area.

Abutment 2 slope has eroded and cattle are using this to get back & forth from one side of the road to the other & have beaten the abutment slope down at the abutment.

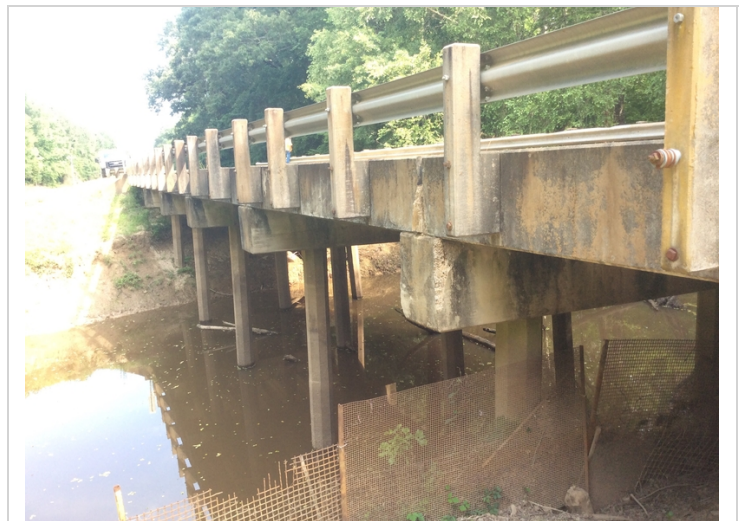
Bent 6 cap has spall on both ahead & back corners of Rt. End of the cap. Also grout between spans 5 & 6 on Rt. end is coming out.

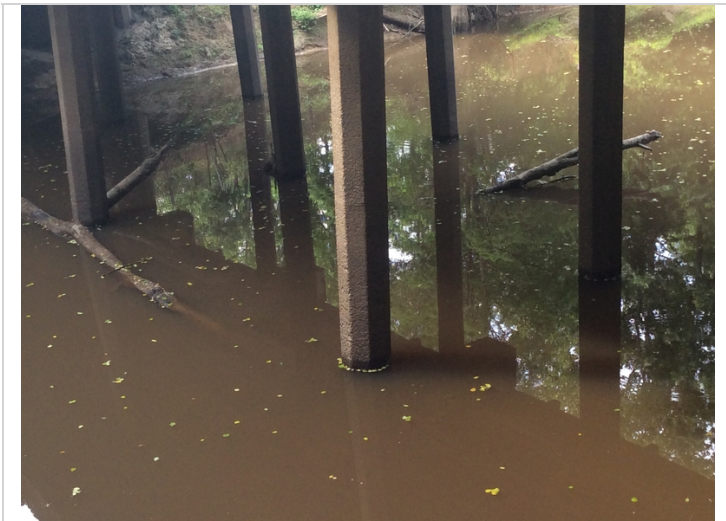
Bent 3 Pile 1 has abrasion & wear 6' - 8' above water line,
this is typical of all piling in bents 2 - 6.
