Asset #03416(Routine)

SH 35 S-5 LM 12.28 over BIG CREEK RELIEF

Team Lead: John Parks, Inspection Date: 07/06/2022

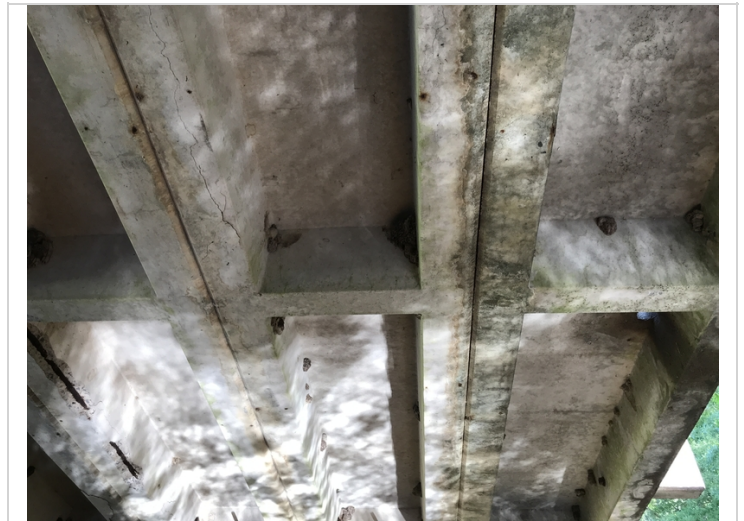
Span 5 Underview

Span 5 units 3,4, & 6, girders have spalls with exposed rebar midspan.(JDP 07/07/2022)

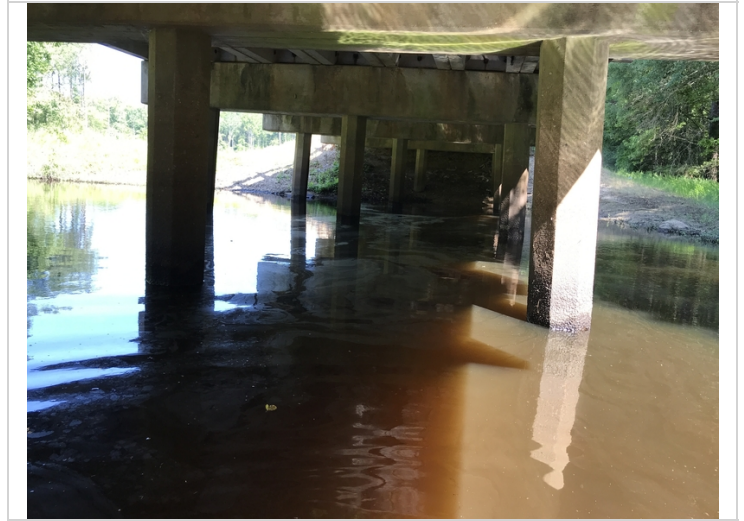
Comment: All columns bents 3-6 are "pebbled" from the high water line down with aggregates showing but still imbedded in the concrete. Approach roadway settlement abutment 1

Piles have abrasion.

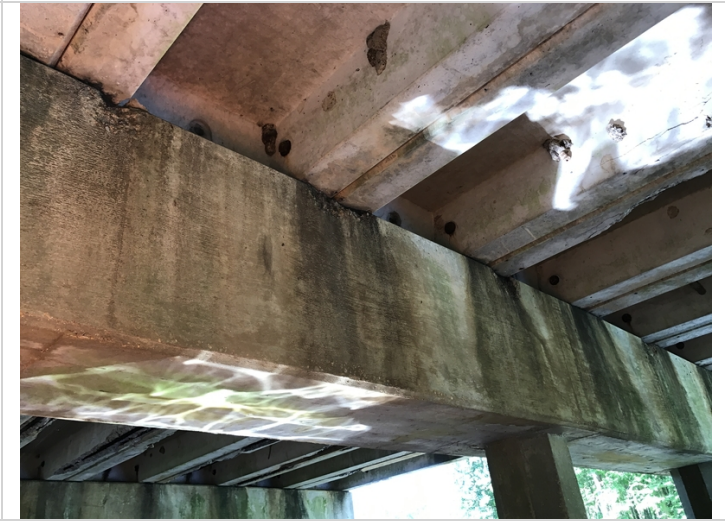
Bt. 6, back side, spalls below girders.

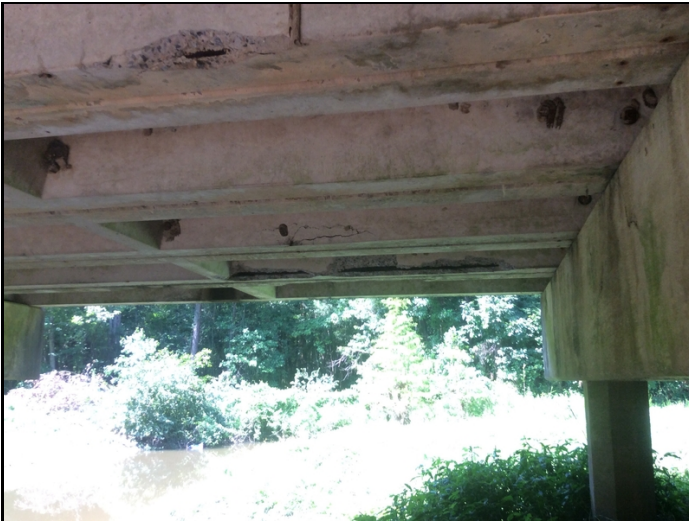
Units 5-6 span 2

Span 2 units 3, 6, & 7 girders have spalls with exposed rebar midspan; unit 3 girder is spalled over cap at Bt. 3.(JDP 07/07/2022)

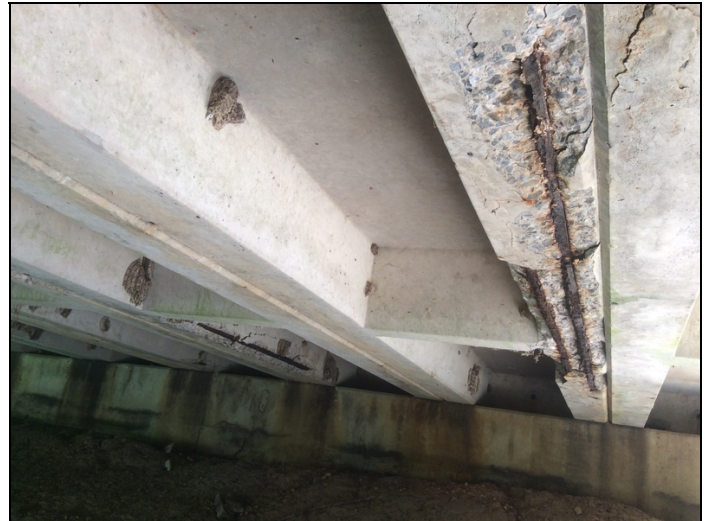
PC Units 2 & 3 span 1

Span 1 units 2,3,4,5,& 7; unit 5 girder is spalled over cap at Bt. 2. (JDP 07/07/2022)

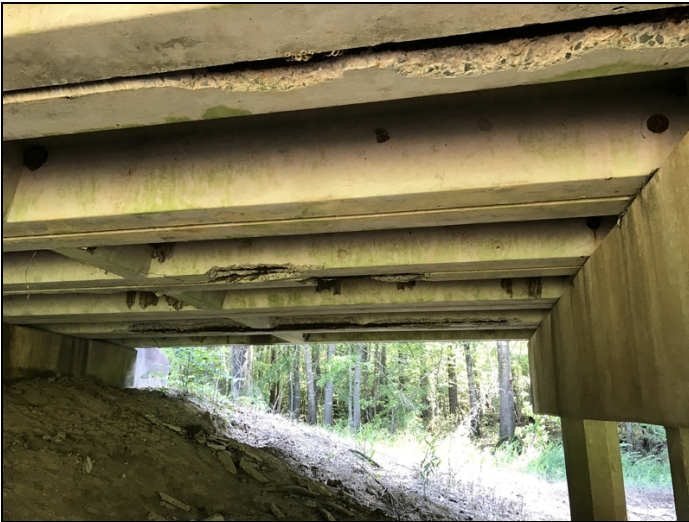
Span 1 units 2,3,4,5,& 7, girder have spalls with exposed rebar.

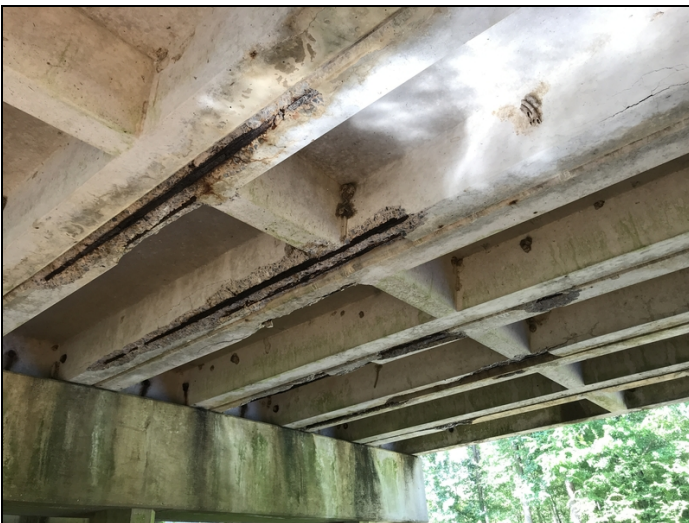
Span six units three thru seven.

Span 6 units 3,4, 5, 6, and 7, girders have spalls with exposed rebar midspan. Unit 5 and 6 girders have spalls with exposed rebar over cap.(JDP 07/07/2022)

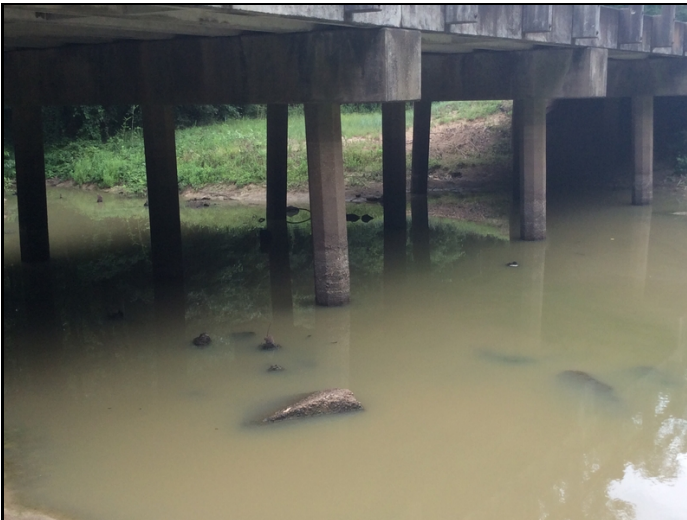
All pile bents 3-6 are "pebbled" from the high water line down with aggregates showing but still imbedded in the concrete.
07/07/2022 - no change JDP.

Abrasion and wear on piles
