Asset #06140(Routine)

SH 35-07 LM 1.01 over Hudgens Creek Relief

Location: 1.01 Mi E ClevelandCo-Rye

Team Lead: Greg Loomis, Inspection Date: 05/24/2023

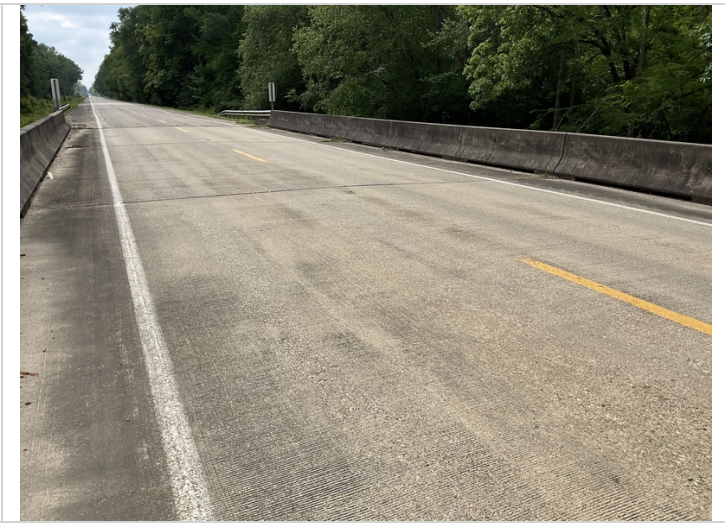
ELEMENTS	DESCRIPTION	UNITS	TOTAL	CS1	CS2	CS3	CS4
38	RC Slab	SF	3447	2358	1089	0	0
1120	Efflorescence/Rust Staining	SF	15	0	15	0	0
1130	Cracking (RC and Other)	SF	234	0	234	0	0
1190	Abrasion/Wear (PSC/RC)	SF	840	0	840	0	0
<p>(38) Deck: 32'-10" wide x 105' long = 3447 sqft.            Some hairline- to minor-sized longitudinal (Span 3 has a hairline longitudinal crack near center line.) and diagonal (corner) cracks, with very little reflective efflorescence on soffit - 234 sqft CS2 cracking.            Light abrasive wear in driving lanes - (2' wide x 4) x 105' long = 840 sqft CS2 abrasive wear.</p> <p>Side of slabs: Some minor vertical cracking with efflorescence near bents at beginning of drain-slots - 15 sqft CS2 efflorescence.</p>

Deck - Spans 1-3: Typical

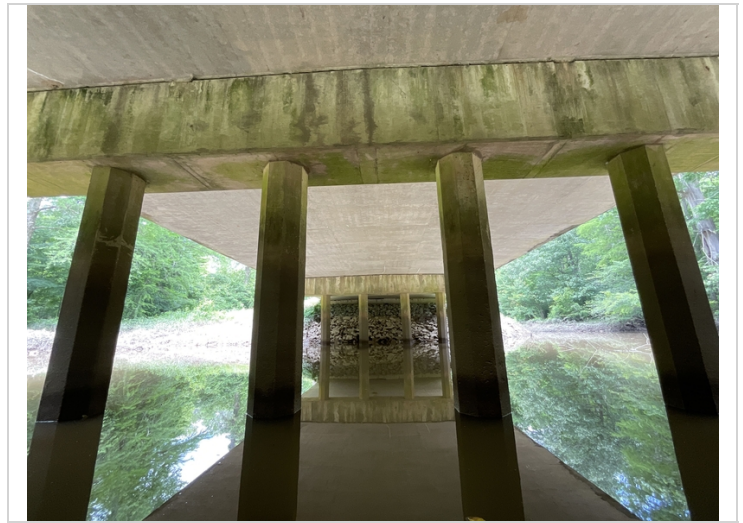
Soffit - Span 2: Typical

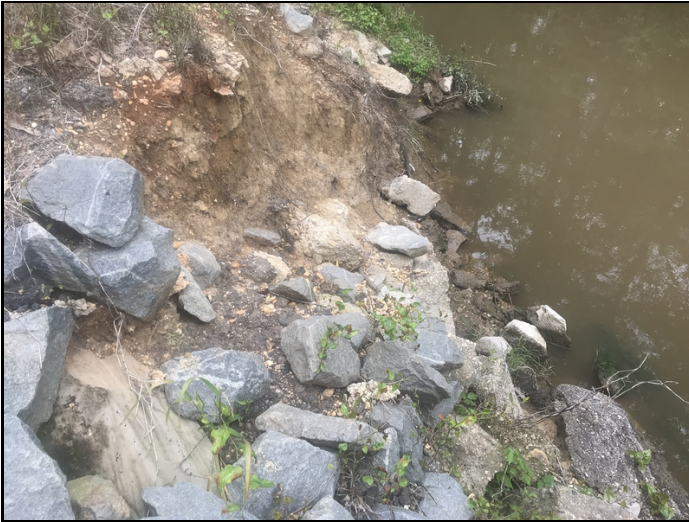
End-slope/channel - Bent 1 left (northwest corner): Some scour/erosion of slope.

Northwest end of bridge has some local scour to embankment at end slope.

**Type of Work:** Channel Work/Drift Removal

**Status:** Monitor
