Asset #06141 (Routine, Underwater type 2)

SH 35-07 LM 1.28 over Hudgins Creek

Team Lead: Sharon Hooks, Inspection Date: 06/14/2022

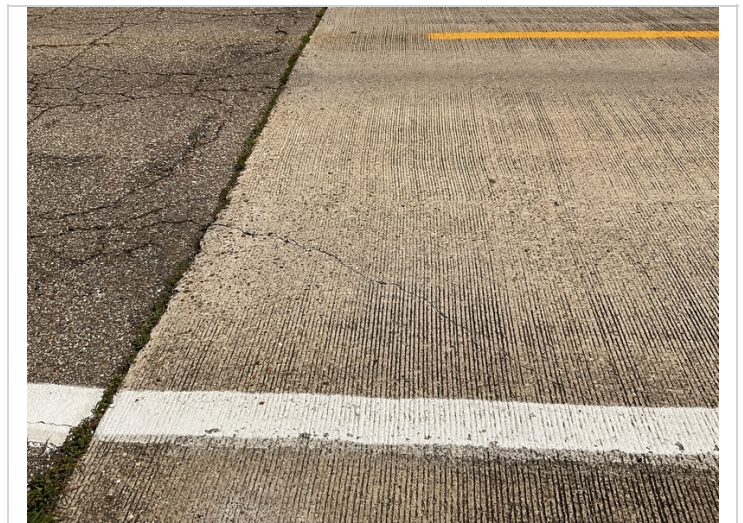
(38) Deck: 32.8' wide x 175 long. Small diagonal cracks on left and right near lane lines of Bents 1, 2, & 5 with some reflective efflorescence on soffit. Scattered longitudinal cracks in all spans - heaviest on centerline and right lane. Sides of slabs have cracking (shear cracks) with light efflorescence.							
215	Reinforced Concrete Abutment	LF	74	74	0	0	0

Span 1 right Shear cracking on corner of deck. And cracking has efflorescence on under side of deck same area.

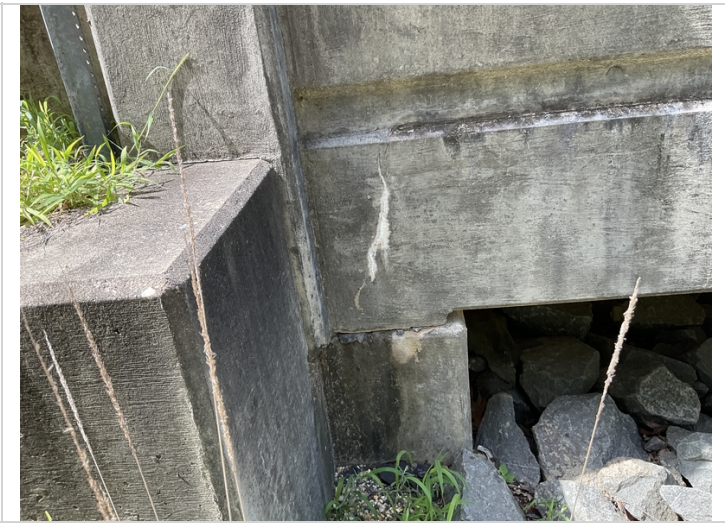
Bent. 6 Shear crack with efflorescence. Common most bents at ends of deck.

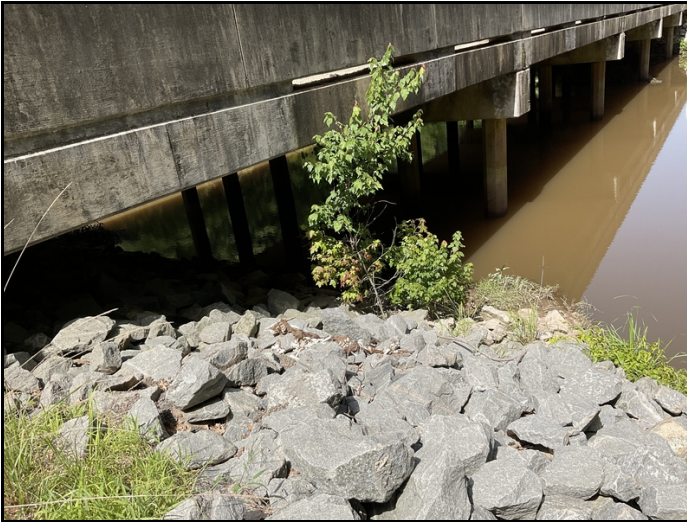
Both ends of Bridge, Trees vines and vegetation growing on and under structure.

Span 5 left tree growing onto soffit of deck.

A-64 - Vegetation Removal Requested

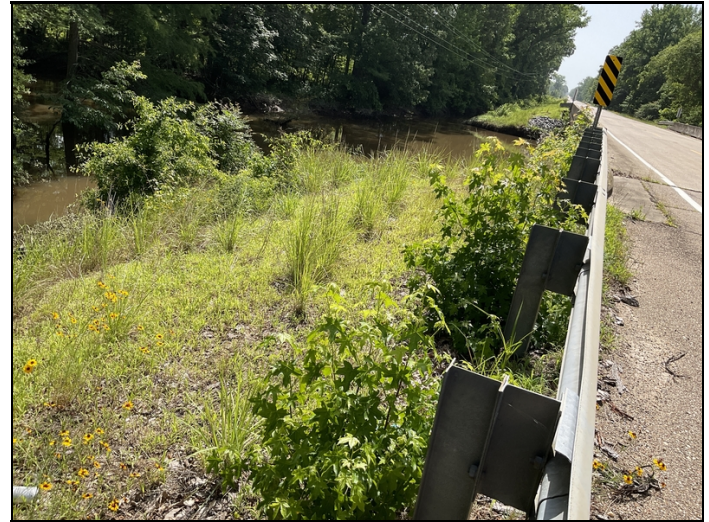
Trees, vines and vegetation on approach under railing and endslopes.

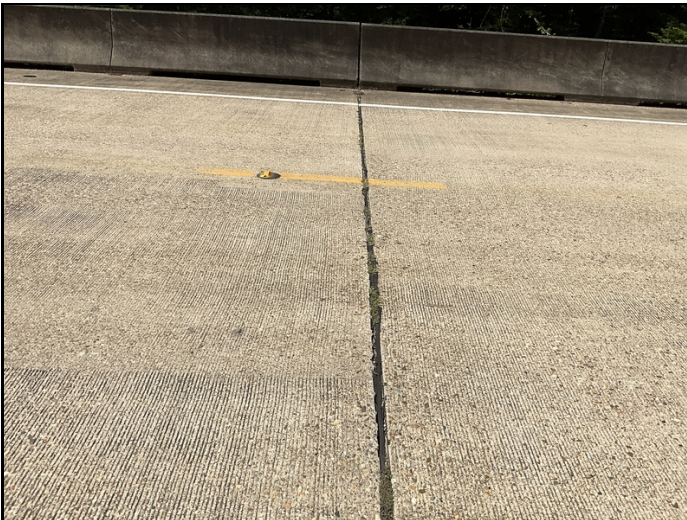
Joints - Bents 2-5: Pourable joint material is intact but has lost adhesion in most places with some very light spalling of adjacent concrete.

Bent 4 joint seals have loss of adhesion.

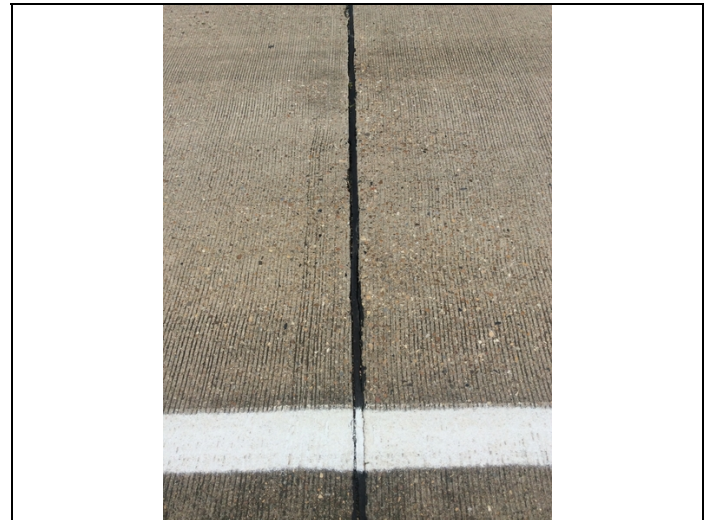
Joint - Bent 3: Loss of adhesion
