Asset #06142(Routine)

SH 35-07 LM 1.50 over Hudgens Creek Relief

Location: 1.50 Mi E ClevelandCo-Rye

Team Lead: Greg Loomis, Inspection Date: 05/24/2023

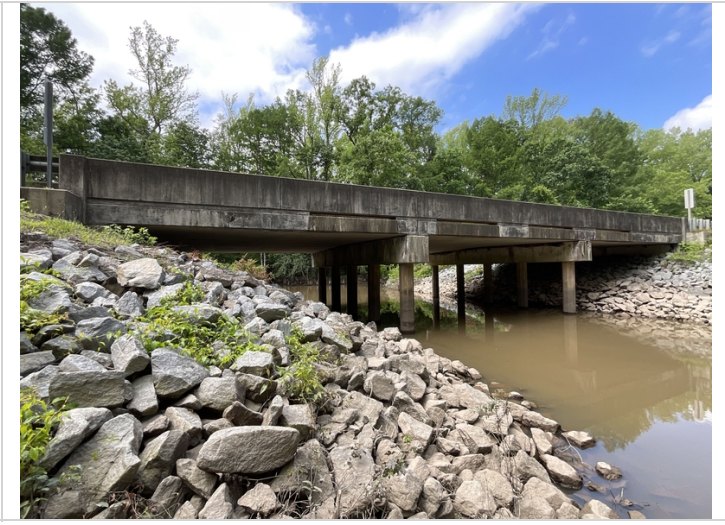
Left side view

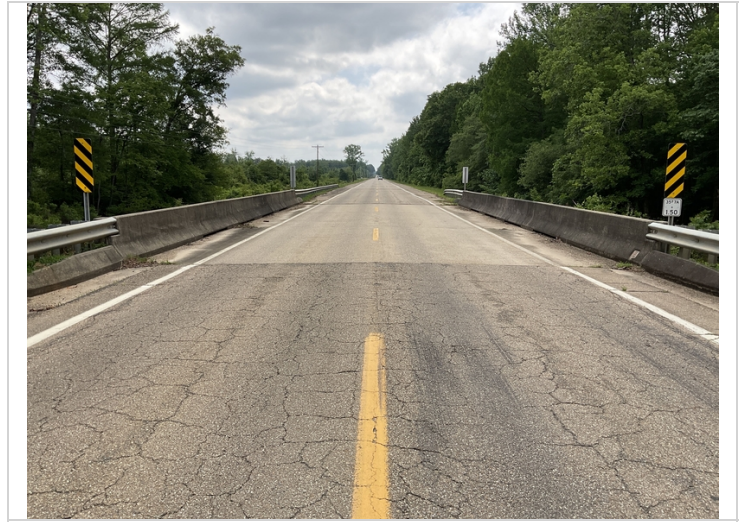
Roadway view

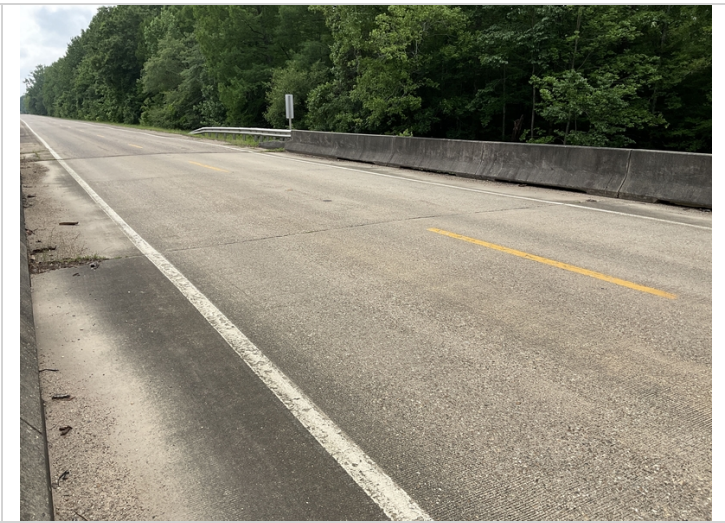
Deck - Spans 1-3: Typical

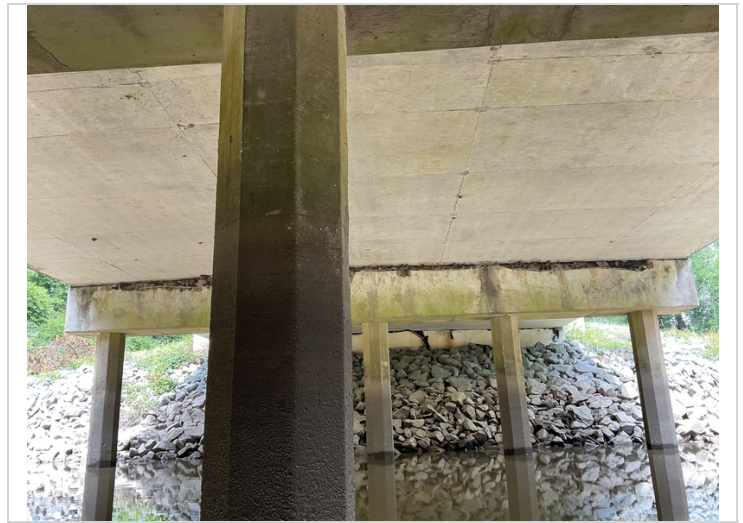
Soffit - Span 2: Typical

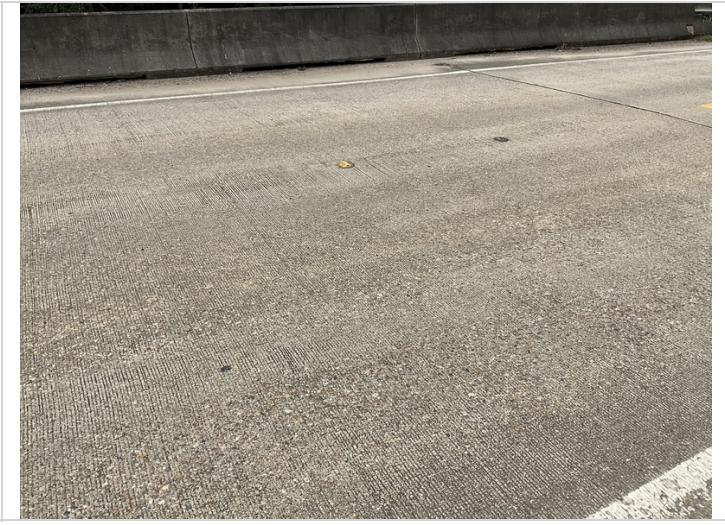
(38) Deck: 32'-10" wide x 75' long = 2462 sqft. Some hairline- to minor-sized longitudinal and diagonal (corner) cracks, with very little reflective efflorescence on soffit - 81 sqft CS2 cracking. Light abrasive wear in driving lanes - (2' wide x 3) x 75' long = 450 sqft CS2 abrasive wear.  Side of slabs: Some minor vertical cracking with efflorescence near bents at beginning of drain-slots - 3 sqft CS2 efflorescence.							
215	Reinforced Concrete Abutment	LF	96	96	0	0	0

Deck - Span 2: Abrasive wear

**A-61 - Polymer Overlay Advised (Yes)**
